The Multi-Purpose Bottom Plug for the Galataport Project

Salvatore Miranda, Technical Manager, TREVI Turkey, Istanbul (Turkey); email: smiranda@trevispa.com

ABSTRACT: The paper describes an innovative geotechnical engineering solution that was provided by TREVI for the renovation project at Galataport in Istanbul, Turkey. Among other interesting geotechnical works included in the project, this paper also presents the design considerations and construction of the multi-purpose bottom plug (MPBP). This original geotechnical engineering solution was employed for a three-basement excavation in Karaköy and consists of a combination of seepage control, ground improvement, and load bearing elements, which were executed with double-fluid jet grouting, pseudo-elliptical jet grouting, and permanent micropiles, respectively. The paper describes each step of the design, execution, and the preliminary and final testing phases. Moreover, it highlights the importance of employing cutting-edge technologies used in deep foundation geo-construction and state-of-the-art electronic control devices, along with expertise, to obtain the desired results for this high-profile project.

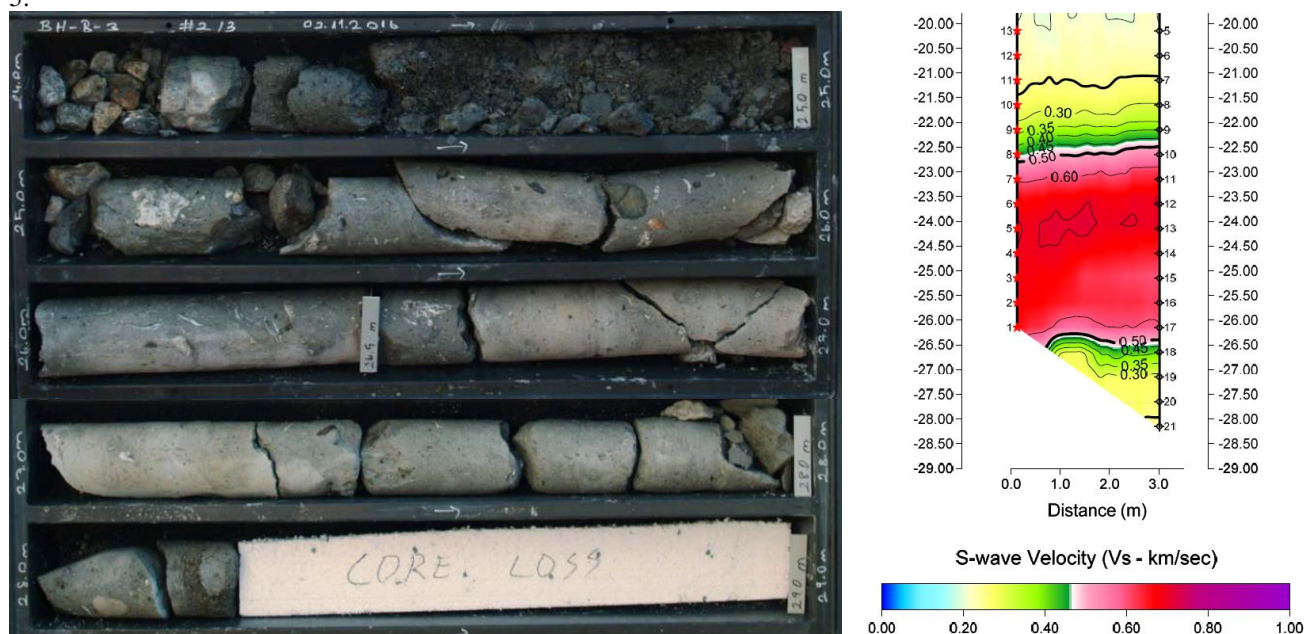
Figure 25. Core box photos of coring BH-B-3 between 24 and 29 m depth. Measured V_s across overlapping columns.

group of six overlapping columns (B-JG-3 to 8) at the design depth of bottom plug. Two continuous corings were executed in the overlapping zones and one seismic crosshole tomography line was also conducted across the columns to verify the presence and quality of the overlapping. Pictures of one coring (BH-B-3) and measured values of shear wave velocity (V_s) can be found in Figure 25. The results of the seismic crosshole tomography executed on the overlapping columns show a full overlapping and continuity in the block of treated soil without relevant defects. The median measured value of V_s was 640 m/s.

Several cracks were visible on the extracted core, which could be due to the coring effects but could be also related to the overlapping of two different jet grouting columns.

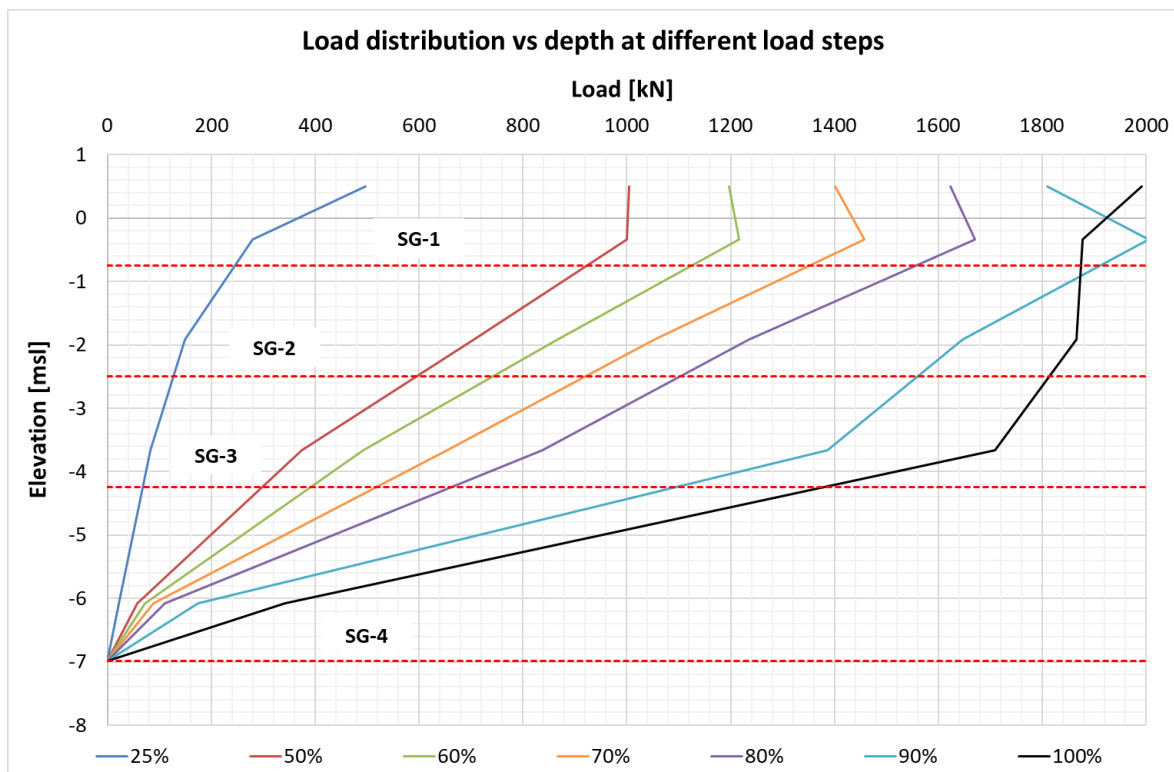
Figure 37. Load distribution at different load steps.

The load distribution (Figure 37) and relevant t-z curves along the micropile shaft (Figures 38 and 39) were calculated according to Fellenius et al (2000). It was possible to see that in the top portion of micropile near ground surface, the limit shaft friction is about 25 to 30 kPa and 300 to 350 kPa at the micropile-to-jet grouting interface and at the jet grouting-to-soil interface, respectively. At greater depths, the shaft friction values of 57 kPa and 720 kPa were achieved at micropile shaft and jet grouting shaft, respectively.

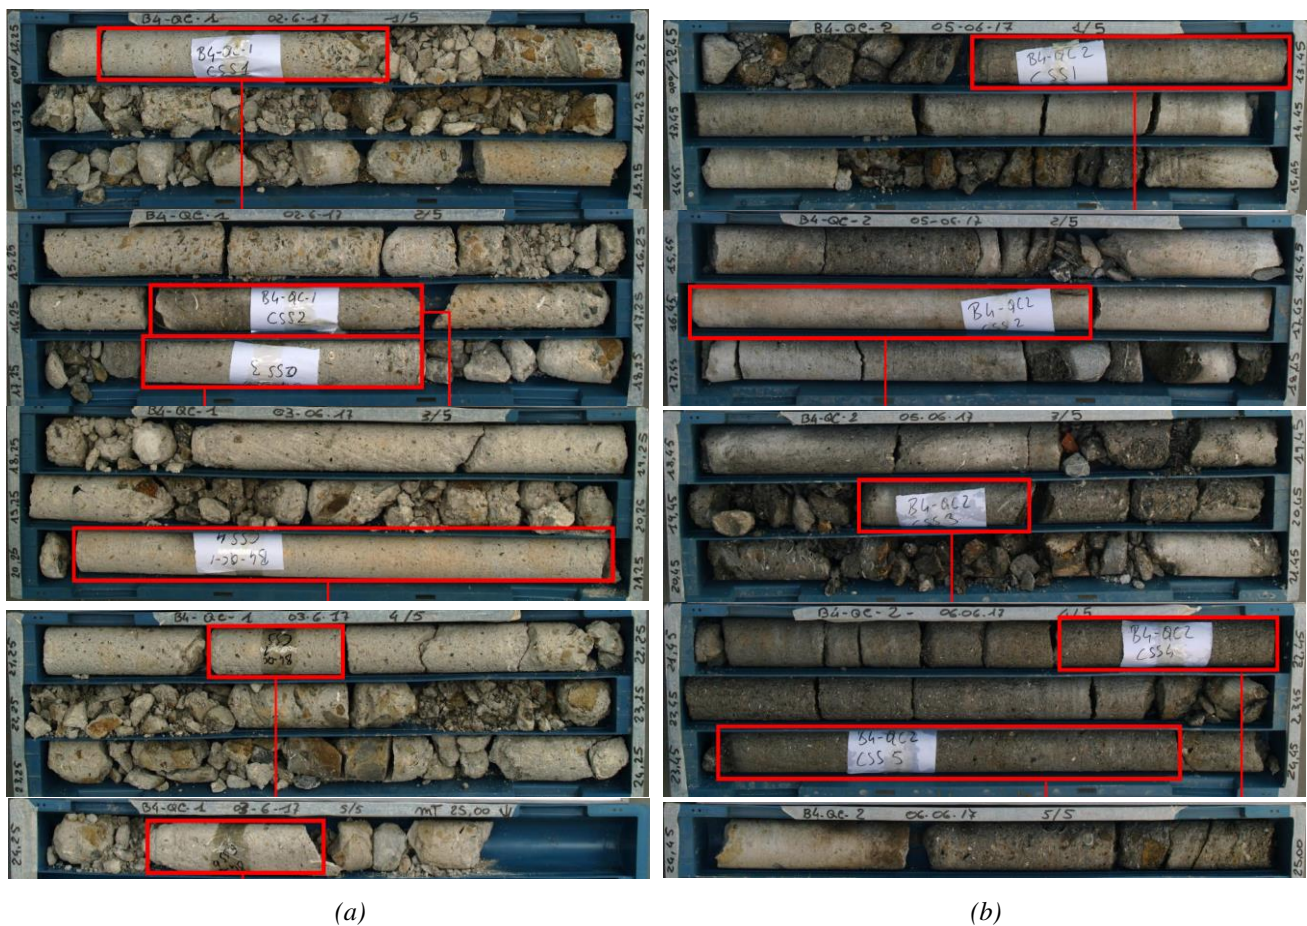
Figure 50. Core box photos of executed continuous coring: (a) QC-1 and (b) QC-2.
