The Multi-Purpose Bottom Plug for the Galataport Project

Salvatore Miranda, Technical Manager, TREVI Turkey, Istanbul (Turkey); email: smiranda@trevispa.com

ABSTRACT: The paper describes an innovative geotechnical engineering solution that was provided by TREVI for the renovation project at Galataport in Istanbul, Turkey. Among other interesting geotechnical works included in the project, this paper also presents the design considerations and construction of the multi-purpose bottom plug (MPBP). This original geotechnical engineering solution was employed for a three-basement excavation in Karaköy and consists of a combination of seepage control, ground improvement, and load bearing elements, which were executed with double-fluid jet grouting, pseudo-elliptical jet grouting, and permanent micropiles, respectively. The paper describes each step of the design, execution, and the preliminary and final testing phases. Moreover, it highlights the importance of employing cutting-edge technologies used in deep foundation geo-construction and state-of-the-art electronic control devices, along with expertise, to obtain the desired results for this high-profile project.

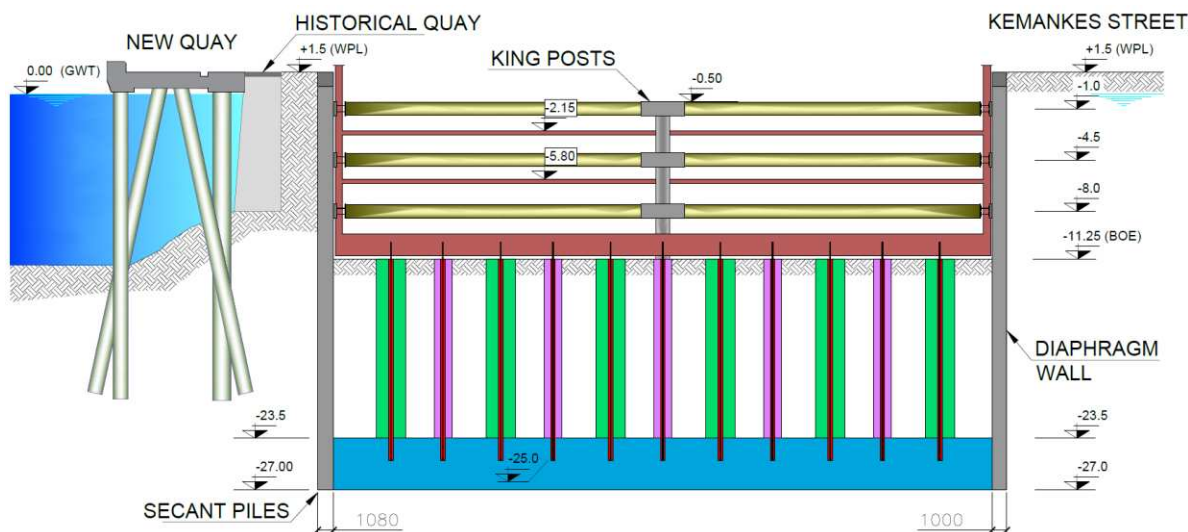
Figure 9. Section view of Bina 4 geotechnical works.

- Difficulties related to the lateral support of shoring. The site condition surrounding the shoring did not allow the installation of ground anchors. Therefore, a steel propping system, composed of 3 levels of 36 struts, was designed and constructed as lateral support of the shoring. This complicated the construction phases of the building with strut installation and removal phases and also complicated the logistics of the site due to the need of a tower crane and no free space for its installation. Horizontal struts were designed to span from the seaside to the roadside shoring, while inclined struts were designed for the four corners. Due to the significant length of the horizontal struts (about 45 m), it was decided to utilize intermediate king post piles to increase the buckling resistance of the strutting system. Moreover, king post piles were specially designed to be used also as the foundation of the tower crane so that one of the difficulties related to site logistics could be addressed (Figures 8 and 9).

To resist the uplift water pressure acting beneath the building during and after its construction, a system of DCP steel bars was designed (Figure 19). Once the jet grout column had reached an adequate value of unconfined compressive strength, the permanent micropiles were installed within a 250 mm drill hole and were installed through the elliptical jet grout column (Figure 20). In this way, the greater cross section of elliptical jet grouting column was used for facilitating the transfer of tensile force from the steel bar to the in-situ soil. Only in Bina 4 where the total uplift force was significant, extra 2,000 mm jet grout columns were installed in between the lattice-type grid, with the only scope of allowing the installation of the necessary number of permanent micropiles. Such circular jet grouting columns were shown in green in Figures 8 and 9.
