The Multi-Purpose Bottom Plug for the Galataport Project

Salvatore Miranda, Technical Manager, TREVI Turkey, Istanbul (Turkey); email: smiranda@trevispa.com

ABSTRACT: *The paper describes an innovative geotechnical engineering solution that was provided by TREVI for the renovation project at Galataport in Istanbul, Turkey. Among other interesting geotechnical works included in the project, this paper also presents the design considerations and construction of the multi-purpose bottom plug (MPBP). This original geotechnical engineering solution was employed for a three-basement excavation in Karaköy and consists of a combination of seepage control, ground improvement, and load bearing elements, which were executed with double-fluid jet grouting, pseudo-elliptical jet grouting, and permanent micropiles, respectively. The paper describes each step of the design, execution, and the preliminary and final testing phases. Moreover, it highlights the importance of employing cutting-edge technologies used in deep foundation geo-construction and state-of-the-art electronic control devices, along with expertise, to obtain the desired results for this high-profile project.*

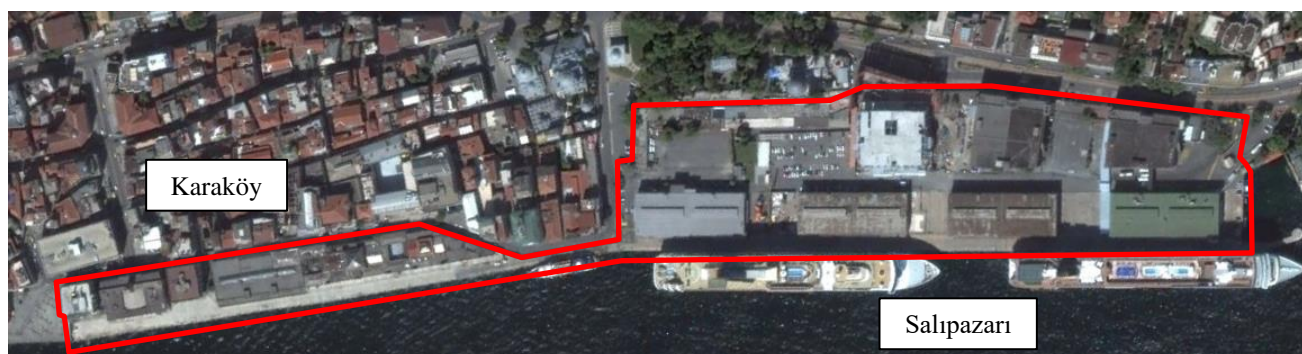
Figure 1. Satellite view of the site before the renovation project's commencement.

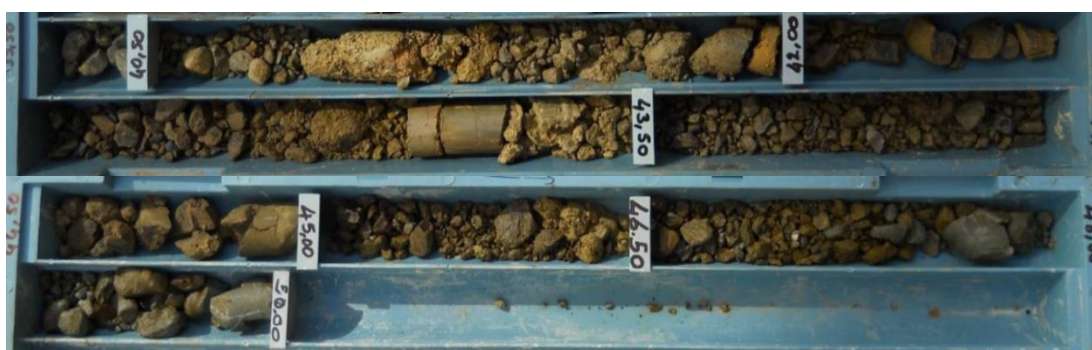
Figure 7. Very weathered GREYWACKE.

The thick fill layer is underlain by a layer of very loose silty sand that is about 5 m to 10 m thick. The bedrock is a very strong, very fractured Greywacke (UCS = 100 to 150 MPa), with the top 10 m to 15 m thickness being very weathered, as shown in Figure 7. The bedrock is located at a depth between 35 m and 45 m below the existing ground level, which is deeper than the geotechnical activities involved in this area; therefore, all structures were executed within the man-made fill and the underlying marine sand layer. The thick fill/sand layer contains a small amount of fine material and is classified as loose-to-very-loose (SPT N-values = 0 to 15 blow/0.3 m, $q_c = 0.5$ to 3.0 MPa), with a high liquefaction risk. The permeability of this layer was assessed to be in the range of 10^{-4} m/s.

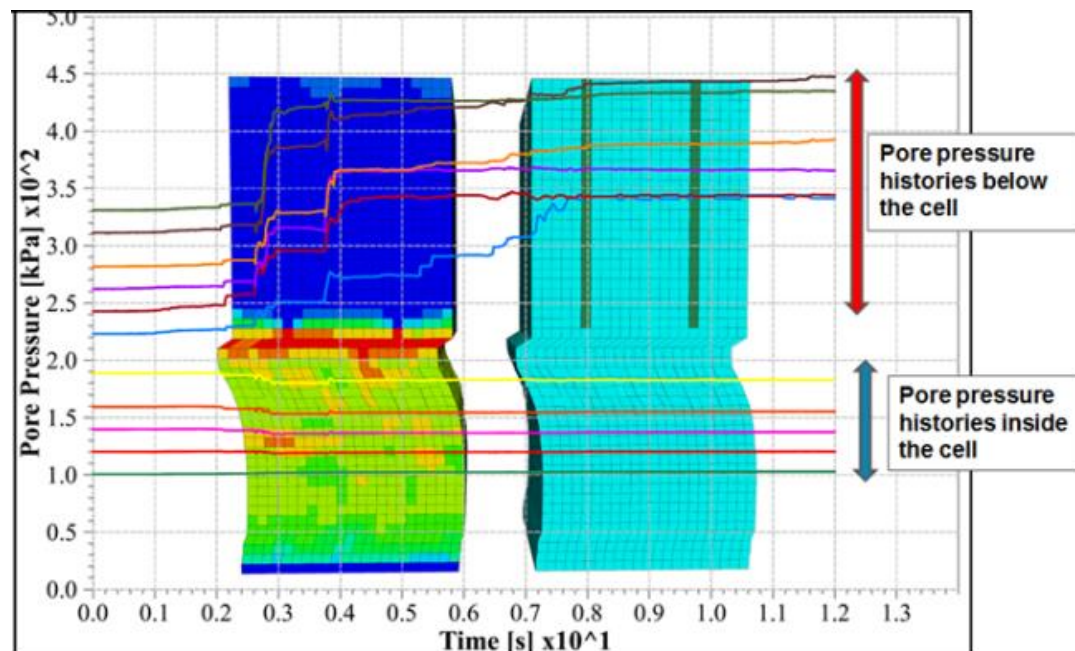
Figure 17. Pore pressure history and Max R_u in improved soil.

The results of the main analysis are shown in Figures 16 and 17: the red points are those where the ratio R_u between the excess pore pressure and the effective vertical stress reach the value of 1. It is possible to notice that, in natural soil, liquefaction occurs down to a depth of 24 m below the groundwater table. Instead, in the presence of the soil improvement, the value of R_u approaches 1 in just a thin band beneath the soil treatment. The 7 m x 7 m grid was selected; the 10 m x 10 m option provided satisfactory results but presented some local liquefaction phenomena at the surface of the excavation.

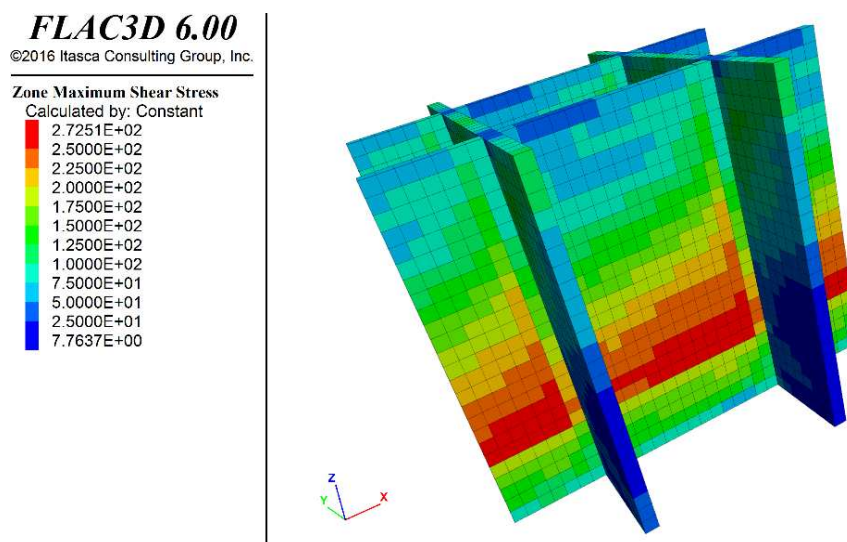
Figure 18. Maximum recorded shear stress in jet grouting cell, expressed in kPa.

The maximum recorded shear stress in lattice-type jet grouting is shown in Figure 18 below and is expressed in kPa.

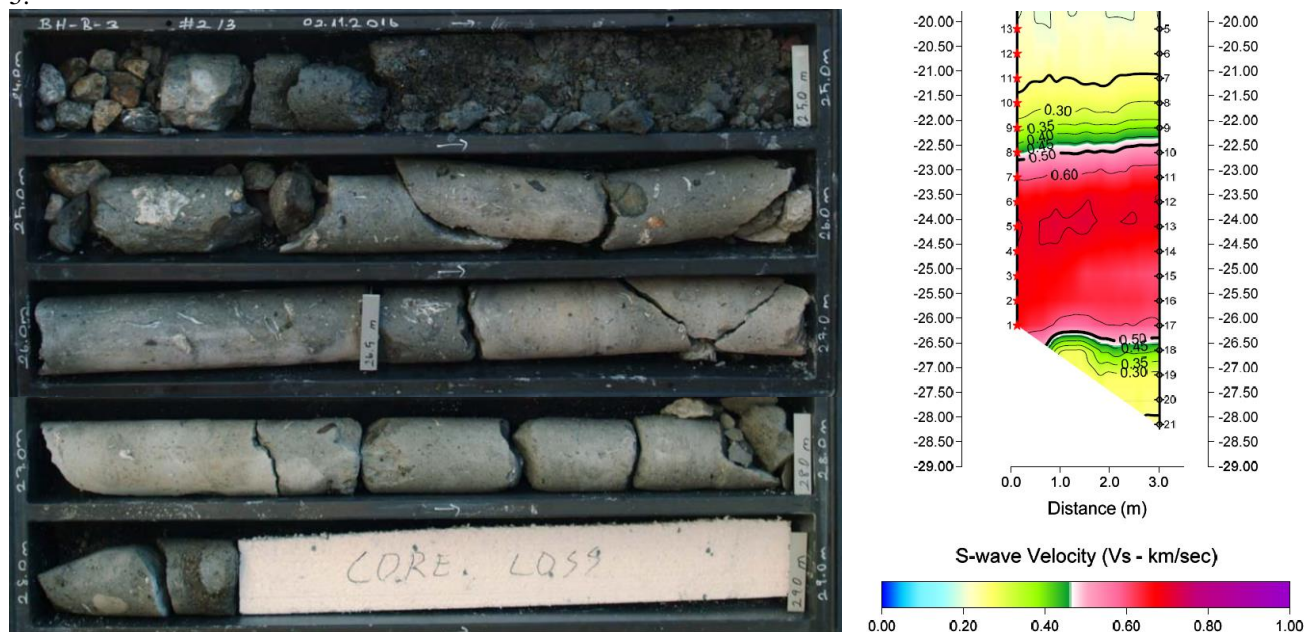
Figure 25. Core box photos of coring BH-B-3 between 24 and 29 m depth. Measured V_s across overlapping columns.

Several cracks were visible on the extracted core, which could be due to the coring effects but could be also related to the overlapping of two different jet grouting columns.

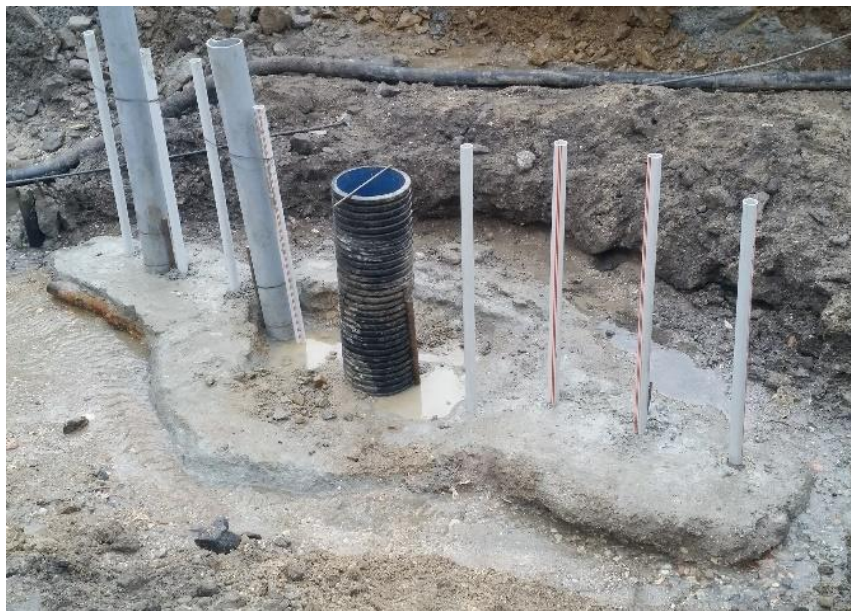
Figure 30. (a) Exposed jet grouting column and preparation for drilling; (b) Installation of instrumented DPC bar, with visible vibrating wire miniature embedment strain gauges; and (c) General view of test set-up.

To monitor the strain development along the micropile shaft, two sets of vibrating wire miniature embedment strain gauges were installed at 4 levels along the DCP bar: at El. -6.00 m, El. -4.25 m, El. -2.50 m, and El. -0.75 m msl. For measuring the strain development inside the jet grouting column, two sets of 4 retrievable extensometers were installed at a distance of 0.5 m (EXT-B) and 1.5 m (EXT-A) from the micropile axis. Extensometers were inserted inside 51 mm diameter steel pipes, which were previously drilled and grouted. Two tell tale rods were used to measure the total pile extension and 14 displacement transducers (POTs) were needed to monitor the uplift at the surface at different locations. An automated digital survey level was used for monitoring the movement of the reference beam (precision of ± 0.01 mm) during the testing. Displacement, load, and strain data were automatically recorded at 30 second intervals. The main test geometry and general instrumentation layout are shown in Figures 29 and 30.

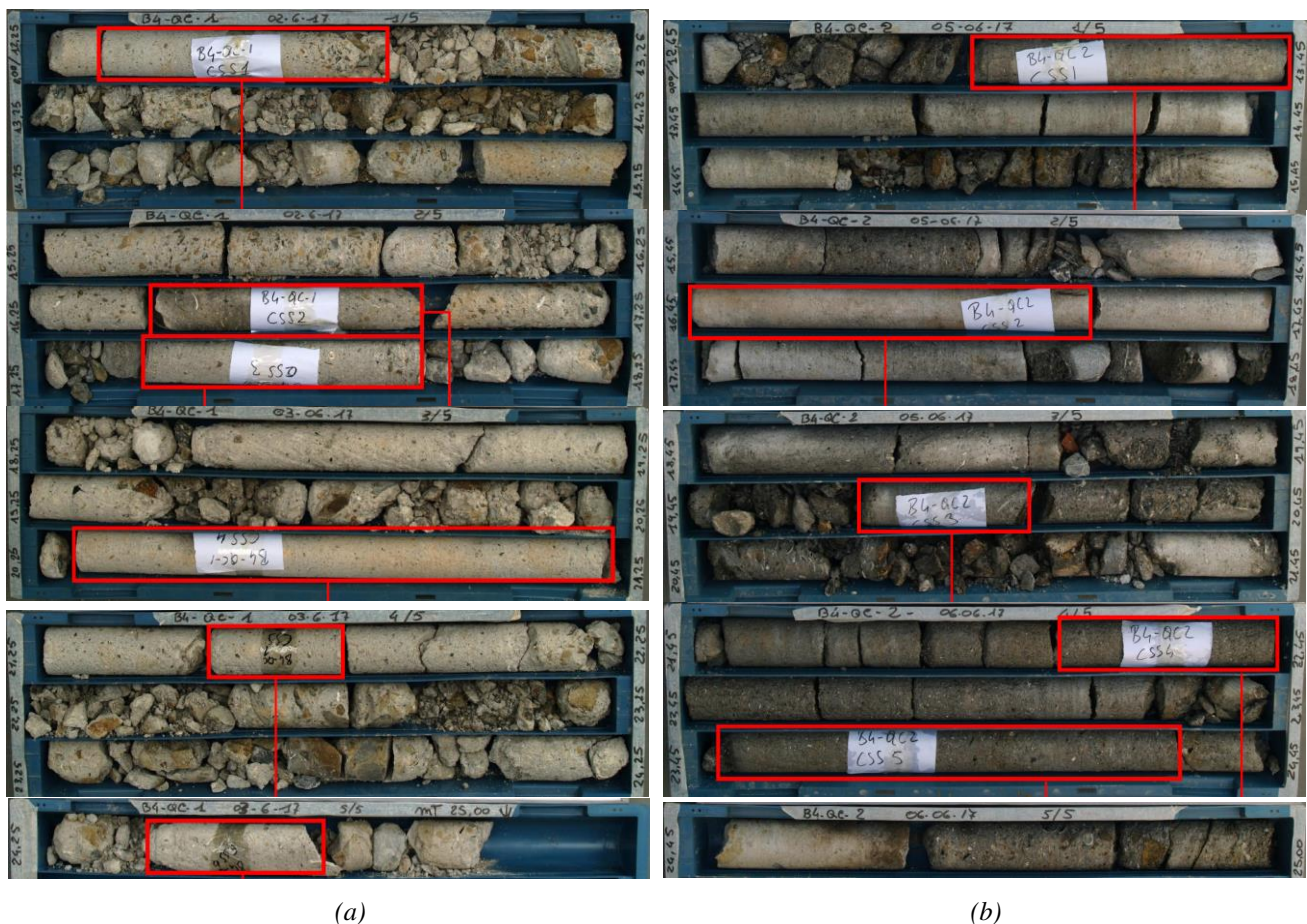
Figure 50. Core box photos of executed continuous coring: (a) QC-1 and (b) QC-2.

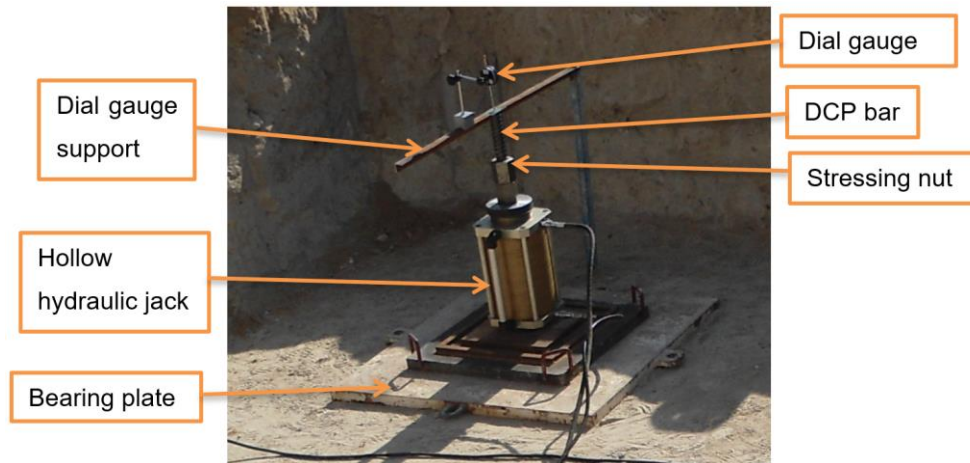
Figure 51. Typical arrangement of acceptance test.

Once the final excavation level was reached, all permanent micropiles were subjected to acceptance testing up to 125% of the design working load (test load of 1,731 kN and design working load of 1,385 kN) to evaluate the micropile response. The typical acceptance test arrangement is shown in Figure 51.
