40 Years of Full-Scale Infrastructure Testing at a National Geotechnical Experimentation Site: Sand Site.

ABSTRACT: A site at the Texas A&M University RELLIS campus near College Station, Texas, was dedicated to full-scale infrastructure testing in 1978. It was designated as a National Geotechnical Experimentation Site by NSF and FHWA in 1992. The site is made of 15 m of medium dense silty sand, within which most experiments took place, underlain by a deep layer of clay shale. The water table is approximately 7.5 m deep. Over the last 40 years, many full-scale instrumented experiments on infrastructure elements have been conducted at that site. The main projects include a box culvert within an embankment, spread footings of various sizes, drilled shafts with intentional construction defects, an anchored top down retaining wall, a top down deep-soil-mixing retaining wall, post grouted drilled shafts, vibro-driven steel piles, a drilled shaft embedded in an MSE wall and pushing on it, a tractor trailer truck crashing against a barrier on top of an MSE wall, a single unit truck crashing against a row of in line piles, and erosion in-situ tests. This paper describes each one of those p

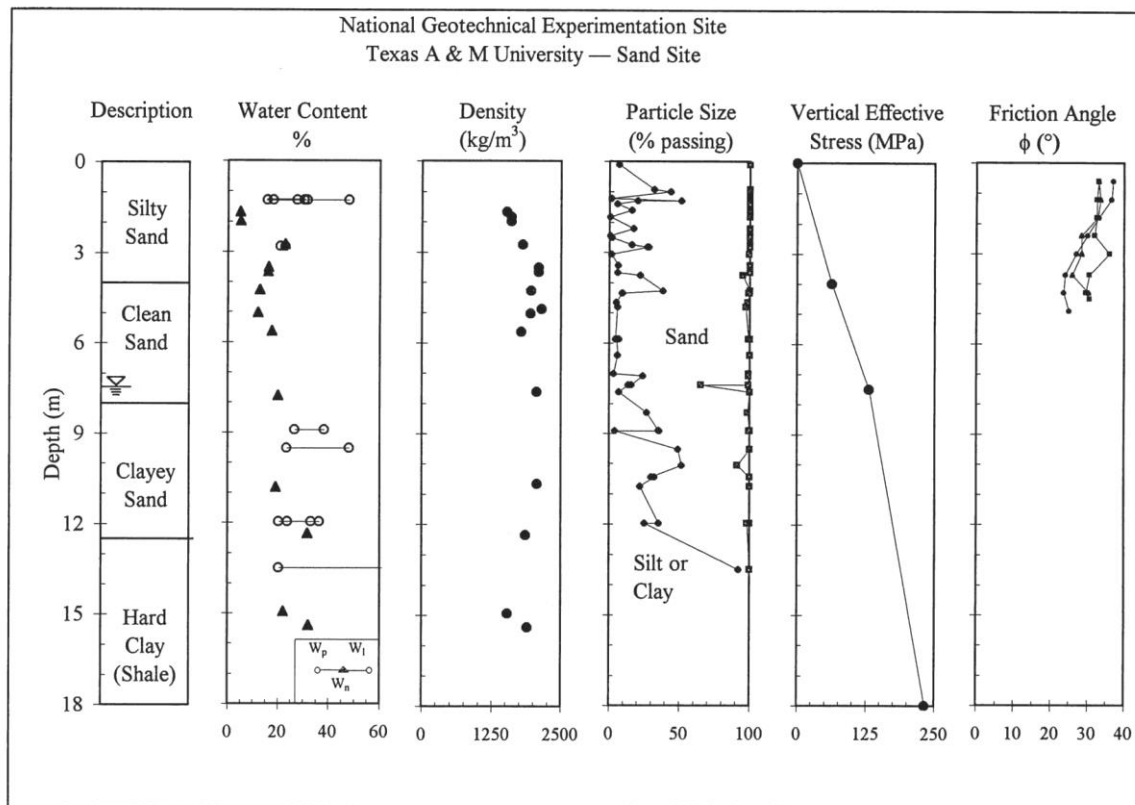
Figure 2. Laboratory test results (Briaud, 1997).

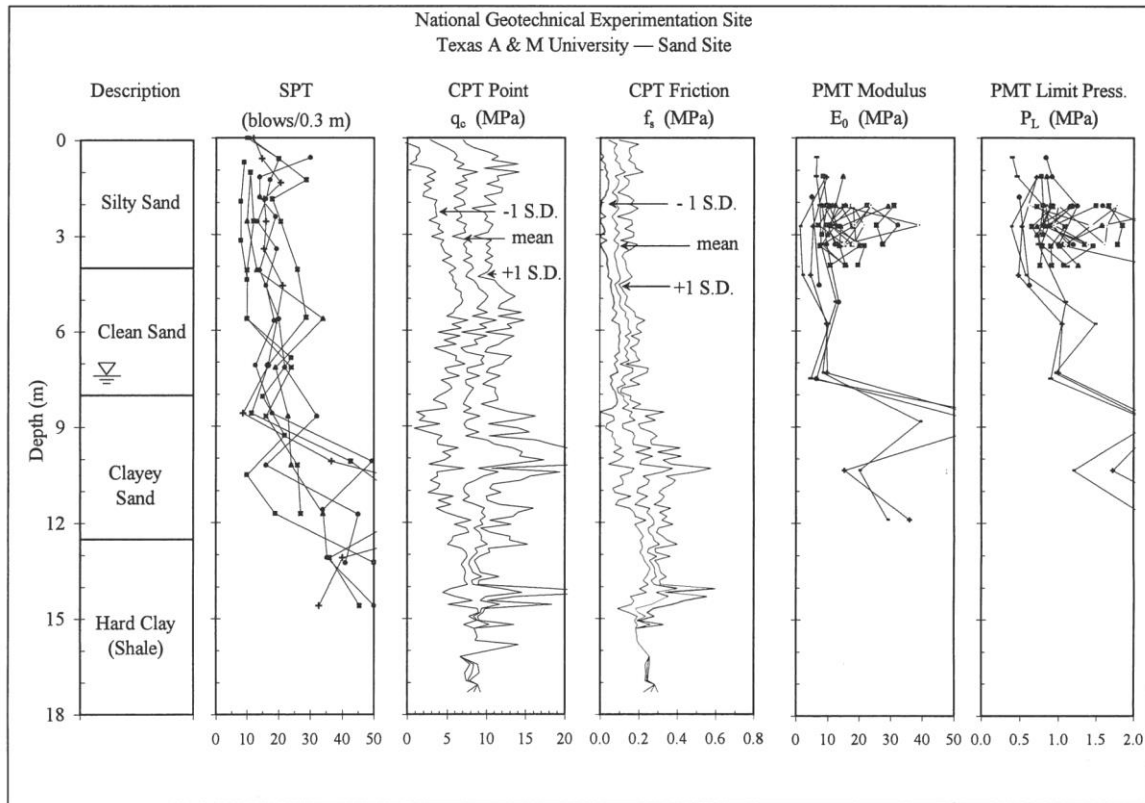
Figure 3. In-situ test results (Briaud, 1997).

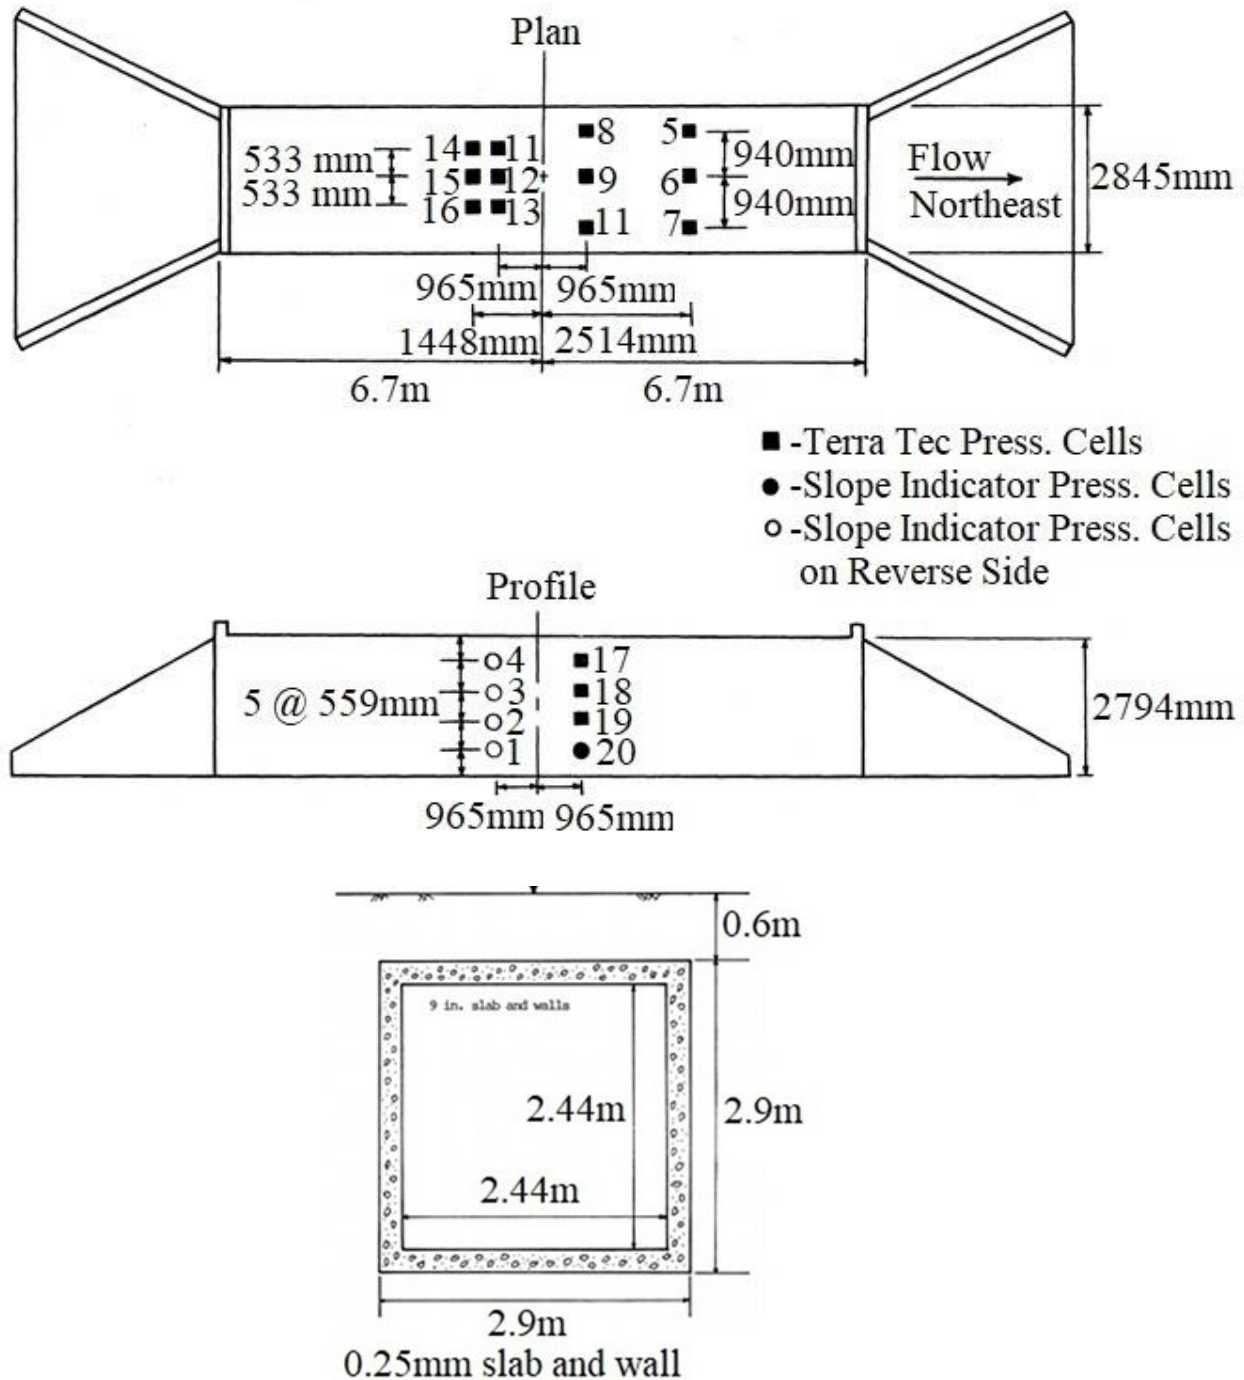
Figure 4. Culvert and location of pressure cells (after James et al., 1986).

This project started in 1982 and consisted of constructing a concrete box culvert, instrumenting it with pressure cells and recording the pressure generated by the fill placed on top of it and by a heavy truck passing over it (James et al., 1986). The inside dimensions of the culvert were 2.44 m wide, 2.44 m high, and 13.42 m long (Fig. 4). The roof and walls of the culvert were 200 mm thick and made of reinforced concrete. It was instrumented with 20 pressure cells, 12 on the top and 4 on each side, as well as strain gages in the concrete reinforcement. An embankment was built with the sand from the site in a direction perpendicular to the culvert main axis. Thus, the fill was a poorly graded red silty sand with 89 % finer than 0.425 mm (sieve no.40) and 8.3% finer than 0.075 mm (sieve no. 200).

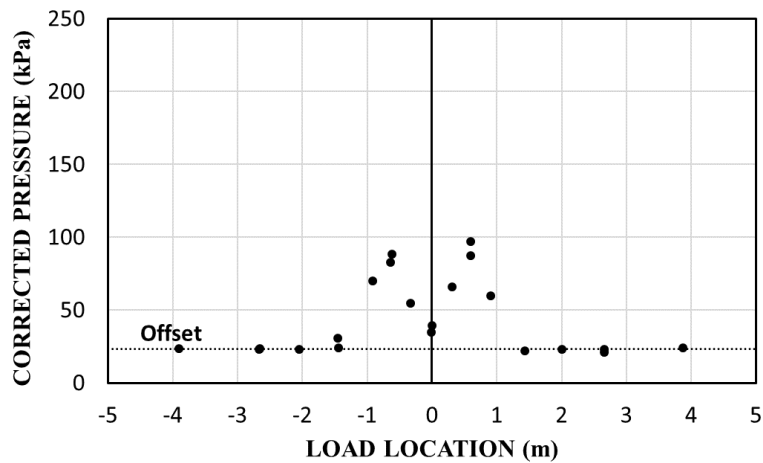
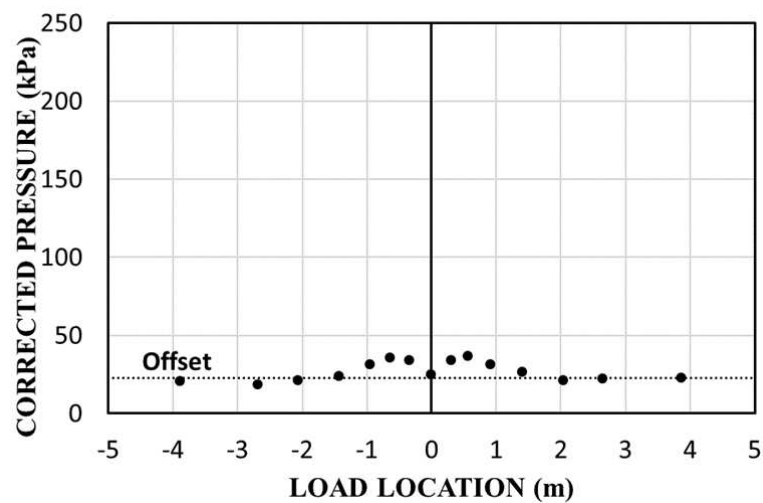
Figure 7. Pressure on top of the culvert for different heights of cover as the truck passes:
a) 0.2 m of cover, b) 0.61 m of cover, c) 1.22 m of cover (after James et al., 1986).

Indeed, for a 0.25 m diameter loaded area of the tire, as discussed above, the vertical stress increase at a depth of 0.20 m, or 0.8 times the diameter of the loaded area, was 0.44 times the pressure at the surface according to the elastic approach. This would be $0.44 \times 550 \text{ kPa} = 242 \text{ kPa}$ while the maximum recorded pressure in that case was 190 kPa. At a depth of 0.61 m, the stress increase was 69 kPa—more than that given by the elastic approach for one tire (39 kPa), likely because of the overlap of stress bulbs between the two tires on one side of the axle. At a depth of 1.22 m, the vertical stress increase under the tires was insignificant. The horizontal pressure on the pressure cells mounted on the side walls of the culvert indicated pressures about two times higher than the active pressure and was likely induced by the compaction process (Fig. 8).

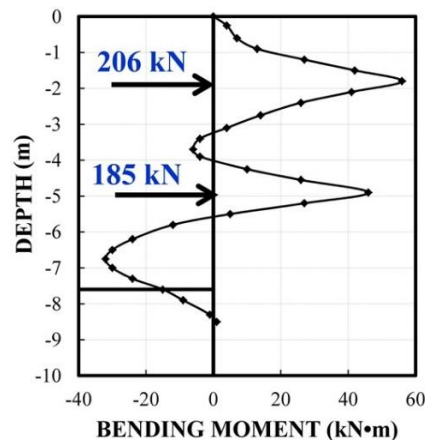
Figure 19. Wall bending moment profile at end of construction for two rows of anchors (after Chung, Briaud, 1992).

Figs. 18, 19, and 20 show the average results for the section of the wall with two rows of anchors. Fig. 18 shows the horizontal deflection profile at the end of construction, Fig. 19 shows the bending moment profile, and Fig. 20 depicts the vertical load in the soldier piles. The same results are shown for the section of the wall with the one row of anchors in Figs. 21, 22, and 23. One of the many lessons learned from this project was that to limit the horizontal deflection of a tieback wall, the wall must have good vertical capacity. Indeed, such walls are subjected to significant downdrag from the retained mass (Figs. 20, 23), which is likely to induce settlement of the facing. This settlement generates rotation around the back of the anchors and an associated horizontal movement even if the anchors properly resist the horizontal load. Another outcome was the development of P-y curves, which do well in predicting the bending moment distribution in the soldier piles. The P-y curve approach was unable to accurately predict the deflection; only the finite element method could accomplish a good fit.

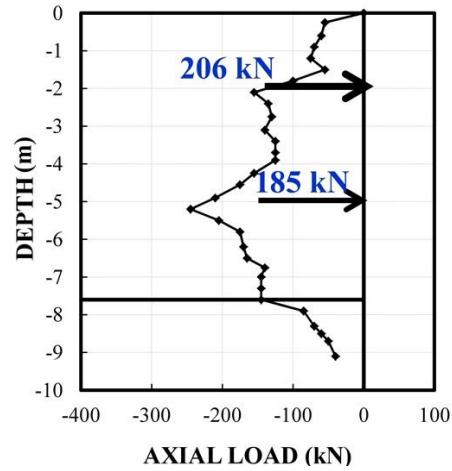
Figure 20. Wall vertical load at end of construction for two rows of anchors (after Chung, Briaud, 1992).

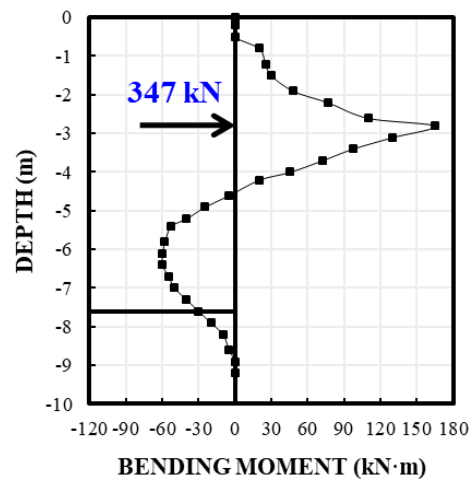
Figure 22. Wall bending moment profile at end of construction for one row of anchors (after Chung, Briaud, 1992).

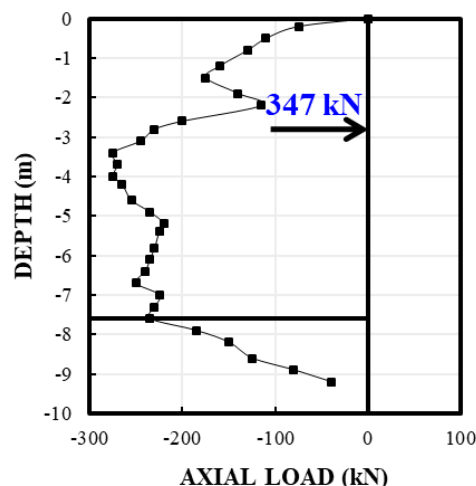
Figure 23. Wall vertical load at end of construction for one row of anchors (after Chung, Briaud, 1992).

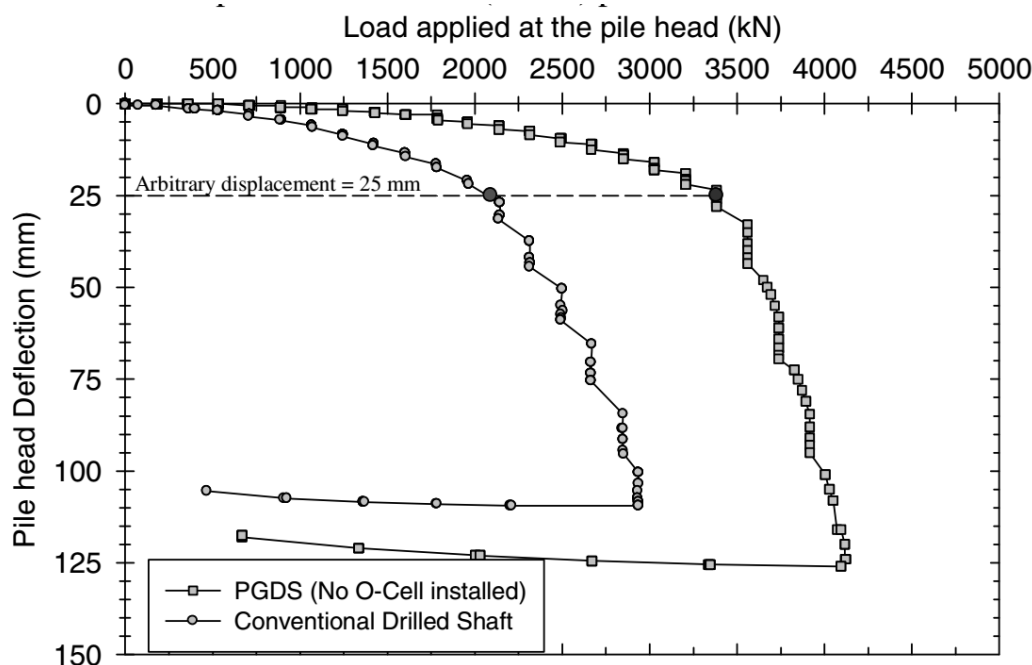
Figure 28. Load settlement curve for conventional and post grouted drilled shaft (King et al. 2015).

This 2005 project was sponsored by Synchropile to evaluate the increase in capacity due to post grouting of the drilled shaft bottom in sand (King et al., 2009, 2015). It consisted of building three drilled shafts: one post grouted drilled shaft (PGDS), one PGDS with a bottom O'Cell, and one regular drilled shaft without post grouting. All three drilled shafts were load tested to failure. The shafts were instrumented and had a 0.76 m nominal diameter and a length of 10 m. During the post grouting, the grout pressure reached 2000 kPa and the top of the shaft moved up about 15 mm. The load tests were carried out in general accordance with the quick load procedure of ASTM D1143. The load-deflection curves of Fig. 28 show that the ultimate capacities for the conventional and the PGDS drilled shaft are 2937 kN and 4116 kN, respectively. This represents an axial load capacity increase of 40.1%. Similarly, in Fig. 28, the axial loads required to produce a 25 mm top settlement are compared; they are 2090 kN and 3380 kN for the conventional and the PGDS drilled shafts, respectively. This shows that for a top deflection of 25 mm, an axial load of about 62% higher could be used for the PGDS as compared to the conventional drilled shaft. This is due to the fact that the post grouting process prestresses the drilled shaft against the soil, thereby limiting the amount of movement necessary to engage the soil response.

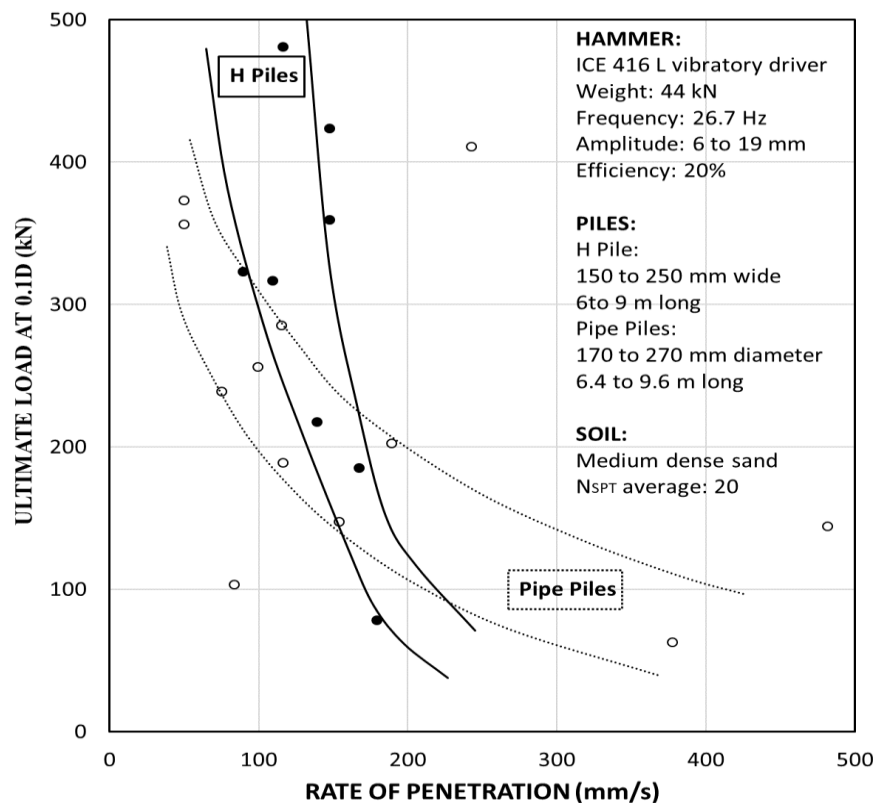
Figure 29. Ultimate pile capacity ($D/10$ criterion) vs. vibration rate of penetration (after Bossher et al., 1998).

Fig. 29 shows the rate within the last 0.5 m of penetration vs. the ultimate capacity of the pile defined as the load reached at a displacement equal to $1/10^{\text{th}}$ of the pile diameter in the static load test. Note that the penetration rate profile was sometimes erratic at the end of vibrating; this makes the case for using the end of re-vibrating to improve upon the predictions. Nonetheless, the trend is as expected with a decrease in capacity as the penetration rate increases, but the plot exhibits quite a bit of scatter. The Briaud Tucker method, meant to calculate the ultimate capacity of impact driven piles in sand on the basis of SPT blow count (Briaud, 2013), was used and compared well with the measured data after applying a 0.75 reduction factor for vibro-driven piles. Thus, it seems reasonable to propose that:

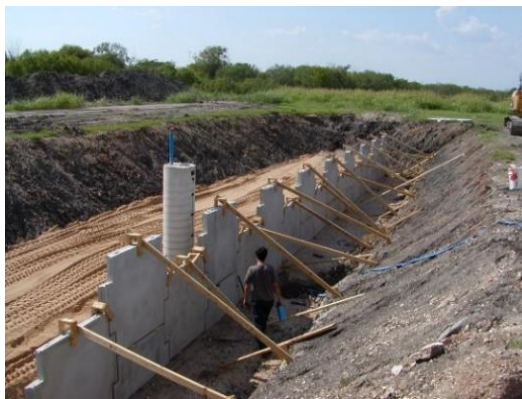
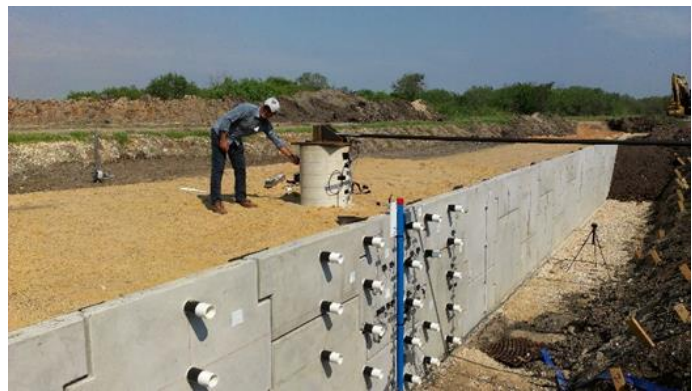
Figure 30. Construction of the MSE wall.

A 2.3 m high instrumented MSE wall was constructed and a 0.6 m diameter drilled shaft was placed behind the facing of the wall, with a clear spacing between the drilled shaft and the panel of the wall equal to 0.6 m (Figs. 30 and 31). The 5.5m long

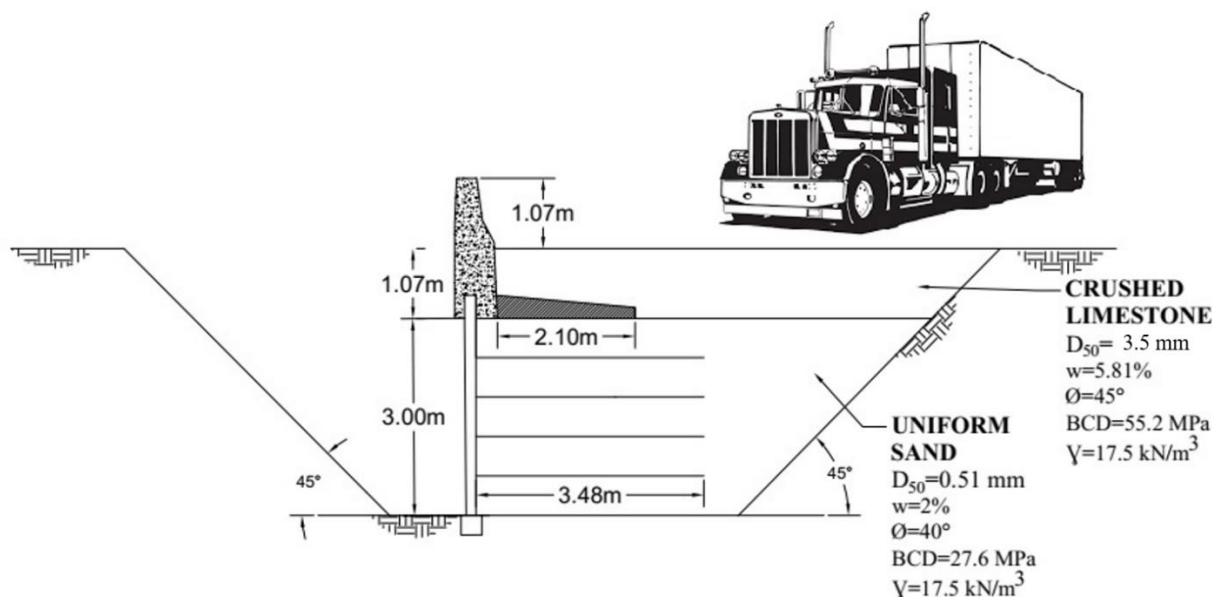
Figure 34. MSE wall / barrier / moment slab system with tractor trailer before impact.

the barrier was 1.07 m above the roadway level and the moment slab was 2.1 m wide (Fig. 34). The MSE wall backfill from the bottom of the wall to the bottom of the moment slab was compacted clean uniform sand; the mean grain size D_{50} was 0.51 mm, the in-place dry unit weight was 17.5 kN/m³, the in-place water content was 2%, the direct shear friction angle was 40 degrees, and the modulus measured with the Briaud Compaction Device or BCD (Briaud et al., 2006) was 27.6 MPa.

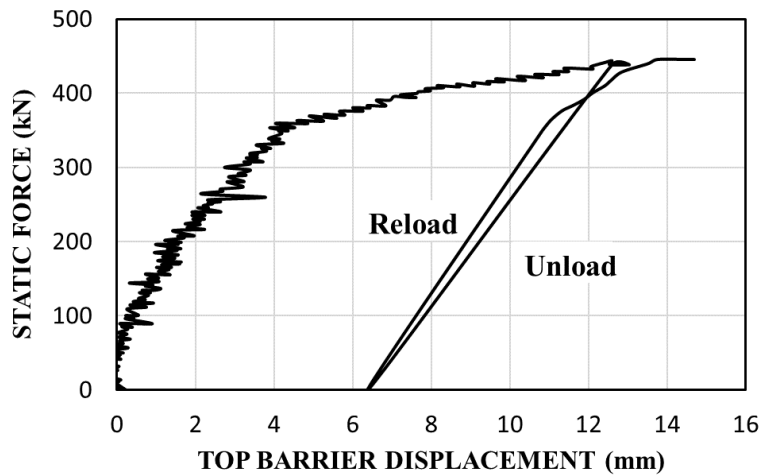
Figure 36. Static horizontal load-displacement curve for the barrier.

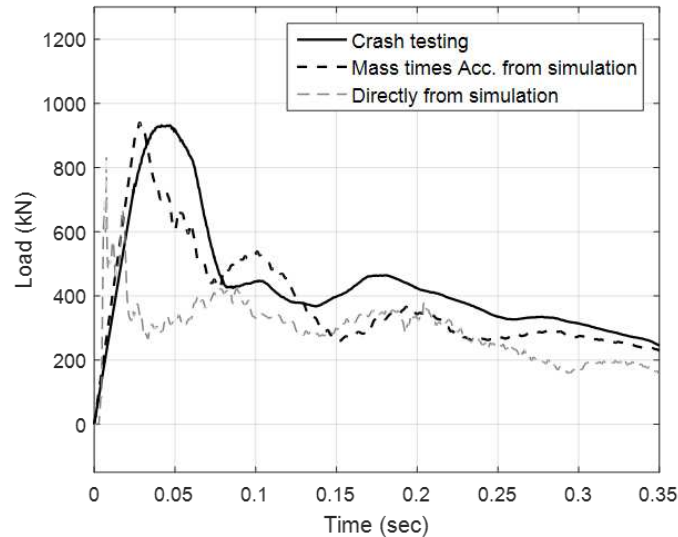
Figure 39. Impact load versus time during the crash test.

Fig. 39 also shows the impact force at the point of contact obtained from the numerical simulation calculated in two ways: mass times acceleration of the bed of the truck behind the cab and directly from the finite element at the point of contact. This work was part of a larger project on barriers to protect embassies, which is documented in three PhD dissertations (Lim, 2011, Mirdamadi, 2014, Pajouh, 2015). The test was deemed successful since the truck was stopped and did not override the barrier. Numerical simulations, first calibrated against the full-scale measurements, led to design guidelines for protecting embassies against truck impact (Lim, 2011, Mirdamadi, 2014, Pajouh, 2015).

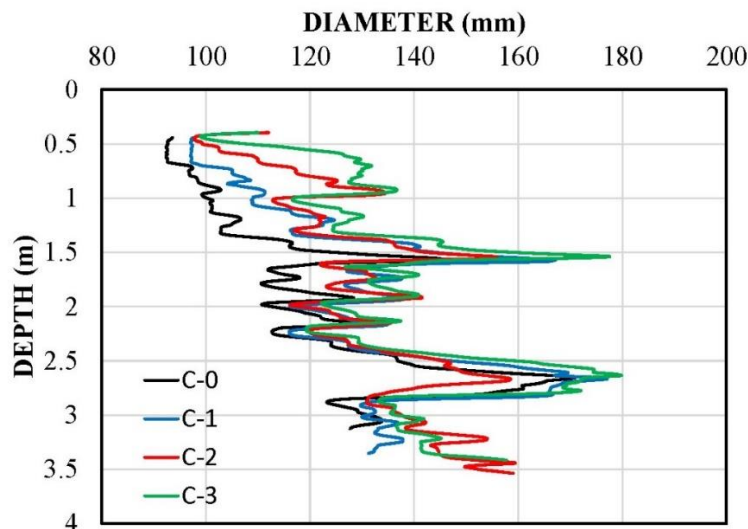
Figure 40. Borehole Erosion Test results (Briaud et al., 2015).

By repeating this process for other velocities, the erosion function is described for all soils within the borehole depth. A typical result from a test at the site is shown in Fig. 40. The diameter profile C-0 was the zero-reading profile for the borehole as drilled, profile C-1 was obtained after 8 minutes of water flow at an average velocity of 1.07 m/s, profile C-2 after 8 minutes at an average velocity of 0.47 m/s, and profile C-3 after 9 minutes at an average velocity of 0.5 m/s. The BET has applications to bridge scour, meander migration, dam erosion, levee overtopping, and beach erosion.
