40 Years of Full-Scale Infrastructure Testing at a National Geotechnical Experimentation Site: Sand Site.

ABSTRACT: A site at the Texas A&M University RELLIS campus near College Station, Texas, was dedicated to full-scale infrastructure testing in 1978. It was designated as a National Geotechnical Experimentation Site by NSF and FHWA in 1992. The site is made of 15 m of medium dense silty sand, within which most experiments took place, underlain by a deep layer of clay shale. The water table is approximately 7.5 m deep. Over the last 40 years, many full-scale instrumented experiments on infrastructure elements have been conducted at that site. The main projects include a box culvert within an embankment, spread footings of various sizes, drilled shafts with intentional construction defects, an anchored top down retaining wall, a top down deep-soil-mixing retaining wall, post grouted drilled shafts, vibro-driven steel piles, a drilled shaft embedded in an MSE wall and pushing on it, a tractor trailer truck crashing against a barrier on top of an MSE wall, a single unit truck crashing against a row of in line piles, and erosion in-situ tests. This paper describes each one of those p

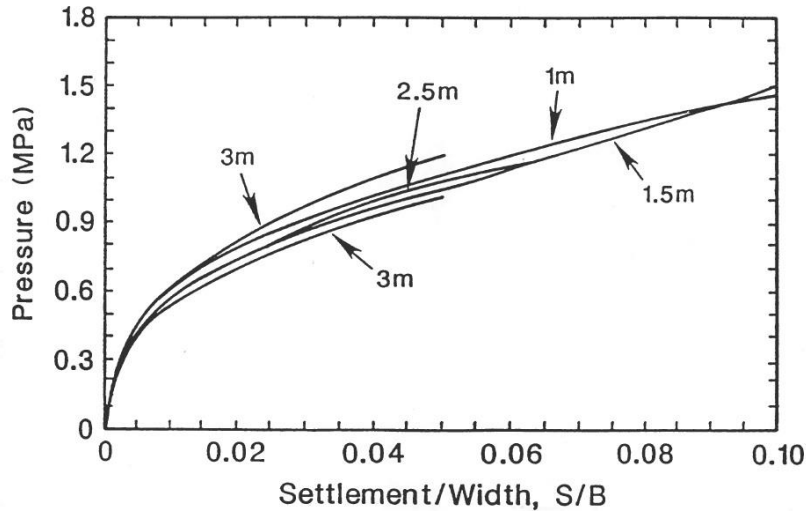
Figure 10. Normalized load test results for the five footings (Briaud, Gibbens, 1999).

Five square footings were load tested in 1993 (Briaud, Gibbens, 1999; Briaud, 2007). The footing sizes were 1 m, 1.5 m, 2.5 m, 3 m, and 3 m; all were embedded 0.75 m into the sand. They were all pushed to 150 mm of penetration into the sand using the load test setup of Fig. 9. The load test results are shown in a normalized fashion on Fig. 10. The soil around and under the footings was instrumented to monitor the vertical soil movement versus depth by using tell tales and the lateral soil movement versus depth and versus lateral extent by using inclinometers on the side of the footings. The vertical movement with depth revealed that the zone of influence was shallower than given by elastic theories (i.e., bulbs of pressure); this was confirmed by the lateral measurements as well.

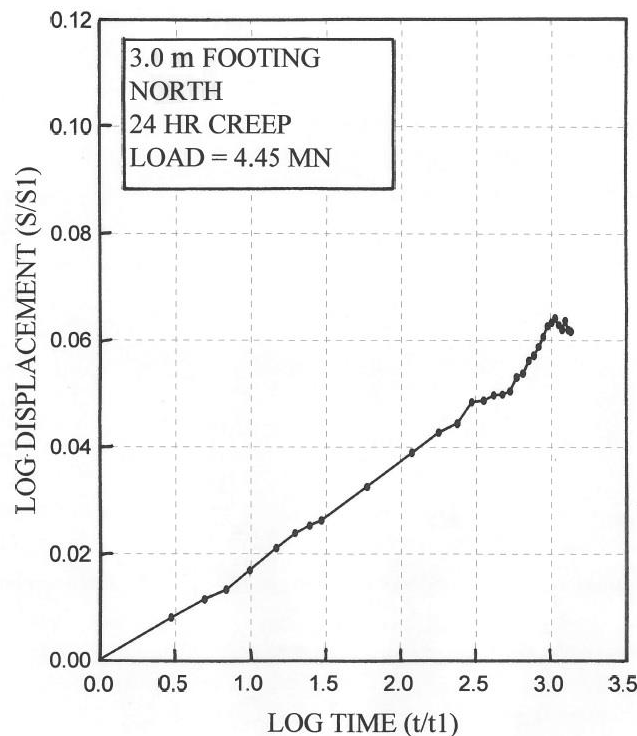
Figure 11. 24-hour creep test under constant load; t_1 is one minute and s_1 is the settlement corresponding to the one-minute reading (Briaud, Gibbens, 1999).

Where s is the settlement at time t , s_1 is the settlement at reference time t_1 , and n is the long-term creep exponent. In Fig. 11, the time t_1 was chosen as one minute and the settlement s_1 was the settlement corresponding to the one-minute reading; the creep exponent can then be calculated as 0.02 and it matched the one found in special PMT creep tests at the site. Then the settlement at 50 years, for example, can be calculated from Eq. 1. These full-scale footing tests also gave the ultimate bearing pressure defined as the pressure corresponding to a settlement equal to 10% of the footing width. This ultimate pressure $p_{0.1B}$ was then correlated to the soil properties and gave:

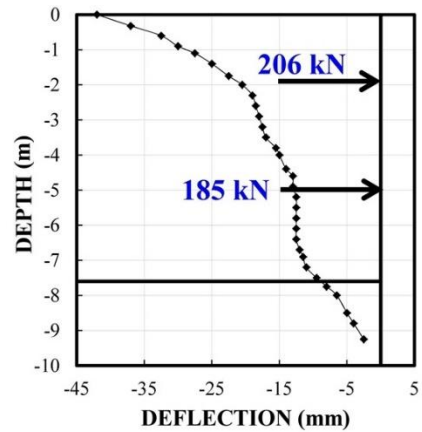
Figure 18. Wall deflection profile at end of construction for two rows of anchors (after Chung, Briaud, 1992).

Figs. 18, 19, and 20 show the average results for the section of the wall with two rows of anchors. Fig. 18 shows the horizontal deflection profile at the end of construction, Fig. 19 shows the bending moment profile, and Fig. 20 depicts the vertical load in the soldier piles. The same results are shown for the section of the wall with the one row of anchors in Figs. 21, 22, and 23. One of the many lessons learned from this project was that to limit the horizontal deflection of a tieback wall, the wall must have good vertical capacity. Indeed, such walls are subjected to significant downdrag from the retained mass (Figs. 20, 23), which is likely to induce settlement of the facing. This settlement generates rotation around the back of the anchors and an associated horizontal movement even if the anchors properly resist the horizontal load. Another outcome was the development of P-y curves, which do well in predicting the bending moment distribution in the soldier piles. The P-y curve approach was unable to accurately predict the deflection; only the finite element method could accomplish a good fit.

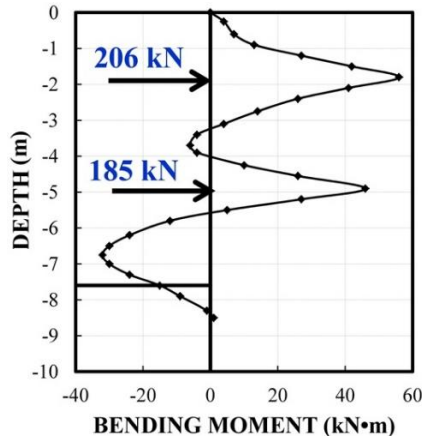
Figure 19. Wall bending moment profile at end of construction for two rows of anchors (after Chung, Briaud, 1992).

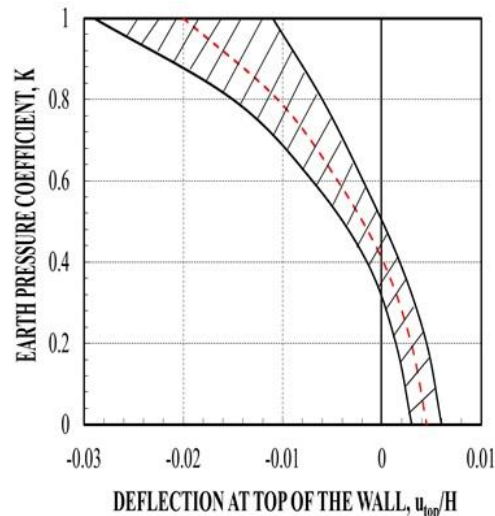
Figure 24. Earth pressure coefficient for pre-stressed anchored walls with proper vertical capacity (Briaud, 2013); positive deflection refers to movement towards the excavation, while negative deflection refers to movement of the wall into the retained soil.

Other case histories were analyzed to generate a relationship between the horizontal pressure coefficient K and the deflection at the top of the wall normalized by the wall height (Fig. 24). The pressure coefficient K is defined here as the mean pressure on the wall divided by the vertical effective stress behind the wall at the bottom of the excavation. The value of K for the Terzaghi and Peck constant pressure diagram for tieback walls in sand (0.65 K_a) corresponds to a K value of about 0.2 in Fig. 24. Note that tieback walls are one of the few retaining wall cases where the engineer can choose a deflection-based design; in fact, the anchor load can be chosen to achieve a desired deflection via a chart, as shown in Fig. 24, for example. Note that this chart is limited to tieback walls with proper vertical capacity.

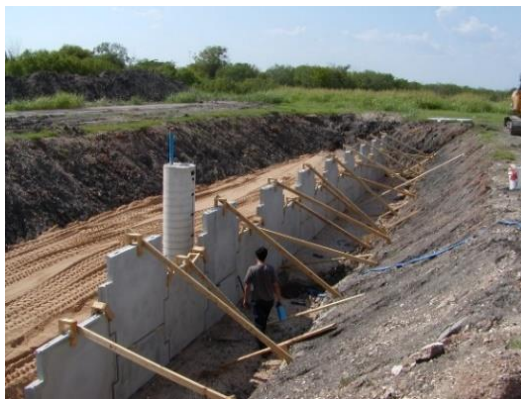
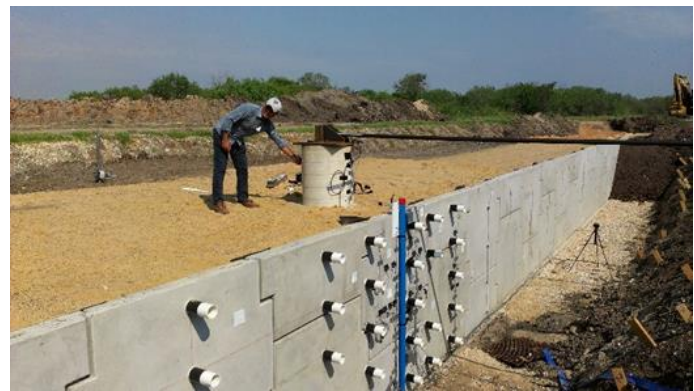
Figure 30. Construction of the MSE wall.

A 2.3 m high instrumented MSE wall was constructed and a 0.6 m diameter drilled shaft was placed behind the facing of the wall, with a clear spacing between the drilled shaft and the panel of the wall equal to 0.6 m (Figs. 30 and 31). The 5.5m long

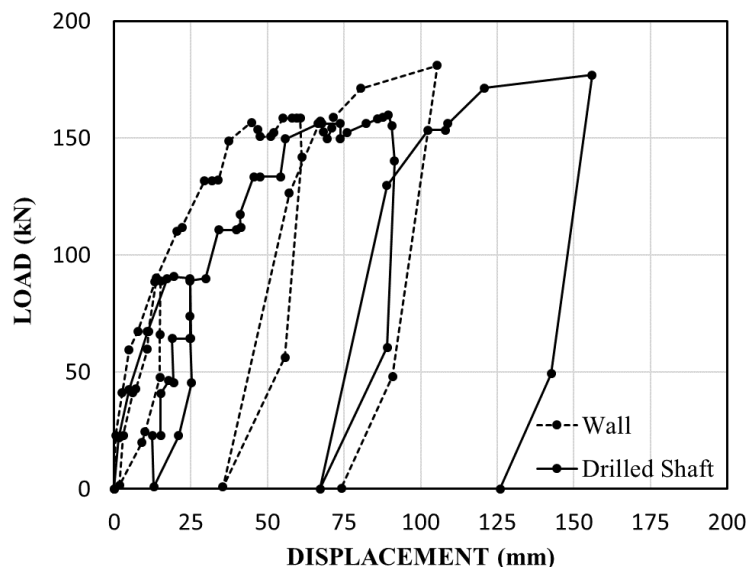
Figure 32. Measured load vs. displacement results for the drilled shaft and for the wall.

The data collected included the measurement of the horizontal load, the horizontal movement of the drilled shaft, the horizontal movement of the wall in front of the drilled shaft, and the pressure on the wall in front of the drilled shaft and on the drilled shaft. In addition, numerical simulations were conducted using FLAC 3D. All components of the MSE wall-drilled shaft system were simulated. The simulations were first calibrated against the full-scale experiment. A parametric study was then performed to identify the influence of each parameter on the MSE wall reinforcement. The load on the drilled shaft vs. the horizontal displacement of the drilled shaft, as well as the load on the drilled shaft vs. the horizontal displacement of the wall in front of the drilled shaft, are shown in Fig. 32.

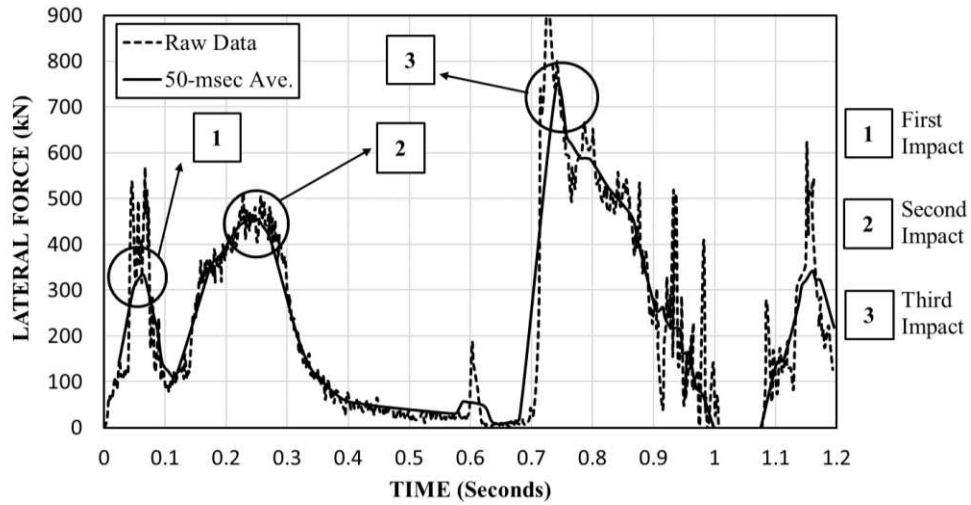
Figure 35. Impact load on the barrier during the event from numerical simulation.

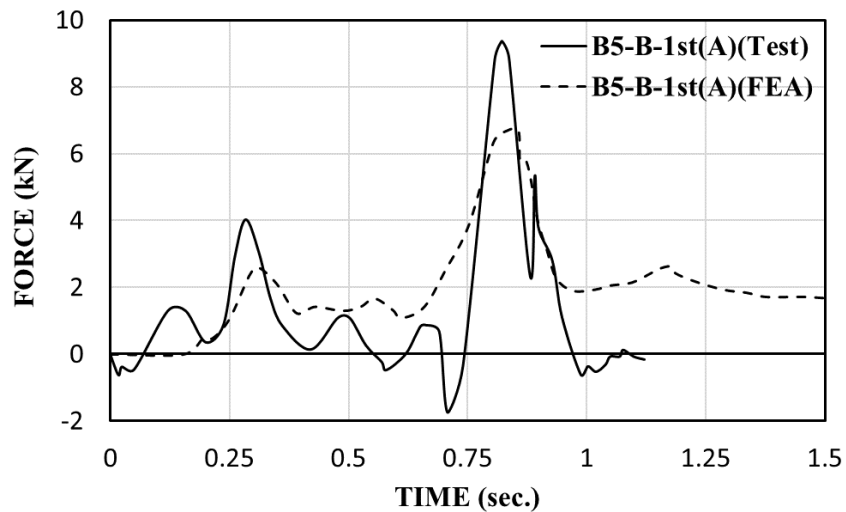
Figure 37. Tension load in the reinforcement.
