40 Years of Full-Scale Infrastructure Testing at a National Geotechnical Experimentation Site: Sand Site.

Jean-Louis Briaud, Distinguished Professor, Zachry Dpt. of Civil Engineering, Texas A&M University, College Station, Texas, 77834-3136, U.S.A.; email: briaud@tamu.edu

Reference: Briaud J.L. (2021). 40 Years of Full-scale Infrastructure Testing at a National Geotechnical

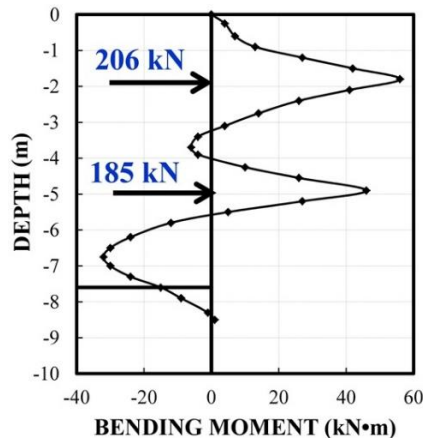
Figure 19. Wall bending moment profile at end of construction for two rows of anchors (after Chung, Briaud, 1992).

Figs. 18, 19, and 20 show the average results for the section of the wall with two rows of anchors. Fig. 18 shows the horizontal deflection profile at the end of construction, Fig. 19 shows the bending moment profile, and Fig. 20 depicts the vertical load in the soldier piles. The same results are shown for the section of the wall with the one row of anchors in Figs. 21, 22, and 23. One of the many lessons learned from this project was that to limit the horizontal deflection of a tieback wall, the wall must have good vertical capacity. Indeed, such walls are subjected to significant downdrag from the retained mass (Figs. 20, 23), which is likely to induce settlement of the facing. This settlement generates rotation around the back of the anchors and an associated horizontal movement even if the anchors properly resist the horizontal load. Another outcome was the development of P-y curves, which do well in predicting the bending moment distribution in the soldier piles. The P-y curve approach was unable to accurately predict the deflection; only the finite element method could accomplish a good fit.
