40 Years of Full-Scale Infrastructure Testing at a National Geotechnical Experimentation Site: Sand Site.

ABSTRACT: A site at the Texas A&M University RELLIS campus near College Station, Texas, was dedicated to full-scale infrastructure testing in 1978. It was designated as a National Geotechnical Experimentation Site by NSF and FHWA in 1992. The site is made of 15 m of medium dense silty sand, within which most experiments took place, underlain by a deep layer of clay shale. The water table is approximately 7.5 m deep. Over the last 40 years, many full-scale instrumented experiments on infrastructure elements have been conducted at that site. The main projects include a box culvert within an embankment, spread footings of various sizes, drilled shafts with intentional construction defects, an anchored top down retaining wall, a top down deep-soil-mixing retaining wall, post grouted drilled shafts, vibro-driven steel piles, a drilled shaft embedded in an MSE wall and pushing on it, a tractor trailer truck crashing against a barrier on top of an MSE wall, a single unit truck crashing against a row of in line piles, and erosion in-situ tests. This paper describes each one of those p

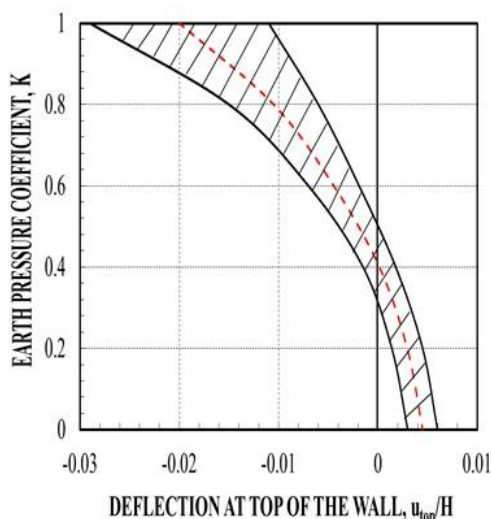
Figure 24. Earth pressure coefficient for pre-stressed anchored walls with proper vertical capacity (Briaud, 2013); positive deflection refers to movement towards the excavation, while negative deflection refers to movement of the wall into the retained soil.

Other case histories were analyzed to generate a relationship between the horizontal pressure coefficient K and the deflection at the top of the wall normalized by the wall height (Fig. 24). The pressure coefficient K is defined here as the mean pressure on the wall divided by the vertical effective stress behind the wall at the bottom of the excavation. The value of K for the Terzaghi and Peck constant pressure diagram for tieback walls in sand (0.65 K_a) corresponds to a K value of about 0.2 in Fig. 24. Note that tieback walls are one of the few retaining wall cases where the engineer can choose a deflection-based design; in fact, the anchor load can be chosen to achieve a desired deflection via a chart, as shown in Fig. 24, for example. Note that this chart is limited to tieback walls with proper vertical capacity.
