Asynchronous Mobilization of Shear Resistance in Slope Failures

ABSTRACT: *This paper focuses on the case study of the 2014 embankment failure at the Mount Polley TSF in Canada to study deformation-controlled mechanisms of instability leading to the asynchronous mobilization of shear strength and causing progressive failure. Three such mechanisms were identified in this failure: strain-weakening, the delayed mobilization of shear strength in the shell owing to stiffness incompatibility, and a reduction of mobilized shear resistance in the extending regions of the slide due to loss of confinement. Changes associated with these mechanisms were identified in the numerical analysis to help diagnose the impending collapse. These are: the emergence in the strain-weakening unit of a substantive area on the brink of strain-weakening, the depletion of reserve strengths in the foundation materials, and the extension of the unit above the strain-weakening zone owing to differential shear displacements within and outside the failure zone. Safety factor calculations do not adequately capture the stability of the Mount Polley embankment in the year preceding its collapse, and limit equilibrium

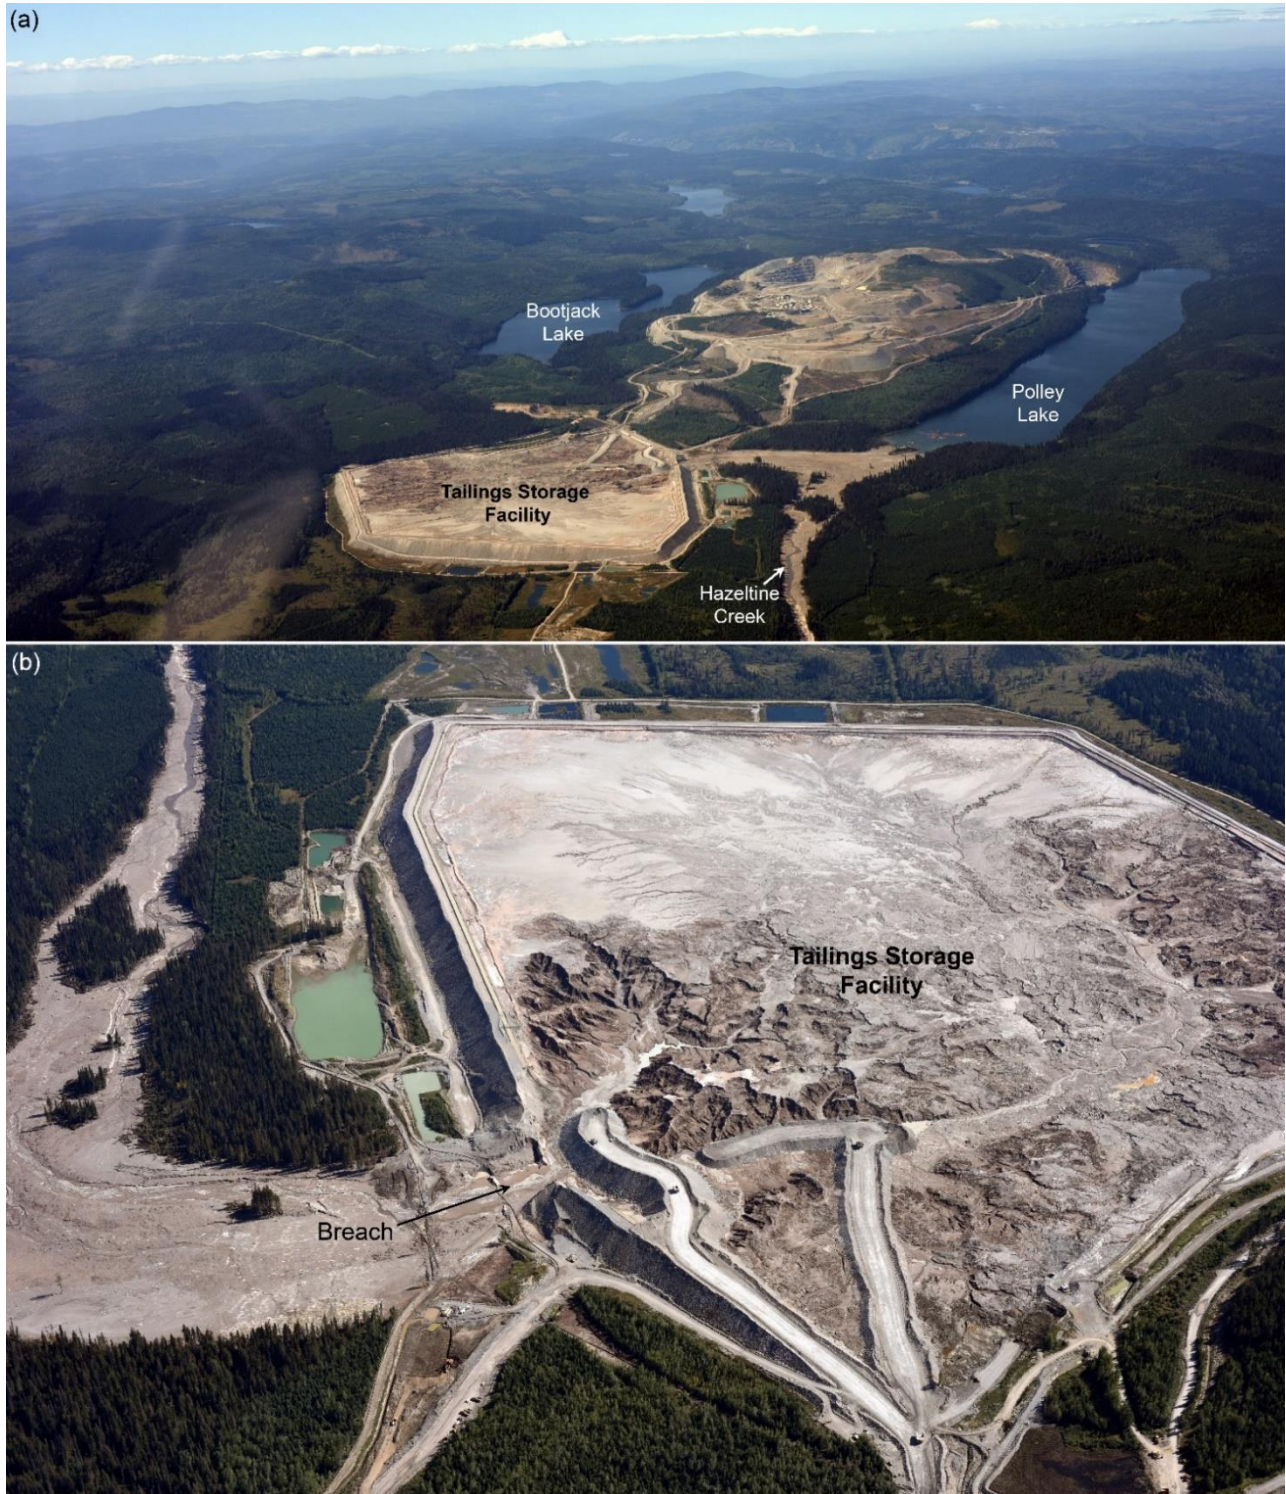
Figure 1. (a) Aerial diagonal view of the Polley Mine looking NNW; (b) Aerial diagonal view of the Mount Polley TSF, looking SSW. Photography courtesy of Jamie Heath, therrasaurus.ca, taken 09/05/2014, reproduced with permission, altered to add labels and enhance contrast/tonne.

Mount Polley mine is a gold and copper mining operation managed by the MPMC. It is located in the Cariboo Region of British Columbia, Canada at the approximate coordinates 52°33'N 121°38'W. The mine is situated on glaciated terrain and is surrounded by pristine boreal forest along with a system of glacial lakes and creeks (Zabolotnii 2020, p. 75; Fig. 1).

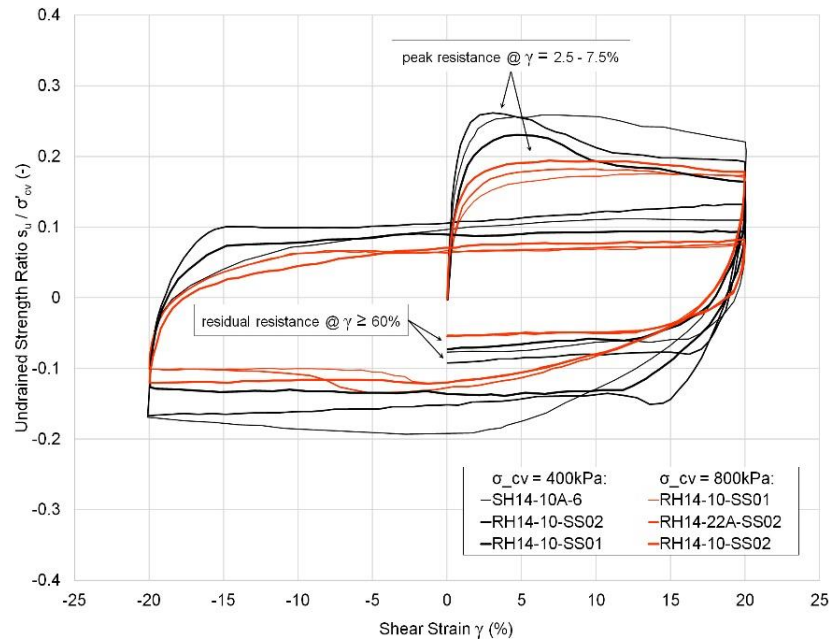
Figure 3. Upper GLU's response to shearing in the DSS tests in the range of vertical consolidation pressures corresponding to a state of normal consolidation in this unit (based on select data adapted from KCB 2015, Fig. 5.23)

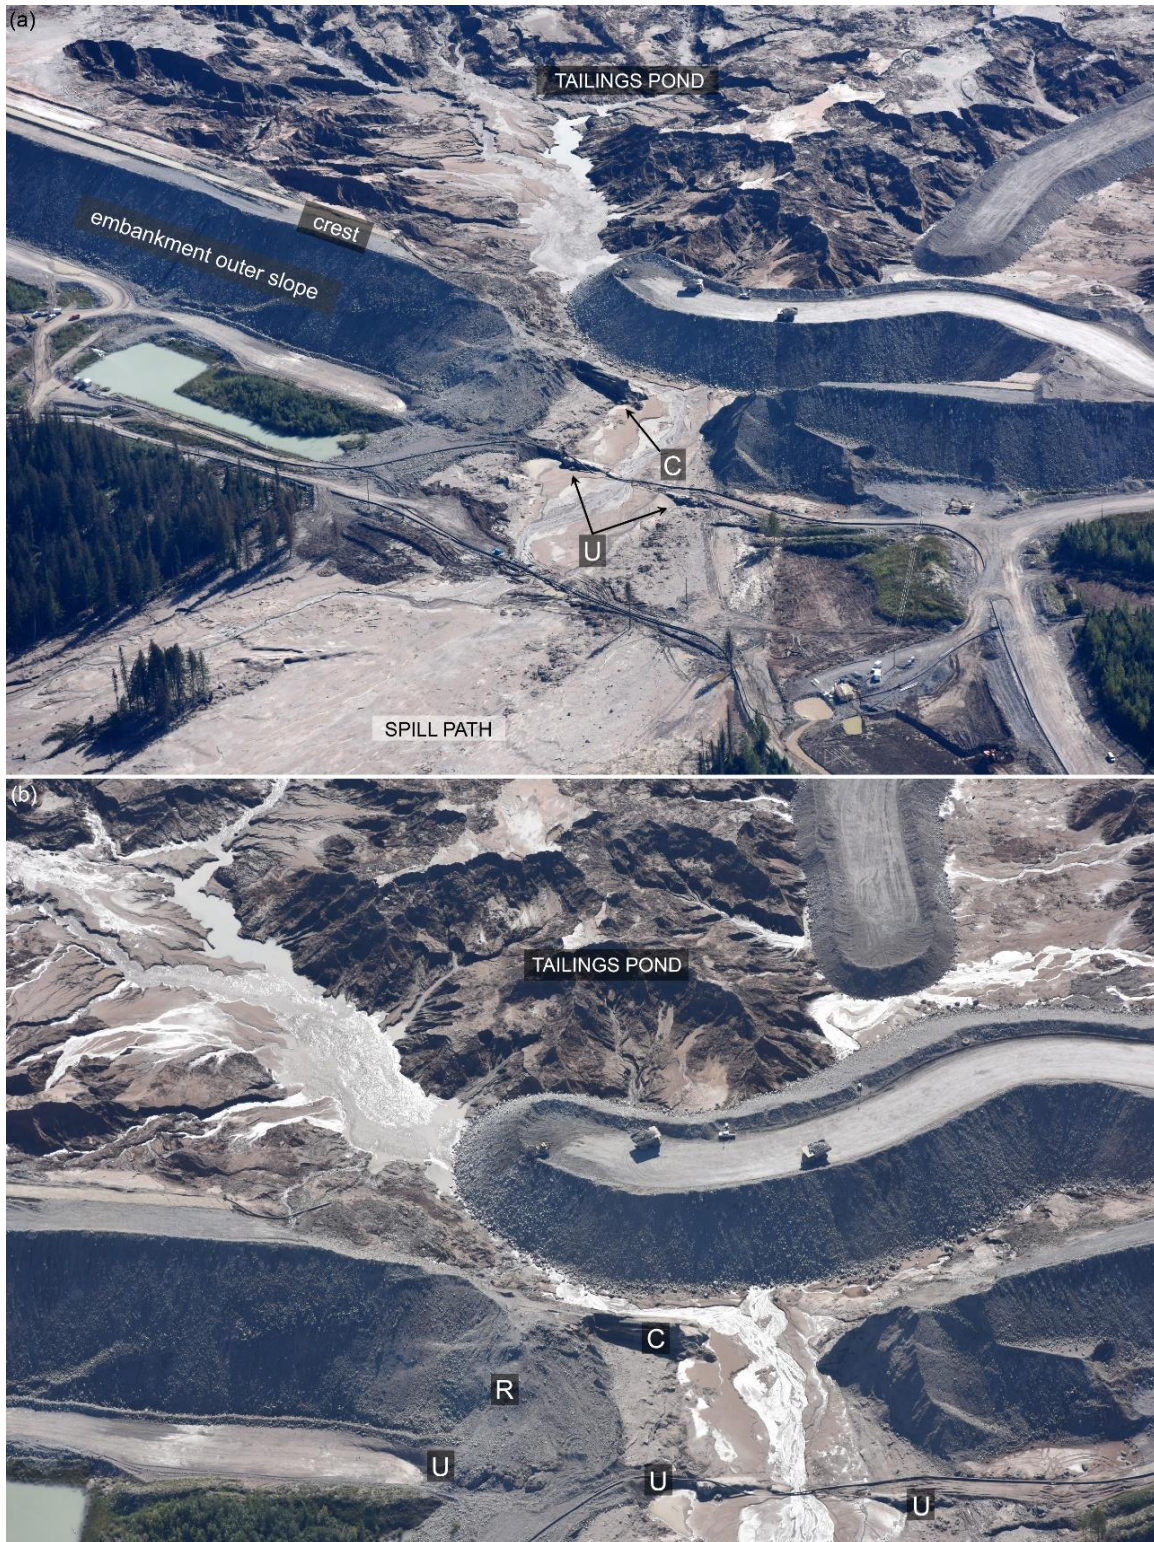
Figure 4. (a) Aerial diagonal view of the breach and spill path areas; (b) Aerial diagonal close-up of the breach location. Labels: C – core remnant, R – rockfill at the east boundary of the slide, U – uplift at the toe of the slide. Photography courtesy of Jamie Heath of terrasaurus.ca, taken 09/05/2014, reproduced with permission, altered to add labels.

Above the slide base, the geometry of the slip was irregular. Extensive ground cracking, shear zones (IRP 2015, Fig. 5.1.7), and sheared remnants of core (Fig. 4, feature C) delineated the extent of the slide in the upstream region roughly along the dam centerline and just few meters upstream of the Upper GLU's upstream edge. The failure zone was restricted to a width $\sim 100\text{m}$ at ground level, widening to $\leq 150\text{m}$ at crest level. The broad (200-250m) slip surface in the Upper GLU did not clearly propagate into the embankment; however, the rockfill in the shell zone flanking the breach is seen to have undergone significant deformation (Fig. 4, feature R). This material's lower deformation modulus and resulting stress-strain incompatibility with the rest of the structure was inferred both from the large deformations at failure but also from a documented history of poor compaction and low confinement stresses.
