Asynchronous Mobilization of Shear Resistance in Slope Failures

ABSTRACT: *This paper focuses on the case study of the 2014 embankment failure at the Mount Polley TSF in Canada to study deformation-controlled mechanisms of instability leading to the asynchronous mobilization of shear strength and causing progressive failure. Three such mechanisms were identified in this failure: strain-weakening, the delayed mobilization of shear strength in the shell owing to stiffness incompatibility, and a reduction of mobilized shear resistance in the extending regions of the slide due to loss of confinement. Changes associated with these mechanisms were identified in the numerical analysis to help diagnose the impending collapse. These are: the emergence in the strain-weakening unit of a substantive area on the brink of strain-weakening, the depletion of reserve strengths in the foundation materials, and the extension of the unit above the strain-weakening zone owing to differential shear displacements within and outside the failure zone. Safety factor calculations do not adequately capture the stability of the Mount Polley embankment in the year preceding its collapse, and limit equilibrium

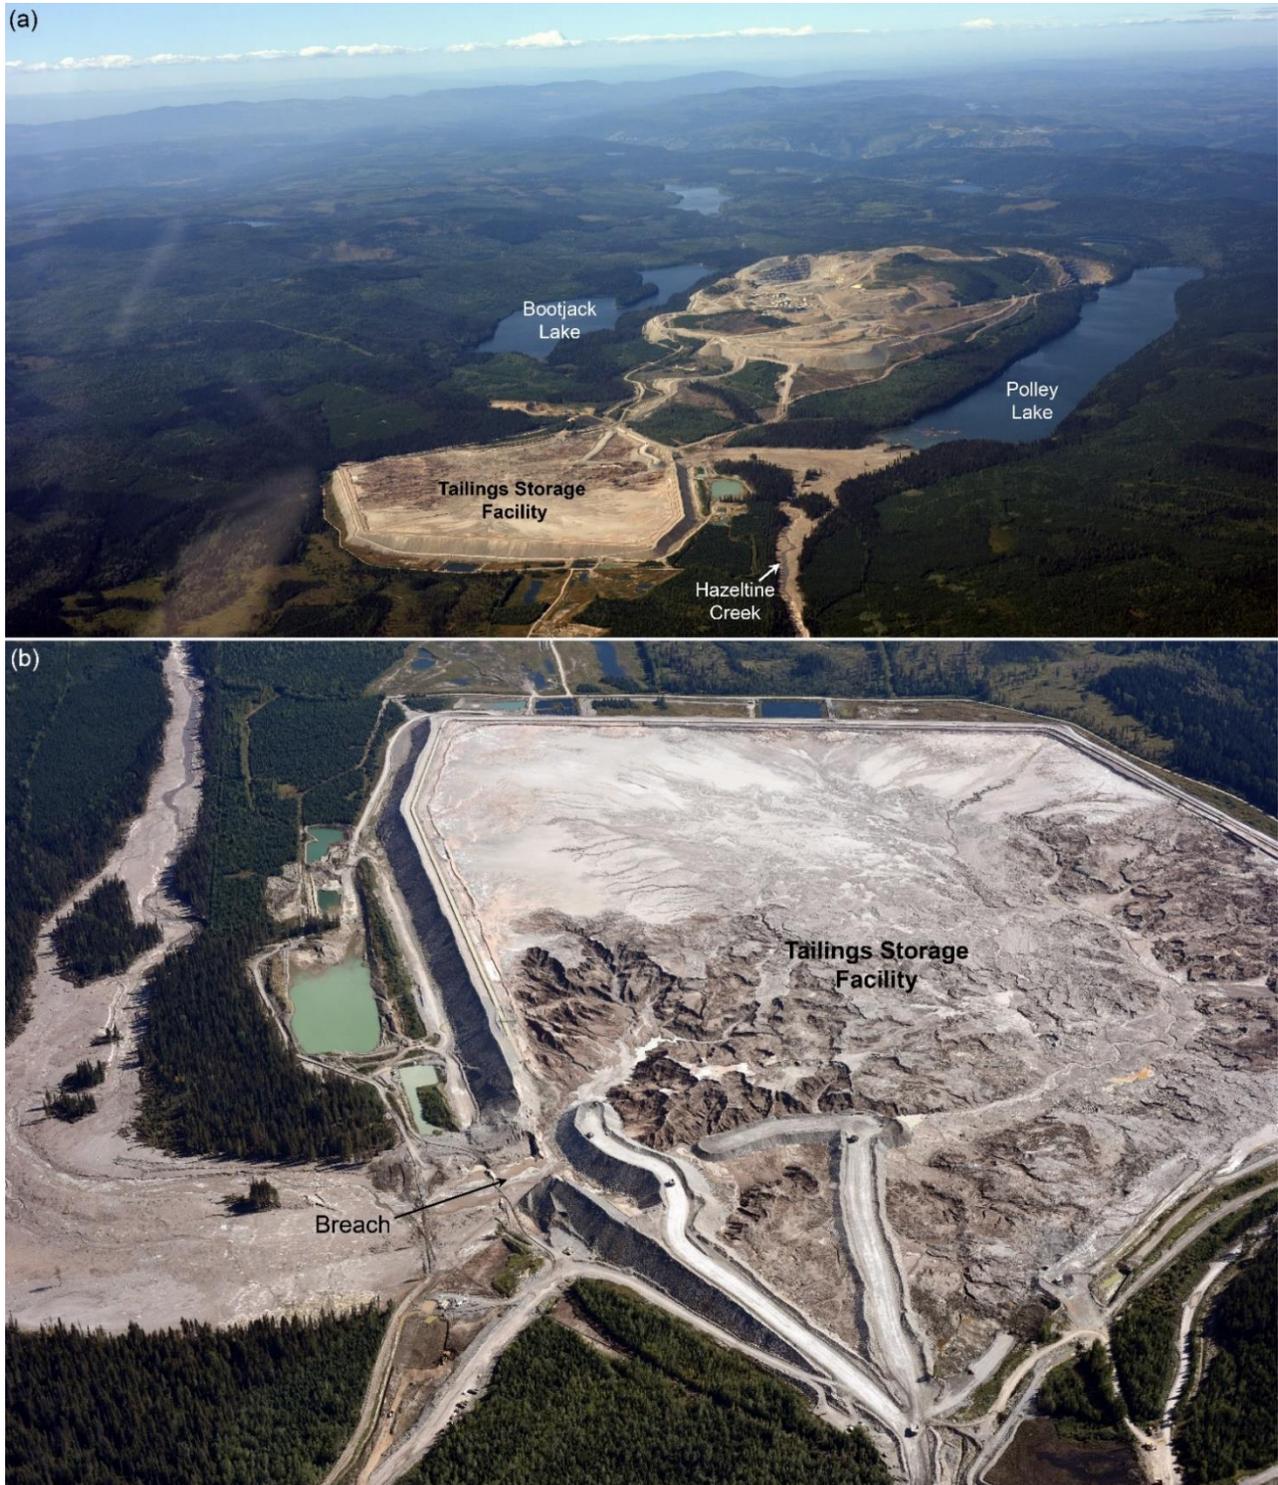
Figure 1. (a) Aerial diagonal view of the Polley Mine looking NNW; (b) Aerial diagonal view of the Mount Polley TSF, looking SSW. Photography courtesy of Jamie Heath, therrasaurus.ca, taken 09/05/2014, reproduced with permission, altered to add labels and enhance contrast/tonne.

Mount Polley mine is a gold and copper mining operation managed by the MPMC. It is located in the Cariboo Region of British Columbia, Canada at the approximate coordinates 52°33'N 121°38'W. The mine is situated on glaciated terrain and is surrounded by pristine boreal forest along with a system of glacial lakes and creeks (Zabolotnii 2020, p. 75; Fig. 1).

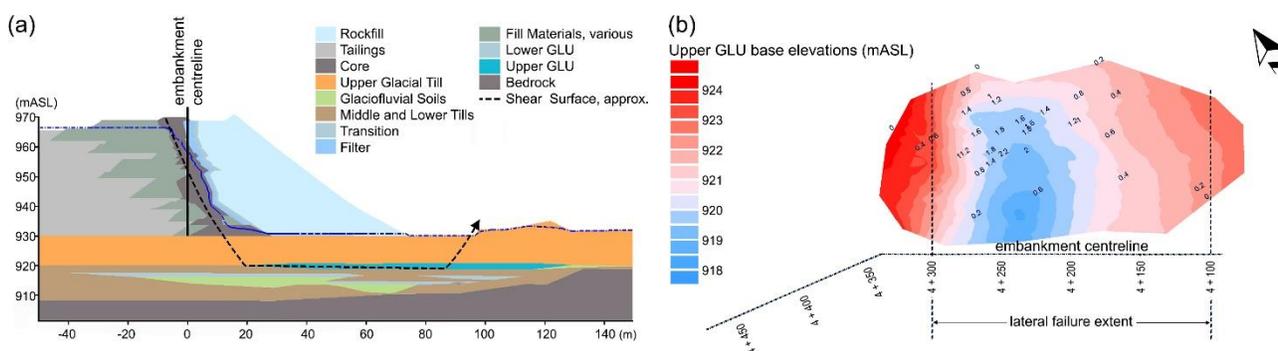
Figure 2. (a) Pre-failure profile of embankment and foundation soils at the failure location, based on KCB's (2015) interpretation; (b) Plan view of the Upper GLU with base elevations and labeled deposit thickness (m) showing slide extent at base.

The soil profile at the failure location, seen in Fig. 2a, was shaped by a complex depositional history involving three or more glaciation periods. Three distinct glacial till deposits, designated as the upper, middle, and lower tills, were separated by discontinuous interstitial deposits of glaciofluvial and glaciolacustrine provenance, including the Upper GLU, a varved deposit consisting of 1-clayey (CL-CH) layers alternating with ~1mm lamina of silt and fine sand (KCB 2015, p. 22). This deposit was located ~10m below original ground, and was spatially limited to a ~300m long, ~200m wide “pancake” with a thickness of ~2m in the middle, tapered to near-zero towards the edges. The disturbance and large shear displacements in this deposit but not below it, along with the good agreement between its spatial location and the lateral extent of slippage at base (sketched in Fig. 2b and evidenced by the ground uplift at the slide’s toe, seen in Fig. 4, feature U) underscore its critical role in the failure (IRP 2015, pp. 21-22). The Upper GLU was closely examined and subjected to extensive in-situ and laboratory testing.

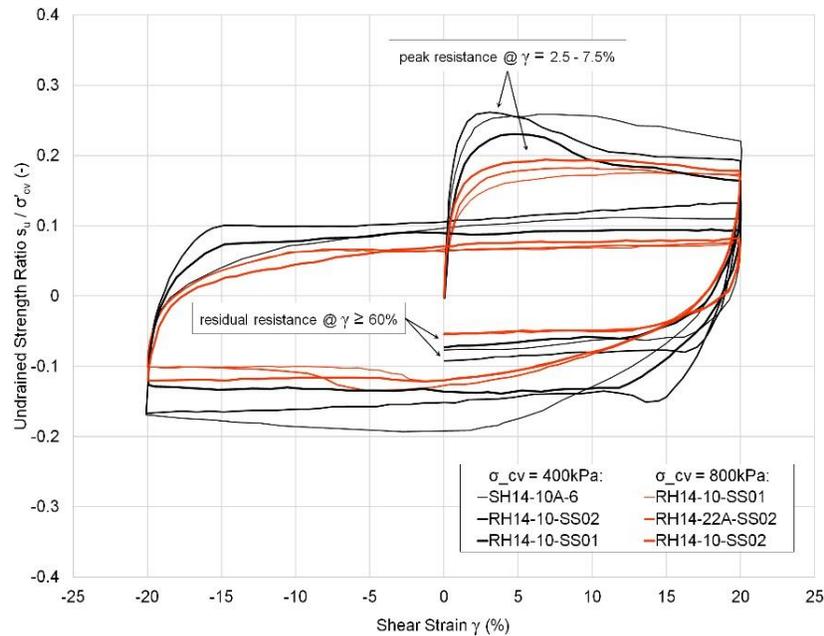
Figure 3. Upper GLU's response to shearing in the DSS tests in the range of vertical consolidation pressures corresponding to a state of normal consolidation in this unit (based on select data adapted from KCB 2015, Fig. 5.23)

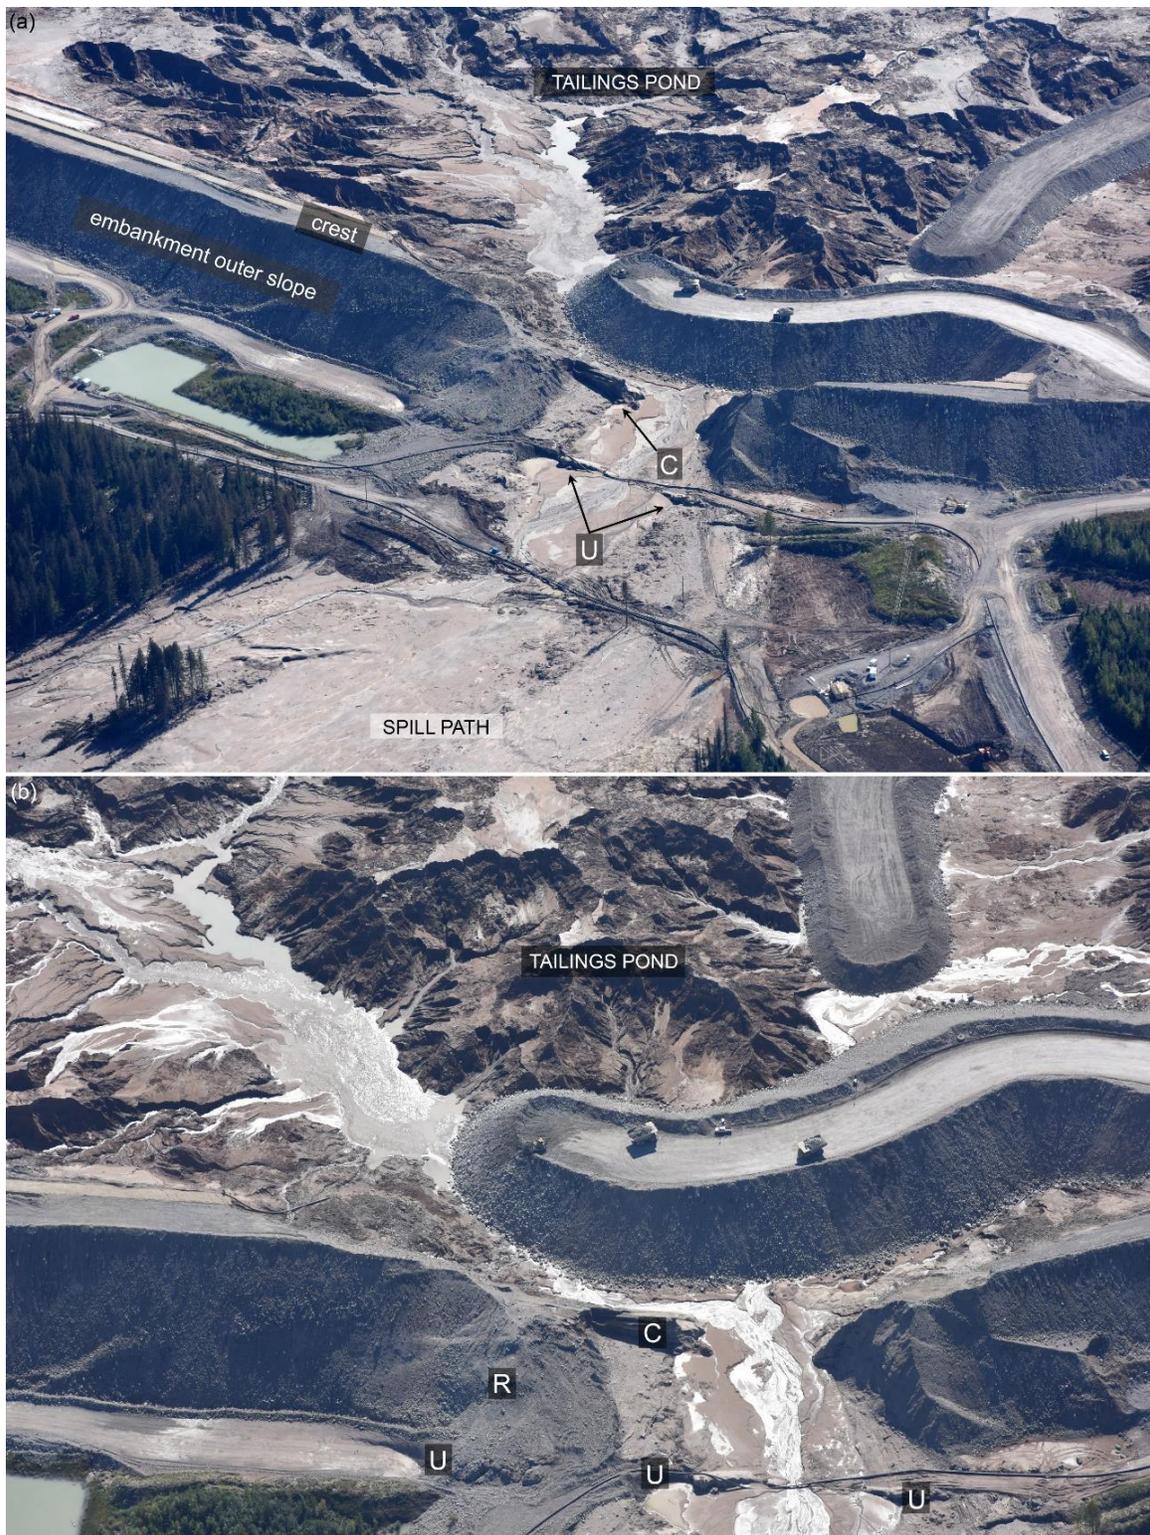
Figure 4. (a) Aerial diagonal view of the breach and spill path areas; (b) Aerial diagonal close-up of the breach location. Labels: C – core remnant, R – rockfill at the east boundary of the slide, U – uplift at the toe of the slide. Photography courtesy of Jamie Heath of terrasaurus.ca, taken 09/05/2014, reproduced with permission, altered to add labels.

Above the slide base, the geometry of the slip was irregular. Extensive ground cracking, shear zones (IRP 2015, Fig. 5.1.7), and sheared remnants of core (Fig. 4, feature C) delineated the extent of the slide in the upstream region roughly along the dam centerline and just few meters upstream of the Upper GLU's upstream edge. The failure zone was restricted to a width ~100m at ground level, widening to $\leq 150\text{m}$ at crest level. The broad (200-250m) slip surface in the Upper GLU did not clearly propagate into the embankment; however, the rockfill in the shell zone flanking the breach is seen to have undergone significant deformation (Fig. 4, feature R). This material's lower deformation modulus and resulting stress-strain incompatibility with the rest of the structure was inferred both from the large deformations at failure but also from a documented history of poor compaction and low confinement stresses.

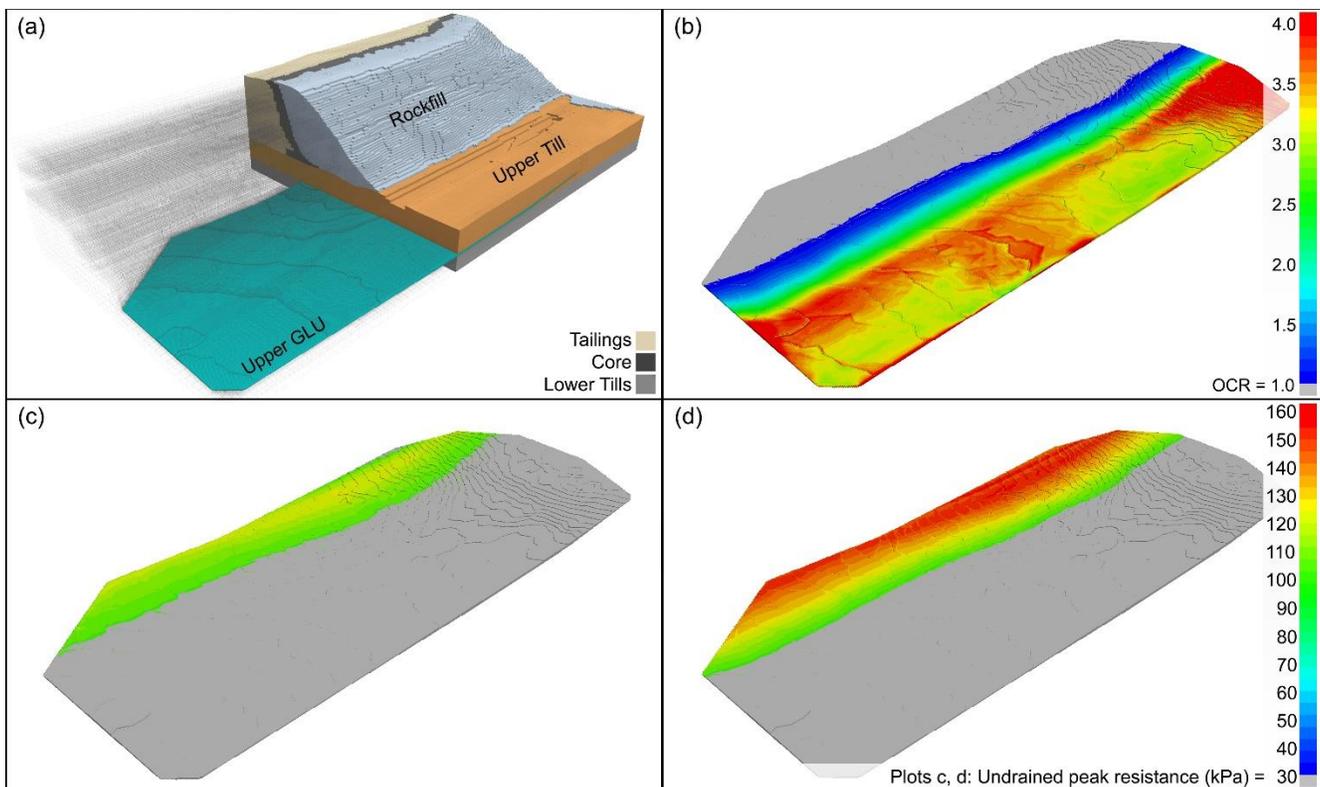
Figure 5. (a) The three-dimensional model of the failure location in Stage 9B (pre-failure) shown in a cross-sectional view through the middle of the slide; the rest of the domain rendered as a mesh, and the Upper GLU is rendered in full; (b) View of the Upper GLU in Stage 9B showing overconsolidation ratios; the rest of the model is rendered invisible; (c), (d) Views of the Upper GLU in Stages 5 and 9B, respectively, showing peak undrained resistance in the normally consolidated zone.

In the simulation, the Upper GLU's transition from an overconsolidated to a normally consolidated state denotes a change in its mechanical response from drained to undrained. The Upper GLU material under the crest becomes normally consolidated by Stage 5. With growing embankment heights, this zone continues to expand until Stage 9A, encompassing, prior to collapse, $\sim 1/4$ of its total area. The extent of the normally consolidated zone at failure is pictured in Fig. 5b.

The hardening of the Upper GLU is illustrated in Fig. 5c-d. Unlike other changes in the Upper GLU described here, its consolidation-induced hardening has a beneficial effect on the stability of the structure, buffering it to some degree against failure.

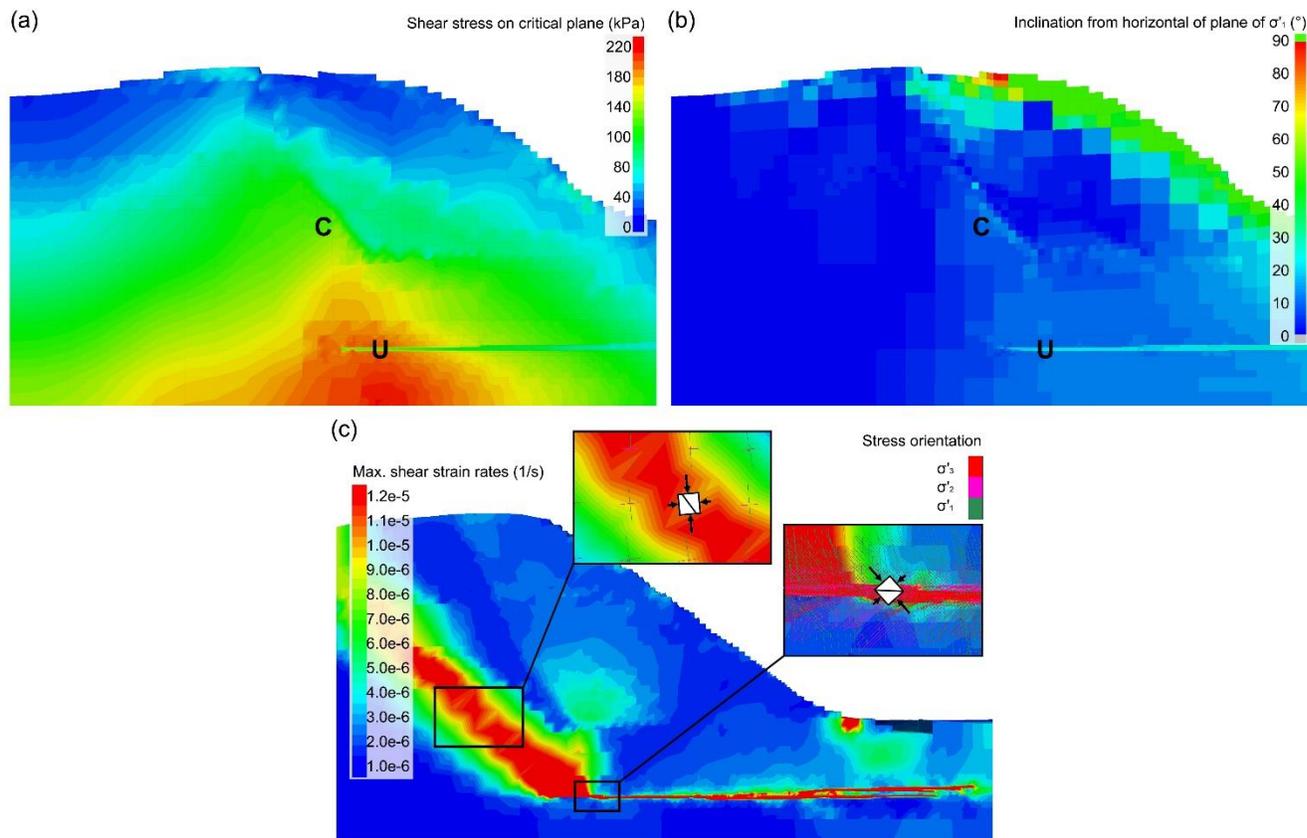
Figure 6. A cross-sectional view through the middle of the slide showing: (a) shear stresses on the critical plane after the adjustment to Stage 6 loads; (b) the deviation from horizontal of the plane of major principal stress after the adjustment to Stage 6 loads; and (c) maximum shear strain rates, the orientation of principal stresses, and of the planes of critical stress at an advanced point of collapse in Stage 9B. Labels: C – core; U – upstream portion of the Upper GLU.

A region of high shear stresses develops in the core and below it (Fig. 6a). At this location, the Upper GLU, being the weakest of the units, is the first material to reach yield; this takes place as early as Stage 5. Its yielding is evidenced by the band of

The reorientation of the planes of critical stress influences the position and alignment of the slip surface. This effect is illustrated in Fig. 6c, showing the inclination of principal stresses and that of the planes of critical stress at two key locations, the core and the upstream portion of the Upper GLU, superimposed on the plot of maximum shear strain rates in the cross-section through the middle of the slide at an advanced point of collapse. The plot demonstrates the good alignment of critical planes with the dominant shearing directions at large shear strains during failure. One may surmise that these processes are mirrored in situ, although confirmatory evidence is indirect in the form of matching performance as stress tensors are calculated, not measured.

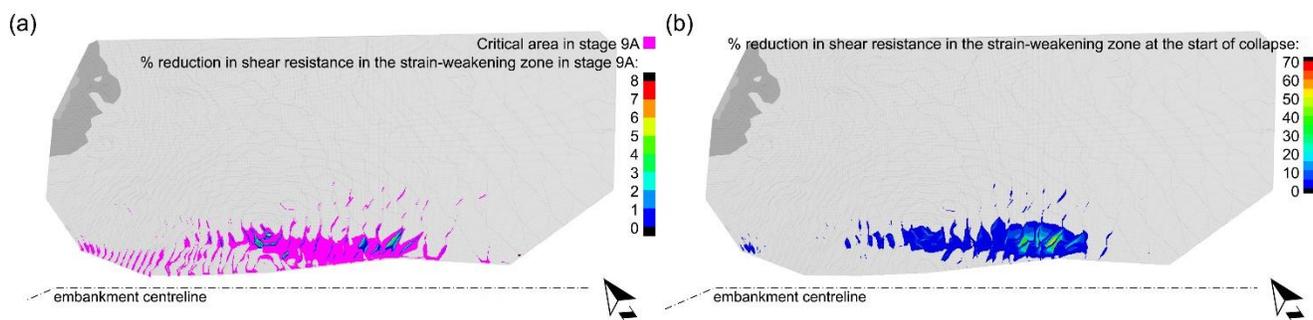
Figure 7. Plan view of the Upper GLU. (a) The critical area and the strain-weakening zone with % strength reduction below peak in Stage 9A. (b) The strain-weakening zone at the onset of global failure with % strength reduction below peak.

after the adjustment to Stage 9A loads is estimated at 4,000-6,000m² (Fig. 7a). This material engulfs the strain-weakening zone.

In the Mount Polley numerical analysis, the onset of global failure is precipitated by a surge in the aggregate rate of loss of shear resistance to strain-weakening largely owing to a ~30-fold areal expansion of the strain-weakening zone. The expansion of this zone after the application of Stage 9B loads is illustrated in Fig. 7, showing side-by-side its areal extent at the end of Stage 9A and at the onset of global failure. The figure showcases the good agreement between the locations of the critical area in Stage 9A and the strain-weakening zone at the onset of global failure.

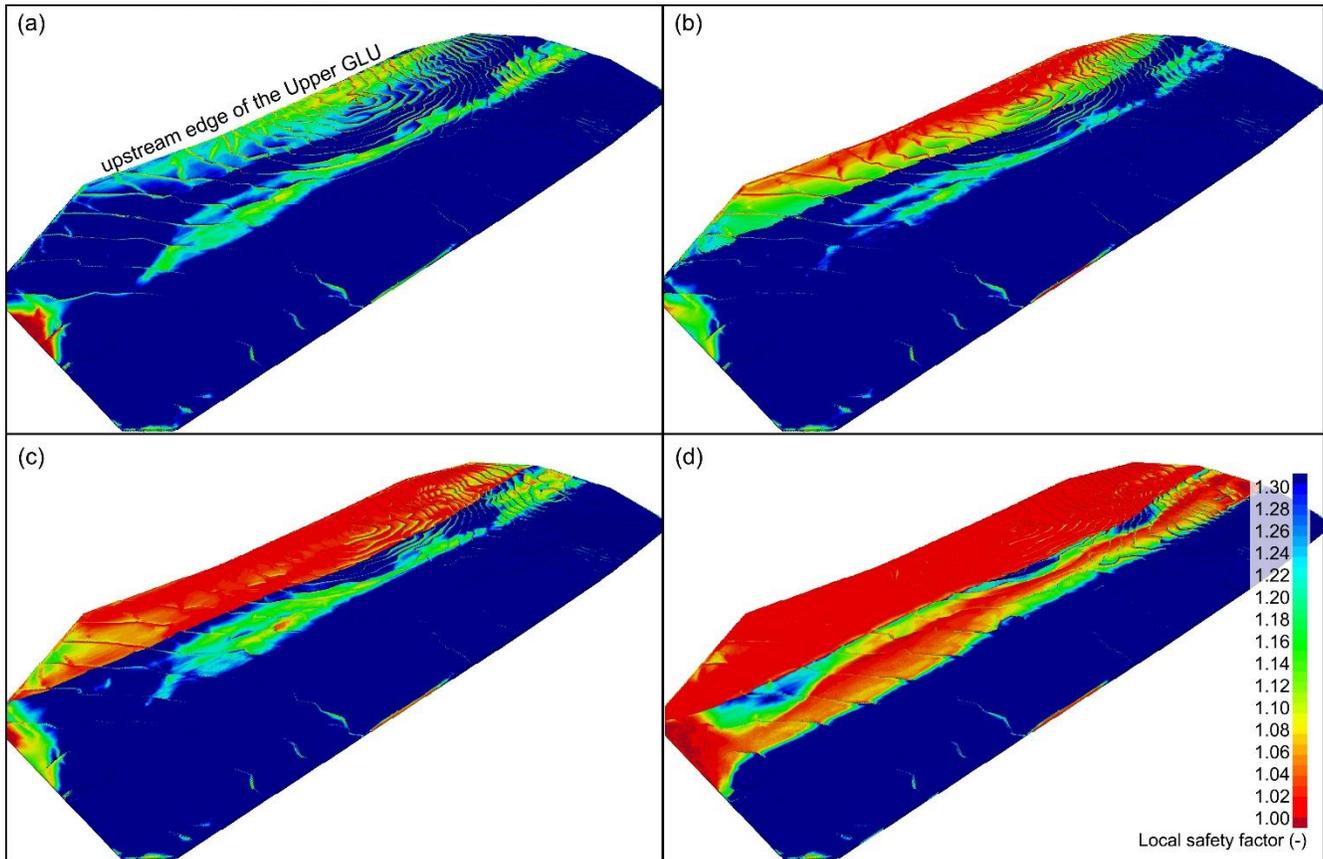
Figure 8. Plots of local safety factors in the Upper GLU after the adjustment to loading conditions corresponding to: Stages (a) 5, (b) 6, (c) 7, and (d) 8 respectively.

One reason why the progressive failure remains contained in Stages 7-9A is that there is a reserve of not yet mobilized shear strength present in the soil mass around the strain-weakening zone. This allows the surrounding soils to accommodate stress transfers from the strain-weakening areas. The ongoing construction of the embankment gradually depletes this reserve (Zaboltnii 2020, p. 303). This effect can be visualized by examining local safety factors, representing the ratio of shear strength τ_{ff} to mobilized shear stress along the critical plane s_{cr} :

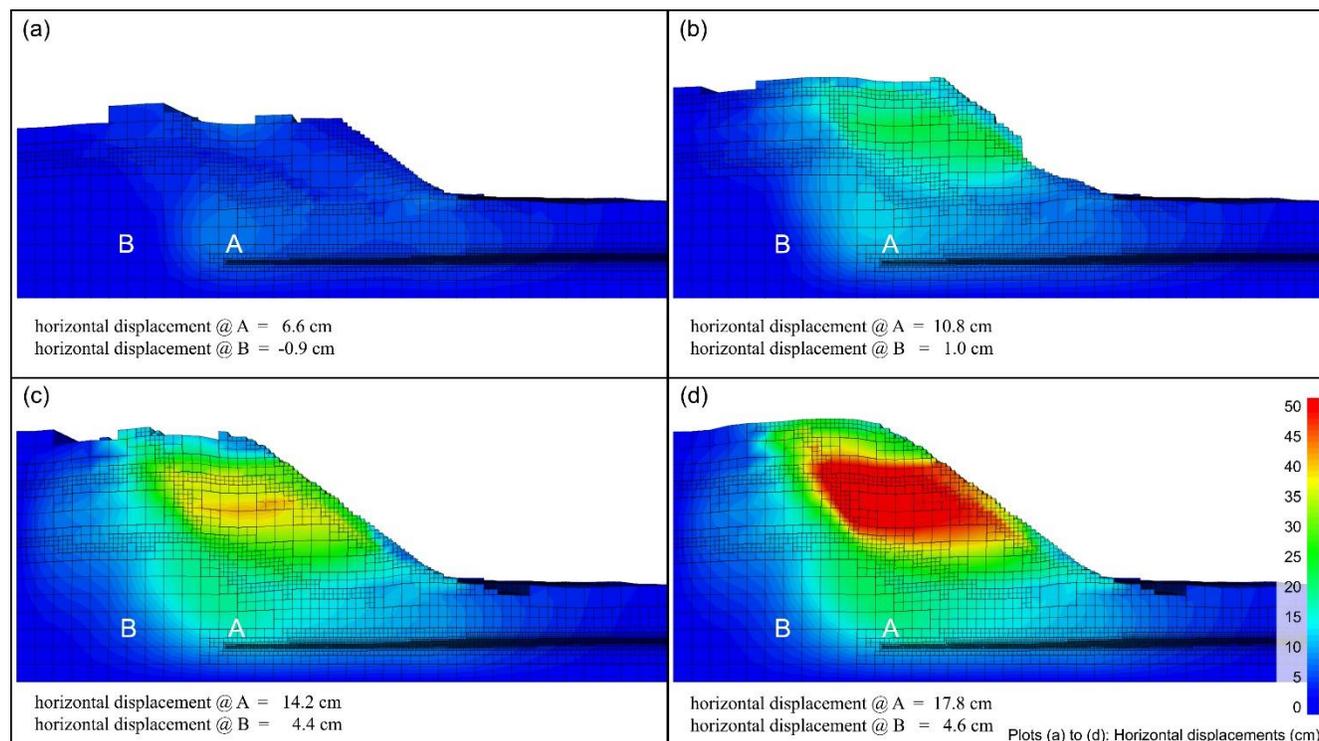
Figure 9. A cross-sectional view of the fine model through the middle of the slide showing horizontal displacements in the downstream direction in Stages (a) 5, (b) 7, (c) 9A, and (d) 9B at the start of Phase II. Labels: A – the upper till above the strain-weakening zone; and B – the upper till on the upstream of the slide (adapted with permission from Zabolotnii 2020, Figure 6.11).

Finally, ongoing plastic processes in the Upper GLU cause an accumulation of shear displacements in this region, predominantly in the downstream direction. Starting around Stage 7, the upper glacial till deposit located directly above the Upper GLU carried with it. Figure 9 illustrates the horizontal displacements in the downstream direction of the slide at its mid-point. Point A, located in the upper till above the strain-weakening zone in the upstream region of the slide, displaces by ~6.6cm in Stage 5 (Fig. 9a), and by ~14.2cm in Stage 9A (Fig. 9c); in contrast, point B, located in the upper till immediately upstream of the failing soil mass, is displacing considerably less. These displacements suggest that, to accommodate the growing shear displacements in the foundation, the upper till is extending. In the figure, the horizontal displacements in the upstream region of the slide (point A) increase from ~7cm in Stage 5 to ~14cm in Stage 9A.

After the addition of Stage 9B loads, the foundation materials, already at yield, respond by straining. The critical area begins strain-weakening, causing an upsurge in the rate of loss of shear resistance. The broader Upper GLU deposit surrounding the strain-weakening zone, also at yield, is now readily accumulating plastic shear strains approaching the onset of strain-weakening. Associated with the increase in the rate of strain-weakening is a renewed accumulation of shear displacements in the downstream direction. The glacial till above it continues to accommodate these displacements until 500-3,000 mechanical steps into the simulation; at this point, the differential horizontal displacements in this unit above the strain-weakening zone increase to ~14-18cm, up from 12-14cm prior to the addition of new loads (Fig. 9c-d).

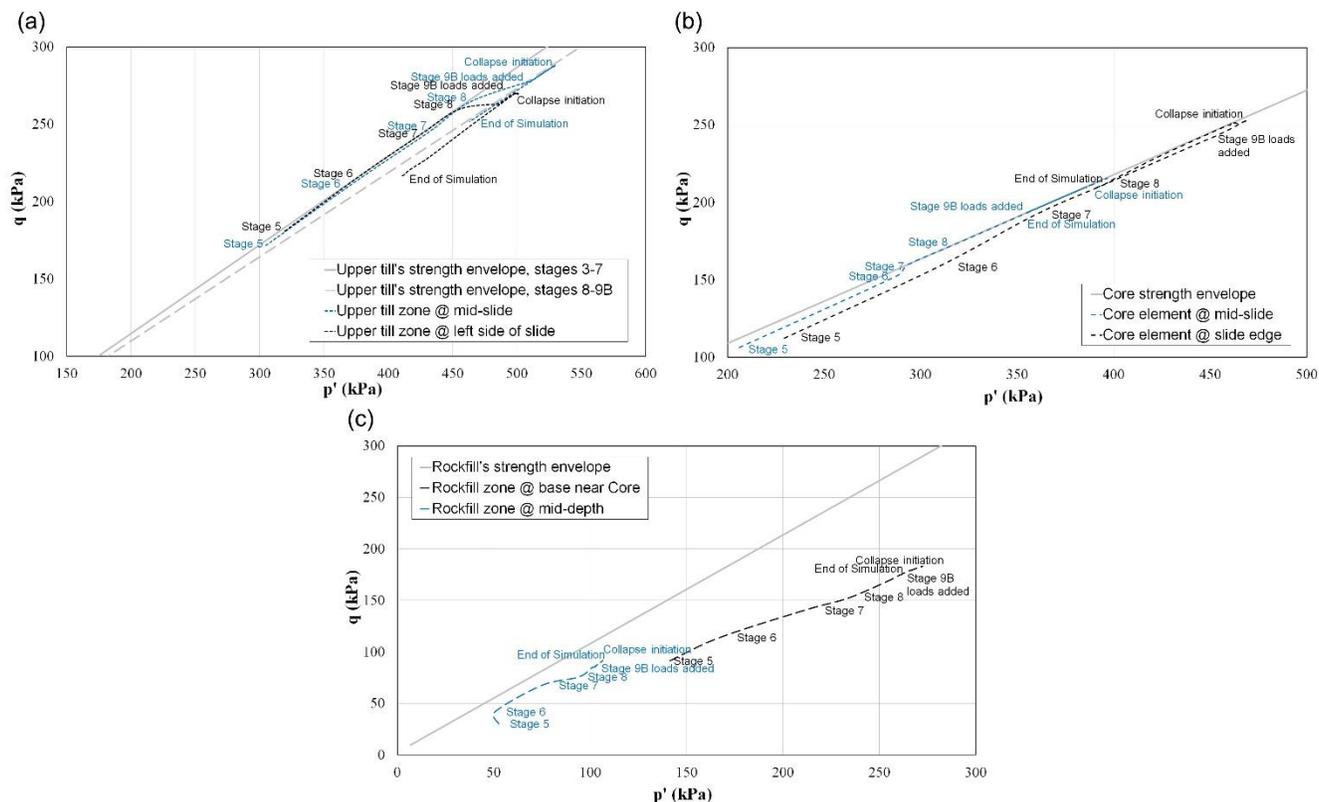
Figure 10. (a,b,c) Stress states in representative elements of the upper till and core materials in the upstream regions of the slide, and in the rockfill, respectively.

About 500-3,000 mechanical calculation steps after the addition of Stage 9B loads (depending on the location in the failing soil mass), the stress response in the till unit changes qualitatively: in this region, the effective stress states, which until this point were experiencing a steady increase in response to growing loads, are now decreasing owing to a relaxation of confining stresses. This produces, among other things, a gradual reduction in the levels of mobilized shear resistance acting along the planes of critical stress in this region. This effect is seen in Fig. 10a, illustrating the stress responses recorded at two representative locations in the upper till, one at the slide mid-point another ~30m south-east of it. At these points, the stress states increase consistently throughout the simulation in response to the loads imposed by the newly added embankment materials, until shortly after the addition of Stage 9B loads when the stress states begin steadily decreasing. This process sets in earlier at the slide mid-point, located directly above the middle of the strain-weakening zone, and later at the point located further away from the slide epicenter.

stress response noted previously in the upper till is also observed in the core in step with the propagation of the shear surface (Fig. 10b).

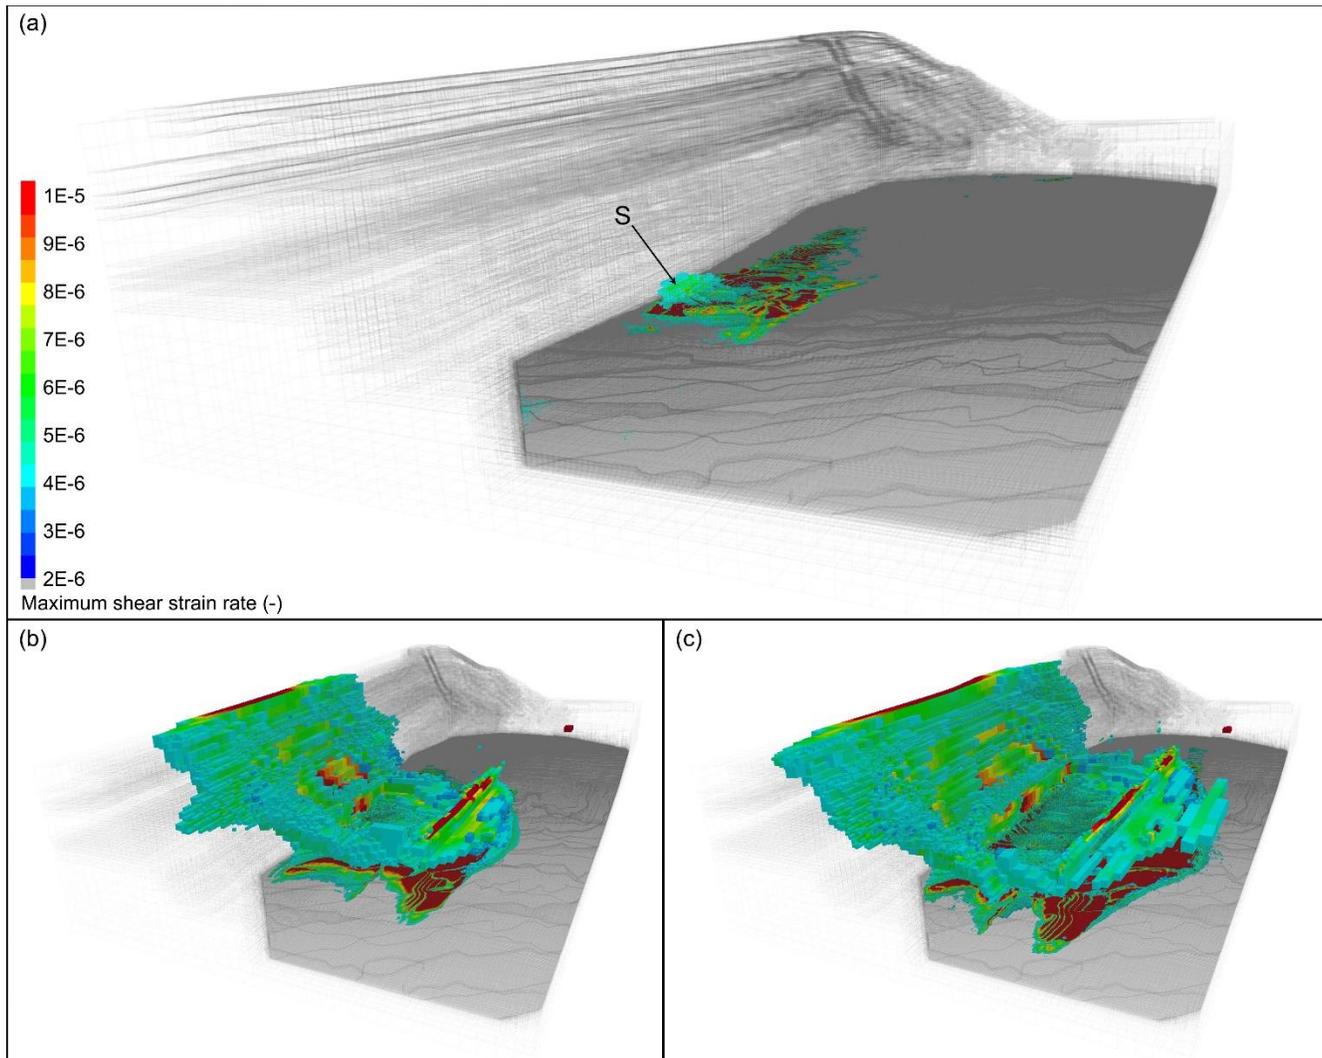
Figure 11. (a,b,c) Shear surface 2,700, 5,200 and 6,700 mechanical steps after the application of Stage 9B loads, respectively. Elements with maximum shear rates ranging between 2×10^{-6} and 10^{-5} (-) are rendered in color; all other zones are shown as transparent mesh. Labels: S – location where the shear surface propagates outside the Upper GLU and into the upper till at ~2,700 mechanical steps into the simulation of Stage 9B.

The qualitative change in the stress response of the upper till in the upstream region of the slide precedes the moment when global failure develops in the simulation, evidenced by the overall acceleration of the soil mass ~3,000 mechanical steps into the simulation of Stage 9B (Zabolotnii 2020, p. 313 & Fig. 4.41). At this point in the simulation, the rate of loss of shear resistance to strain-weakening has increased ~30-fold. The rate of accumulation of shear displacements at the middle of the strain-weakening zone increases three- to fourfold (Zabolotnii 2020, p. 309 & Fig. 6.12). The growing shear displacements in the foundation drive the shear surface upward into the core as well as laterally, as seen in Fig. 11b-c. The change in the
