# Liquefaction Ejecta Case Histories for 2010-11 Canterbury Earthquakes

**ABSTRACT:** *Liquefaction ejecta damaged the land and light-weight residential houses during the 2010-2011 Canterbury earthquakes. A database of well-documented field case histories that can be used to develop a procedure to estimate the settlement due to ejecta does not currently exist. In this paper, 235 case histories that document the occurrence and quantity of ejecta and its effects on infrastructure at 61 sites for each of the four primary earthquakes of the Canterbury sequence are presented. The case histories were developed with access to the geotechnical database that includes thousands of CPTs and boreholes, airborne LiDAR surveys, aerial photographs, and detailed property inspection reports in Christchurch, New Zealand. Direct measurements of ejecta were not available; hence, the ejecta-induced settlement values were estimated using LiDAR- and photographic-based approaches. The information related to ground conditions and seismic demand leading to differing quantities of ejecta-induced settlement during the Canterbury earthquake sequence were also described. This database of detailed ejecta case h

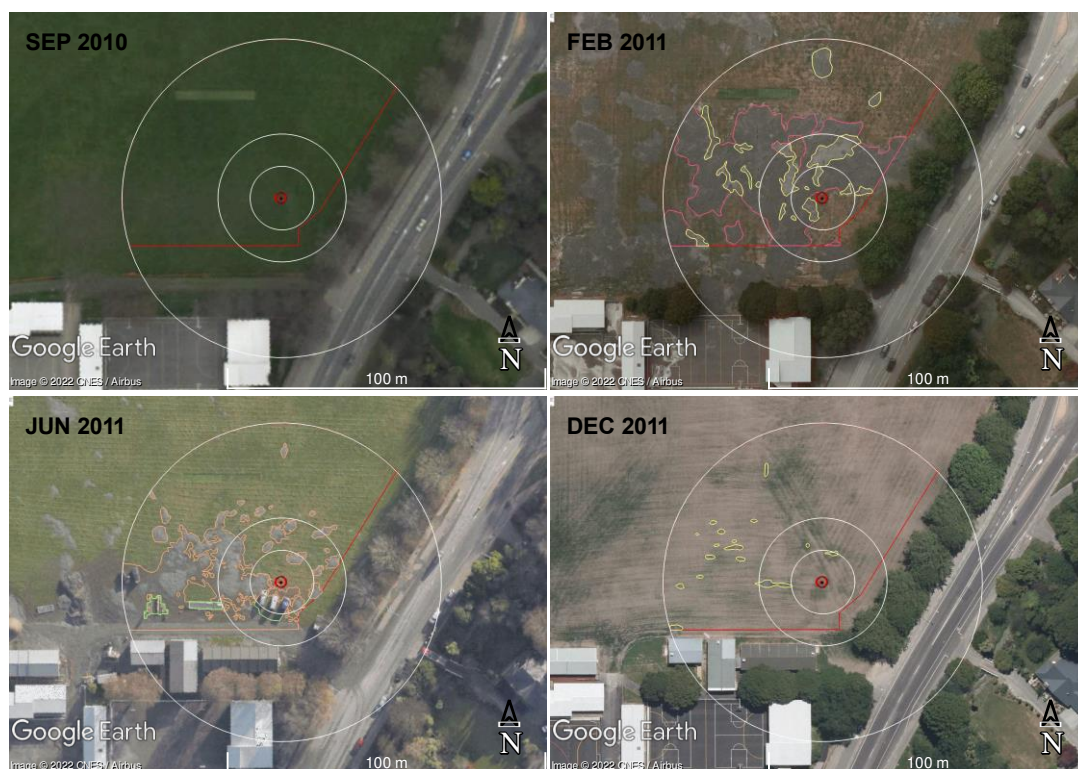
Figure 6. Aerial photographs acquired for Shirley Intermediate School in Sep 2010, Feb 2011, Jun 2011, and Dec 2011 (CGD, 2012a) with ejecta outlines for the 10-, 20-, and 50-m buffers.

The aerial photographs in Figure 6 were used to estimate the occurrence of ejecta and to measure the area of ejecta coverage within the assessment area (the red outline). The absence of ejecta is evident for the Sep 2010 earthquake. For the Feb 2011 earthquake, ejecta occurred across the site in a pattern of interconnected soil deposits originating from different fissures and forming irregularly shaped ejecta blankets rather than in a pattern of individual conically shaped soil boils. Different shades of gray of the ejecta were interpreted as different ejecta thicknesses. The light gray ejecta outlined in yellow were classified

as thin ejecta, while the dark gray ejecta outlined in pink were classified as thick ejecta. The total areas of the outlined thick ejecta layers and the outlined thin ejecta layers ( $A_{E,thick}$  and  $A_{E,thin}$ , respectively) were measured in Google Earth Pro. The  $A_{E,thick}$  and  $A_{E,thin}$  values for the 10-m buffer are summarized in Table 2. In the absence of ground photographs, the height range for the thick and thin ejecta layers ( $H_{E,thick}$  and  $H_{E,thin}$ , respectively) was estimated based on the typical height of similar-looking ejecta for the neighboring area and observations made by people (Table 2). Finally, the volume of ejecta was estimated using Eq. 1 and was divided by the total assessment area,  $A_T$ , to obtain the areal ejecta-induced free-field settlement,  $S_{E,P\_areal}$  (Table 3), while the localized ejecta-induced settlement,  $S_{E,P\_localized}$  (Table 3) was obtained by dividing the total volume of ejecta within  $A_T$  by the coverage area of ejecta,  $A_E$ . Figure 6 also shows the presence of ejecta for the Jun 2011 earthquake. However, ejecta appeared to be partially cleaned from the site. To account for this uncertainty, the height of ejecta was provided as a wider range, while assuming ejecta covered the portion of the site in light brown color. The area for the Jun 2011 earthquake reported in Table 2 corresponds to the area outlined in orange and within the 10-m buffer. Also, cars, shadows, and construction equipment obscured a portion of the assessment area in the Jun 2011 aerial photograph, resulting in that portion of the site being excluded from the analysis. For the Dec 2011 earthquake, only minor ejecta (outlined in yellow in Figure 6) were present.

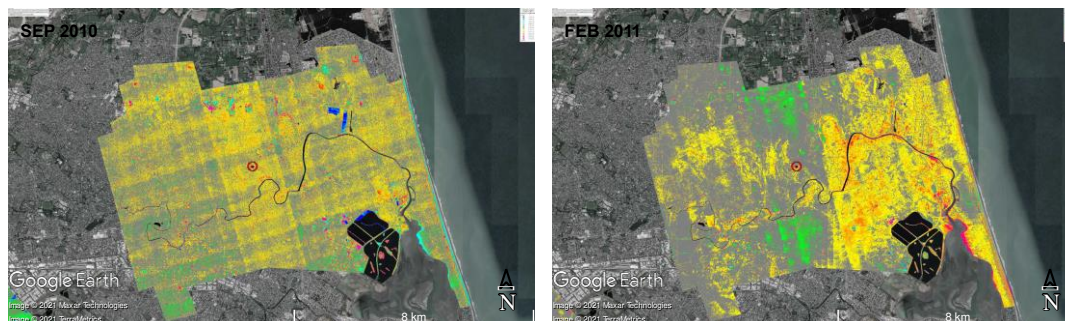
Figure 8. Vertical Ground Movements (adjusted for the tectonic component) for the Sep 2010 and Feb 2011 earthquakes (CGD, 2012b) – the site is in the zone of overestimated ground surface subsidence for the Sep 2010 earthquake and the zone of underestimated ground surface subsidence for the Feb 2011 earthquake.

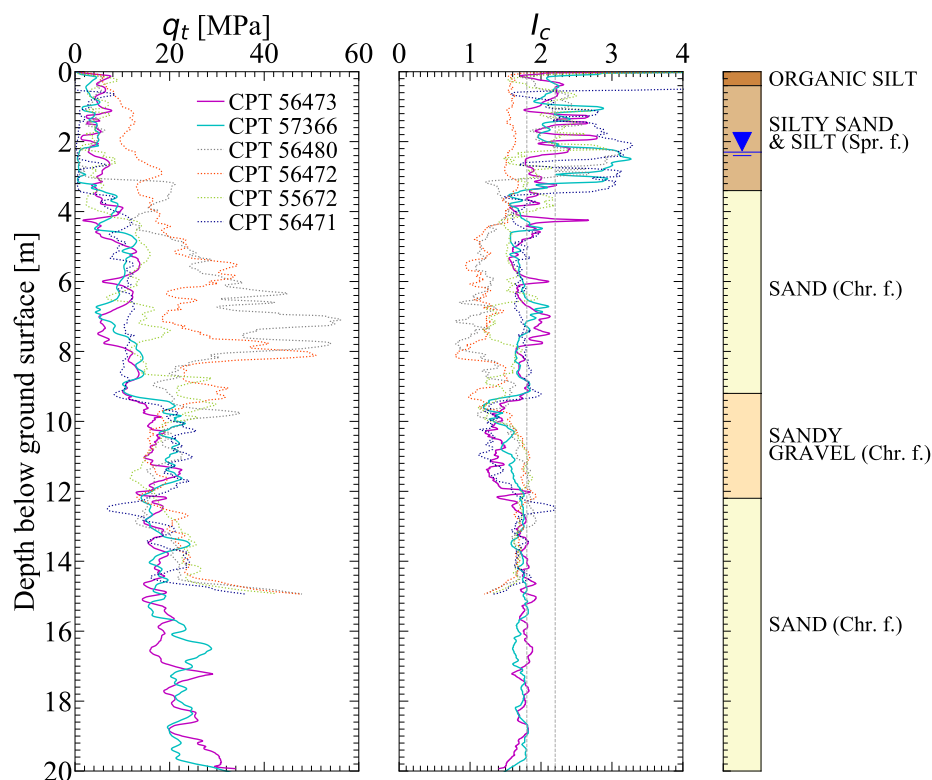
Figure 10. CPT traces and simplified soil profile for Shirley Intermediate School. (The soil layer colors are arbitrary.)

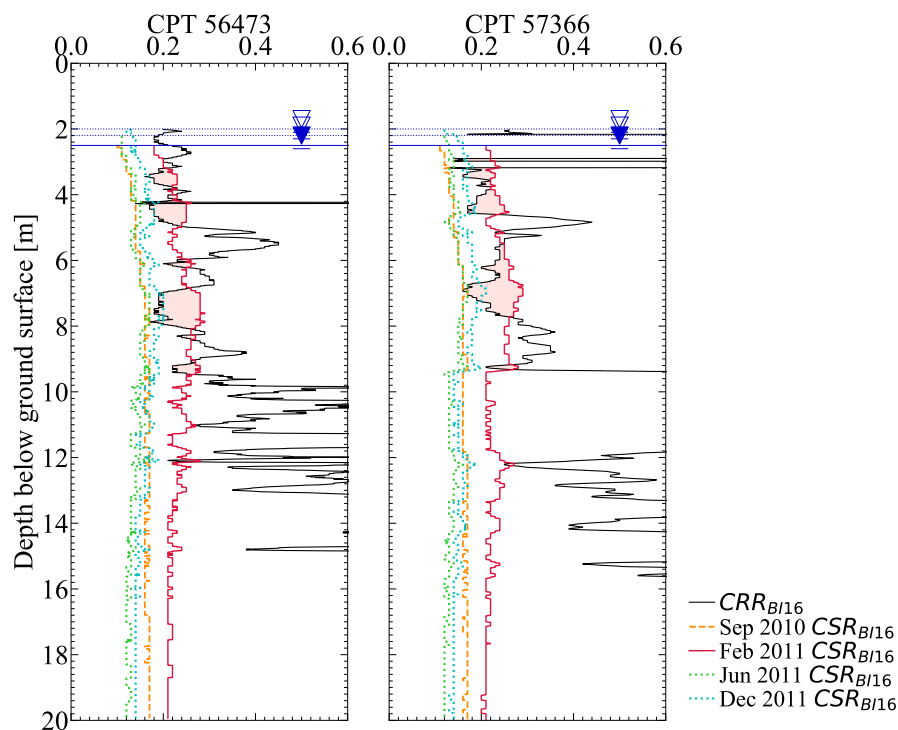
Figure 11. The Boulanger and Idriss (2016) estimated cyclic resistance ( $CRR_{B1/16}$ ) and the cyclic stress ratio ( $CSR_{B1/16}$ ) adjusted for  $M_w = 7.5$  and  $\sigma'_{vo} = 1 \text{ atm}$  for the Sep 2010, Feb 2011, Jun 2011, and Dec 2011 earthquakes for CPTs 56473 and 57366 at Shirley Intermediate School. Layers with  $FS_L < 1$  for the Feb 2011 event are shaded.
