Practical Design, Numerical Analysis, and Site Monitoring for Huge Arching Effect during Massive Excavation of Undercut Slope in Open-Pit Mine

ABSTRACT: *This paper reviews a successful case history where applications of numerical predictions for a massive excavation were undertaken for both Class A and Class B predictions. Forming a stable arch across the pit of an open-pit mine is beneficial to the design of an undercut slope. However, predicting the maximum stable undercut width under which the slope does not collapse is a challenging problem in geotechnical engineering. Slope undercutting techniques originally developed for 1g physical and centrifuge models were realized in practice for a full-scale design at the Mae Moh mine, one of the large coal open-pit mines in Southeast Asia, during the period of 2011 - 2017. Numerical analyses, along with in-situ measurements for data assimilation, were applied to test the novel design concept before and during the surface excavation. At the initial stage of excavating the undercut slope, the mine was studied in terms of forming an arch, by conducting a field experiment of a partial undercutting in Area 4.1, which was of monumental size

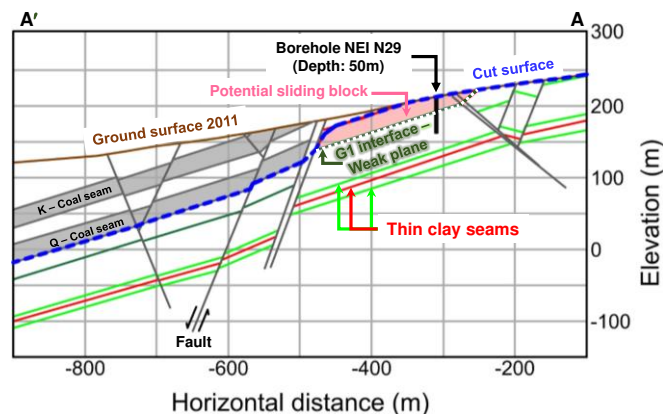
Figure 2. General geological information of Mae Moh mine and Area 4.1.

(a) Stratigraphy of Mae Moh basin

(b) Profile of Area 4.1 along A-A' cross section

(c) Area 4.1 overview and location of borehole NEI N29

(d) Core photos of borehole NEI N29

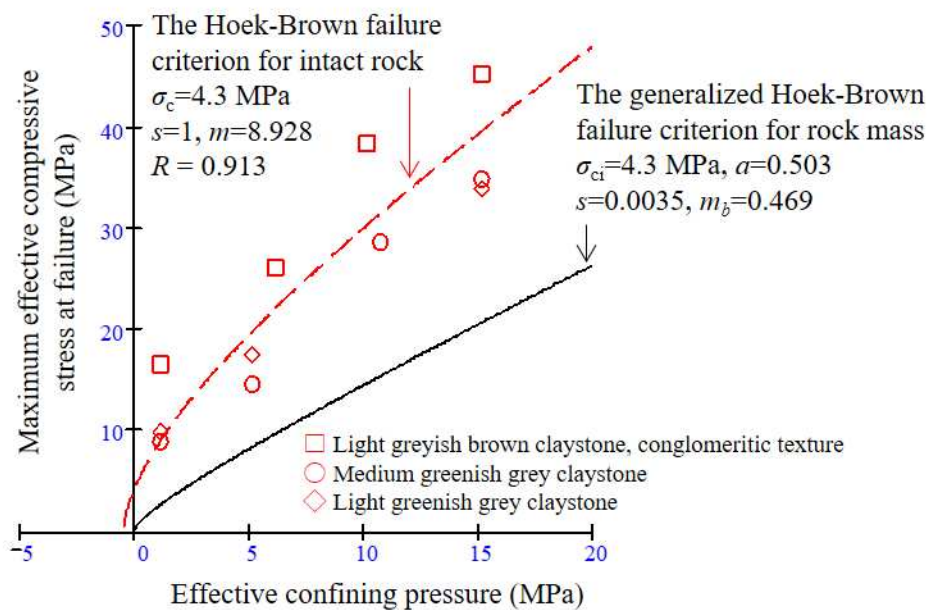
Figure 4. Principal stresses at failure for all samples.

Figure 4 shows the maximum and minimum effective compressive stresses at failure for each sample. Herein, the notation adopted in this study follows the sign convention used in soil mechanics, where compression is positive and tension is negative. It should be noted that one core sample was excluded because its appearance, texture, and test results deviated considerably from the others in the same sample set. The results of high pressure triaxial tests, conducted on three sets of core samples under effective confining pressures in the range of 1.1 – 15.1 MPa, are plotted in Figure 4. Subsequently, the high pressure triaxial test data were used to determine the material properties of the intact claystone and underburden claystone rock mass, e.g., the elastic constants and shear strength parameters.

At first, the Hoek-Brown failure criterion of the intact underburden claystone was determined by fitting the maximum and minimum effective compressive stresses at failure from the high pressure triaxial tests and the UCS of the intact underburden claystone. The average and standard deviations in the UCS of the intact underburden claystone were reportedly 4.3 MPa and 2.7 MPa, respectively (EGAT 1985). Over 200 intact underburden claystone samples were tested for the UCS in the laboratory. After fitting 11 states of stresses at failure to the average UCS of the intact rock, the intact underburden claystone's Hoek-Brown failure criterion was able to be written as Eq. (1). The m constant was 8.928 and the s constant definitely equaled 1. The Hoek-Brown failure criterion of the intact underburden claystone is plotted in Figure 4 (red dashed line).

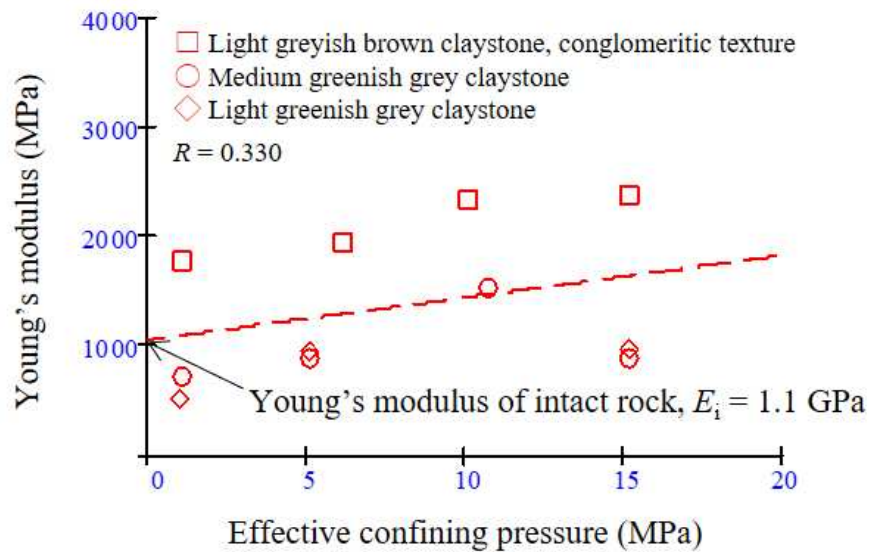
Figure 5. Elastic moduli and applied confining pressures.

The Young's moduli of all 11 samples of underburden claystone rock core were determined from slopes in the elastic range of the stress-strain curves obtained from the high pressure triaxial tests. Figure 5 shows the elastic modulus plotted against a variation in the effective confining pressure for each intact sample. The Young's moduli of all the samples were linearly fit and the elastic modulus of 1.1 GPa, determined at the zero effective confining pressure, was presumably the Young's modulus of the intact rock sample. The correlation coefficient (R) of the Young's modulus linear fitting was 0.330. Despite the intact rock and rock masses exhibiting pressure-dependent behavior, the Poisson's ratio of the intact rock sample can be determined from the linear relationship between the states of stress and strain in the elastic range of high pressure triaxial tests by assuming that Hooke's law is valid. However, only those obtained under the effective confining pressure of 1.1 – 6.1 MPa were in the acceptable range; therefore, the values ranging from 0.1 – 0.35 were obtained. Nevertheless, in many cases, the Poisson's ratio of the rock mass was larger than that of the intact rock sample, and the typical range of 0.25 – 0.40 was reported for the Poisson's ratio of the claystone (Gercek 2007). Consequently, the Poisson's ratio of the underburden claystone rock mass was assumed to be 0.3 for simplicity.

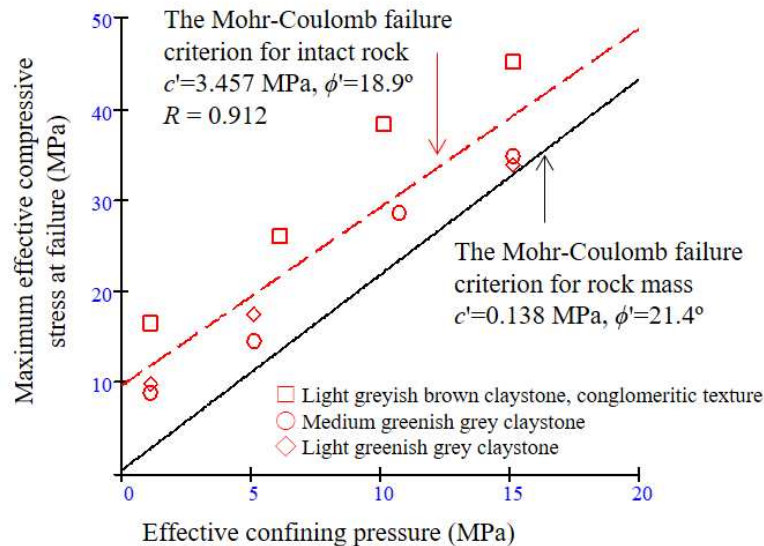
Figure 6. Mohr-Coulomb failure criteria of intact claystone and rock mass.

Figure 6 also shows the states of stresses at failure of the intact claystone samples from the high pressure triaxial tests and Mohr-Coulomb failure criterion of the intact claystone and rock mass. The cohesion and friction angle of the intact claystone were linearly fit and calculated using the high pressure triaxial test data and Eq. (3). The cohesion and friction angle of the intact claystone were 3.457 MPa and 18.9°, respectively. The statistical measures for the linear and nonlinear regression of the triaxial test data were $R=0.912$ or $R^2=0.833$ and $R=0.913$ or $R^2=0.834$, respectively. For the underburden claystone rock mass, the friction angle was fit with the generalized Hoek-Brown failure criterion in the range of the expected minimum effective compressive stresses in Area 4.1. The friction angle of the underburden claystone rock mass was slightly higher than that of the intact claystone because the expected minimum effective compressive stress in Area 4.1 was as low as 0.94 MPa. Obviously, the strength of the underburden claystone rock mass was notably lower than the strength of the intact claystone, based on the generalized Hoek-Brown failure criterion (Figure 4) and the Mohr-Coulomb fit (Figure 6). Ultimately, the material properties required for the numerical analyses were the underburden claystone rock mass properties, which were reduced from the intact claystone properties. The Young's modulus, Poisson's ratio, and the cohesion and friction angle of the rock mass assigned to the numerical models were 0.2 GPa, 0.30, 0.138 MPa, and 21.4°, respectively.

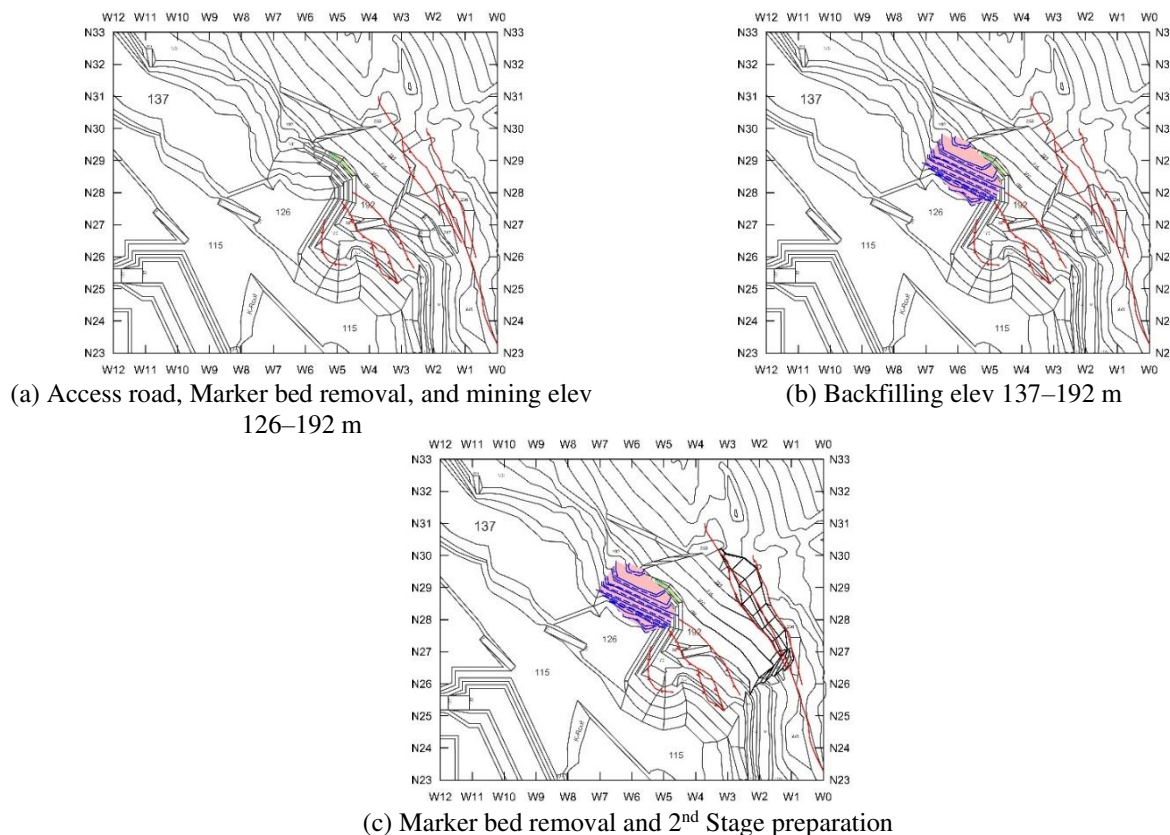
Figure 11. Sequential excavation of the 1st Stage in Area 4.1.

The mining sequence for the 1st Stage in Area 4.1 was planned as presented in Figure 11. The development and mining sequences began by cutting a main access ramp. To lower the potential block mass and driving force, highly laminated claystone layers, referred to as the “Marker bed”, were mined from an elevation of 192-236 msl (Figure 11(a)). Then, the cut-and-fill mining method was employed to obtain the coal. Area 4.1 was mined and backfilled from an elevation of 126-192 msl (Figures 11(a) to (c)).

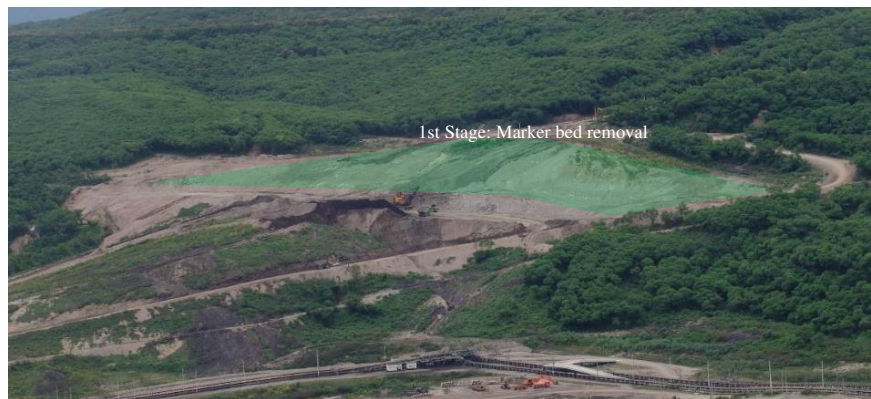
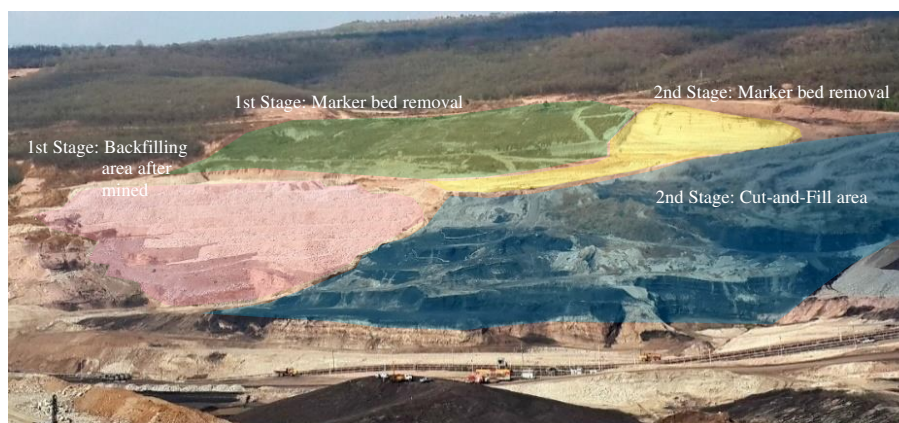
Figure 12. Photographs of the 1st Stage in Area 4.1.

The undercutting in Area 4.1 was periodically photographed for archival purposes; some of the photographs are presented in Figure 12. The mine equipment was moved to Area 4.1 and the site preparation began in April 2011. Three months later, in July 2011, the Marker bed was ready to be excavated; by August 2011, it had been totally removed. The undercutting of the northern part of Area 4.1 began in August and reached an elevation of 170 msl by January 2012. The undercut span was approximately 80 m. The undercutting continued and reached an elevation of 137 msl by April 2012. The undercut width was approximately 90 m. Between May and June 2012, the backfill, comprising 30,000 cubic meters, was placed from an elevation of 115-192 msl. The undercut width was then shortened to 30 m. The undercutting was restarted and continued in the southern direction in August 2012. The 1st Stage was completed in May 2014. Finally, the undercut width had been extended to approximately 100 m by the end of the 1st Stage.

(a) Access road and Marker bed removal in 1st Stage (as of August 2011)

(b) Mining elev 170 m in 1st Stage (as of January 2012)

(c) Marker bed removal and 2nd Stage preparation in 1st Stage (as of April 2014)

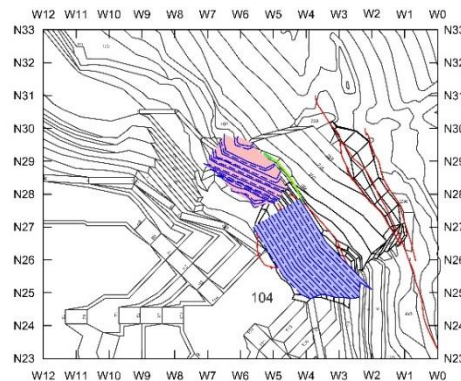
Figure 13. Sequential excavation of the 2nd Stage in Area 4.1.

The mining sequence of the 2nd Stage is depicted in Figures 13(a) to 13(c). In Figure 13, the daylighted G1 interface and the normal faults in Area 4.1 are represented by green and red lines, respectively. The 2nd Stage was launched by mining the interburden and coal from an elevation of 104-192 msl during the period of 2014 to 2016. At the beginning of 2017, the backfilling of the 2nd Stage began and was completed in October 2017. The undercut face could not be fully backfilled and supported, as presented in Figure 13(c), because of the working space constraints. Consequently, the G1 interface (green line) was still daylighted on the undercut slope face for a length of 190 m.

(a) At the beginning of 2nd Stage

(b) Mining elev 192–104 m

(c) Backfilling elev 104–192 m

(d) Aerial view at end of 2nd Stage (as of October 2017)

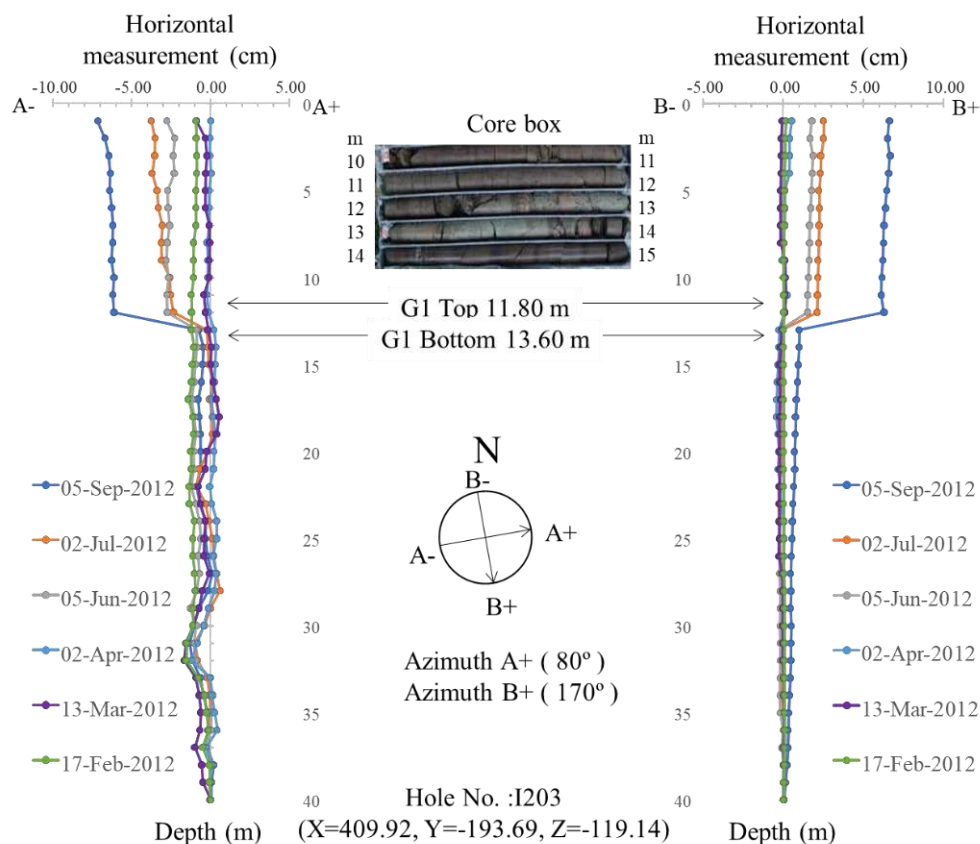
Figure 15. Surface and subsurface displacements measured by I203.

recorded from the ground surface to a depth of 12 m. The depth of 12 m was indicated as the depth of the G1 interface. Along with the progress of the mining activity and the rainy season, the slope was slowly displaced and borehole I203 was gradually bent and totally sheared off by September 2012. The maximum surface and subsurface displacements at the G1 interface were 0.097 m and 0.088 m, respectively. The displacements measured by I203 were likely to be in the G1 interface dip direction. The data obtained by I203 revealed that the ground surface of the potential sliding block above the G1 interface was slightly more displaced than the subsurface.

According to Figure 15, although the potential sliding block above the daylighted G1 interface obviously moved along the G1 interface, a slight shear deformation was observed in the underlying rock mass and the potential sliding block. Therefore, the magnitude of the movements observed in Figure 25 is always larger than that of Figure 26 and their difference represents the shear deformation of the potential sliding block.

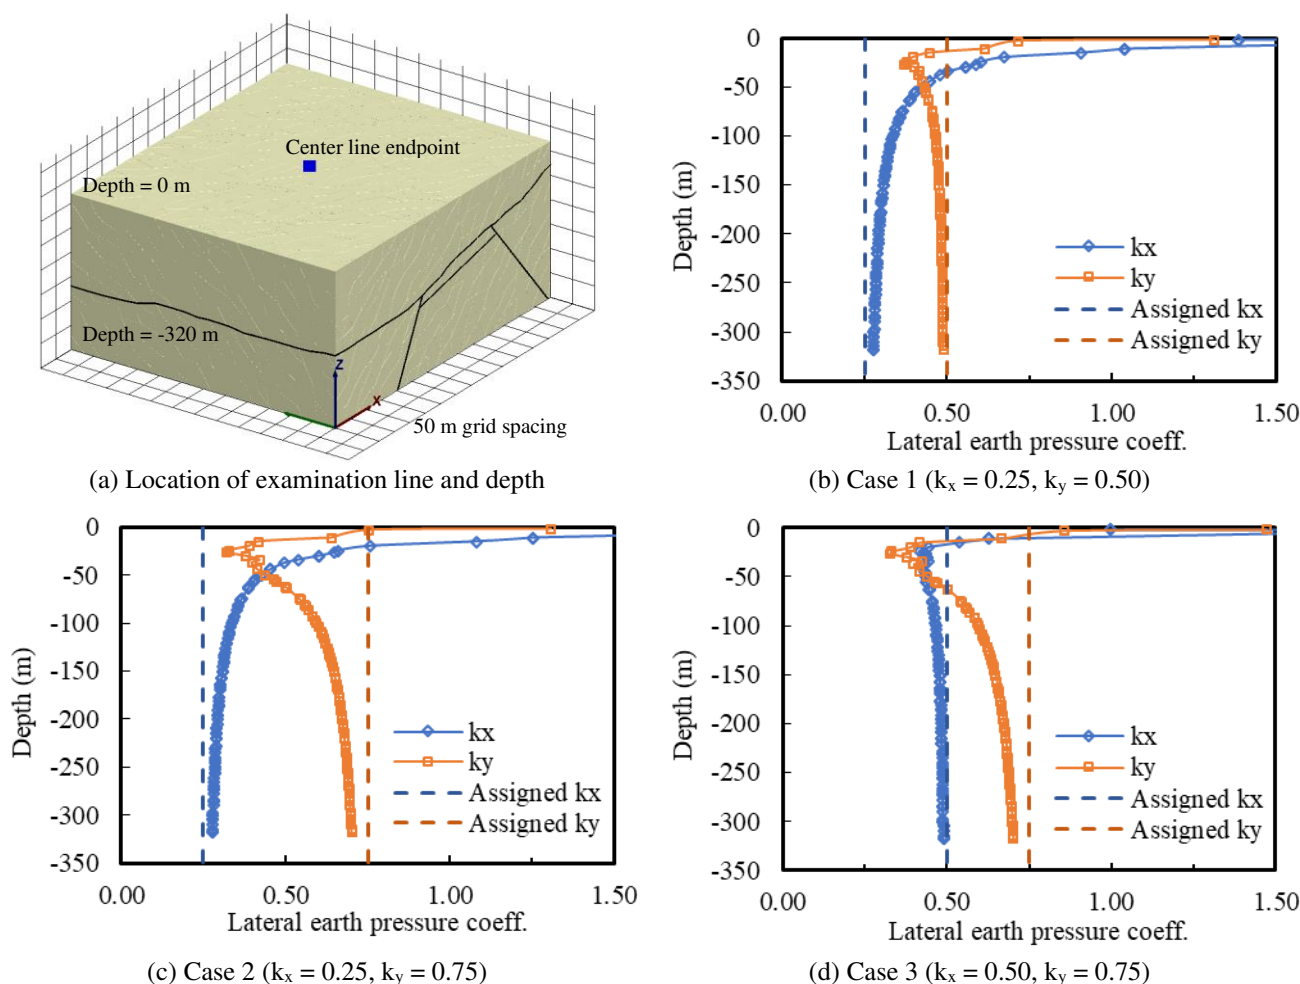
Figure 18. Lateral earth pressure coefficients and depth at original ground surface.

Figure 18 presents k_x and k_y with the depth along the vertical center line of the model. The depth of the model was measured from the top of the big block (blue dot). Near the free face, the values for both k_x and k_y of the zones were much greater than those assigned. They continuously converged to the initially assigned horizontal stresses with depth.

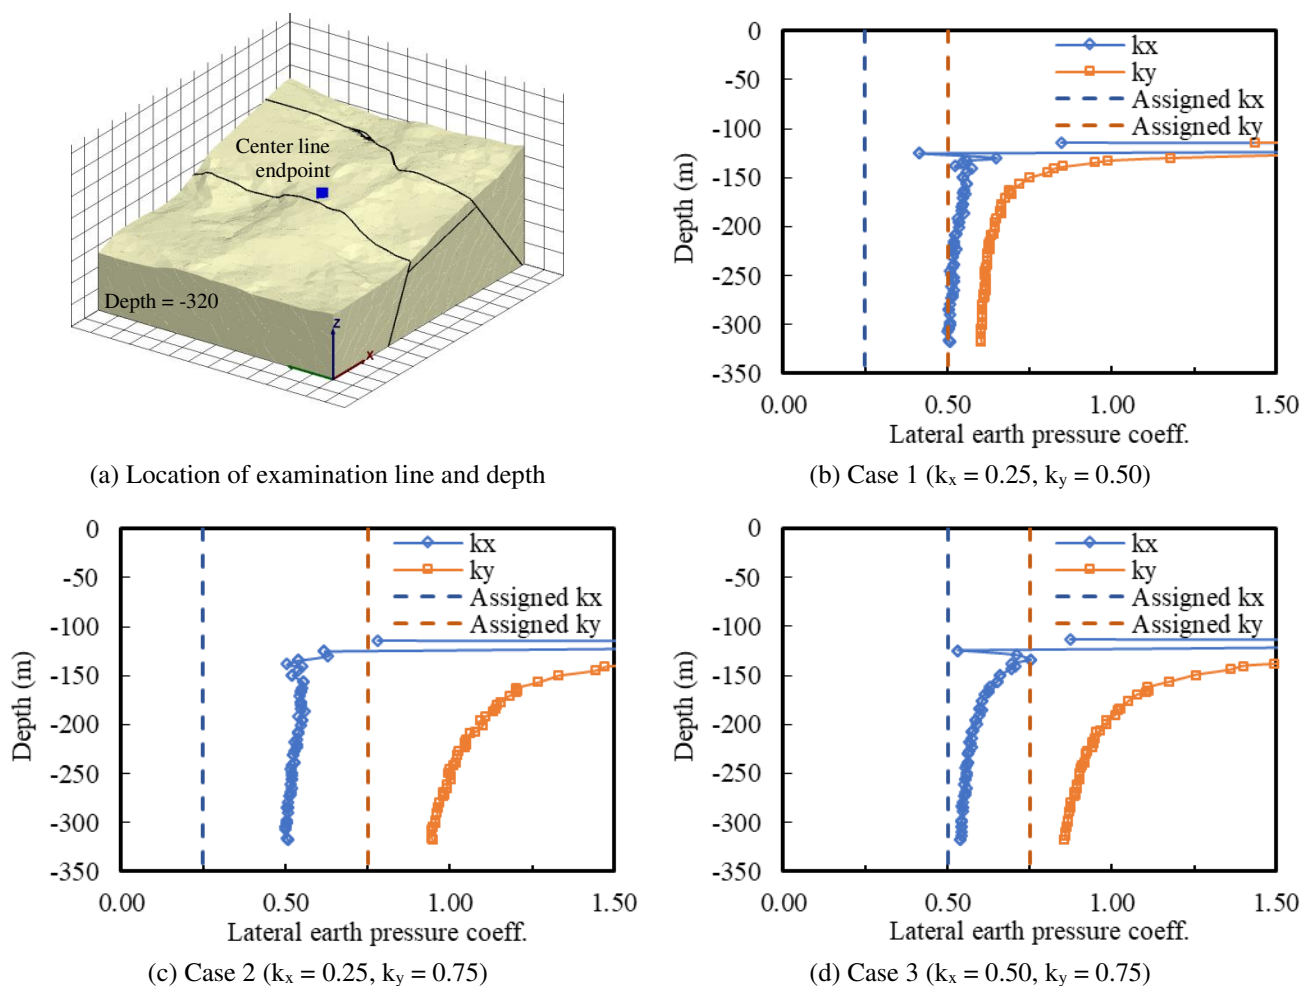
Figure 19. Increase in lateral earth pressure coefficients and depth at ground surface 2011.

Figure 19 also presents the coefficients with depth after the original ground surface was excavated to ground surface 2011. Initial coefficients k_x and k_y are both seen to have increased by quite a fair amount. The lateral earth pressure coefficient in the x direction (k_x) increased from 0.25 to 0.50 in Cases 1 and 2 and rose slightly in Case 3. The values for k_y also increased approximately 0.125 from their initial values in all cases.

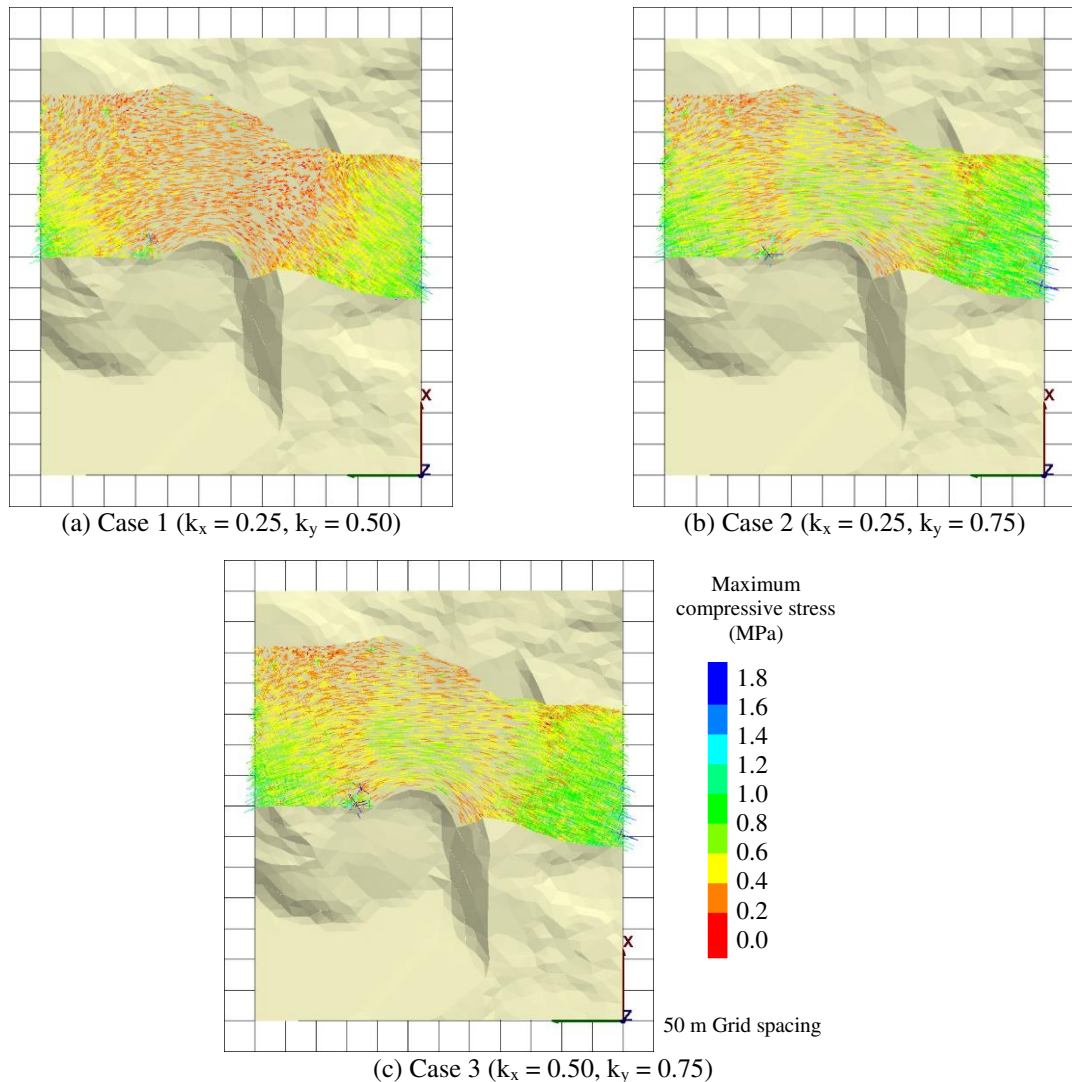
Figure 21. Principal stress trajectories in potential sliding block of undercut models.

The principal stress trajectories of the models are plotted in Figure 21. The positive stress indicates the compressive stress. The direction of the maximum compressive stress is obviously aligned in the tangential direction to the excavation in all cases. The magnitude of the maximum compressive stress in Case 1 was the least. The magnitudes of the maximum compressive stress were apparently similar in Cases 2 and 3. The total displacement contours and principal stresses of all the cases clearly showed arching in the potential sliding block, similar to the simple model. As the total displacements for all cases were slightly different, Case 1 was selected as the case for more undercut slope behavior investigations of Area 4.1.

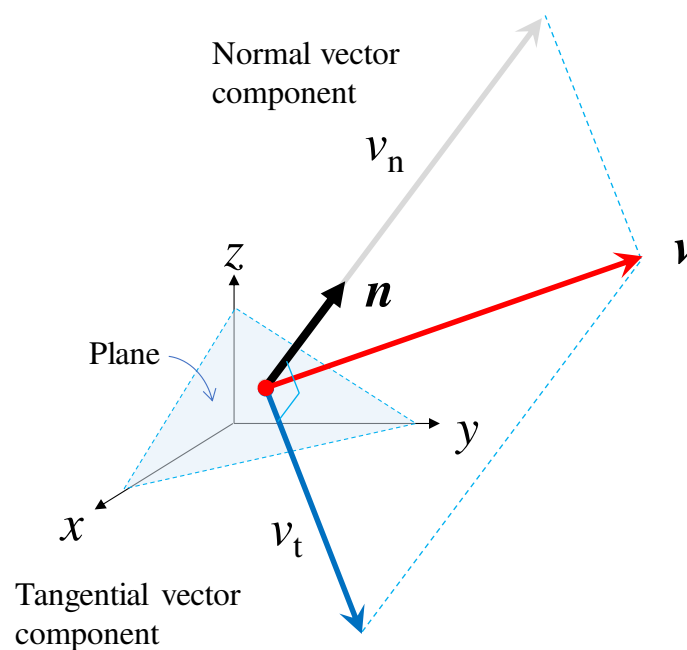
Figure 23. Tangential vector of a given vector at a plane.

Based on the simple numerical model, the undercut slope displaced along the weak or sliding plane. Therefore, the displacement vectors of the 13 nodes located near the prisms were utilized to obtain the magnitudes of the tangential displacement vectors at the G1 interface plane (sliding plane). Tangential vector v_t of vector v at a plane is depicted in Figure 23. The normal vector or the pole of the G1 interface, an essential input for determining the tangential displacement vector, was calculated and equaled $087.8^\circ/75.7^\circ$ (Trend/Plunge). The normal vector of the G1 interface was the mean normal vector of the G1 interface faces, which were extracted from the numerical model.

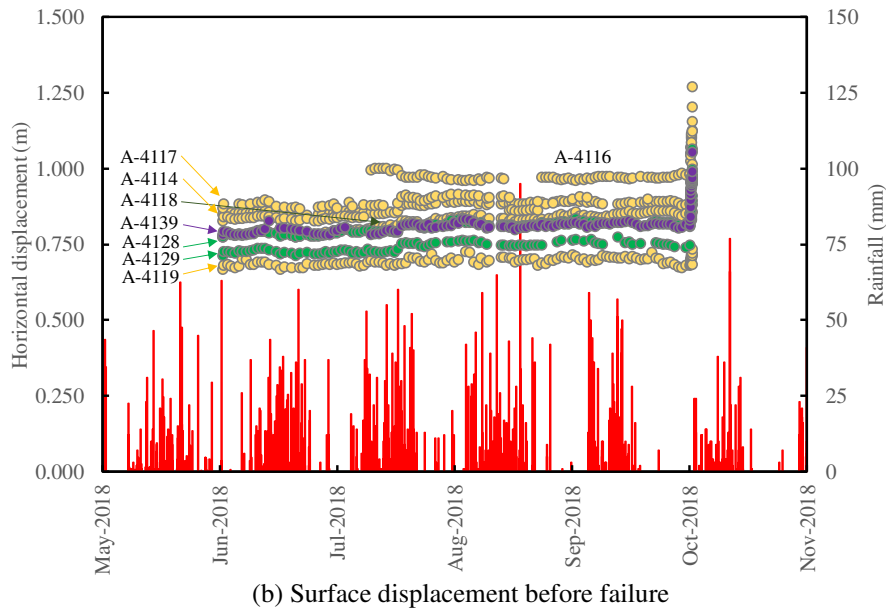
Figure 30 Surface displacement of 2nd Stage of Area 4.1.

As stated earlier, the monitoring data gathered during the undercutting of the 2nd Stage was unfortunately damaged, but partially recovered. Thus, comparative data between the numerical analyses and the field measurements will be presented. The recovered monitoring data of the 2nd Stage, which were the surface displacements from eight prisms, are presented in this section. Figure 30 shows the surface displacement data between March 2015 and February 2016, and between June 2018 and October 2018.

After the undercutting and before the failure, all the available surface displacement data showed that the potential sliding block had the accumulative surface displacement of approximately 1 m and rapidly displaced on the day of failure. The surface displacements from the monitoring data, one day before the failure, are plotted with the surface displacement of the numerical model of the 2nd Stage in Figure 31. The surface displacements of the numerical model were incomparable. The displacement magnitudes of the monitoring data were much larger than those of the numerical model.

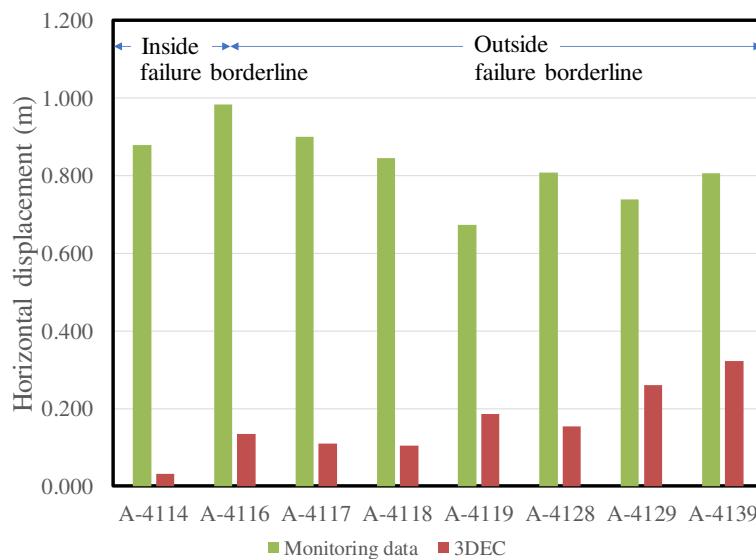
Figure 31 Comparison of surface displacements at 2nd Stage of Area 4.1.

(a) Location of prisms in model

(b) Surface displacements
