Practical Design, Numerical Analysis, and Site Monitoring for Huge Arching Effect during Massive Excavation of Undercut Slope in Open-Pit Mine

ABSTRACT: *This paper reviews a successful case history where applications of numerical predictions for a massive excavation were undertaken for both Class A and Class B predictions. Forming a stable arch across the pit of an open-pit mine is beneficial to the design of an undercut slope. However, predicting the maximum stable undercut width under which the slope does not collapse is a challenging problem in geotechnical engineering. Slope undercutting techniques originally developed for 1g physical and centrifuge models were realized in practice for a full-scale design at the Mae Moh mine, one of the large coal open-pit mines in Southeast Asia, during the period of 2011 - 2017. Numerical analyses, along with in-situ measurements for data assimilation, were applied to test the novel design concept before and during the surface excavation. At the initial stage of excavating the undercut slope, the mine was studied in terms of forming an arch, by conducting a field experiment of a partial undercutting in Area 4.1, which was of monumental size

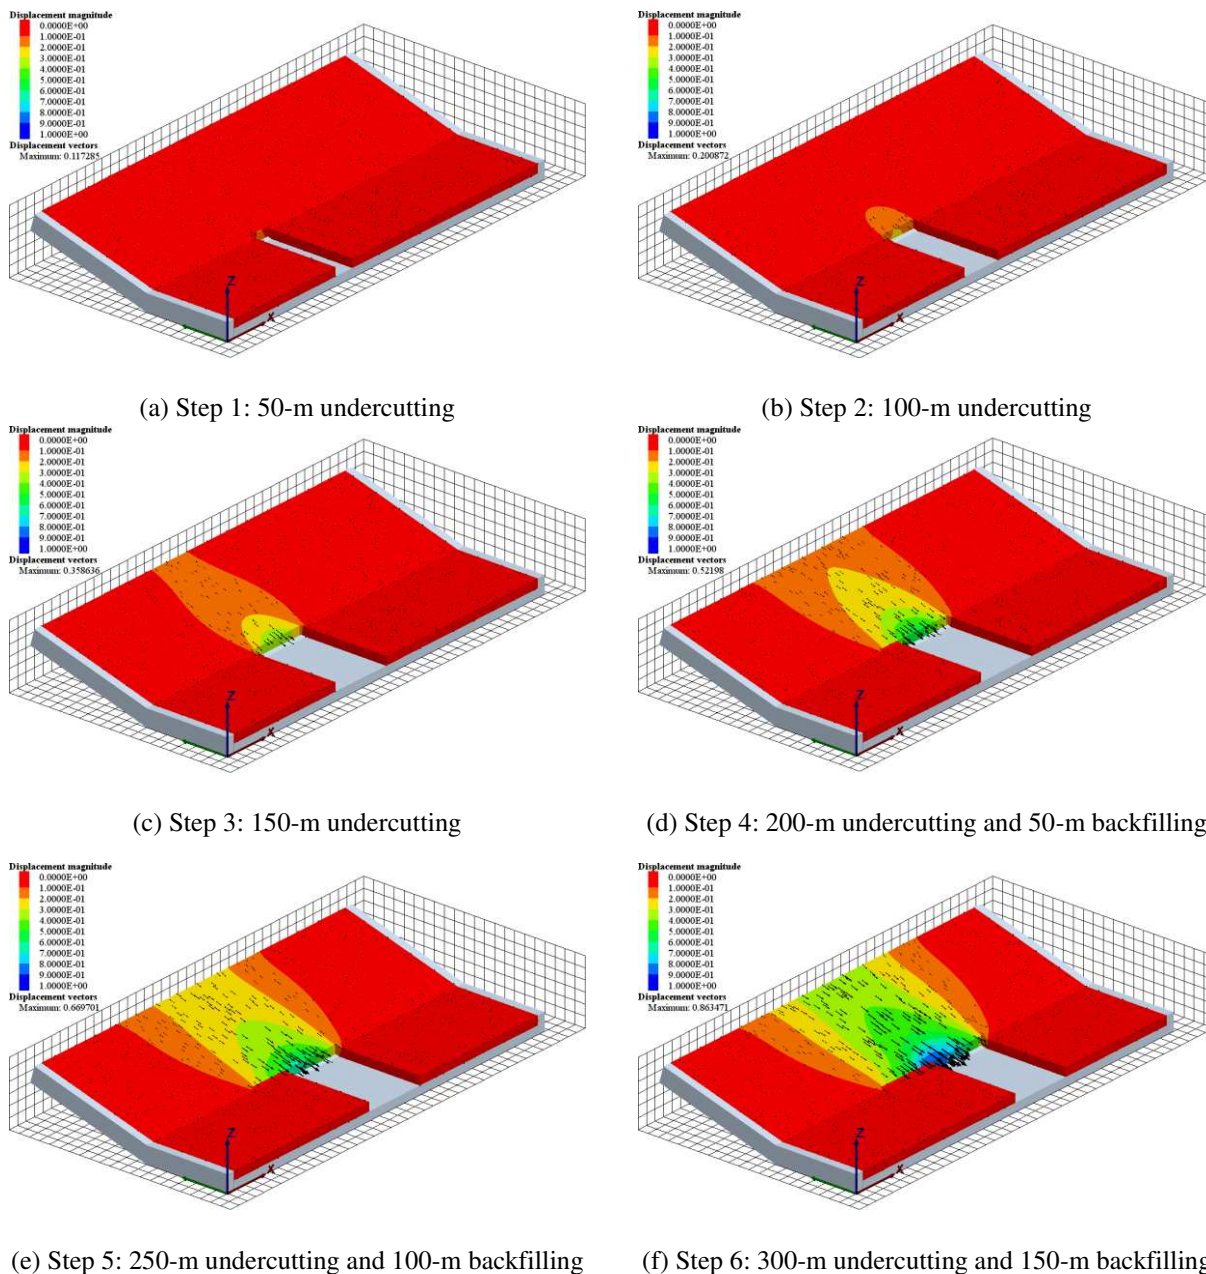
Figure 8. Total displacement contour and vectors of simple Area 4.1 undercut slope model.

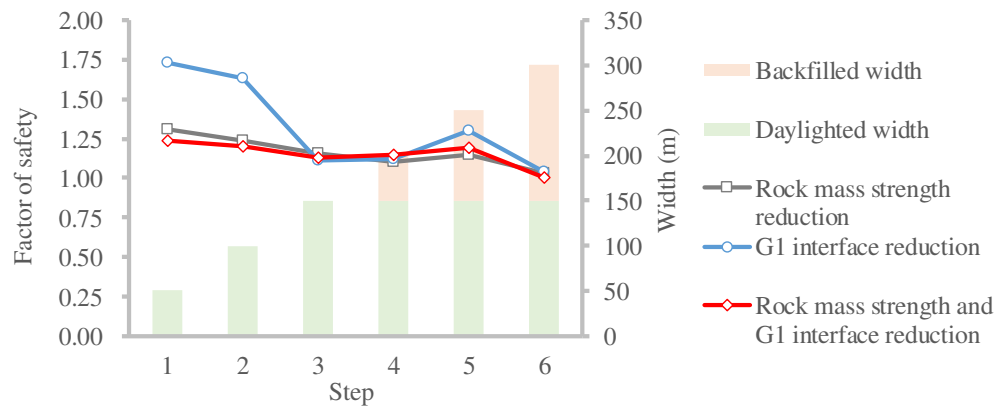
Figure 10. Factor of safety for each sequential excavation step using three reduction cases.

At each step of the sequential excavation, the factor of safety was calculated using the shear strength reduction technique (Matsui and San 1992). The factors of safety are presented in Figure 10 for comparison. The factors of safety for Steps 1 to 3 are seen to progressively decrease because of the undercut span extension. The factors of safety for Steps 4 and 5 are seen to slightly increase, but the factor of safety for Step 6 is seen to drop steeply to 1.00. This drop in the factor of safety for Step 6 stems from the accumulation of strain in the rock mass.

Hence, the factor of safety calculated in Figure 10 was governed by either the claystone rock mass or the G1 interface, depending on the sequential excavation step. In the simple model, the stability of the undercut slope was marginal when the accumulation of the undercut width and the backfill were 300 m and 150 m, respectively, for which the factor of safety equaled 1. Therefore, the base sliding surface and lateral resistance or deep-seated failure would occur simultaneously at the final step. Consequently, no strength reduction was applied to the G1 interface (interface friction angle of 12°) or the claystone rock mass (friction angle of 21.4° and cohesion 0.138 MPa). Based on the simple numerical analyses, the engineers and mine administration decided to undercut and mine the coal in Area 4.1. Area 4.1 became a large-scale experiment for undercutting in a weak rock mass (Mavong et al. 2014). The designs and plans for Area 4.1 of the mine were initiated in 2010.

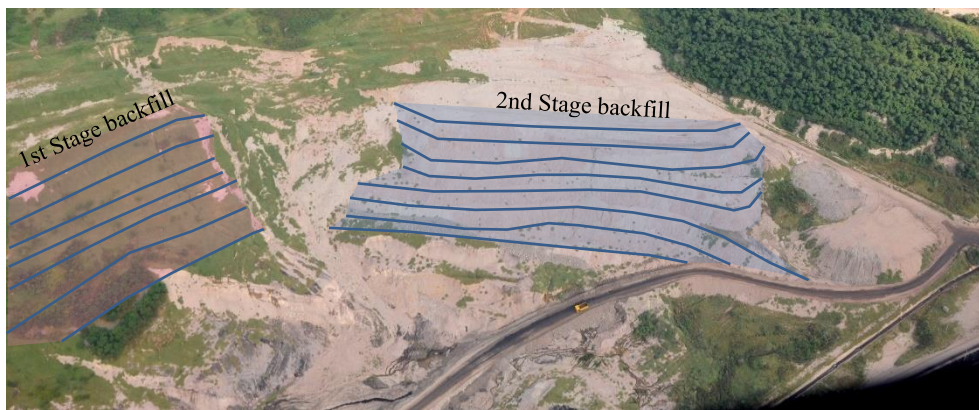
(a) At the beginning of 2nd Stage

(b) Mining elev 192–104 m

(c) Backfilling elev 104–192 m

(d) Aerial view at end of 2nd Stage (as of October 2017)

Figure 13. Sequential excavation of the 2nd Stage in Area 4.1.

The mining sequence of the 2nd Stage is depicted in Figures 13(a) to 13(c). In Figure 13, the daylighted G1 interface and the normal faults in Area 4.1 are represented by green and red lines, respectively. The 2nd Stage was launched by mining the interburden and coal from an elevation of 104-192 msl during the period of 2014 to 2016. At the beginning of 2017, the backfilling of the 2nd Stage began and was completed in October 2017. The undercut face could not be fully backfilled and supported, as presented in Figure 13(c), because of the working space constraints. Consequently, the G1 interface (green line) was still daylighted on the undercut slope face for a length of 190 m.

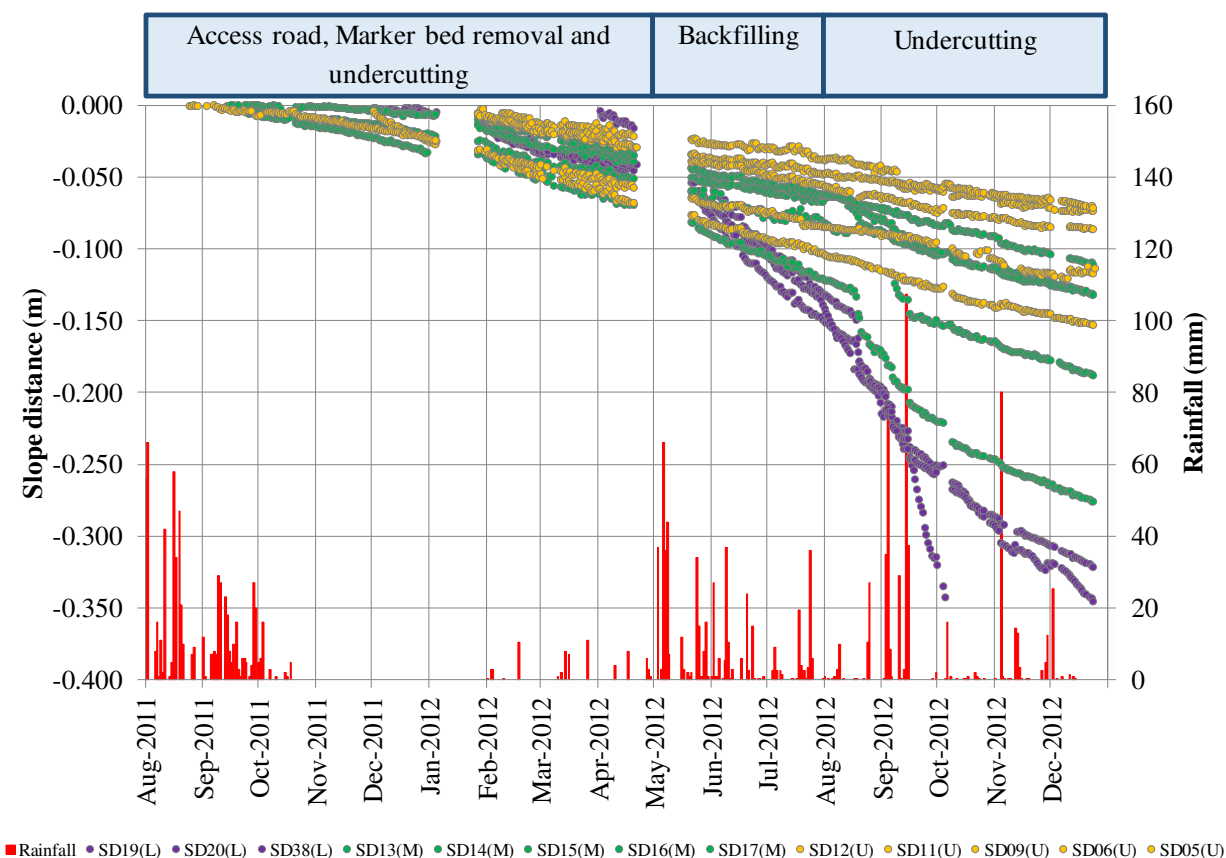
Figure 16. Surface displacements measured by prisms and amounts of precipitation.

The monitoring data for the ground surface displacements during the undercutting of Area 4.1 from 13 prisms are presented in Figure 16 along with the amounts of precipitation. The scheduled preventive maintenance program and an accidental system failure caused the monitoring to be discontinued. However, the monitoring data that were collected were still valuable. In Figure 16, the monitoring data are colorized according to the installation locations of the prisms. The ground surface displacement monitoring data on the Upper Floor, Mid Floor, and Lower floor have been colorized in yellow, green, and purple, respectively.

The surface displacements of the Upper, Mid, and Lower Floors – presented as the changes in the measured distance between the total station and the monitored prisms – were approximately -0.10 m, -0.25 m and -0.35 m, respectively, in early January 2013. The negative values indicate that the prisms displaced toward the total station. It is clear from the figure that the Lower Floor had the largest displacement because of its vicinity to the undercut face, while the Upper Floor had the smallest displacement. It should be noted that the surface displacement, measured by the Robotic Total Station with prisms (Figure 16), is a result of the interface shearing as captured by inclinometer I203 (Figure 15) and the deformation of the potential sliding block.

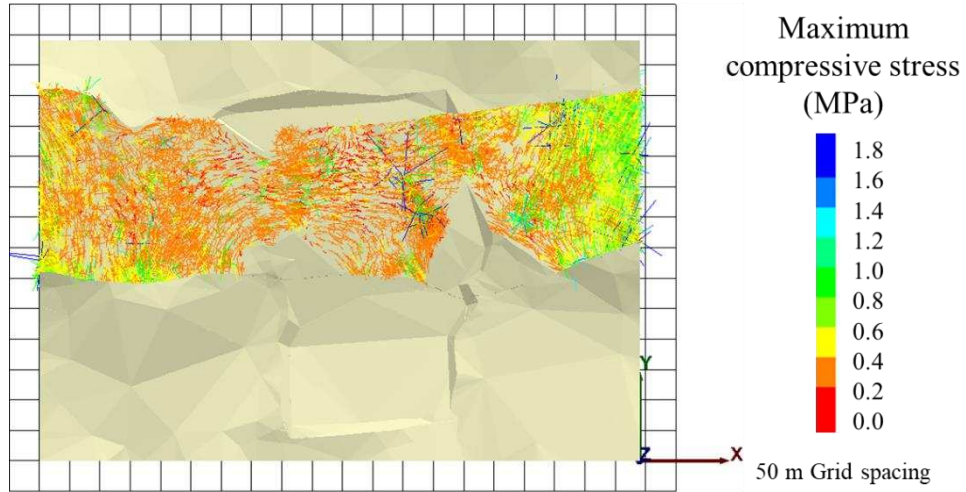
Figure 28. Principal stress trajectories in potential sliding block of 2nd Stage.

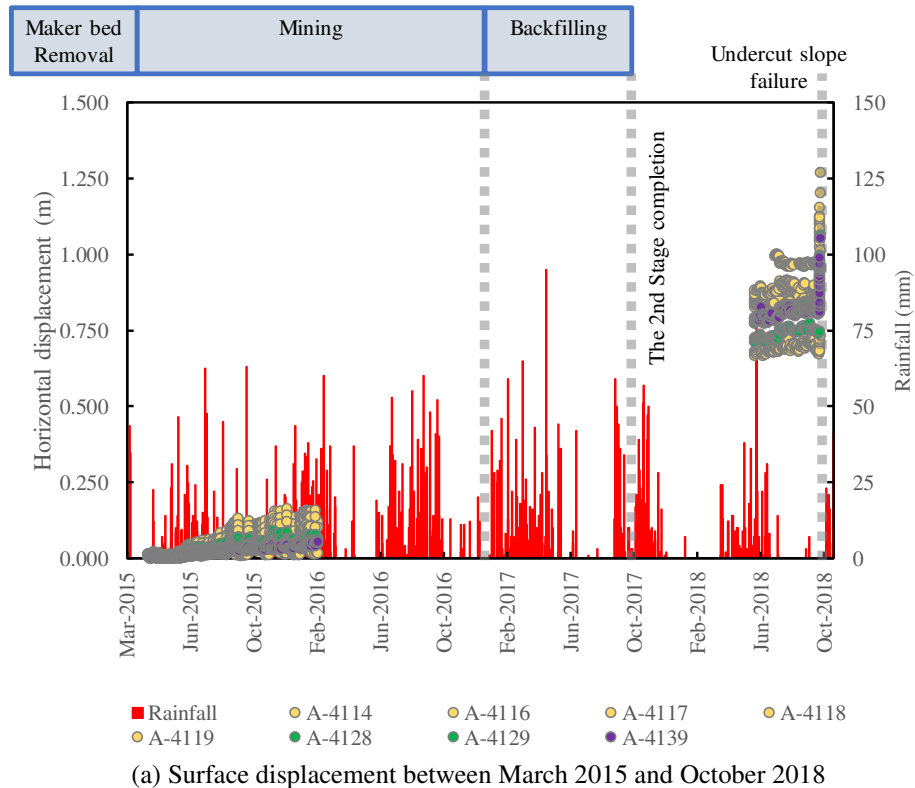
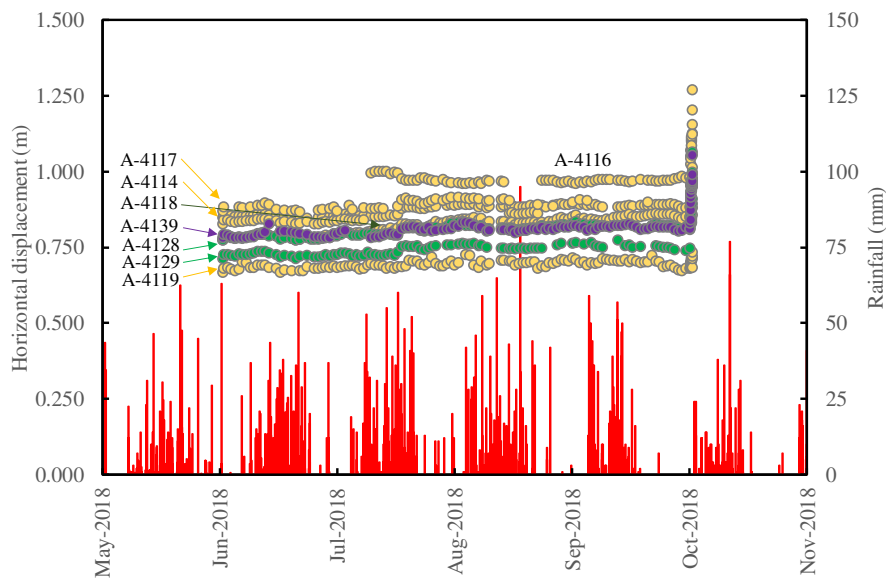
(a) Surface displacement between March 2015 and October 2018

(b) Surface displacement before failure

Figure 30 Surface displacement of 2nd Stage of Area 4.1.

As stated earlier, the monitoring data gathered during the undercutting of the 2nd Stage was unfortunately damaged, but partially recovered. Thus, comparative data between the numerical analyses and the field measurements will be presented. The recovered monitoring data of the 2nd Stage, which were the surface displacements from eight prisms, are presented in this section. Figure 30 shows the surface displacement data between March 2015 and February 2016, and between June 2018 and October 2018.

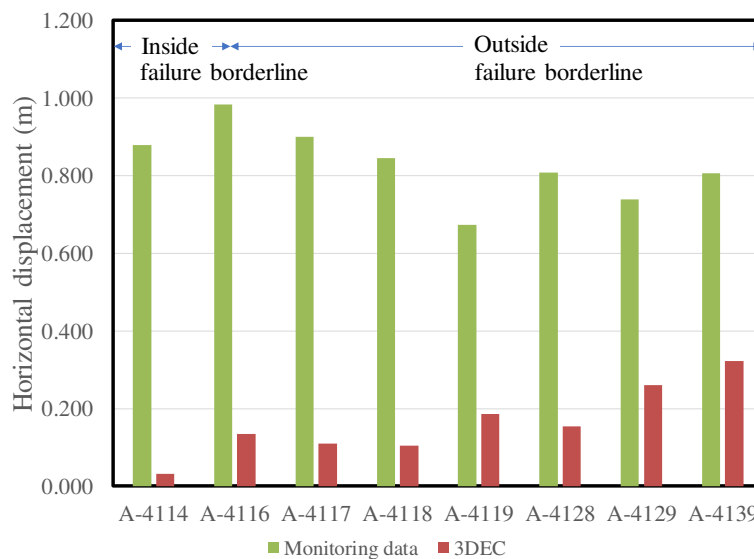
(a) Location of prisms in model

(b) Surface displacements

After the undercutting and before the failure, all the available surface displacement data showed that the potential sliding block had the accumulative surface displacement of approximately 1 m and rapidly displaced on the day of failure. The surface displacements from the monitoring data, one day before the failure, are plotted with the surface displacement of the numerical model of the 2nd Stage in Figure 31. The surface displacements of the numerical model were incomparable. The displacement magnitudes of the monitoring data were much larger than those of the numerical model.
