Practical Design, Numerical Analysis, and Site Monitoring for Huge Arching Effect during Massive Excavation of Undercut Slope in Open-Pit Mine

ABSTRACT: *This paper reviews a successful case history where applications of numerical predictions for a massive excavation were undertaken for both Class A and Class B predictions. Forming a stable arch across the pit of an open-pit mine is beneficial to the design of an undercut slope. However, predicting the maximum stable undercut width under which the slope does not collapse is a challenging problem in geotechnical engineering. Slope undercutting techniques originally developed for 1g physical and centrifuge models were realized in practice for a full-scale design at the Mae Moh mine, one of the large coal open-pit mines in Southeast Asia, during the period of 2011 - 2017. Numerical analyses, along with in-situ measurements for data assimilation, were applied to test the novel design concept before and during the surface excavation. At the initial stage of excavating the undercut slope, the mine was studied in terms of forming an arch, by conducting a field experiment of a partial undercutting in Area 4.1, which was of monumental size

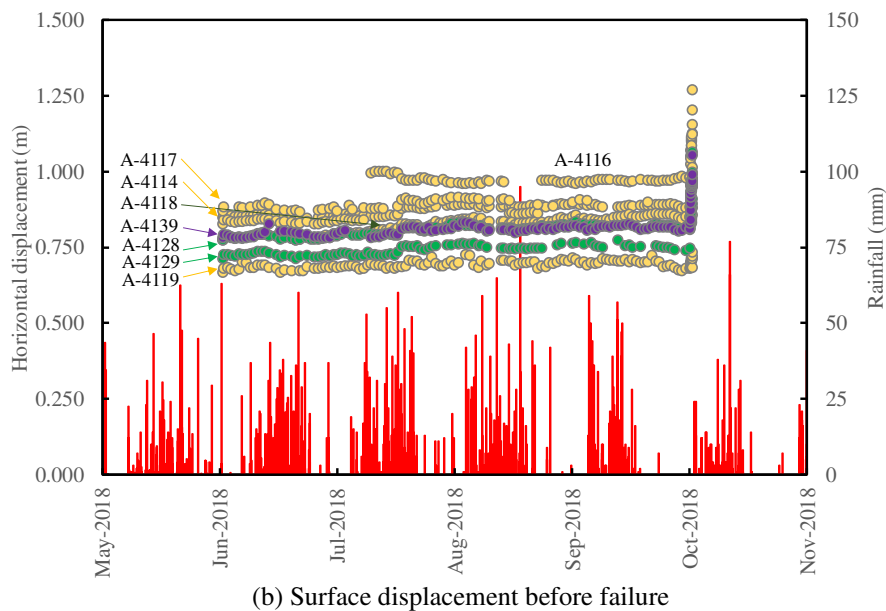
Figure 30 Surface displacement of 2nd Stage of Area 4.1.

As stated earlier, the monitoring data gathered during the undercutting of the 2nd Stage was unfortunately damaged, but partially recovered. Thus, comparative data between the numerical analyses and the field measurements will be presented. The recovered monitoring data of the 2nd Stage, which were the surface displacements from eight prisms, are presented in this section. Figure 30 shows the surface displacement data between March 2015 and February 2016, and between June 2018 and October 2018.
