Practical Design, Numerical Analysis, and Site Monitoring for Huge Arching Effect during Massive Excavation of Undercut Slope in Open-Pit Mine

ABSTRACT: *This paper reviews a successful case history where applications of numerical predictions for a massive excavation were undertaken for both Class A and Class B predictions. Forming a stable arch across the pit of an open-pit mine is beneficial to the design of an undercut slope. However, predicting the maximum stable undercut width under which the slope does not collapse is a challenging problem in geotechnical engineering. Slope undercutting techniques originally developed for 1g physical and centrifuge models were realized in practice for a full-scale design at the Mae Moh mine, one of the large coal open-pit mines in Southeast Asia, during the period of 2011 - 2017. Numerical analyses, along with in-situ measurements for data assimilation, were applied to test the novel design concept before and during the surface excavation. At the initial stage of excavating the undercut slope, the mine was studied in terms of forming an arch, by conducting a field experiment of a partial undercutting in Area 4.1, which was of monumental size

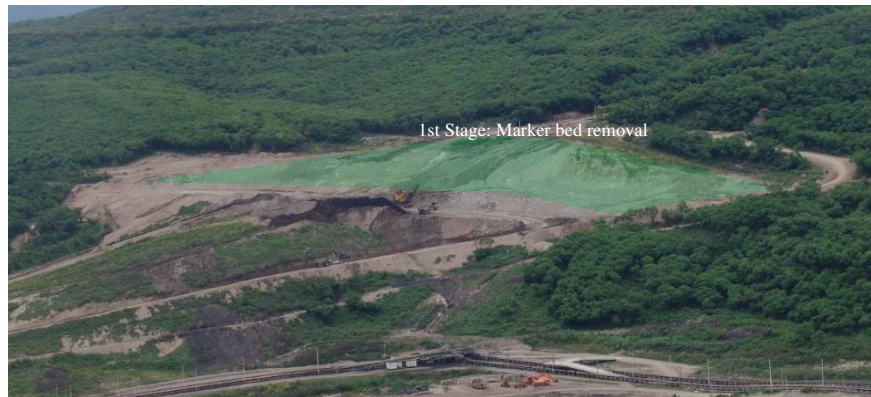
(a) Access road and Marker bed removal in 1st Stage (as of August 2011)

(b) Mining elev 170 m in 1st Stage (as of January 2012)

(c) Marker bed removal and 2nd Stage preparation in 1st Stage (as of April 2014)

Figure 12. Photographs of the 1st Stage in Area 4.1.

The undercutting in Area 4.1 was periodically photographed for archival purposes; some of the photographs are presented in Figure 12. The mine equipment was moved to Area 4.1 and the site preparation began in April 2011. Three months later, in July 2011, the Marker bed was ready to be excavated; by August 2011, it had been totally removed. The undercutting of the northern part of Area 4.1 began in August and reached an elevation of 170 msl by January 2012. The undercut span was approximately 80 m. The undercutting continued and reached an elevation of 137 msl by April 2012. The undercut width was approximately 90 m. Between May and June 2012, the backfill, comprising 30,000 cubic meters, was placed from an elevation of 115-192 msl. The undercut width was then shortened to 30 m. The undercutting was restarted and continued in the southern direction in August 2012. The 1st Stage was completed in May 2014. Finally, the undercut width had been extended to approximately 100 m by the end of the 1st Stage.

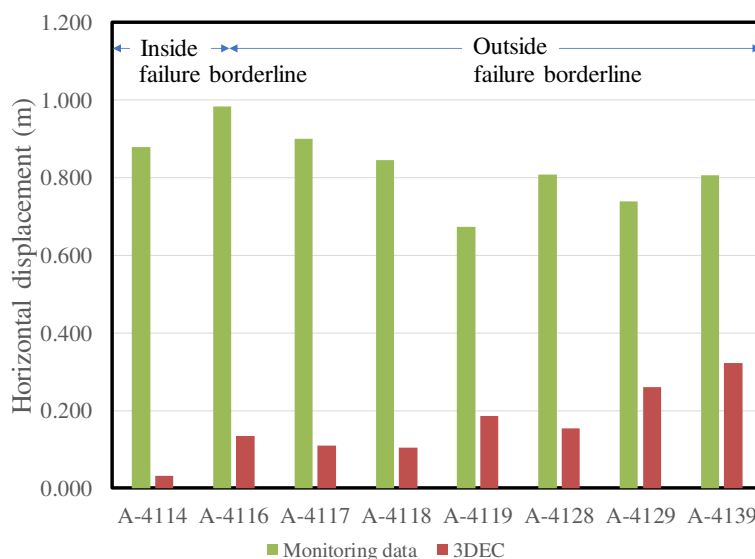
(a) Location of prisms in model

(b) Surface displacements

After the undercutting and before the failure, all the available surface displacement data showed that the potential sliding block had the accumulative surface displacement of approximately 1 m and rapidly displaced on the day of failure. The surface displacements from the monitoring data, one day before the failure, are plotted with the surface displacement of the numerical model of the 2nd Stage in Figure 31. The surface displacements of the numerical model were incomparable. The displacement magnitudes of the monitoring data were much larger than those of the numerical model.
