# Practical Design, Numerical Analysis, and Site Monitoring for Huge Arching Effect during Massive Excavation of Undercut Slope in Open-Pit Mine

**ABSTRACT:** *This paper reviews a successful case history where applications of numerical predictions for a massive excavation were undertaken for both Class A and Class B predictions. Forming a stable arch across the pit of an open-pit mine is beneficial to the design of an undercut slope. However, predicting the maximum stable undercut width under which the slope does not collapse is a challenging problem in geotechnical engineering. Slope undercutting techniques originally developed for 1g physical and centrifuge models were realized in practice for a full-scale design at the Mae Moh mine, one of the large coal open-pit mines in Southeast Asia, during the period of 2011 - 2017. Numerical analyses, along with in-situ measurements for data assimilation, were applied to test the novel design concept before and during the surface excavation. At the initial stage of excavating the undercut slope, the mine was studied in terms of forming an arch, by conducting a field experiment of a partial undercutting in Area 4.1, which was of monumenta

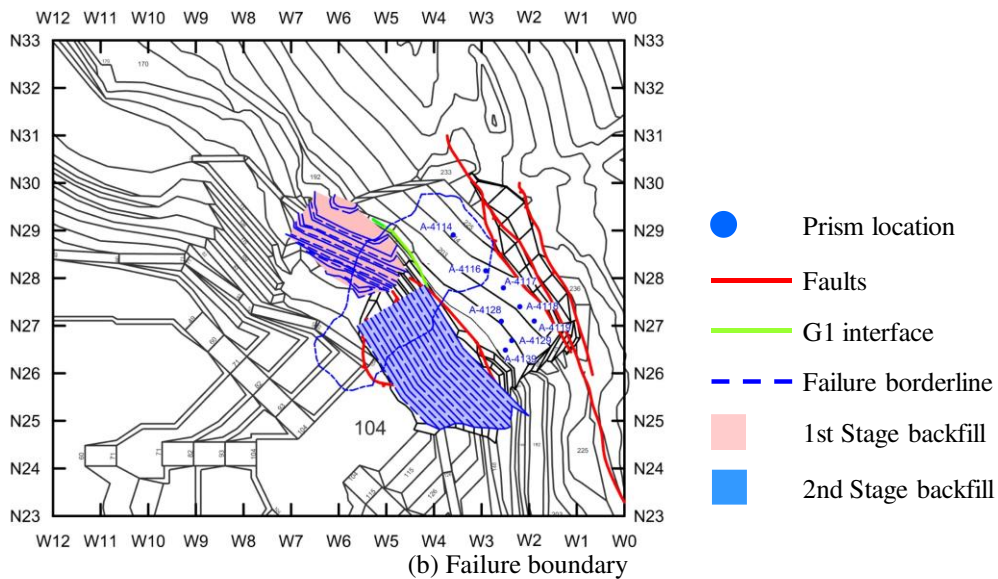
The slope failure in the field (Figure 29) is shown as a vertical shear plane and is evidence of the rock mass failure on the side of the sliding block (side resistance), also called flank. However, the failure of the rock mass of the block was hardly captured by the numerical model in this study because of the complexity of the geologic structures in Area 4.1. In fact, the results of one case of failure would not be sufficient to confirm other unknown multiple variables. Later, Area 4.1 was treated as an abandoned mining site; therefore, there was no further investigation of this failure.

(a) Photo of Area 4.1 failure

Figure 29. Area 4.1's debris after failure in October 2018.
