Segmental Retaining Wall Reinforced with Geogrids, in New Hospital Works (Salamanca, Spain)

ABSTRACT: *The construction of a new hospital, located by the river Tormes in the Spanish city of Salamanca, involved the expansion of roads and the construction of a new way of access to the complex, as well as a large retaining wall to bridge the gap between them and the river level. The project original solution was in situ foundations and precast concrete walls. However, at both ends of the alignment of Transición Española Avenue, there were several construction constraints (such as the existence of rainwater chambers for discharging into the river, a large-diameter drainage pipe at the back of the walls, communications, and gas services). The need to maintain steady access to the old hospital in service during the COVID-19 pandemic was furthermore required. The wall was founded on fills with low bearing capacity in other sections. Finally, a reinforced segmental retaining wall (SRW) was adopted as the optimum choice. It consists of concrete block (segmental) facing with a high-quality fill reinforced backfill, reinforced with polyester (PET) geogrids. The facing required a variable inc

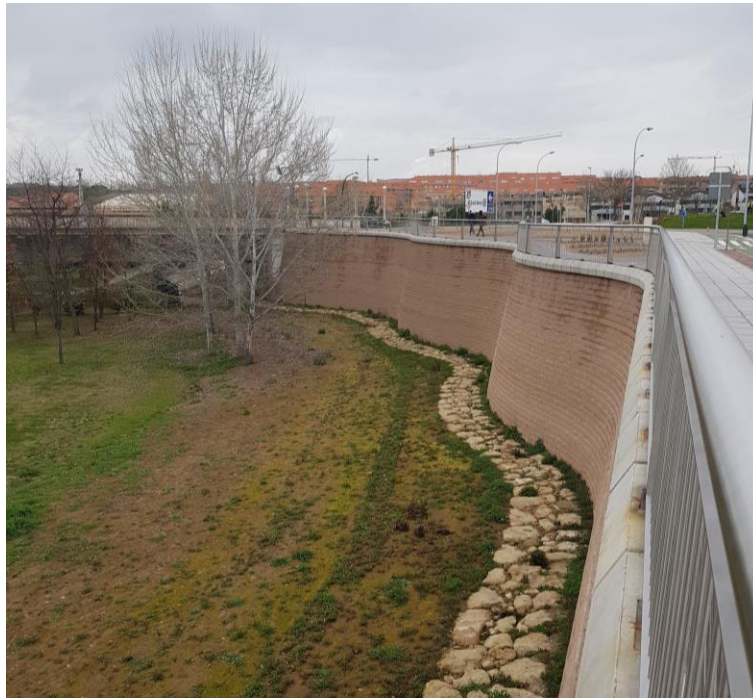
Figure 7. Wall 1 at the present time (Huesker geosintéticos).

owner representative engineer. In addition, a professional team of installers with more than 20 years of experience in the installation of block walls was on site, and the good results are evident (see Figure 7).
