# Liquefaction and Non-liquefaction Cases from the Mataquito Bridge, Chile, after the $M_w$ 8.8 (2010) and $M_w$ 6.6 (2019) Earthquakes

Reference: Moffat, R., and Moss, R. (2022). Liquefaction and Non-liquefaction Cases from the Mataquito Bridge, Chile, after the  $M_w$  8.8 (2010) and  $M_w$  6.6 (2019) Earthquakes. International Journal of Geotechnical Engineering Case Histories, Volume 7, Issue 3, pp. 1-17,

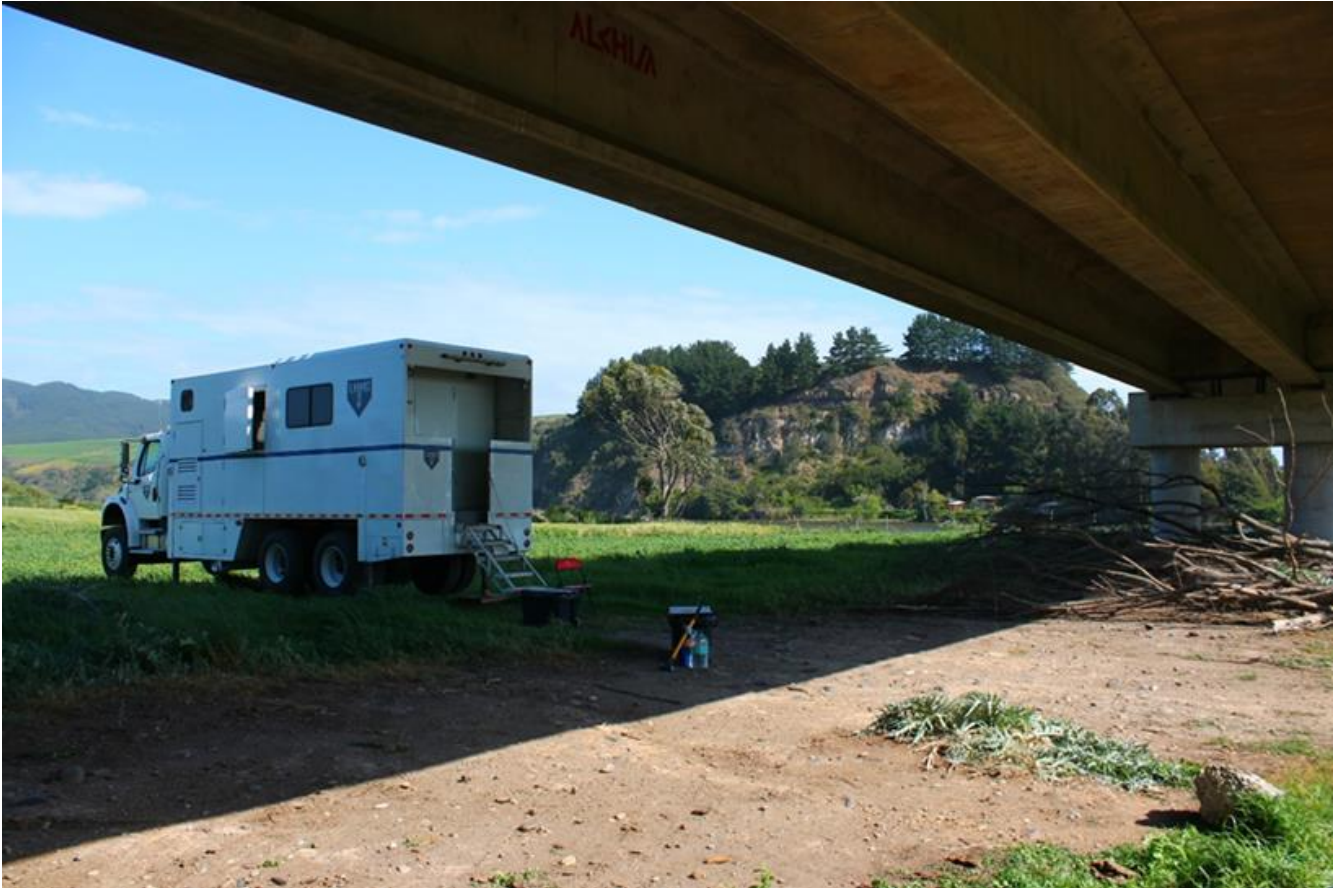
*Figure 6. Photo of the north side after the 2019 earthquake (October 17<sup>th</sup>, 2019). The CPT truck is shown here doing subsurface testing.*

This earthquake did not generate any major reported damage of consideration, as would be common in a seismic country like Chile. The site was visited before and after this earthquake by the authors. There was no evidence of liquefaction or changes on the surface. Figure 6 shows a photo of the north site during repeat CPT soundings after the 2019 earthquake.

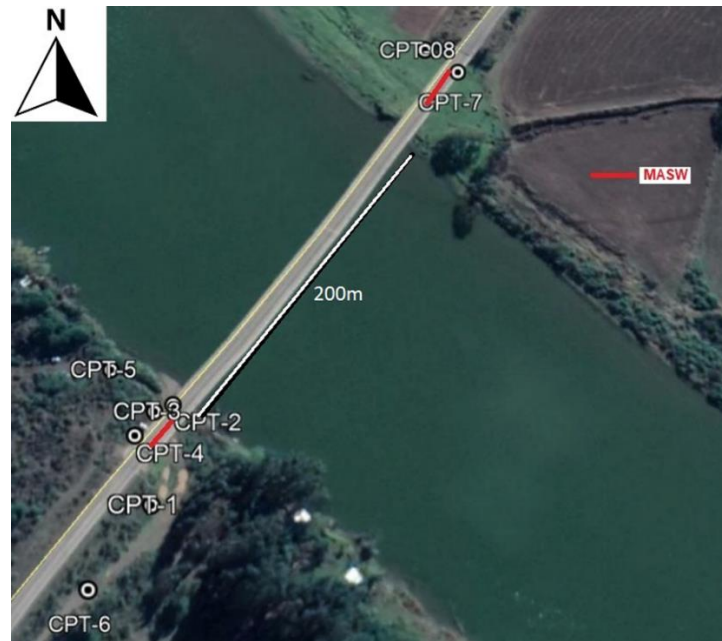
Figure 11. Posterior subsurface investigation locations from the 2019 field campaign.

A new subsurface investigation campaign was performed at the end of 2019. This campaign consisted of seismic CPT soundings, multichannel analysis of surface waves (MASW), and soil sampling using the CPT rigs. CPT soundings were performed using a 22-ton truck ([www.lmmg.cl](http://www.lmmg.cl)) with a seismic piezocone penetrometer arrangement (Figure 6). The cones with a base area of 15 cm<sup>2</sup> and friction sleeve area of 225 cm<sup>2</sup> were used in this campaign, and were calibrated by Gregg Drilling in accordance to ASTM D5778-12 (2012). Pore pressure transducers were located behind the cone tip on the standard ( $u_2$ ) location. A geophone located inside the cone was used to collect seismic shear wave data. A total of 8 CPT soundings were performed to depths that varied between 7 m and just over 17 m where a dense gravel layer was encountered. The locations of CPT and MASW testing are shown in Figure 11.

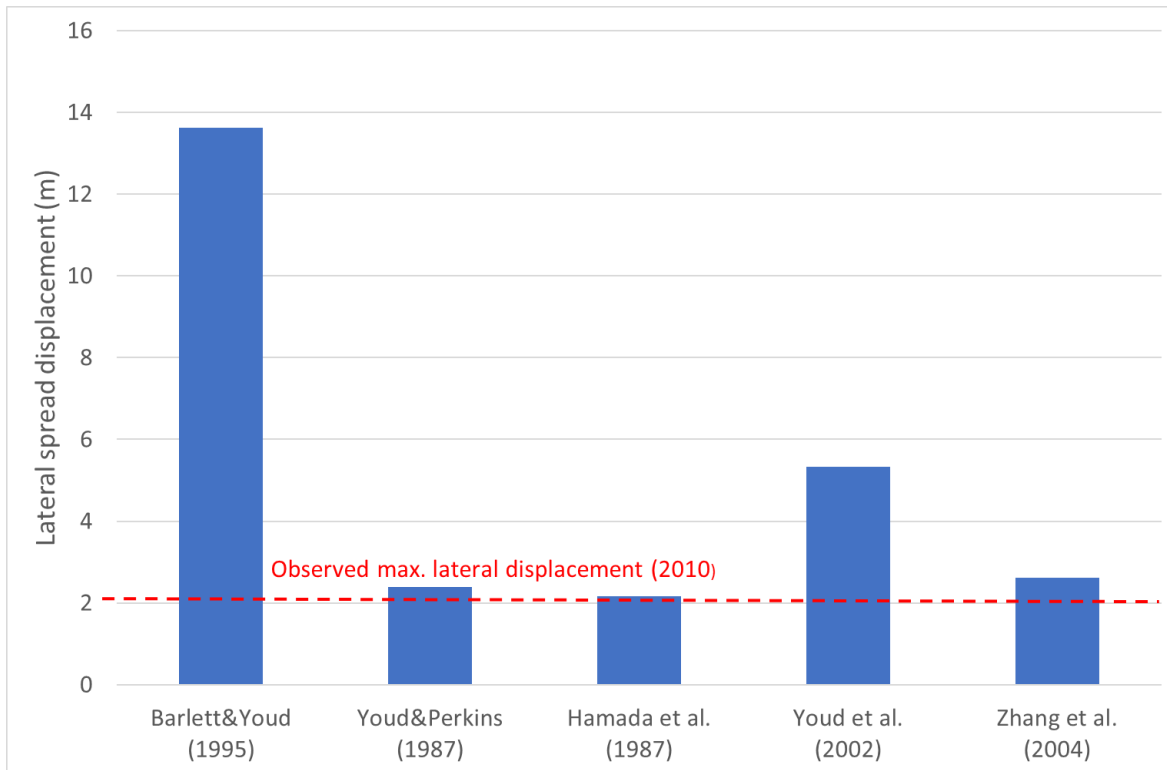
Figure 19. Calculated values of lateral displacement for different predictive models.

Lateral spreading was observed for the 2010 earthquake, as was mentioned previously in this paper. Some of the most common deterministic methods to predict lateral displacement for gently sloping ground without a free face were used to deduce this movement. There is very little data from earthquakes with values of  $M_w$  above 8.0 to compare to these methods, therefore this case is used to compare observed displacement with deduced values (as shown in Figure 19).

It is possible to observe that all methods (Zhang et al., 2002, Barlett and Youd, 1995, Youd et al., 1987, Hamada et al., 1987, Youd et al., 2002), with the exception of Barlett and Youd (1995) that was superseded by Youd et al. (2002), adequately predict the observed lateral displacement. This is consistent with what was mentioned by Youd et al. (2002), that erroneous data estimates were used on Barlett and Youd (1995). That caused this model to over-predict lateral spreading. Upper and lower layers were necessarily considered by these models to predict the observed displacement on the field. This confirms what was also aforementioned in this work: both layers must have liquefied during the 2020 earthquake.
