Liquefaction and Non-liquefaction Cases from the Mataquito Bridge, Chile, after the M_w 8.8 (2010) and M_w 6.6 (2019) Earthquakes

ABSTRACT: *This paper describes field investigations and soil foundation performance of the Mataquito Bridge with respect to the 2010 M_w 8.8 and 2019 M_w 6.6 Chilean earthquakes. The Mataquito Bridge was constructed at the site prior to both earthquakes using a pile foundation designed against liquefaction and lateral spreading. The foundation system performed correctly during both earthquakes, and in the case of the 2010 event it withstood surface manifestation of liquefaction and lateral spreading loads. Different liquefaction severity indices are used to assess the liquefaction hazard with data from in-situ measurements. This paper provides a collection of data (Vs, CPT, SPT) for liquefaction and non-liquefaction cases at the same site under two different levels of shaking, and valuable case history data for future triggering and severity index models. Lateral displacements are also calculated and compared with those observed on the field after the 2010 earthquake.*

Reference: Moffat, R., and Moss, R. (2022). Liquefaction and Non-liquefaction Cases

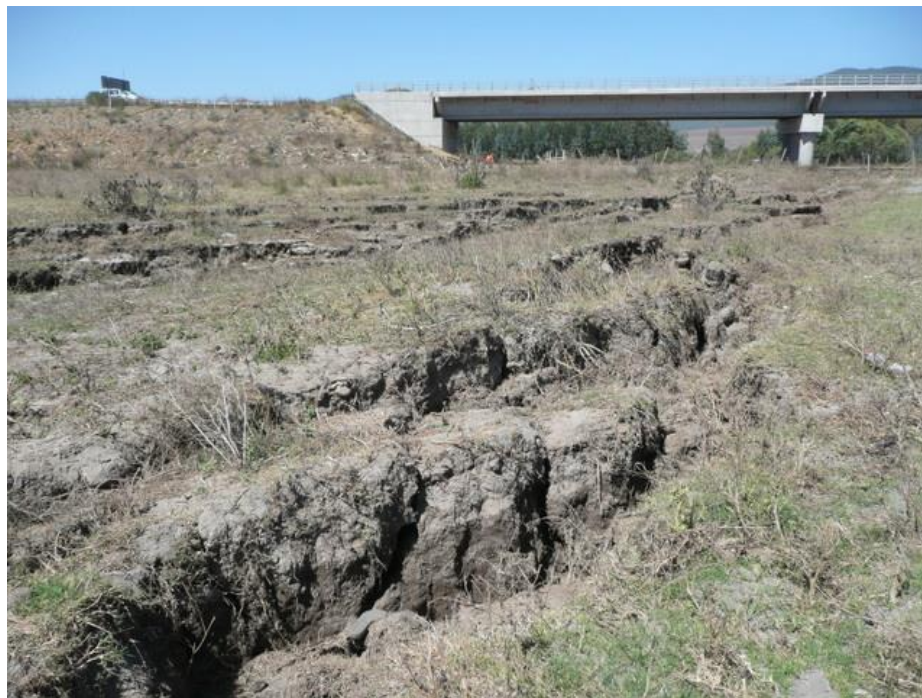
Figure 3. Lateral spreading at the north side of the bridge. Cracking showing roughly 0.6 m of vertical and 0.8 m of lateral displacement toward the river (Bray et al., 2010).

Reconnaissance of the bridge found large lateral spreads towards the river at the north and south abutments in adjacent fields and directly below the bridge deck. Figures 3, 4, and 5 show photos of the settlement and lateral spreading (with sand boils) on the north and south sides of the bridge. Lateral spreading on the south side appeared to be confined to the border of the river, with deformations decreasing rapidly around 20 m from the river's edge to the south. On the north side, due to the relatively flat topography, it was observed to extend up to 250 m from the river's edge. Evidence of settlement was observed on the approach embankment and the rows of piers. Cracking of the asphalt on the north side was also observed along a distance of 200 m from the river's edge along the road.
