Liquefaction and Non-liquefaction Cases from the Mataquito Bridge, Chile, after the M_w 8.8 (2010) and M_w 6.6 (2019) Earthquakes

ABSTRACT: *This paper describes field investigations and soil foundation performance of the Mataquito Bridge with respect to the 2010 M_w 8.8 and 2019 M_w 6.6 Chilean earthquakes. The Mataquito Bridge was constructed at the site prior to both earthquakes using a pile foundation designed against liquefaction and lateral spreading. The foundation system performed correctly during both earthquakes, and in the case of the 2010 event it withstood surface manifestation of liquefaction and lateral spreading loads. Different liquefaction severity indices are used to assess the liquefaction hazard with data from in-situ measurements. This paper provides a collection of data (V_s , CPT, SPT) for liquefaction and non-liquefaction cases at the same site under two different levels of shaking, and valuable case history data for future triggering and severity index models. Lateral displacements are also calculated and compared with those observed on the field after the 2010 earthquake.*

Reference: Moffat, R., and Moss, R. (2022). Liquefaction and Non-liquefaction Cas

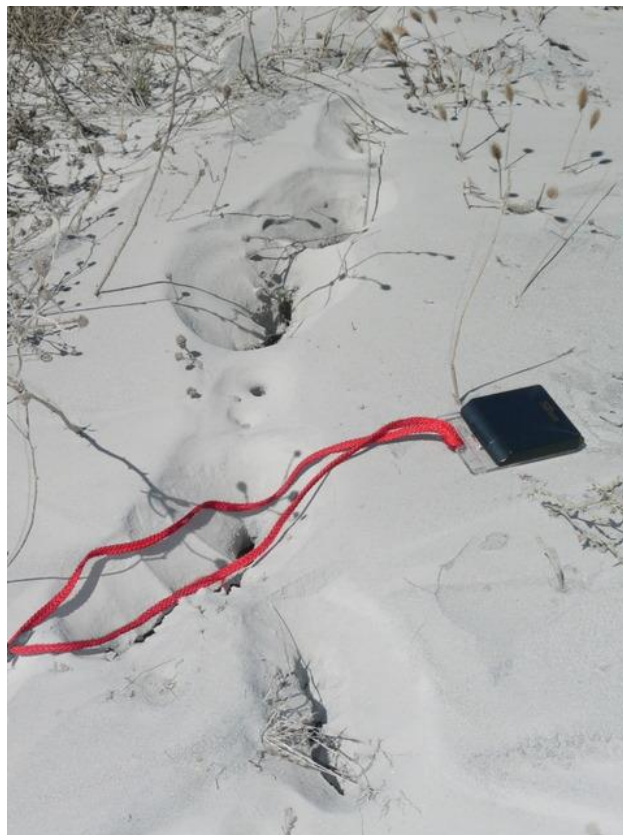
Figure 5. Sand boils observed in the cracks of lateral spreads, with the ejecta being fine sand (Bray et al., 2010).

Reconnaissance of the bridge found large lateral spreads towards the river at the north and south abutments in adjacent fields and directly below the bridge deck. Figures 3, 4, and 5 show photos of the settlement and lateral spreading (with sand boils) on the north and south sides of the bridge. Lateral spreading on the south side appeared to be confined to the border of the river, with deformations decreasing rapidly around 20 m from the river's edge to the south. On the north side, due to the relatively flat topography, it was observed to extend up to 250 m from the river's edge. Evidence of settlement was observed on the approach embankment and the rows of piers. Cracking of the asphalt on the north side was also observed along a distance of 200 m from the river's edge along the road.

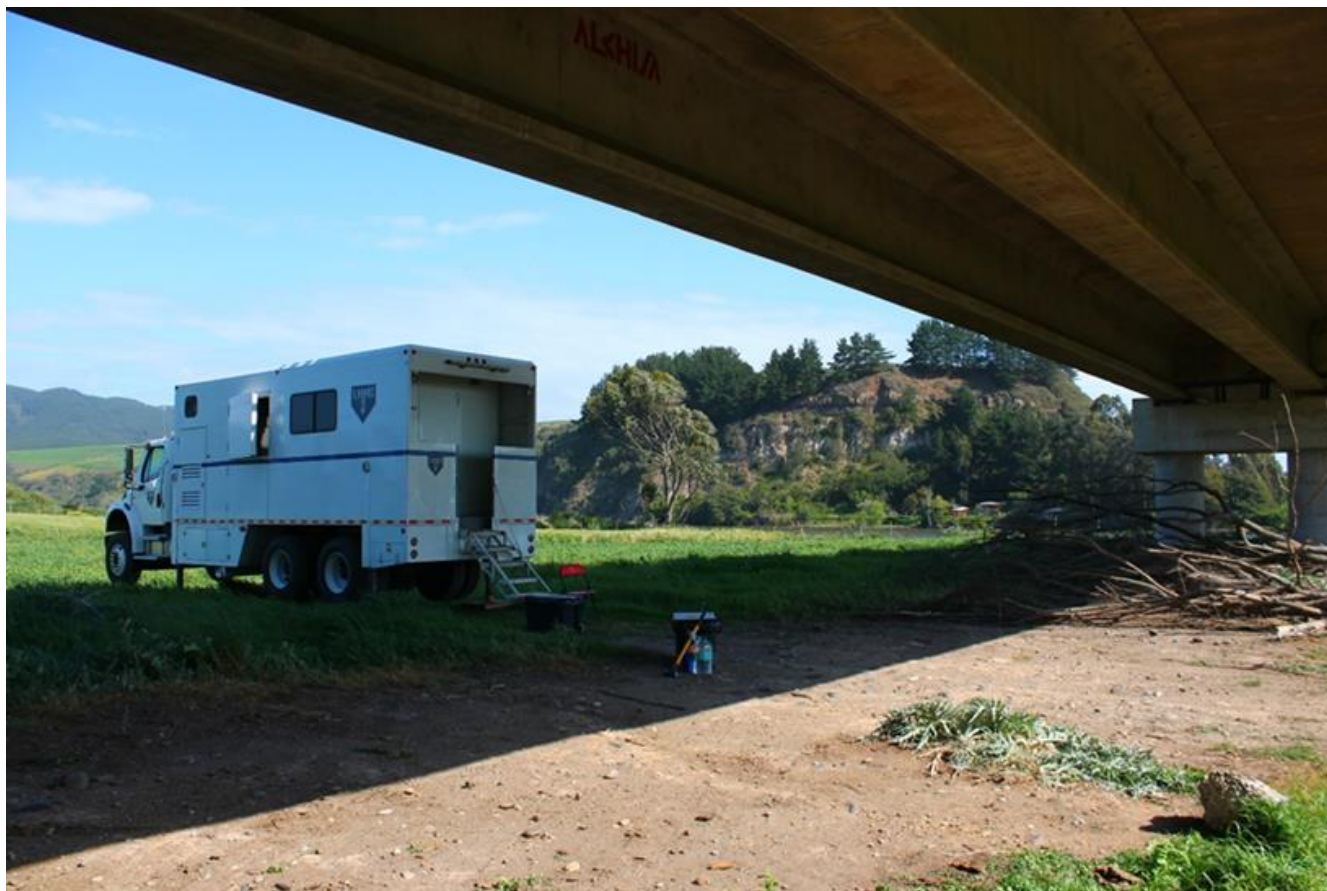
Figure 6. Photo of the north side after the 2019 earthquake (October 17th, 2019). The CPT truck is shown here doing subsurface testing.

This earthquake did not generate any major reported damage of consideration, as would be common in a seismic country like Chile. The site was visited before and after this earthquake by the authors. There was no evidence of liquefaction or changes on the surface. Figure 6 shows a photo of the north site during repeat CPT soundings after the 2019 earthquake.

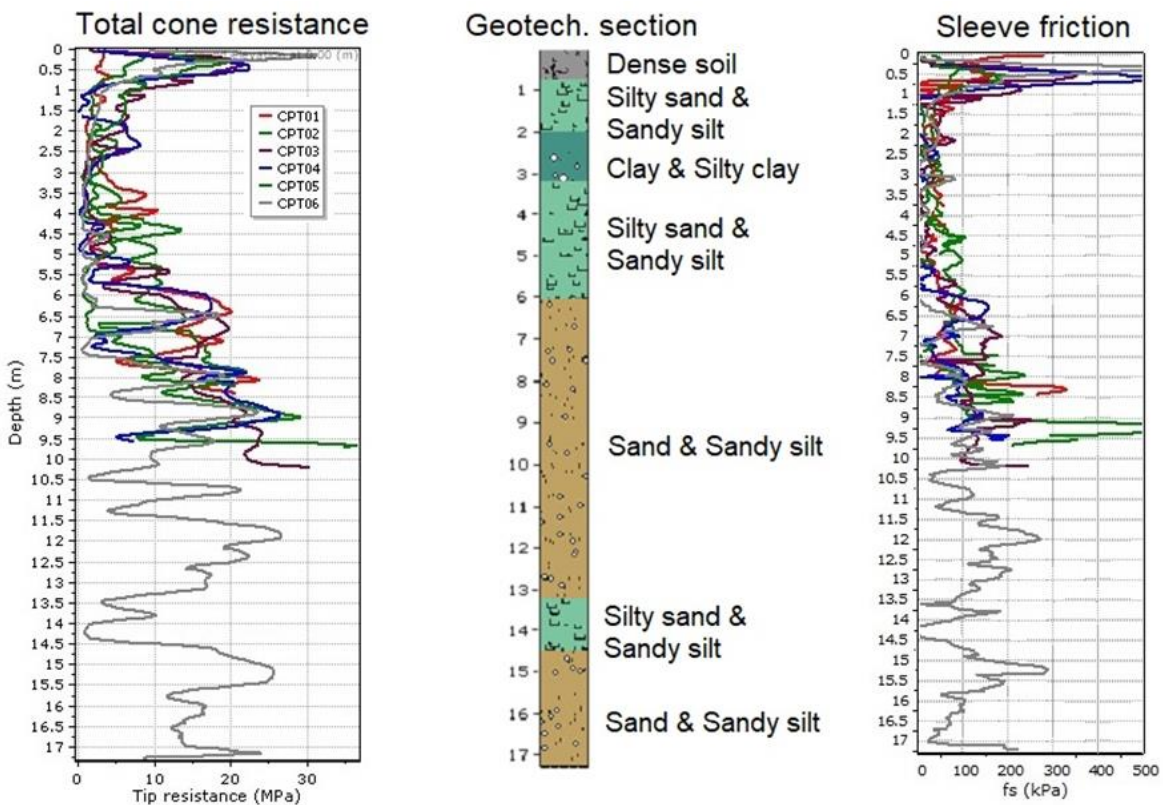
Figure 14. CPT soundings on the south side; the water table varies between 2 m to 5 m across the measured locations.

It is possible to observe that many points (or depths) should have manifested liquefaction according to Boulanger and Idriss (2014); however, this was not observed on the field. The water table was found at 3.4 m and 5.2 m on CPTs 4 and 5 respectively. This could generate a considerable non-liquefiable layer that avoids manifestation of the phenomenon on the surface, as considered originally by Ishihara (1985).
