# Liquefaction and Non-liquefaction Cases from the Mataquito Bridge, Chile, after the $M_w$ 8.8 (2010) and $M_w$ 6.6 (2019) Earthquakes

**ABSTRACT:** *This paper describes field investigations and soil foundation performance of the Mataquito Bridge with respect to the 2010  $M_w$  8.8 and 2019  $M_w$  6.6 Chilean earthquakes. The Mataquito Bridge was constructed at the site prior to both earthquakes using a pile foundation designed against liquefaction and lateral spreading. The foundation system performed correctly during both earthquakes, and in the case of the 2010 event it withstood surface manifestation of liquefaction and lateral spreading loads. Different liquefaction severity indices are used to assess the liquefaction hazard with data from in-situ measurements. This paper provides a collection of data ( $V_s$ , CPT, SPT) for liquefaction and non-liquefaction cases at the same site under two different levels of shaking, and valuable case history data for future triggering and severity index models. Lateral displacements are also calculated and compared with those observed on the field after the 2010 earthquake.*

Reference: Moffat, R., and Moss, R. (2022). Liquefaction and

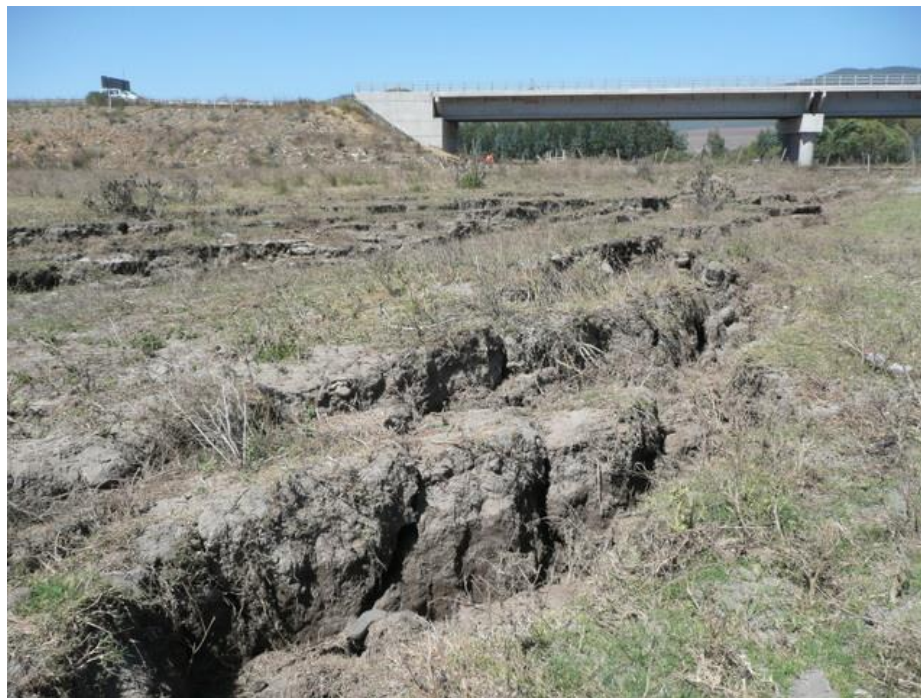
Figure 3. Lateral spreading at the north side of the bridge. Cracking showing roughly 0.6 m of vertical and 0.8 m of lateral displacement toward the river (Bray et al., 2010).

Reconnaissance of the bridge found large lateral spreads towards the river at the north and south abutments in adjacent fields and directly below the bridge deck. Figures 3, 4, and 5 show photos of the settlement and lateral spreading (with sand boils) on the north and south sides of the bridge. Lateral spreading on the south side appeared to be confined to the border of the river, with deformations decreasing rapidly around 20 m from the river's edge to the south. On the north side, due to the relatively flat topography, it was observed to extend up to 250 m from the river's edge. Evidence of settlement was observed on the approach embankment and the rows of piers. Cracking of the asphalt on the north side was also observed along a distance of 200 m from the river's edge along the road.

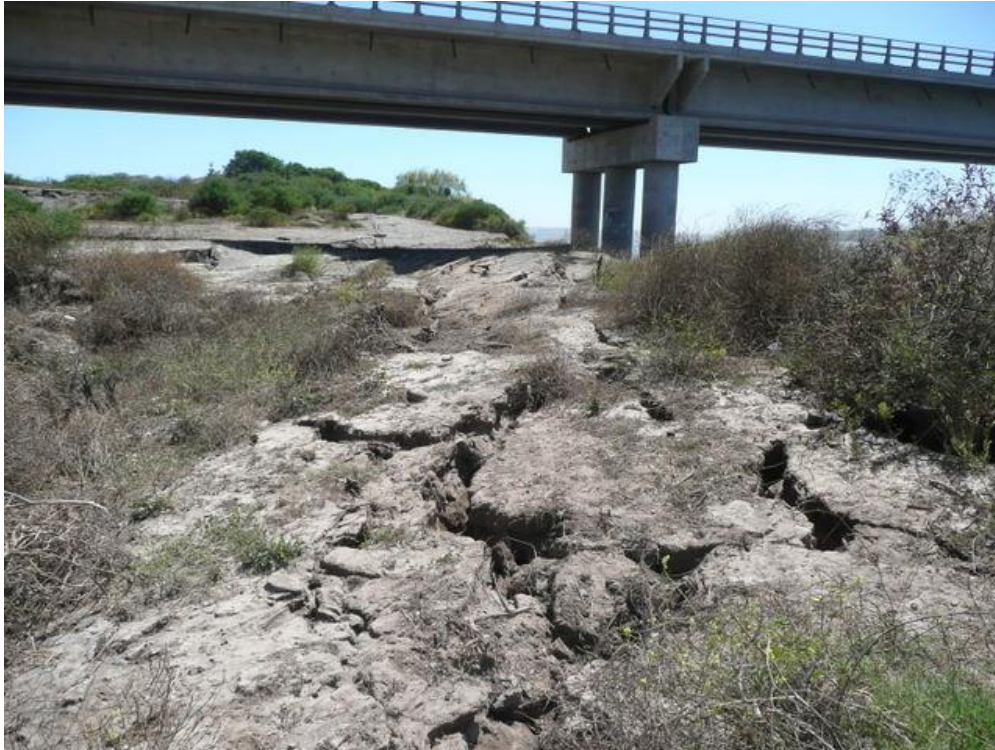
*Figure 4. Liquefaction effects along the south side of the bridge (Bray et al., 2010).*

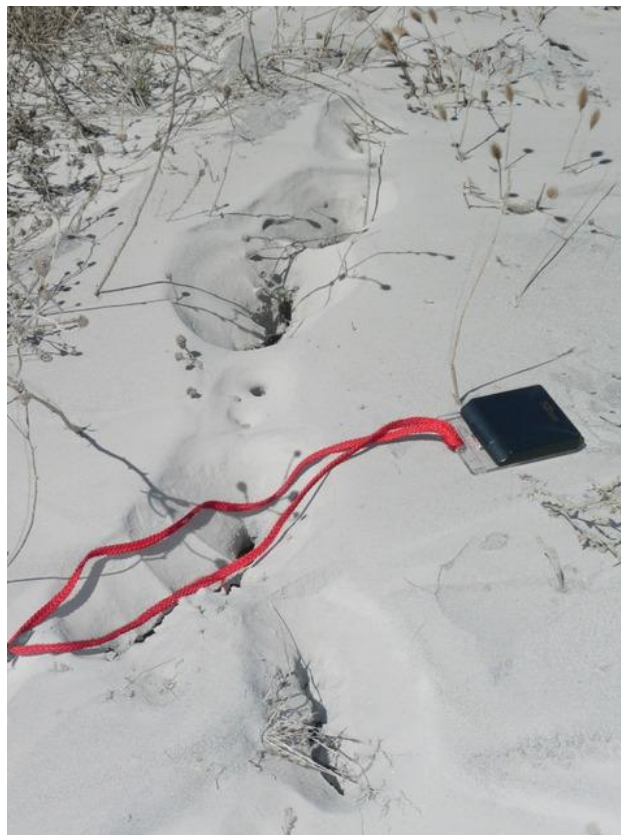
*Figure 5. Sand boils observed in the cracks of lateral spreads, with the ejecta being fine sand (Bray et al., 2010).*

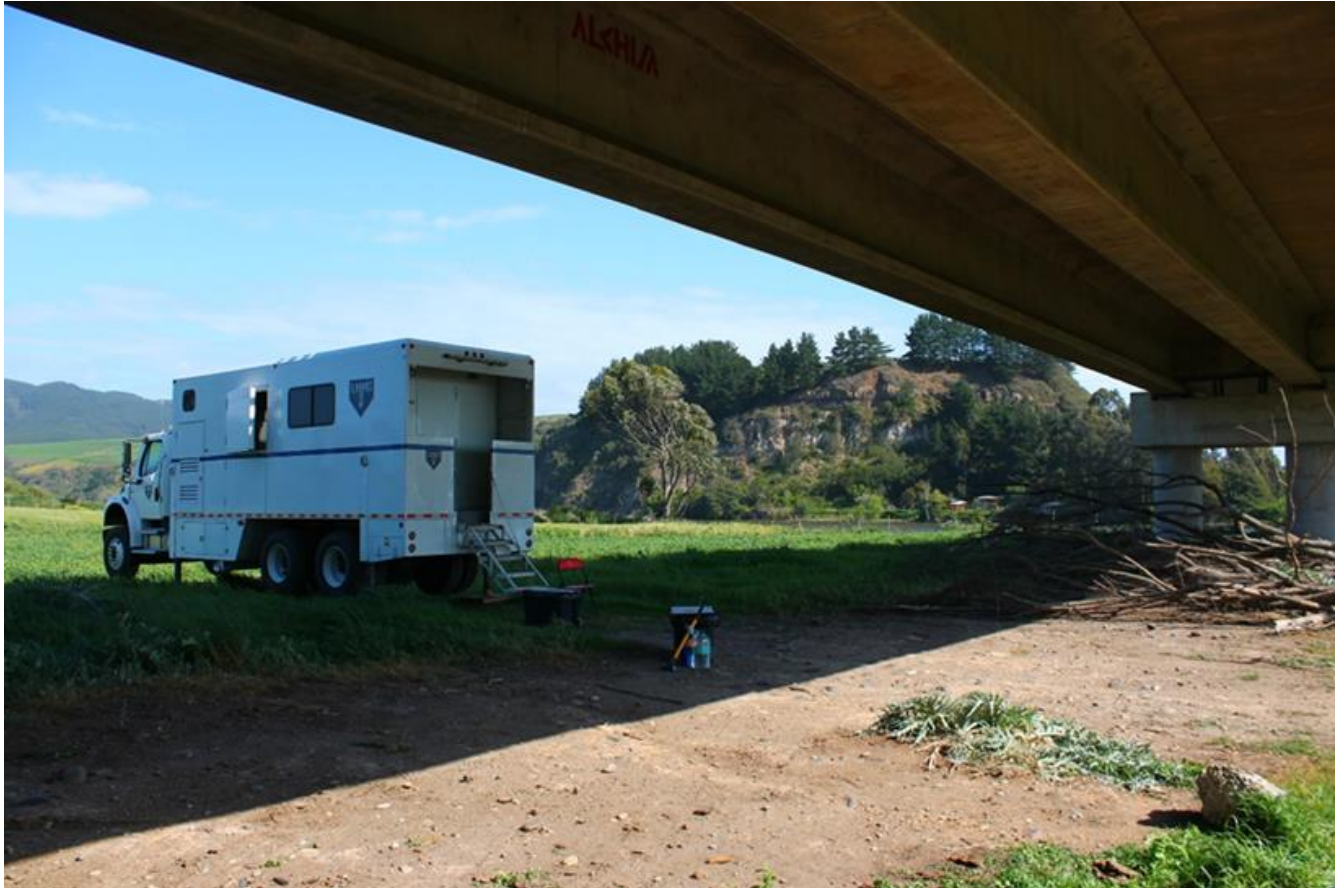
*Figure 6. Photo of the north side after the 2019 earthquake (October 17<sup>th</sup>, 2019). The CPT truck is shown here doing subsurface testing.*

This earthquake did not generate any major reported damage of consideration, as would be common in a seismic country like Chile. The site was visited before and after this earthquake by the authors. There was no evidence of liquefaction or changes on the surface. Figure 6 shows a photo of the north site during repeat CPT soundings after the 2019 earthquake.

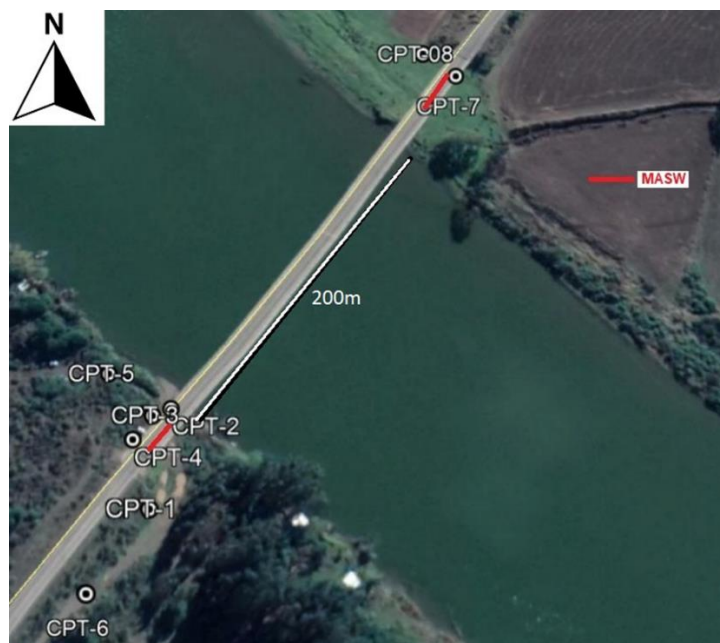
Figure 11. Posterior subsurface investigation locations from the 2019 field campaign.

A new subsurface investigation campaign was performed at the end of 2019. This campaign consisted of seismic CPT soundings, multichannel analysis of surface waves (MASW), and soil sampling using the CPT rigs. CPT soundings were performed using a 22-ton truck ([www.lmmg.cl](http://www.lmmg.cl)) with a seismic piezocone penetrometer arrangement (Figure 6). The cones with a base area of 15 cm<sup>2</sup> and friction sleeve area of 225 cm<sup>2</sup> were used in this campaign, and were calibrated by Gregg Drilling in accordance to ASTM D5778-12 (2012). Pore pressure transducers were located behind the cone tip on the standard ( $u_2$ ) location. A geophone located inside the cone was used to collect seismic shear wave data. A total of 8 CPT soundings were performed to depths that varied between 7 m and just over 17 m where a dense gravel layer was encountered. The locations of CPT and MASW testing are shown in Figure 11.

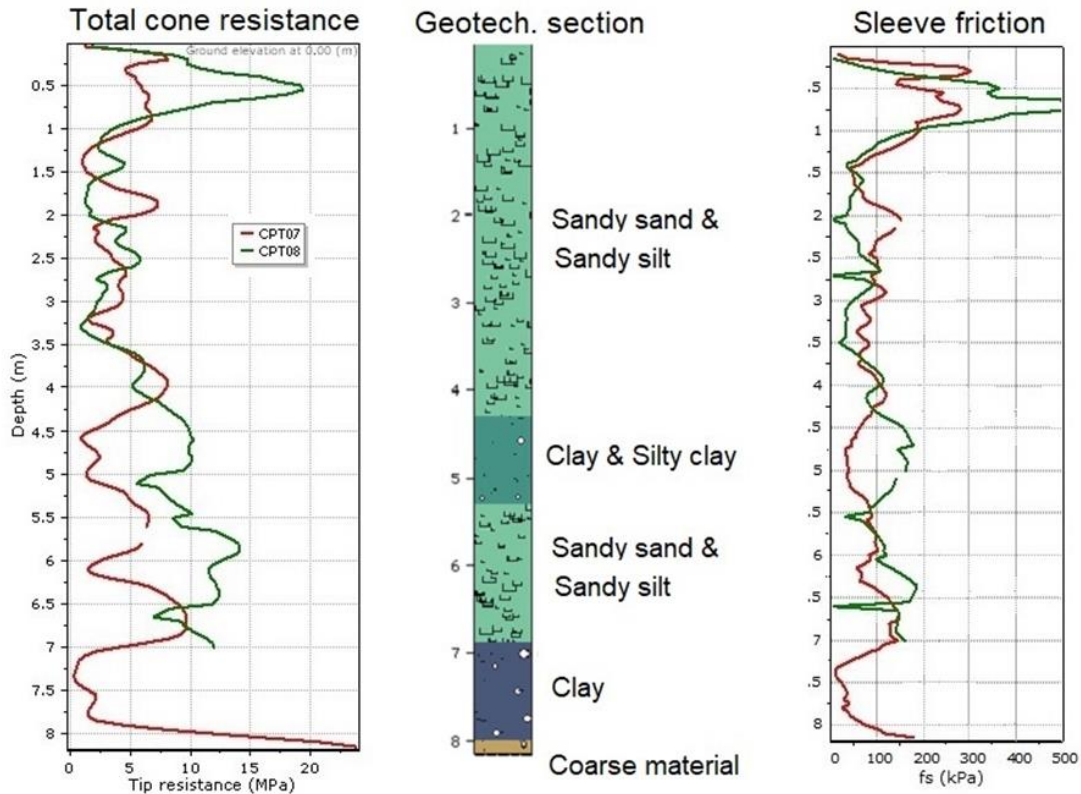
Figure 13. CPT soundings on the north side with the water table located at roughly at 2.5 m.

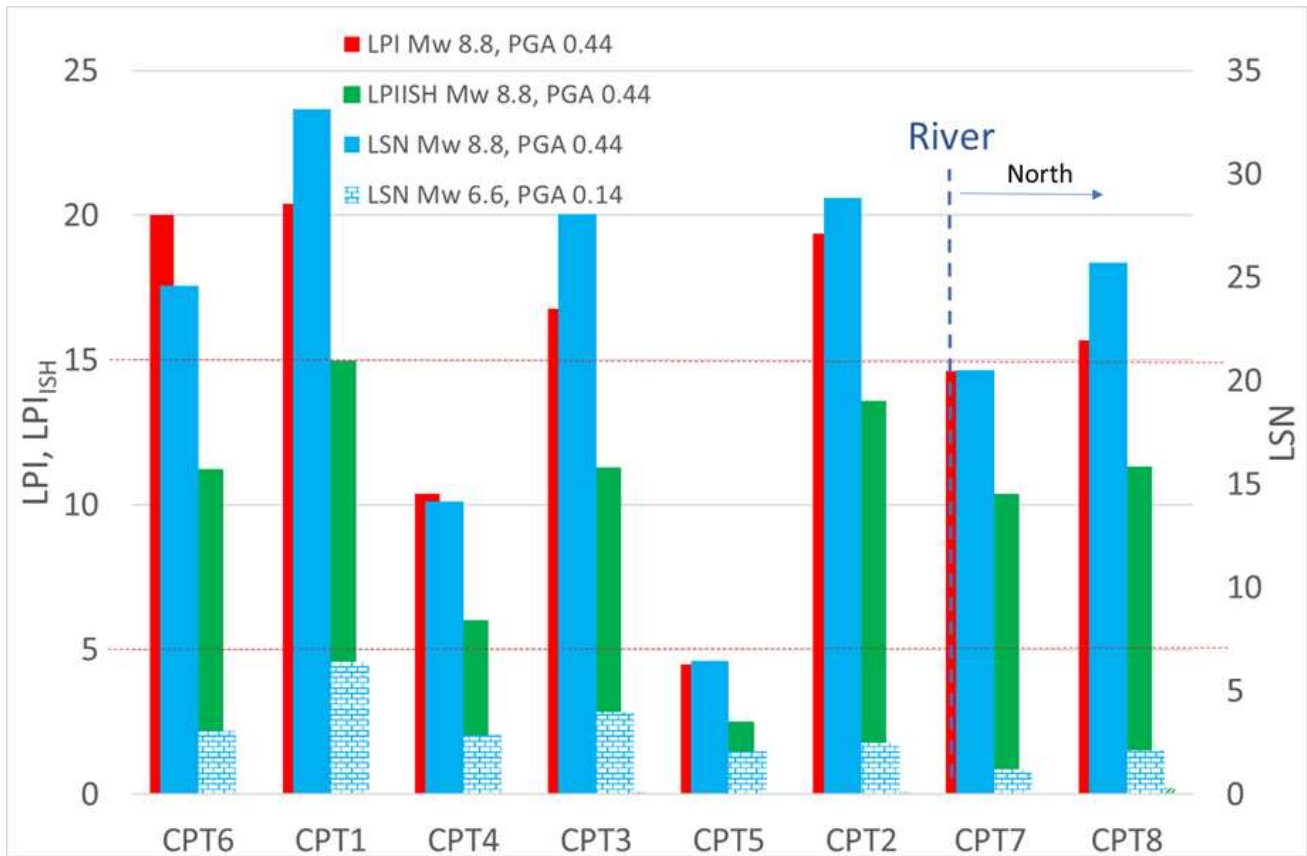
Figure 18. Liquefaction manifestation indexes; LSN, LPI, and LPI<sub>ISH</sub>.

CPT data was also used to evaluate the surface manifestation, using an index such as: LPI,  $LPI_{ISH}$ , and LSN for all CPT soundings (Iwasaki et al., 1978, Maurer et al., 2015, Van Ballegooy et al., 2014). Figure 18 shows values of LSN, LPI, and  $LPI_{ISH}$ . Values of LPI and  $LPI_{ISH}$  are very sensitive when passing from the 2010 to the 2019 earthquake. According to this case history, LPI of 10 showed the liquefaction manifestation on the surface, and LPI of 0.5 did not. Calculated values of LPI and  $LPI_{ISH}$  for the 2019 earthquake were so low that they couldn't be observed in this figure. Similarly, values of  $LPI_{ISH}$  showed that for  $LPI_{ISH}$  of 6, there is liquefaction manifestation; for values lower than 0.2, however, liquefaction is not shown. On the other hand, LSN-calculated values showed that LSN above 15 liquefaction was observed—yet for values of LSN below 6.4, no liquefaction manifestation was observed.

Data from CPT 6—the CPT furthest south from the river's edge—is analyzed to show the possible variation of  $LPI_{ISH}$  with the main variables used for its liquefaction calculation, in order to check the robustness of the calculated values. A sensitivity analysis was performed for this sounding using fictional values of non-liquefaction layer (H1), fine content in depth, and PGA values to check for a possible effect of variation from the values derived from the in-situ soil exploration. The calculated average value of  $LPI_{ISH}$  was 11.2 with a standard deviation of 2.0. Similarly, for LSN, an average value of 26.4 and a standard deviation of 7.2 were obtained. For LPI, an average value of 20.0 and a standard deviation of 3.1 were obtained. Therefore, even a significant change in input values does not explain why there was no clear manifestation of liquefaction for the Mw 8.8 earthquake further away from the river's edge. One possible explanation is that the gravel layer, below the liquefied layer, and/or the ground slope are steeper further to the south from the river. And/or, this could be due to limitations of the simplified procedure used in this work to evaluate liquefaction. It has been shown that the use of the simplified method can overestimate or underestimate the potential of liquefaction as compared to a dynamic analysis of the soil. Correspondingly, assumptions such as horizontally layered soil profile, horizontal ground surface, and vertically propagating waves are not particularly accomplished at the location of CPT 6.

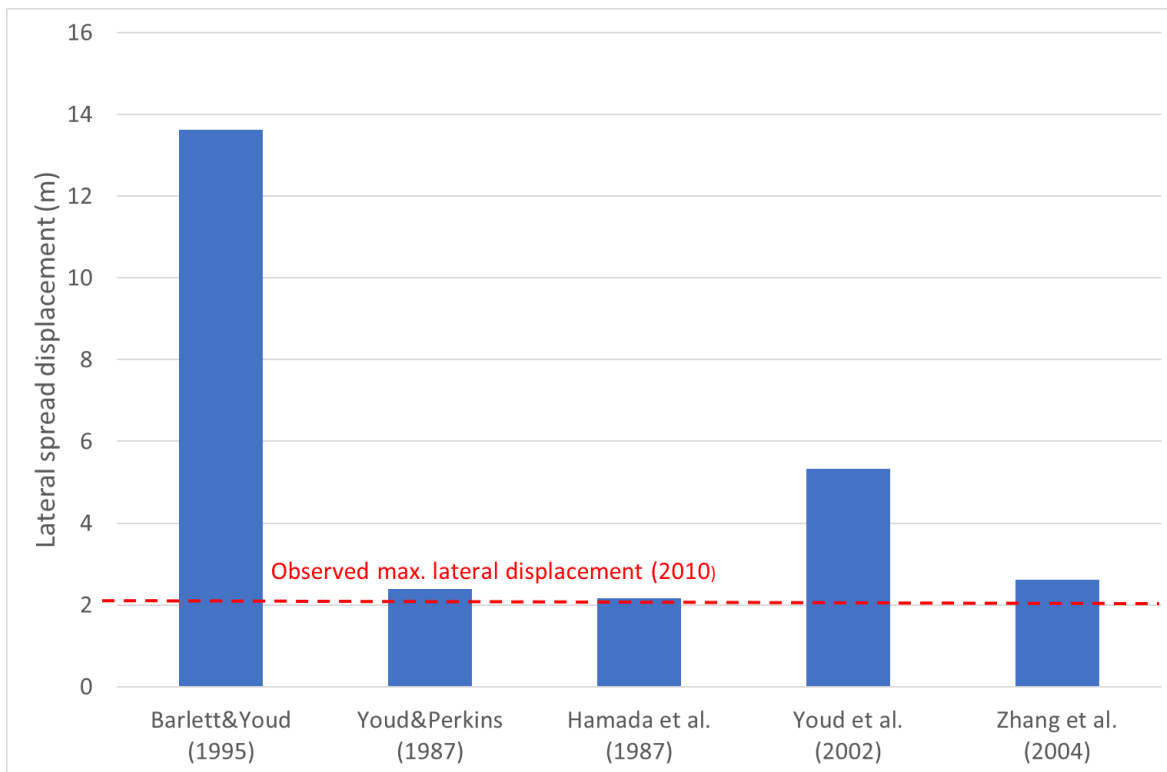
Figure 19. Calculated values of lateral displacement for different predictive models.

Lateral spreading was observed for the 2010 earthquake, as was mentioned previously in this paper. Some of the most common deterministic methods to predict lateral displacement for gently sloping ground without a free face were used to deduce this movement. There is very little data from earthquakes with values of  $M_w$  above 8.0 to compare to these methods, therefore this case is used to compare observed displacement with deduced values (as shown in Figure 19).

It is possible to observe that all methods (Zhang et al., 2002, Barlett and Youd, 1995, Youd et al., 1987, Hamada et al., 1987, Youd et al., 2002), with the exception of Barlett and Youd (1995) that was superseded by Youd et al. (2002), adequately predict the observed lateral displacement. This is consistent with what was mentioned by Youd et al. (2002), that erroneous data estimates were used on Barlett and Youd (1995). That caused this model to over-predict lateral spreading. Upper and lower layers were necessarily considered by these models to predict the observed displacement on the field. This confirms what was also aforementioned in this work: both layers must have liquefied during the 2020 earthquake.
