Practical Design, Numerical Analysis, and Site Monitoring for Huge Arching Effect during Massive Excavation of Undercut Slope in Open-Pit Mine

ABSTRACT: *This paper reviews a successful case history where applications of numerical predictions for a massive excavation were undertaken for both Class A and Class B predictions. Forming a stable arch across the pit of an open-pit mine is beneficial to the design of an undercut slope. However, predicting the maximum stable undercut width under which the slope does not collapse is a challenging problem in geotechnical engineering. Slope undercutting techniques originally developed for 1g physical and centrifuge models were realized in practice for a full-scale design at the Mae Moh mine, one of the large coal open-pit mines in Southeast Asia, during the period of 2011 - 2017. Numerical analyses, along with in-situ measurements for data assimilation, were applied to test the novel design concept before and during the surface excavation. At the initial stage of excavating the undercut slope, the mine was studied in terms of forming an arch, by conducting a field experiment of a partial undercutting in Area 4.1, which was of monumental size

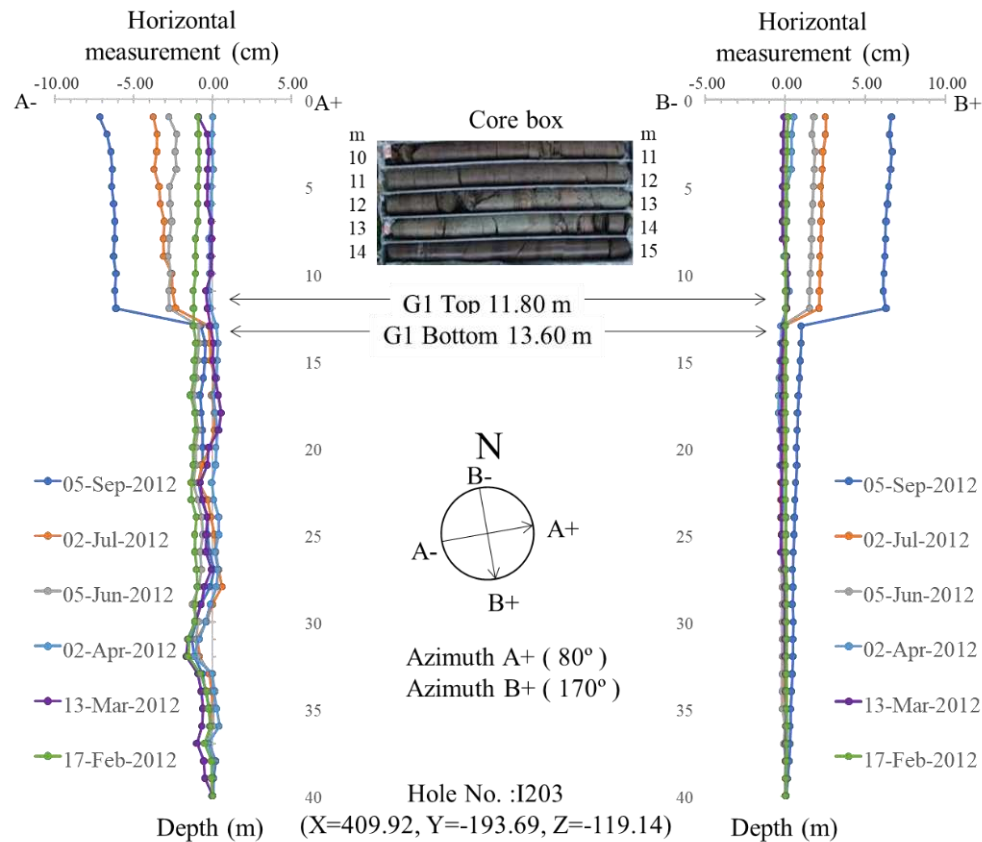
Figure 15. Surface and subsurface displacements measured by I203.

Measurements of the substantial surface and subsurface displacements were taken by I203. The data measured by I203 are plotted in Figure 15. Large displacements of the orthogonal axes of the inclinometer (A and B axes) were measured and

recorded from the ground surface to a depth of 12 m. The depth of 12 m was indicated as the depth of the G1 interface. Along with the progress of the mining activity and the rainy season, the slope was slowly displaced and borehole I203 was gradually bent and totally sheared off by September 2012. The maximum surface and subsurface displacements at the G1 interface were 0.097 m and 0.088 m, respectively. The displacements measured by I203 were likely to be in the G1 interface dip direction. The data obtained by I203 revealed that the ground surface of the potential sliding block above the G1 interface was slightly more displaced than the subsurface.

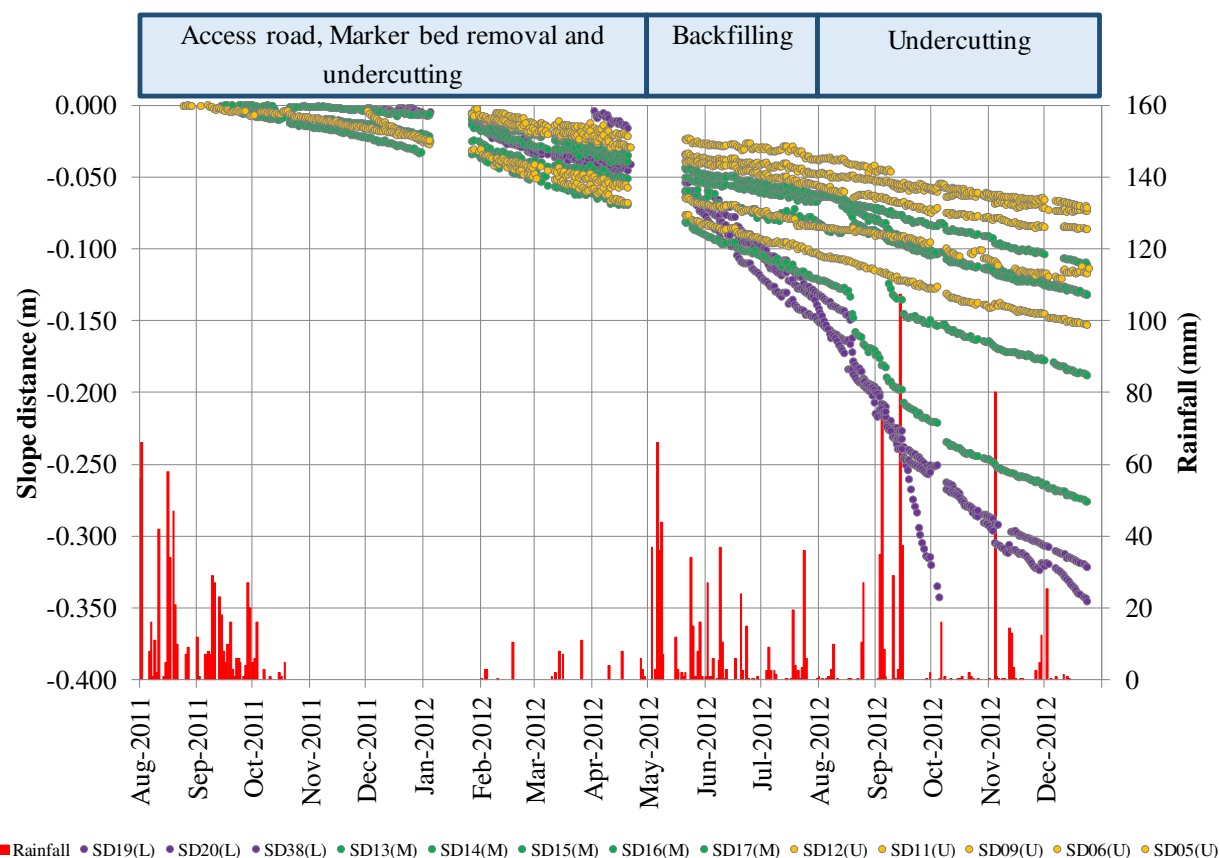
Figure 16. Surface displacements measured by prisms and amounts of precipitation.

The monitoring data for the ground surface displacements during the undercutting of Area 4.1 from 13 prisms are presented in Figure 16 along with the amounts of precipitation. The scheduled preventive maintenance program and an accidental system failure caused the monitoring to be discontinued. However, the monitoring data that were collected were still valuable. In Figure 16, the monitoring data are colorized according to the installation locations of the prisms. The ground surface displacement monitoring data on the Upper Floor, Mid Floor, and Lower floor have been colorized in yellow, green, and purple, respectively.

The surface displacements of the Upper, Mid, and Lower Floors – presented as the changes in the measured distance between the total station and the monitored prisms – were approximately -0.10 m, -0.25 m and -0.35 m, respectively, in early January 2013. The negative values indicate that the prisms displaced toward the total station. It is clear from the figure that the Lower Floor had the largest displacement because of its vicinity to the undercut face, while the Upper Floor had the smallest displacement. It should be noted that the surface displacement, measured by the Robotic Total Station with prisms (Figure 16), is a result of the interface shearing as captured by inclinometer I203 (Figure 15) and the deformation of the potential sliding block.

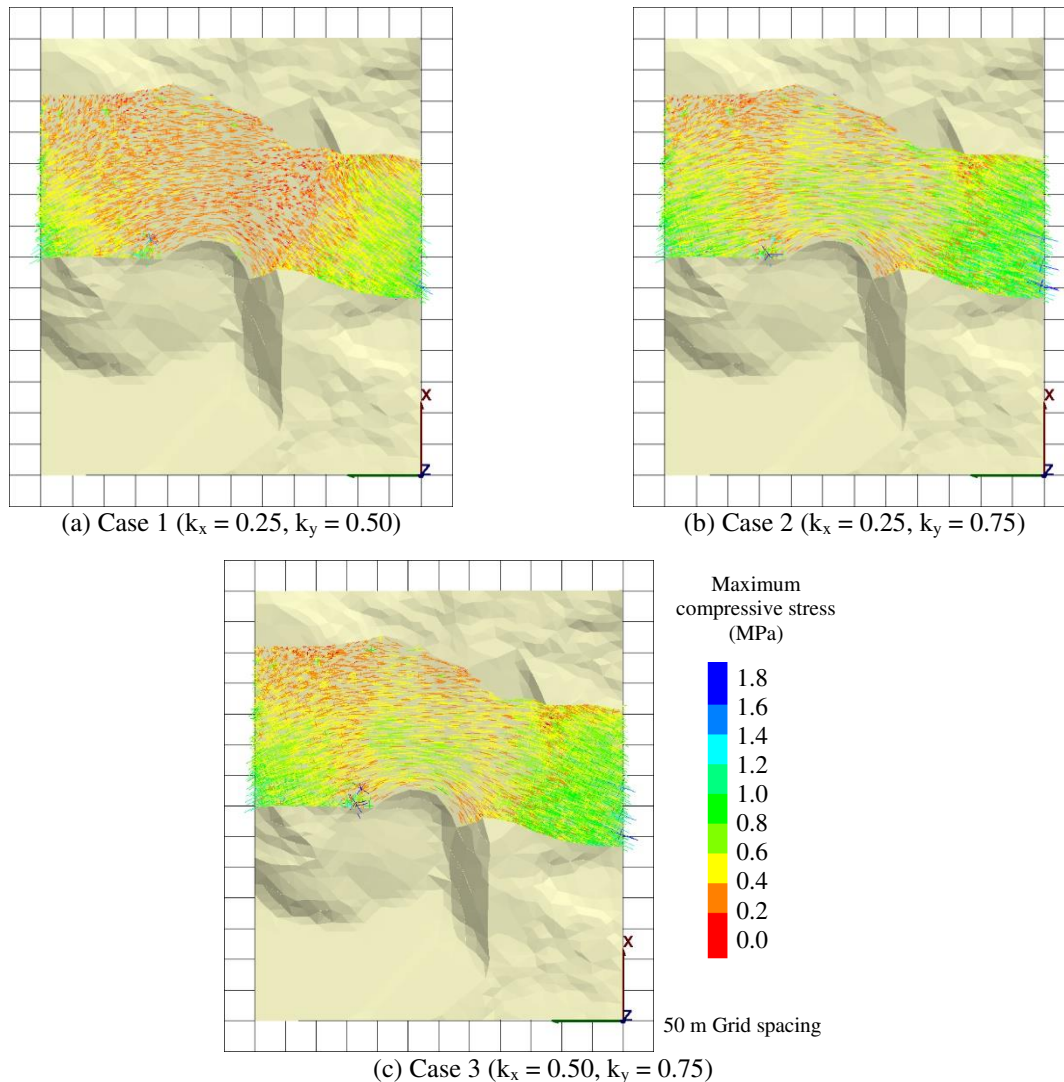
Figure 21. Principal stress trajectories in potential sliding block of undercut models.

The principal stress trajectories of the models are plotted in Figure 21. The positive stress indicates the compressive stress. The direction of the maximum compressive stress is obviously aligned in the tangential direction to the excavation in all cases. The magnitude of the maximum compressive stress in Case 1 was the least. The magnitudes of the maximum compressive stress were apparently similar in Cases 2 and 3. The total displacement contours and principal stresses of all the cases clearly showed arching in the potential sliding block, similar to the simple model. As the total displacements for all cases were slightly different, Case 1 was selected as the case for more undercut slope behavior investigations of Area 4.1.

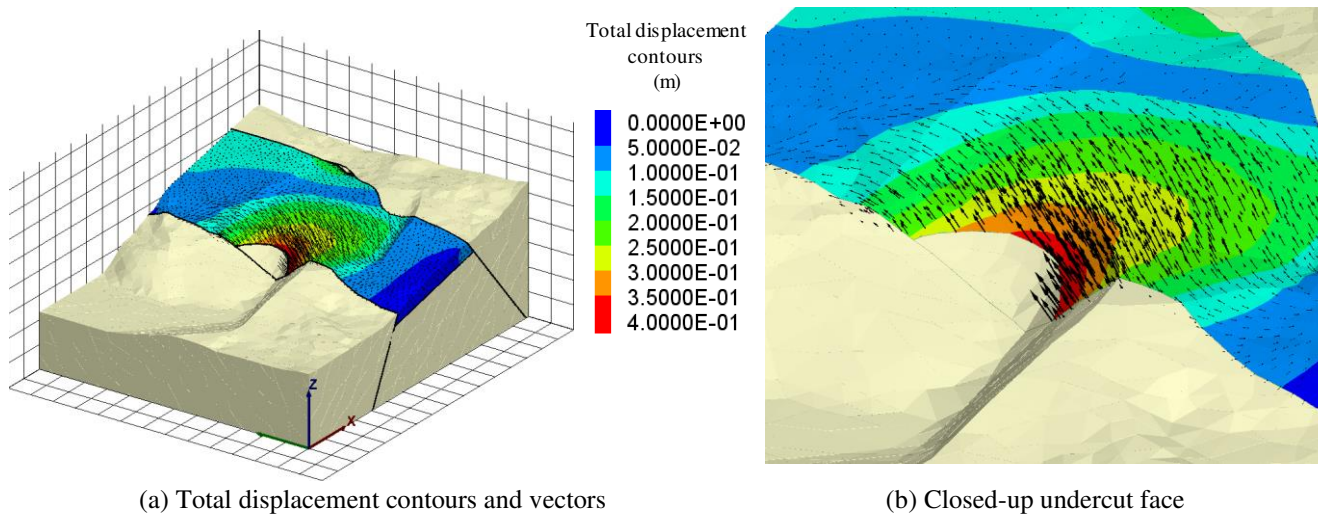
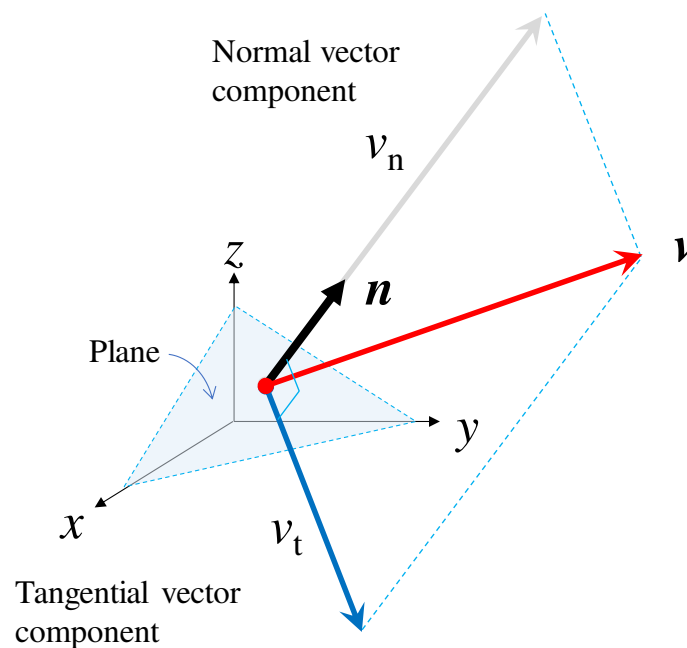
*Figure 22. Total displacement contours and vectors of undercut model.*

As presented in Figure 20(a), the maximum displacement was 0.411 m and it was located at the potential sliding block's slope face, near the G1 interface. In Figure 22, the displacement contours were overlaid with displacement vectors. The vectors showed an unusual upward displacement component. However, the upward displacement near the undercut face went undetected by the Robotic Total Station in the field. It is very likely that the upward displacement vectors were caused by the massive excavation involving the Marker bed removal and the undercutting steps or model unloadings.

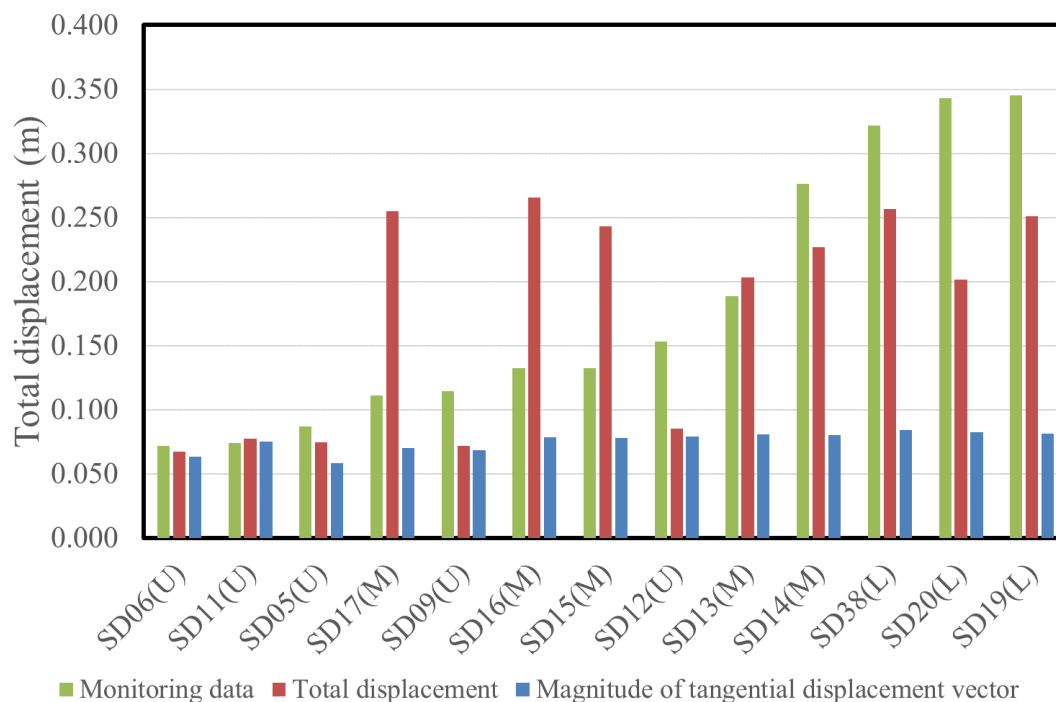
Figure 24. Comparison of surface displacements.

Figure 24 presents the surface displacement plot using the monitoring data, total displacements, and magnitudes of tangential displacement vectors at the G1 interface plane from the numerical model. The total displacements from the numerical model were fairly comparable to those of the monitoring data. The total displacements from the numerical model at SD15, SD16, and SD17 were quite a bit larger than those of the monitoring data. The locations of SD15, SD16, and SD17 were at the Mid Floor and thus not far away from the undercut face.

The total displacements from the numerical model and the magnitudes of tangential displacement were slightly different in the Upper Floor. However, they were incomparable in the Mid and Lower Floors. These floors were located near the excavation, and the nodes around them tended to have the upward displacement component in the numerical model.

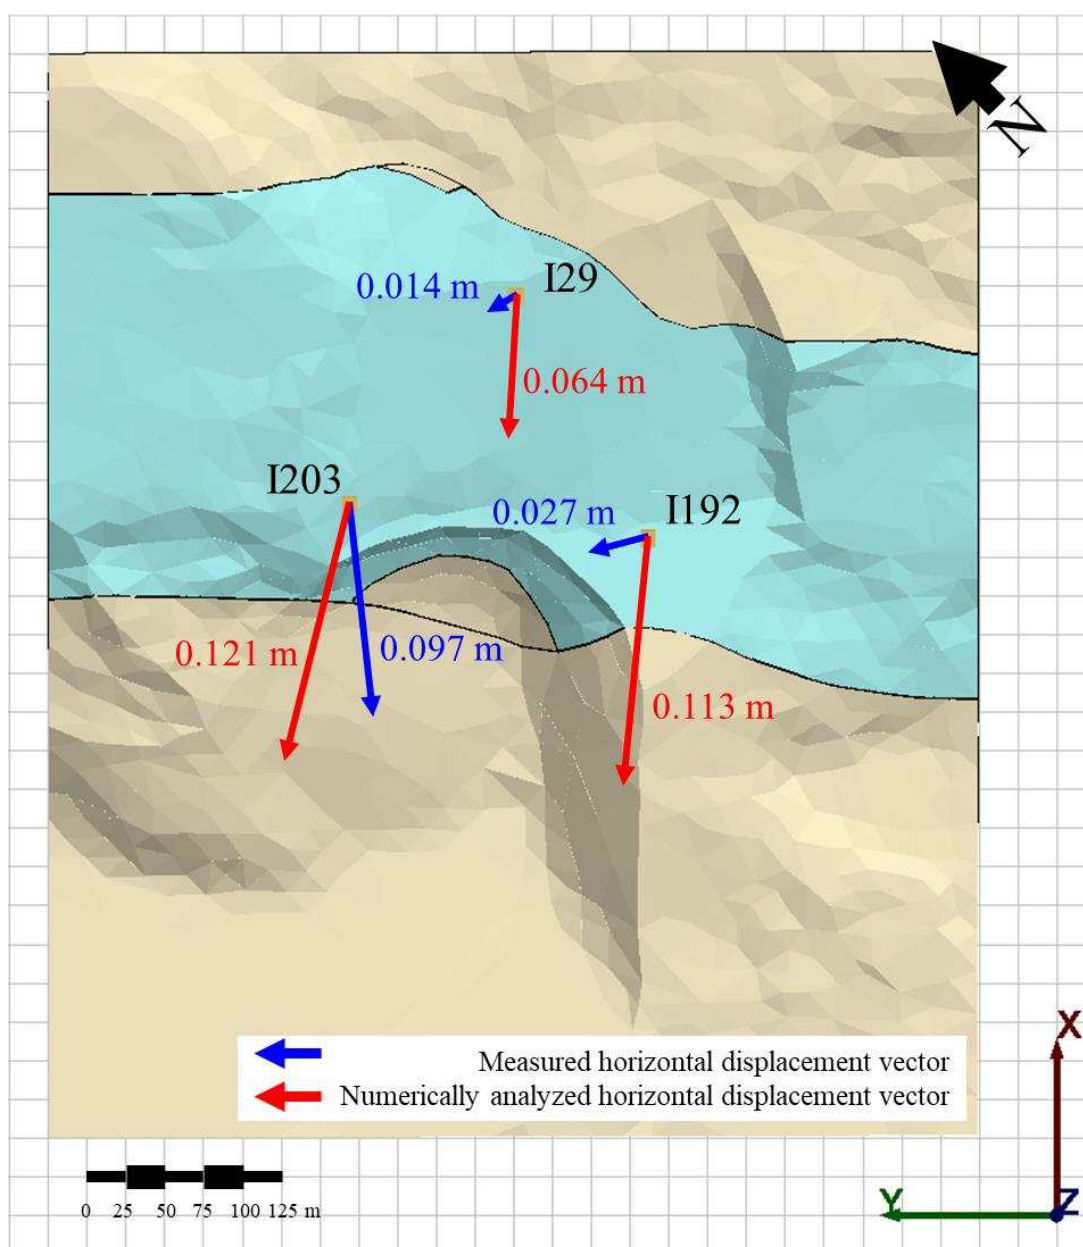
Figure 25. Horizontal displacements of inclinometer collars.

Another comparison of the surface displacements was done for the surface displacements measured by the inclinometers. The surface displacements measured by the inclinometers did not include any vertical displacements. The surface displacements were the horizontal displacements of the borehole collar. The measured borehole collar displacements are tabulated in Table 3. The displacement vectors of the nodes near the inclinometers from the model are also listed in Table 4. To compare the horizontal displacements between the model and the measurements, the horizontal vectors of the nodes near the inclinometers and the borehole collar displacements were drawn together. The horizontal displacements of I203, between the measurements and the numerical model, were comparable both in magnitude and direction. The horizontal displacements from the numerical analysis and the measurements were much different at I192 and I29.

According to Figure 15, although the potential sliding block above the daylighted G1 interface obviously moved along the G1 interface, a slight shear deformation was observed in the underlying rock mass and the potential sliding block. Therefore, the magnitude of the movements observed in Figure 25 is always larger than that of Figure 26 and their difference represents the shear deformation of the potential sliding block.

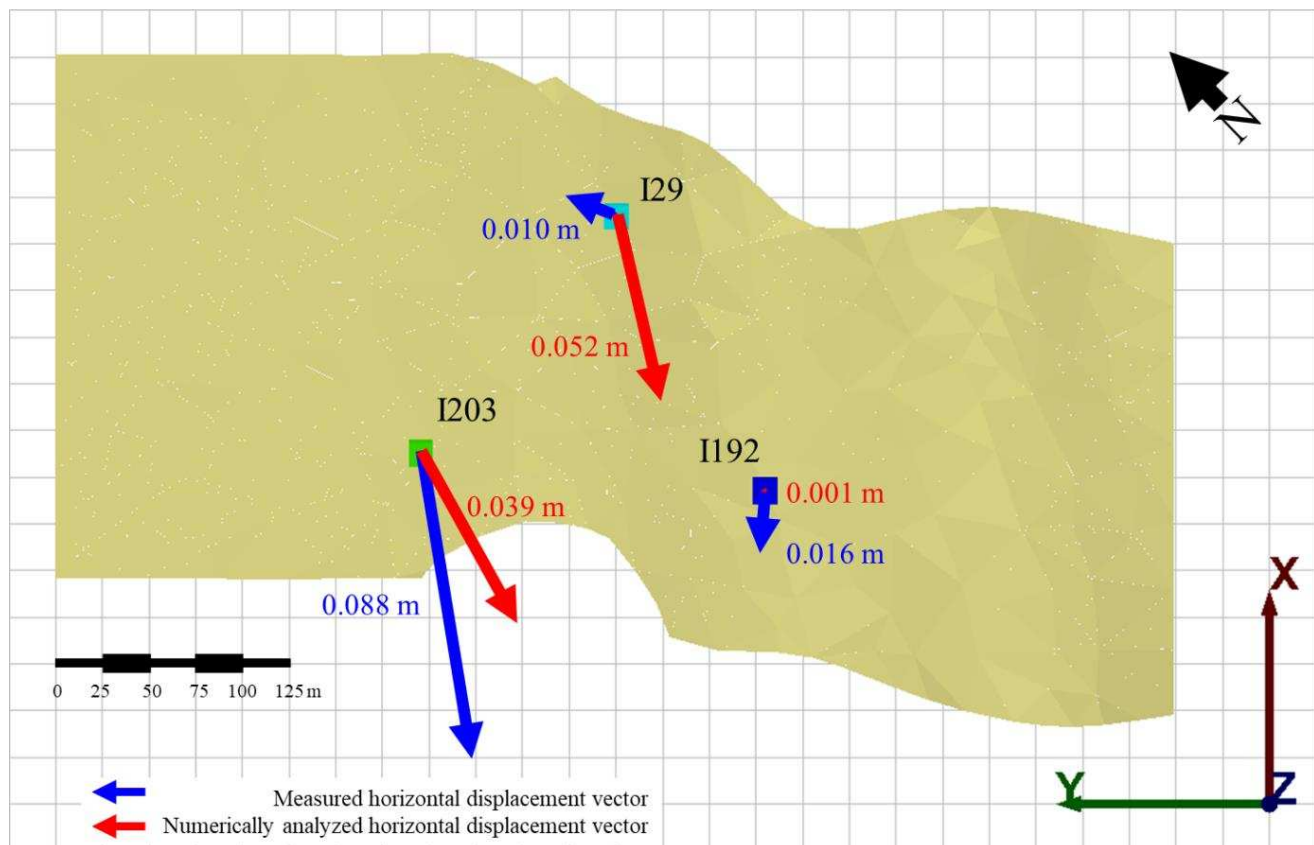
Figure 26. Subsurface displacements of inclinometer at G1 interface.

The subsurface displacements from the numerical analysis on the nodes near the inclinometers fell in the range of 0.001 m to 0.052 m. The subsurface displacement vectors by the inclinometers and the numerical analysis are graphically shown in Figure 26. The subsurface displacements are comparable to the measured ones only for I203. The subsurface displacements near the undercut face, between the inclinometer data and the numerical model, in terms of direction and magnitude, were comparable. For the area farther away from the undercut face, the subsurface displacement directions and magnitudes were unmatched. It is concluded that the complexities of a site's geology could be one of the major challenges of numerical modelings.

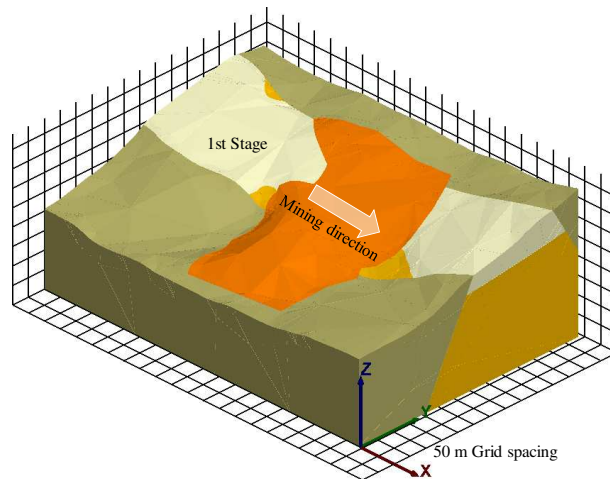
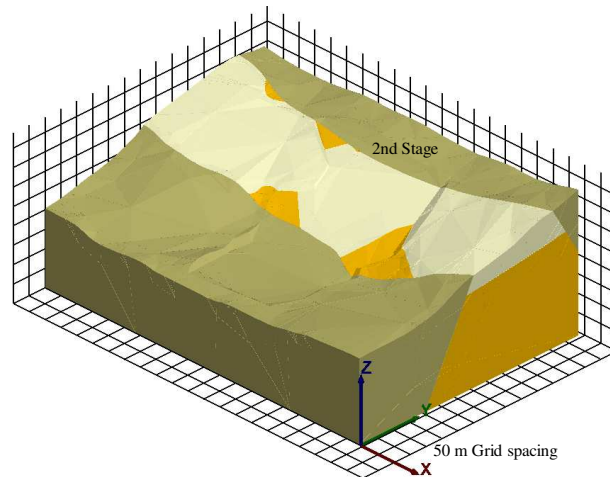
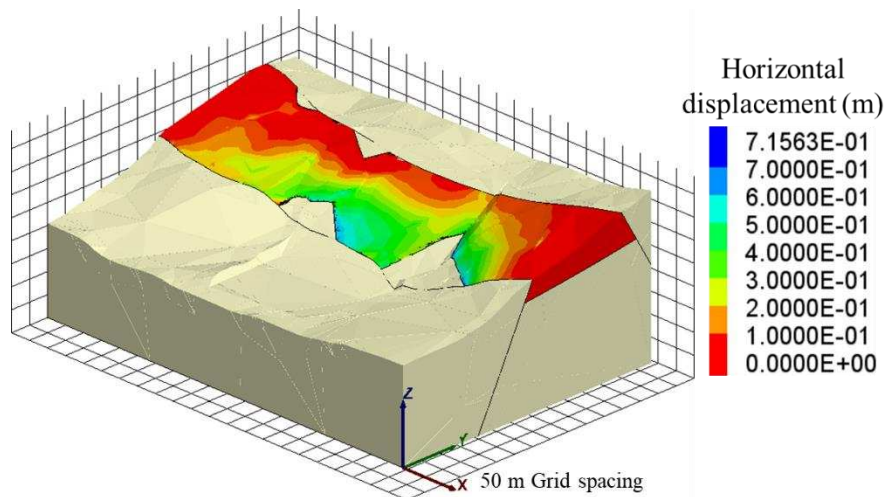
*Figure 27. 2nd Stage numerical model and its horizontal displacements of undercut.*

The displacement and stress trajectory plots for the numerical model clearly show the existence of arching in the potential sliding block, as presented in Figures 27(c) and 28. The maximum displacement was 0.715 m and it was located near the G1 interface. The numerical model was applied additionally to calculate the safety factor at the end of the 2nd Stage using the popular Shear Strength Reduction technique. The safety factor of the model was reportedly 1.07.

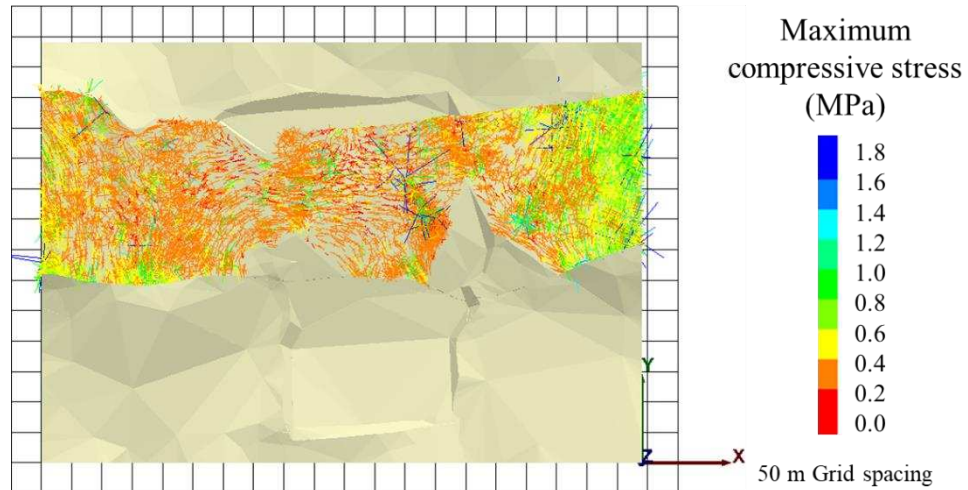
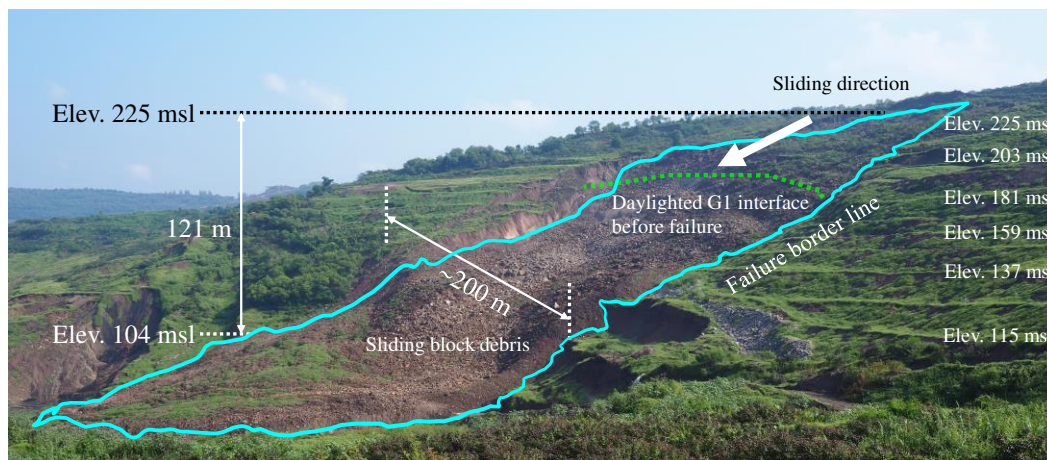
Figure 29. Area 4.1's debris after failure in October 2018.

In October 2017, all mining activities of the 2nd Stage were successfully completed without any casualties. Area 4.1 and the vicinity became a restricted area of the mine. A year later, the displacement of the restricted Area 4.1 immediately spiked during the rainy season of 2018. The mine and all the mine staff actively responded and were well prepared for the failure of the rattling Area 4.1. At the end of October 2018, part of the undercut slope of Area 4.1 (Figure 29) failed between the backfilling of the 1st and 2nd Stages (see Figure 13(c)). The failure extended from elevations of 104 msl and 192 msl, and was approximately 200 m in width. The width of the failure was as wide as the length of the daylighted G1 interface at 190 m. Therefore, the preliminary study giving the maximum undercut width of 150 m (see Figure 8(f)) confirms that the proposed analyses (Class A predictions for the 1st Stage and Class B predictions for the 2nd Stage) are on the safe side.

The slope failure in the field (Figure 29) is shown as a vertical shear plane and is evidence of the rock mass failure on the side of the sliding block (side resistance), also called flank. However, the failure of the rock mass of the block was hardly captured by the numerical model in this study because of the complexity of the geologic structures in Area 4.1. In fact, the results of one case of failure would not be sufficient to confirm other unknown multiple variables. Later, Area 4.1 was treated as an abandoned mining site; therefore, there was no further investigation of this failure.

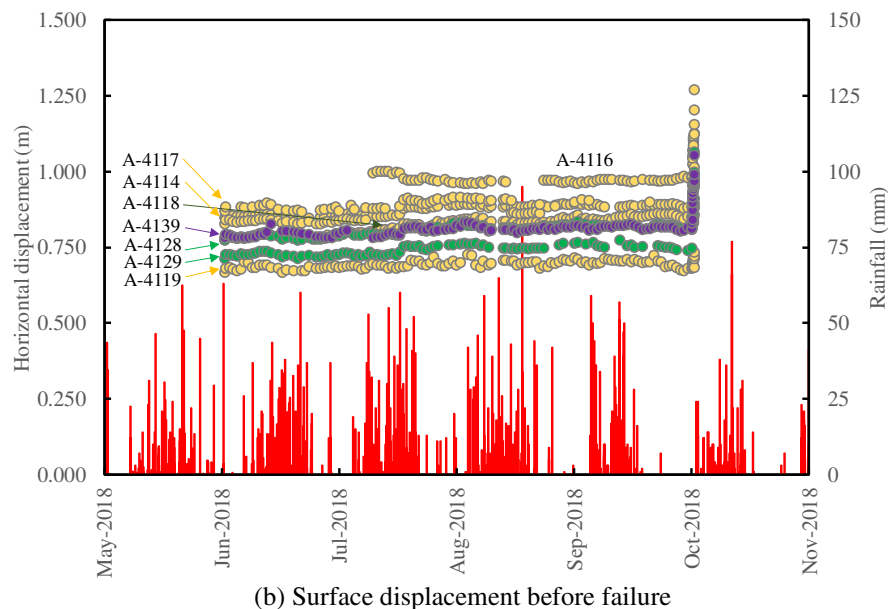
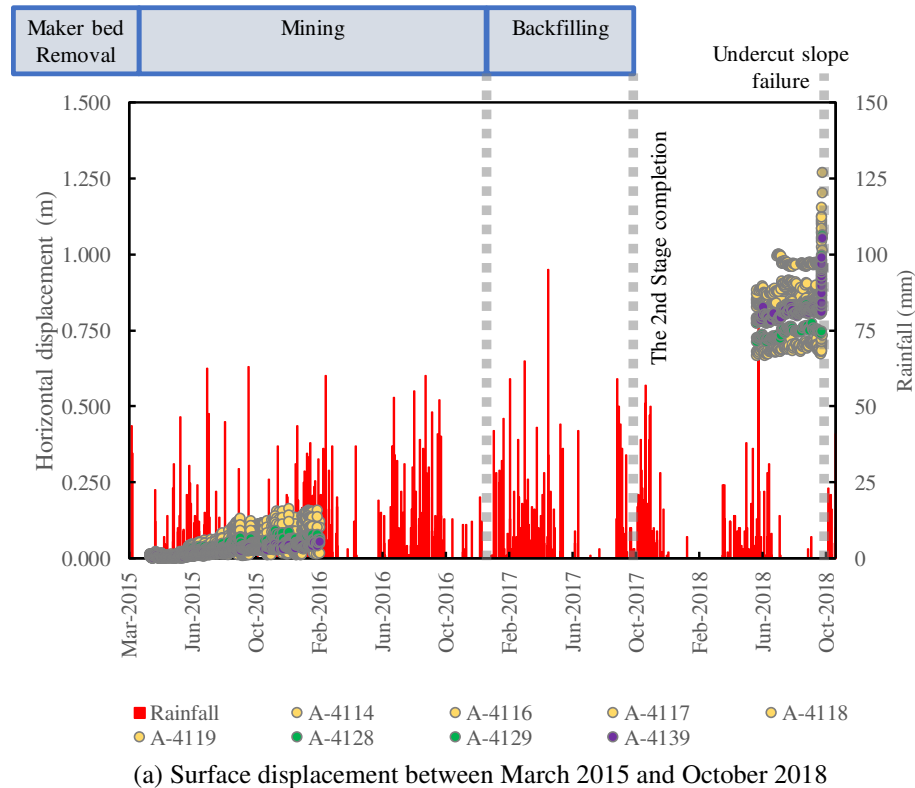
(a) Surface displacement between March 2015 and October 2018

(b) Surface displacement before failure

After the undercutting and before the failure, all the available surface displacement data showed that the potential sliding block had the accumulative surface displacement of approximately 1 m and rapidly displaced on the day of failure. The surface displacements from the monitoring data, one day before the failure, are plotted with the surface displacement of the numerical model of the 2nd Stage in Figure 31. The surface displacements of the numerical model were incomparable. The displacement magnitudes of the monitoring data were much larger than those of the numerical model.
