Lack of Maintenance Compromises Tunnel Structural Safety

Sadek S., Hamad B. (2007). *Lack of Maintenance Compromises Tunnel Structural Safety.* International Journal of Geoengineering Case histories, http://casehistories.geoengineer.org, Vol.1, Issue 2, p. 136-153.

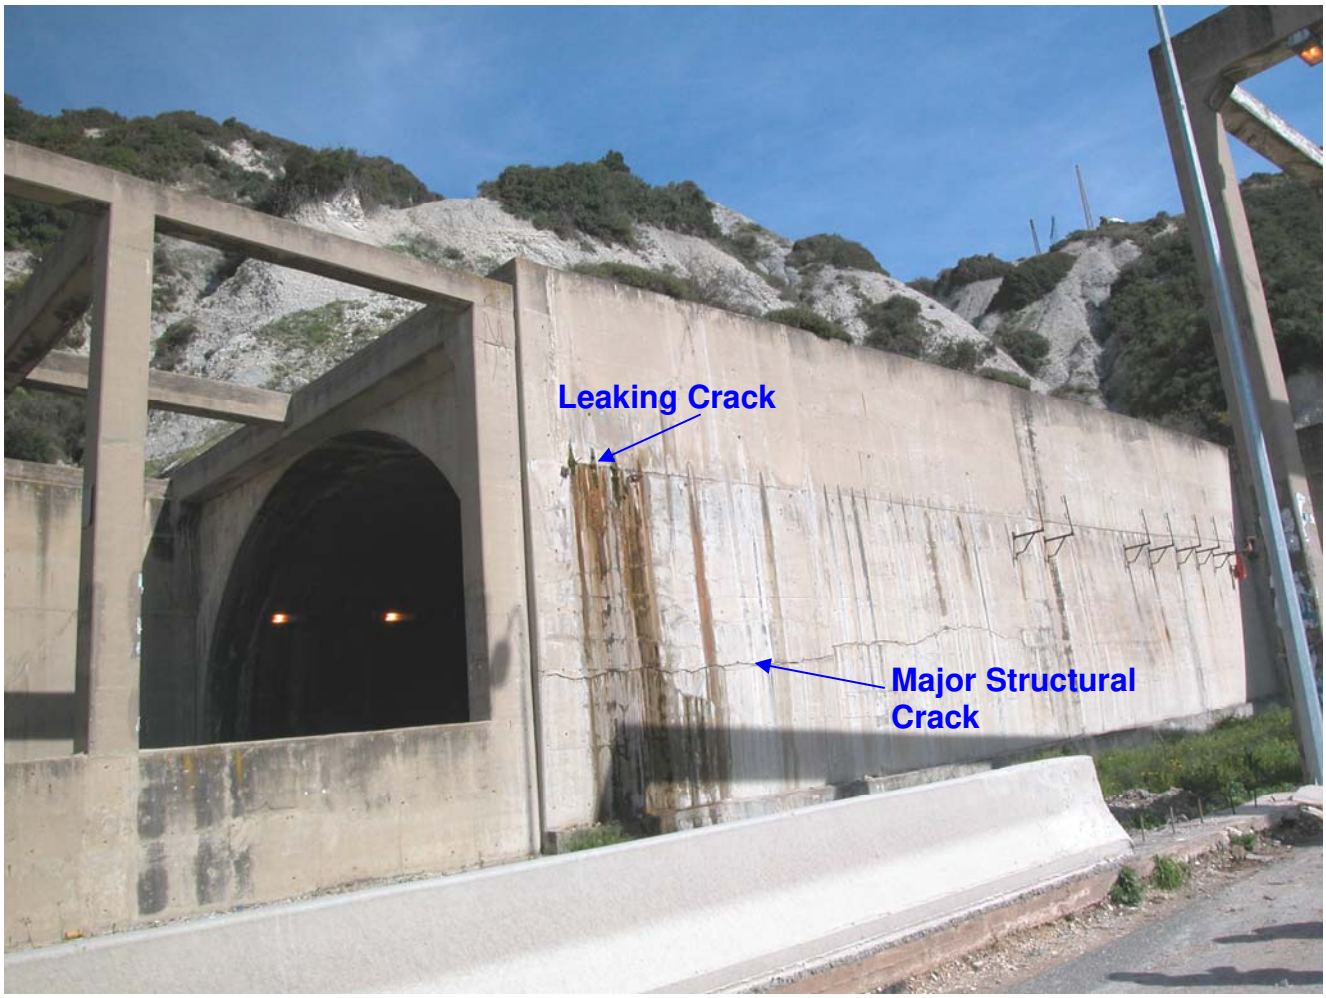
Figure 1. Southbound Tunnel Portal - View of External Distress.

1. A major longitudinal structural crack was clearly evident on the outside face of the eastern wall of the tunnel portal frame in the last 35 m span of the exit side of the southbound tunnel (Fig. 1). Signs of water leakage through a crack in the eastern wall were evident at the junction between the tunnel portal and the 4.72 m high retaining parapet. This pattern of damage was indicative of a number of problems with the tunnel portals, which are typically identified as potentially problematic areas in a number of situations (Rothfuss et al., 1995).

1. The major structural cracks on the outside face of the eastern wall of the portal frame were repaired by "crack-injection" using low viscosity, two-component epoxy resin. The injection was completed after thorough cleaning and preparation of the affected areas and the provision of injection ports to ensure thorough filling of the cracks. Similar treatments were applied to all cracks and damaged areas in the tunnel concrete lining (Fig. 15).

2. The eastern wall of the southbound tunnel portal was further strengthened after the accumulated weathered material above it was removed and the crack treatment/repair completed. Strengthening was achieved by connecting a 15-cm reinforced concrete jacket to the existing wall.

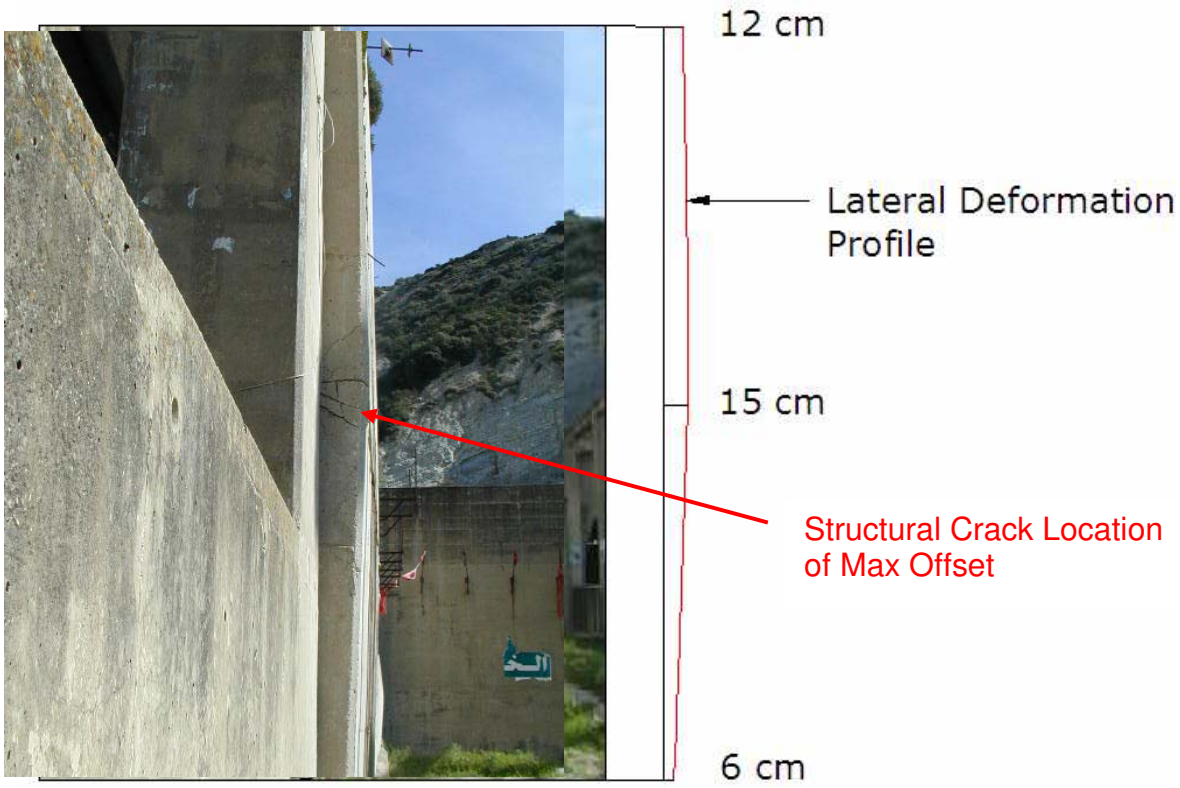
Figure 2. Close-up View of the Outward Movement/bulging of the Eastern Portal Wall.

The major crack along the 35-m long portal structure at the southbound tunnel exit (shown in Fig. 1 and Fig. 2) which initiated the engineering intervention, was attributed to increased differential loading. This possible cause for the structural damage was identified following the observation of a relatively large slumped mass of soil loading the western side of the portal structure of the southbound tunnel (Fig. 3). The slumped soil mass was due to weathering of the friable chalky limestone rock on the adjacent exposed slopes and subsequent instability and mass transport. The differential loading of one side of the portal frame structure by the slumped soil mass, along with other contributing factors, could have led to the observed cracking of the eastern wall of the portal along with the associated lateral deformations of up to 15 cm (Fig. 1 and Fig. 2). Additional pictures of this particular tunnel segment are provided in the online database that accompanies this paper.

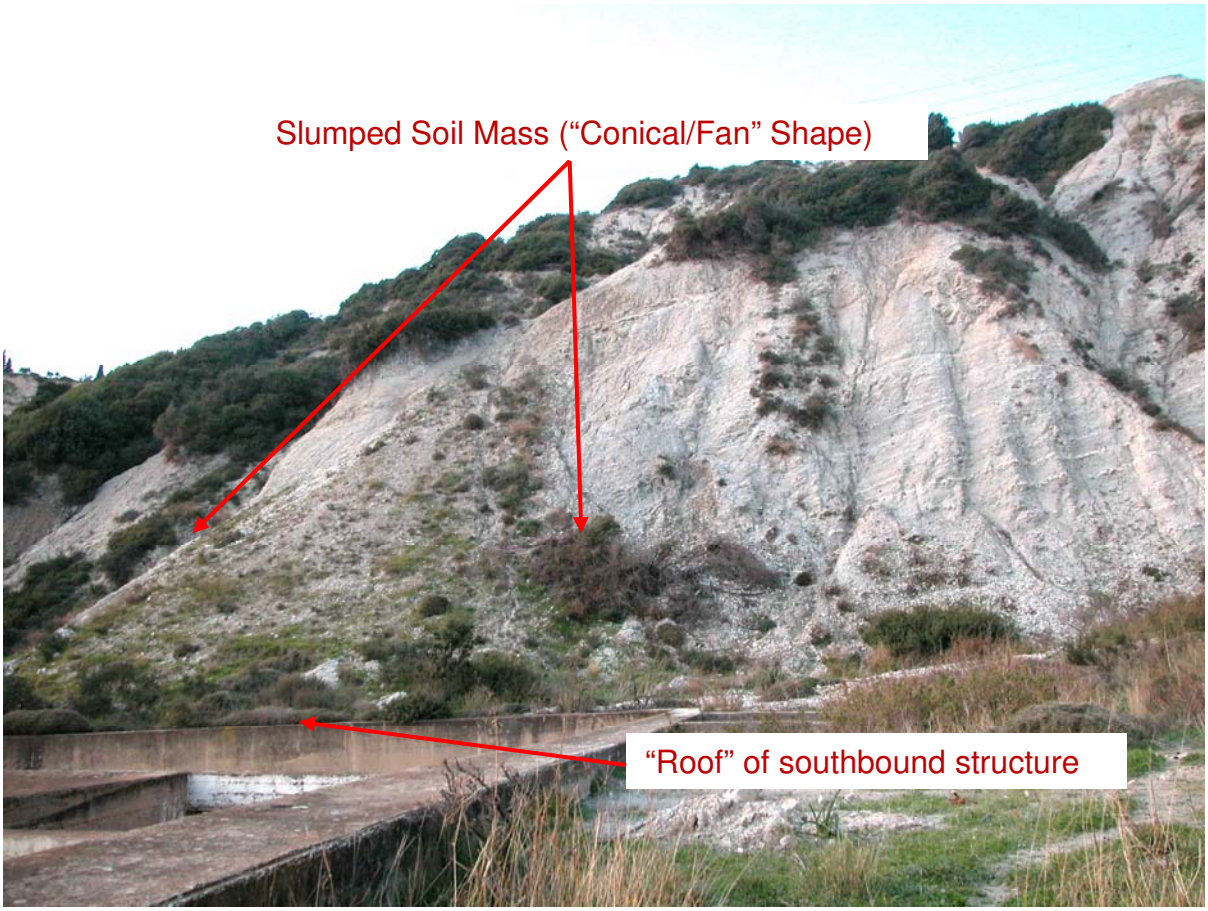
Figure 3. Slumped Soil Mass Loading the Top of the Southbound Tunnel Exit Structure.

1. "Soil 1", is characteristic of the slumped mass above the southbound tunnel cross-section (Fig. 3). This soil type is characterized by relatively low values of the Menard modulus, dry density and unconfined compressive strength.

2. Removal of the slumped mass on top of the southbound tunnel exit structure and the provision of long-term stability and erosion control measures to eliminate the possibility of recurrence. These provisions included the installation of rock bolts/nails with a high strength steel wire mesh facing (Fig. 13 and Fig. 14). A program for regular inspection and maintenance of the structures was also developed.

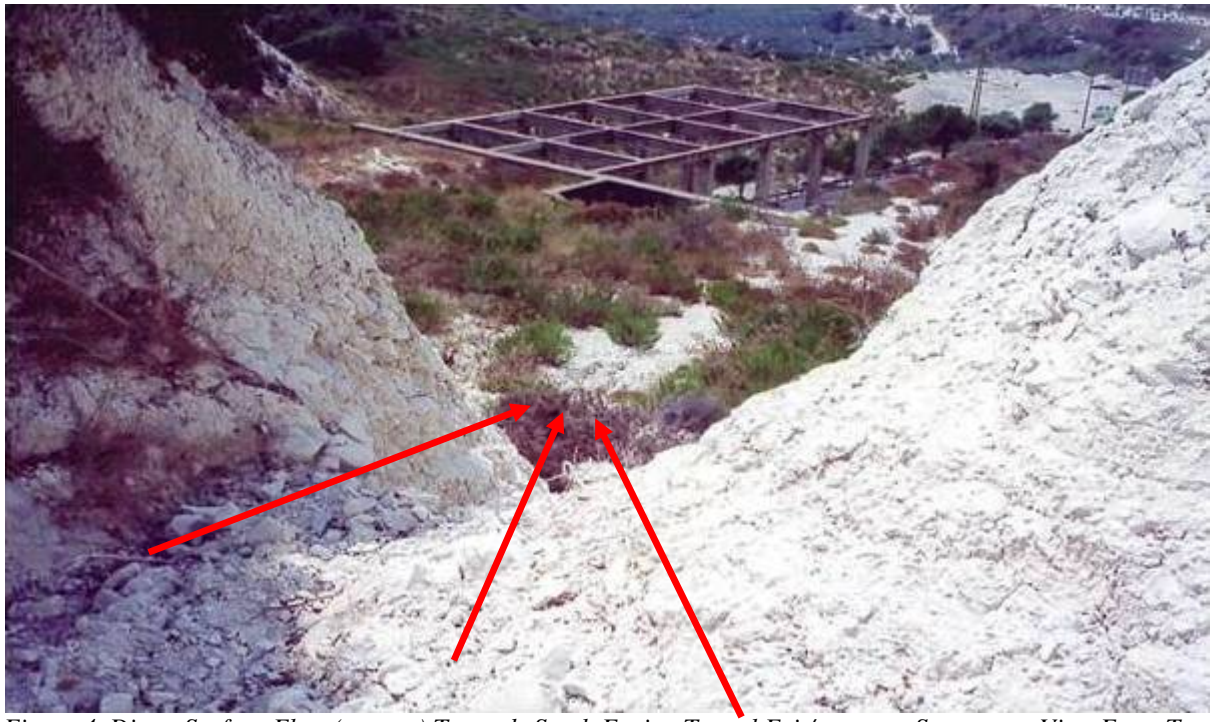
Figure 4. Direct Surface Flow (arrows) Towards South Facing Tunnel Exit/entrance Structures -View From Top.

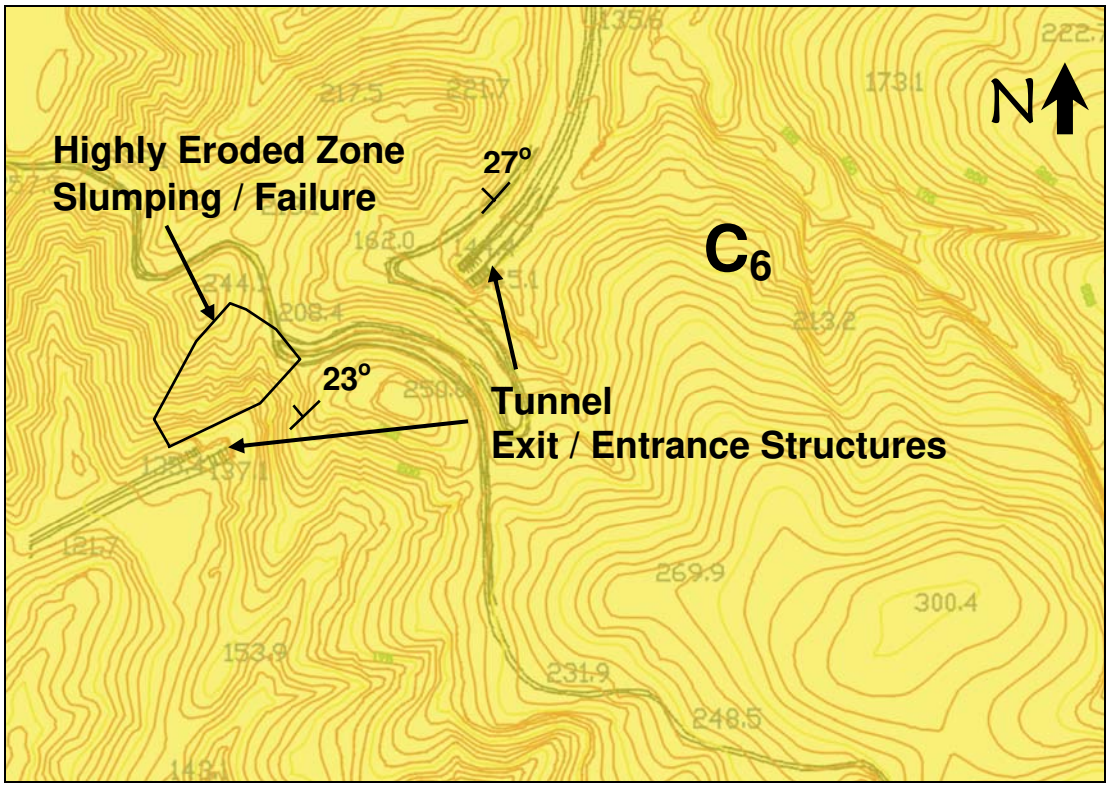
Based on the topographic and geological surveys, it is clear that the prevailing strata are prone to erosion and mass wasting, and that significant slopes are evident in the vicinity of the tunnels with adverse dips identified towards the tunnel exit and entrance points.

Figure 5. Geology of Area: The Only Outcropping Unit is the Chekka Formation C6.

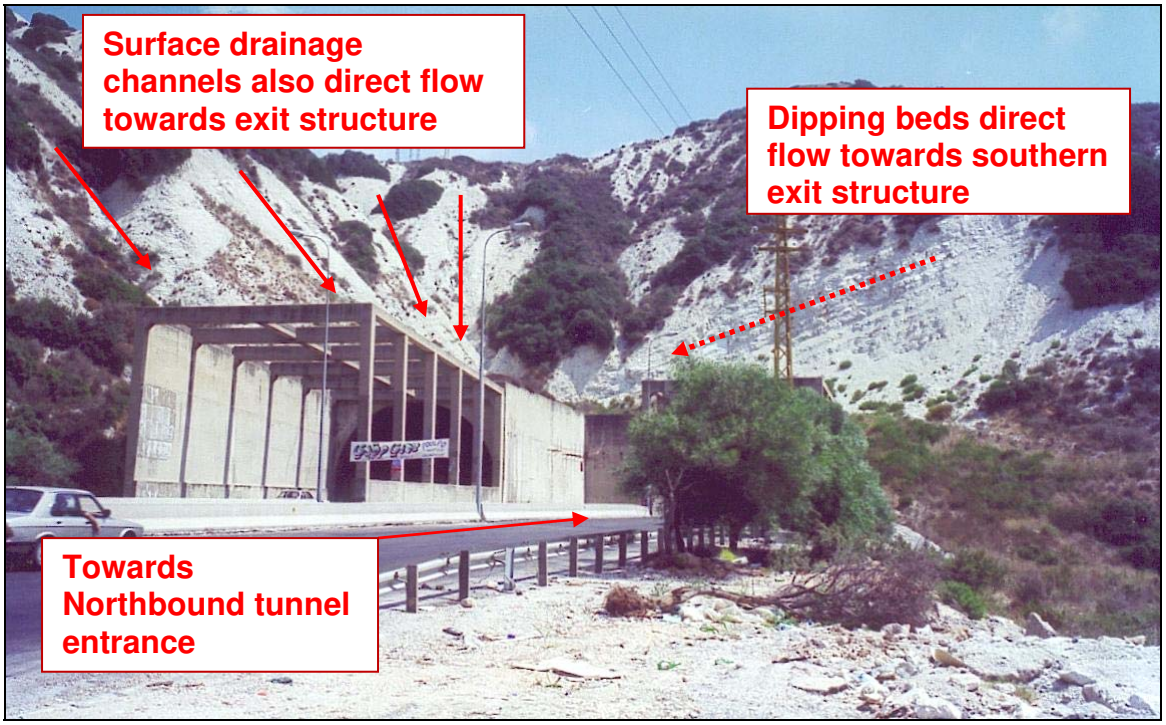
Figure 6. Dipping Beds and Surface Drainage Channels Increase Flow Towards Southbound Tunnel Exit Structure and "Sump" Area Above Tunnels.

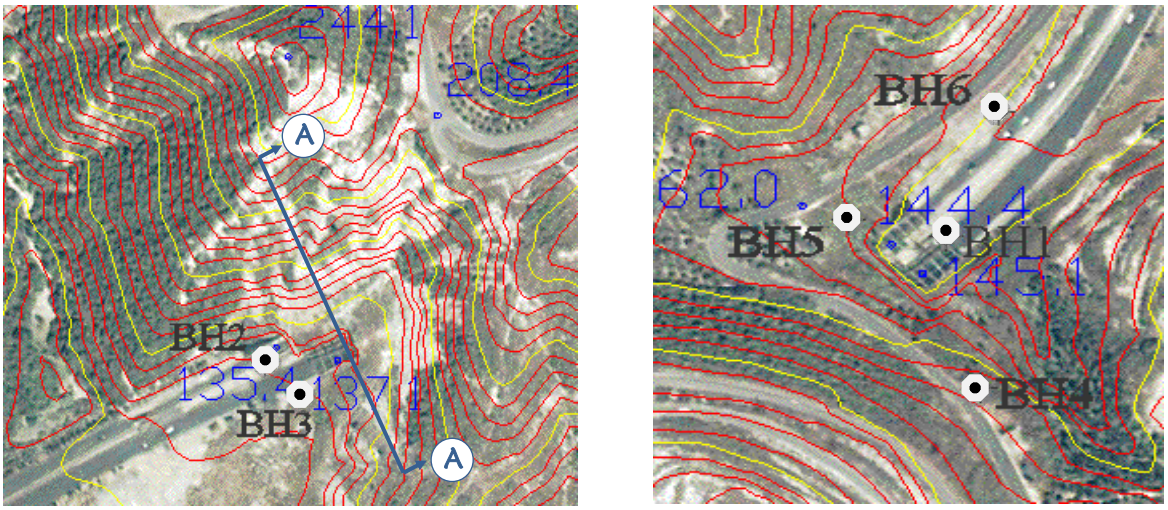
A total of six boreholes, approximately 10 m deep, were drilled in addition to a number of shallow pits. The locations of the boreholes were restricted to accessible areas and are indicated in Fig. 7. The exploration pits complemented the boreholes and were located primarily above the southern entrance/exit points.

Figure 7. Location of Exploration Boreholes BH-1 Through BH-6.

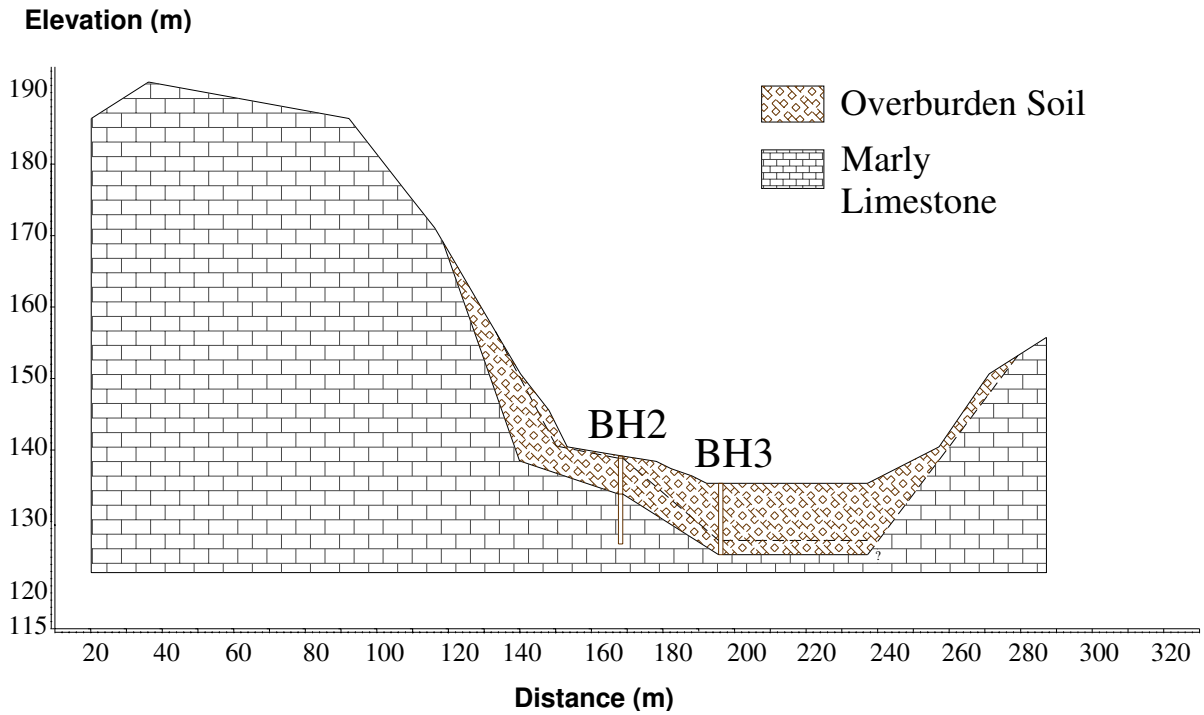
Figure 8. Transverse Section Across South tunnel (A-A in Fig. 7). Tunnel Portal Between Two Hills.

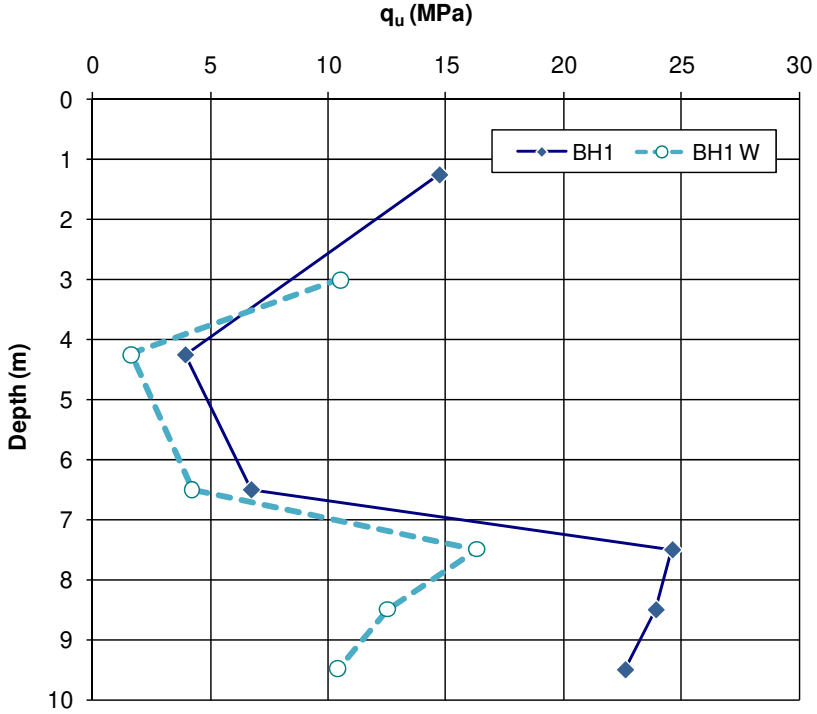
Unconfined compression tests were conducted on rock cores according to ASTM D2166. Some of the samples were submerged in water for 48 hours prior to testing in order to explore the effect of increased water content on the strength of the marlstone/rock samples. The elastic deformation modulus values obtained from the laboratory tests on the cores extracted from the material above the southbound tunnel cross-section are relatively low (from about 5800 to 15000 kPa), which was expected given their higher degree of weathering. The results of the unconfined compression tests showed a significant decrease in strength for the wetted samples. The average unconfined compression strength values from samples from BH-1 and BH-5 for the marly limestone layers are shown in Table 1. The unconfined compressive strengths above the southbound tunnel cross-section suggested an average value of q_u ~19.5 MPa for the natural condition samples, and a value of q_u ~7.0 MPa for the wetted samples. Typical results from BH1 samples are presented in Fig. 9.

Figure 9. Unconfined Compressive Strength Results From BH1: Natural Water Content and Wetted Samples (w).

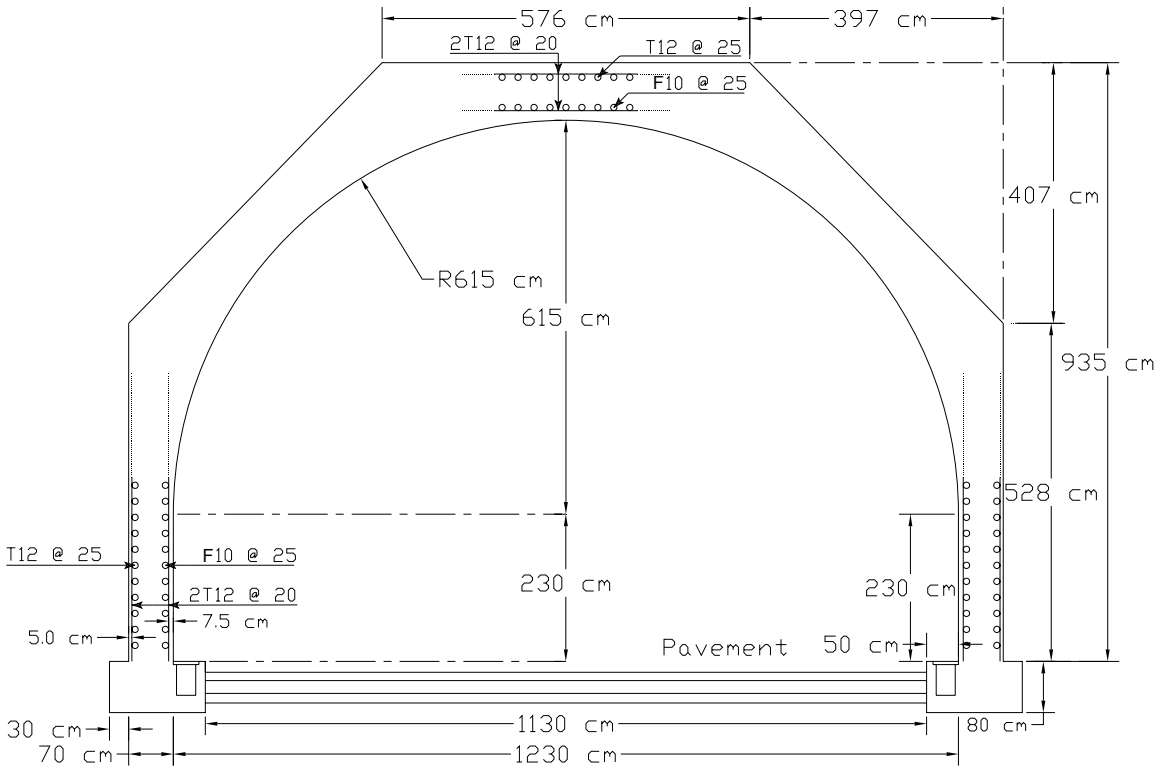
Figure 10. Geometry of the 35-m Long Extension of the Southbound Tunnel Portal.

Table 3 presents the bending moments calculated from the FE analyses and the ultimate moment section capacity at the position of the observed crack ~ 2.5 m above the footing level (Fig. 10).

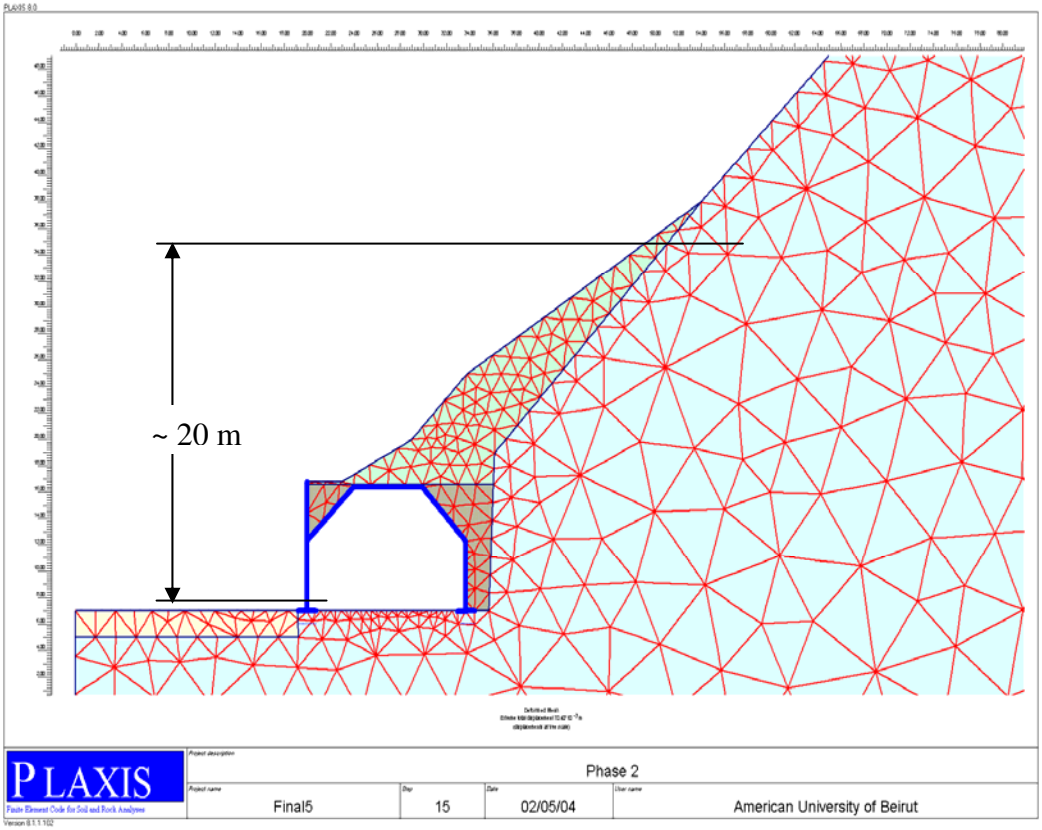
Fig.11 is a detail view of the finite element mesh near the tunnel portal, showing the soil and rock strata as described in Table 2. The intact rock is shown in light blue, while the slumping soil mass is green. The olive green color represents the engineered backfill soil at the end of construction. It is important to note here that the slumping soil mass was only activated for Stage 2.

Figure 11. Finite Element Model Showing the Various Strata and the Loading Sequences – Stages 1 and 2.

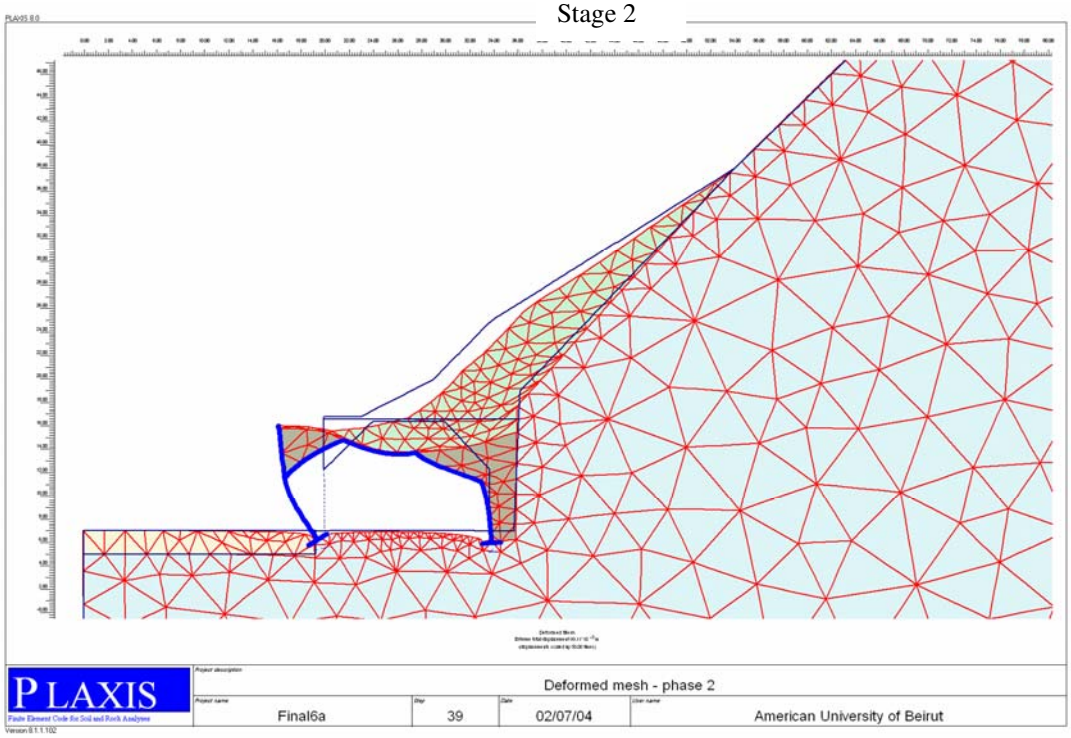
For conditions representing the current loading, Stage 2, the analyses yielded the deformed mesh shown in Fig. 12. The FE results for Stage 2 suggest the following:

1. The maximum bending moment values calculated are much larger than the ultimate moment capacity of the critical wall section. This implies that the additional loading due to the slumped soil accumulated on top of the tunnel section is indeed a major contributing cause of the observed failure of the portal wall section.

Figure 12. Deformed Mesh for Stage-2 (Deformations Are Scaled up 50 times).

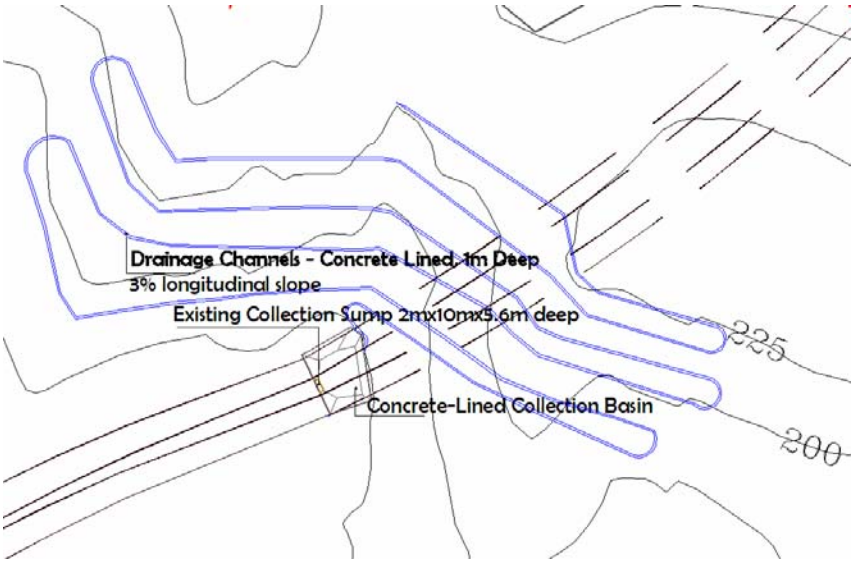
Figure 15. Schematic Plan of the Drainage/interception Channels (Trace of Tunnels Shown as Dashed Lines).

1. A water runoff interception scheme, with particular emphasis on the slopes contributing to the flow patterns towards the southbound tunnel exit. A schematic of the layout of the system is shown in Fig. 15. The interceptor trenches and drainage channels are concrete-lined and feed into controlled sumps and outlets, moving surface water away from the portals and vulnerable tunnel sections.
