Leaning Tower of Pisa: Behaviour after Stabilization Operations

KEYWORDS: Leaning Tower of Pisa, leaning instability, stabilization works

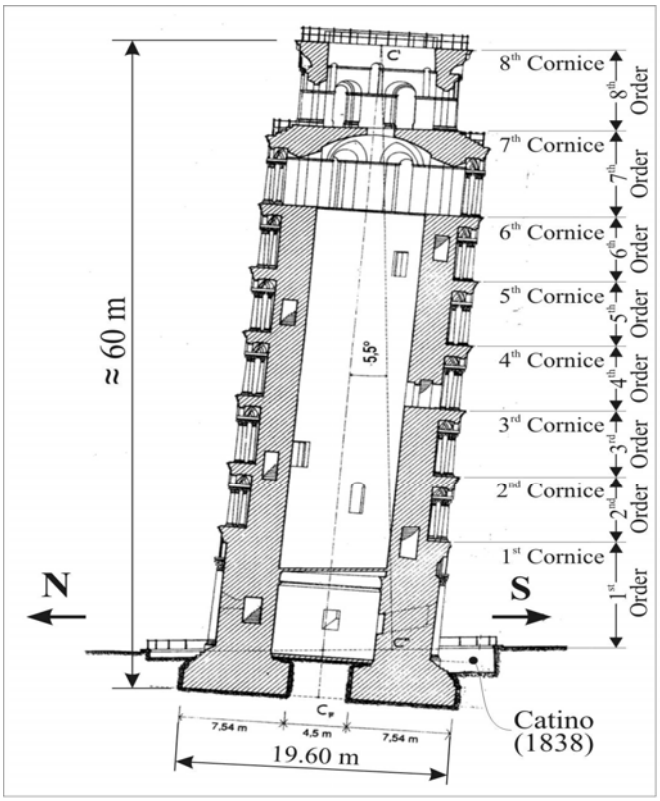
Figure 3. Cross-section in the plane of maximum inclination, situation in year 1993.

Weight	142 MN
Height of the centre of gravity	22.6 m
Overturning moment	327MNm
Average foundation pressure:	≈ 500 kPa

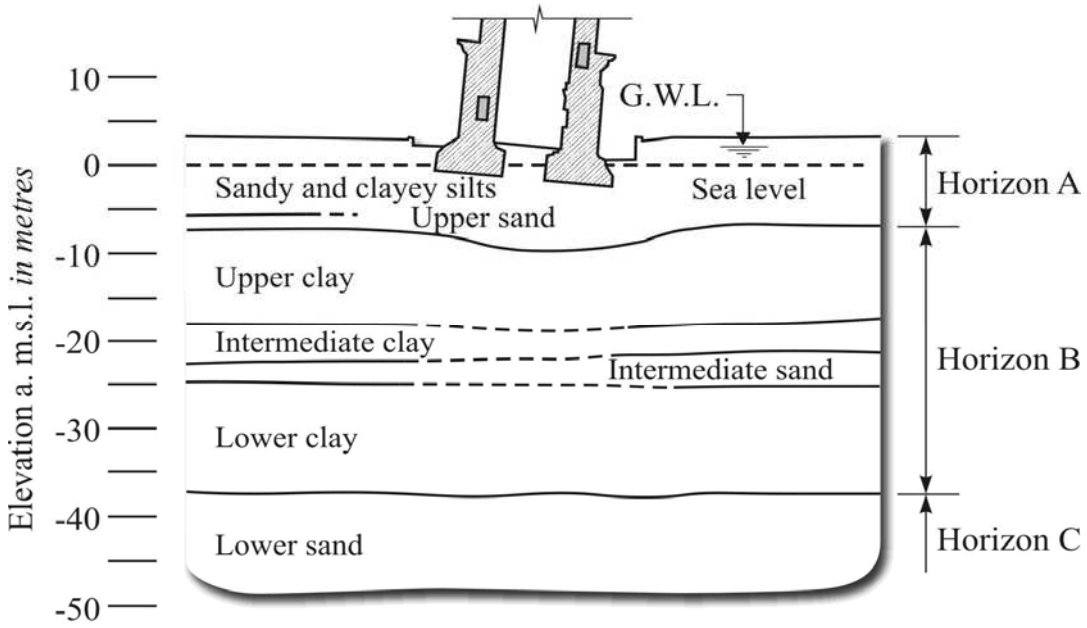
Figure 4. Soil profile.

The ground underlying the Pisa Tower consists of three formations as shown in Fig. 4. Horizon A, about 10m thick, is composed of soft estuarine deposits of sandy and clayey silts laid down under tidal conditions. Horizon B consists of soft sensitive normally consolidated marine clay extending to a depth of about 40m. Because it is very sensitive, this material loses much of its strength if disturbed. Horizon C is dense marine sand extending to a depth of about 60m. An upper perched water table in Horizon A is encountered between 1m and 2m below the level of Piazza dei Miracoli corresponding to elev. +3.0 above m.s.l. The contact between Horizon A and the marine clay of Horizon B is dished beneath the Tower, indicating that it experienced average settlements of between 3.0m and 3.5m.

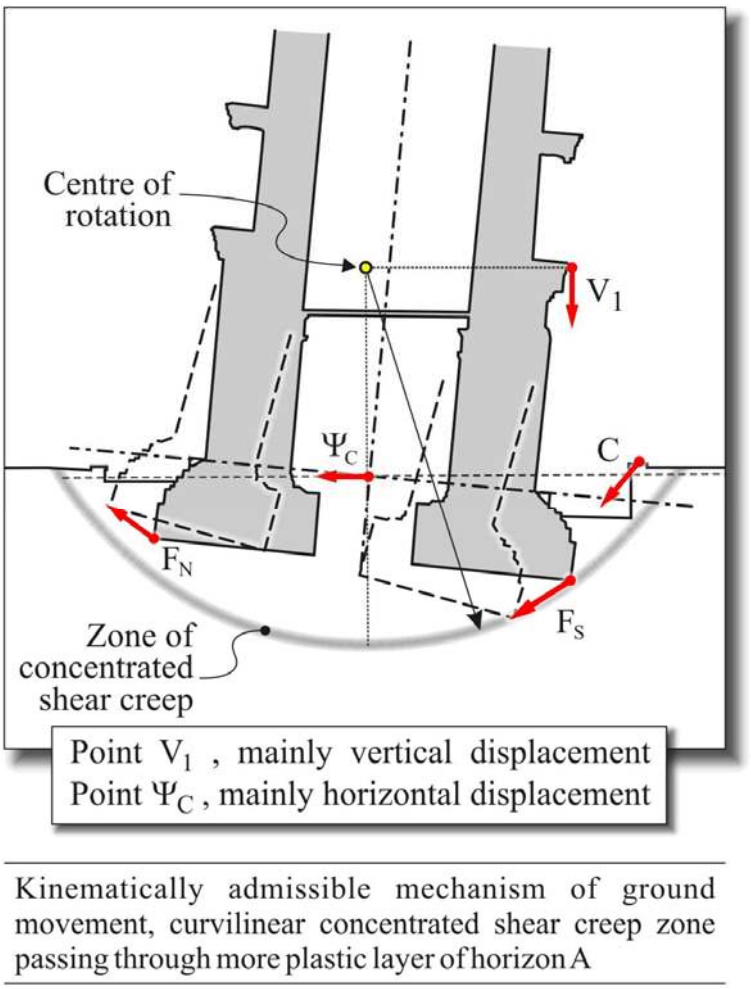
Figure 5. Motion of Tower foundation during steady creep (gradually accelerates) - Burland, Viggiani (1994).

The discovery that the motion of the Tower was as shown in Fig. 5 turned out to be crucial in four respects:

1. The form of motion is consistent with the phenomenon of 'leaning instability' rather than an iminent bearing capacity failure (Hambly, 1985). In simple terms, 'leaning instability' of a tall structure occurs at a critical height when the overturning moment generated by a small increase in inclination is equal to or larger than the resisting moment generated by the foundations. No matter how carefully the structure is built, once it reaches the critical height the smallest perturbation will induce leaning instability. As pointed out by Hambly: "…leaning instability is not due to lack of strength of the ground but is due to insufficient stiffness".

3. The pattern of ground movements depicted in Fig. 5 led to the important conclusion that the seat of the continuing long-term rotation of the Tower lies in Horizon A and not within the underlying marine clay as had been widely assumed in the past. It can therefore be concluded that the latter stratum must have undergone a considerable period of ageing since the end of construction. The ageing resulted in an increased resistance to yield – a conclusion that proved to be of great importance in the successful computer modeling of the application of the temporary counterweight (Burland and Potts, 1994).

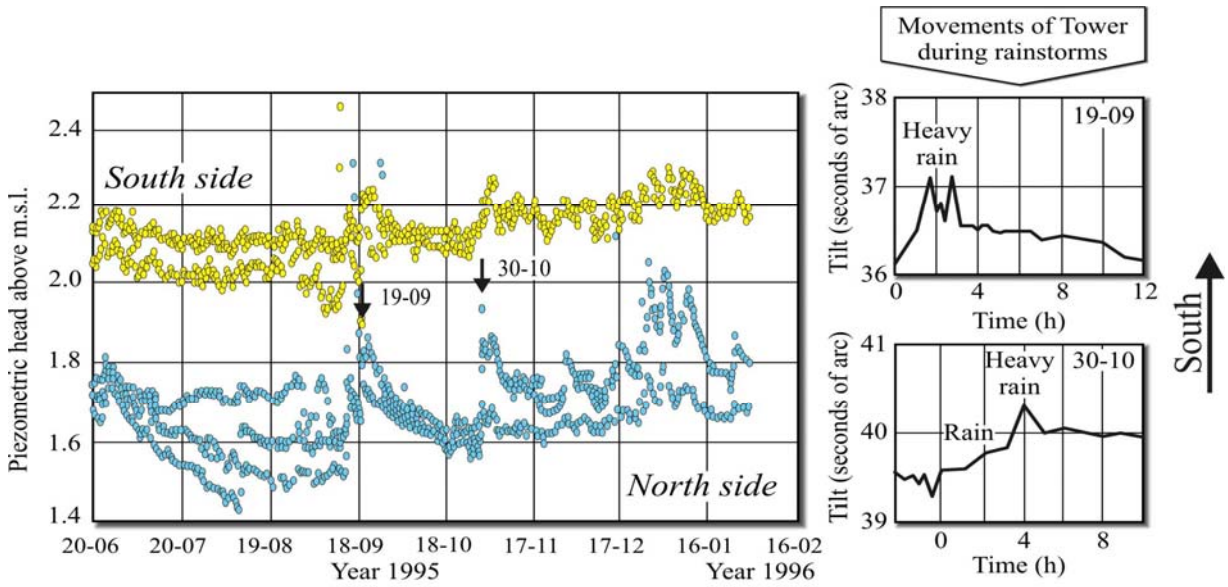
Figure 6. Ground water level fluctuation in horizon A.

4. In the light of the measured motion of the Tower foundation, and consistent with the seat of the movement lying within Horizon A, it was concluded that, in addition to creep, the most likely cause of the progressive seasonal rotation was a fluctuating ground-water level due to seasonal heavy rainstorms that occur between September and December every year. Accordingly a number of stand-pipes were installed in Horizon A around the Tower. Measurements made over a number of years have confirmed this hypothesis. Commencement of rotation each year coincides with very sharp rises in the ground water level in the Horizon A following each heavy rainstorm (Burland et al, 2003). Fig.6 shows the ground water level fluctuations for a selected period of time in the piezometers located to the North and to the South in the vicinity of the Tower. The insert figures to the right show the changes in inclination of the Tower in arc seconds as a result of two heavy rainstorms that occurred in September and October of 1995. Each of these events caused a larger rise in piezometric head on the North side than the South side of the Tower. This resulted in a southward rotation of about one arc second in each case which was only partly reversible.

As mentioned previously, the deduced motion of the Tower foundation shown in Fig. 5 led to the conclusion that the seasonal fluctuating water table in Horizon A during intense periods of rain was the main factor responsible for this continuing movement, see Fig. 6. It is also of significance that, apart from these intense periods of rain, the average ground water levels close to the South side of the Tower in Horizon A are 200mm to 300mm higher than those to the North, as shown in Fig. 6. This difference generates a small, but not negligible stabilising moment for the Monument which is so close to falling over. In the autumn and winter, when rainfall events are more intense, the water table rises sharply, reduces the difference in piezometric level and thereby produces southward rotations of the Tower which are not fully recoverable. To minimise this effect it was necessary to eliminate the fluctuations of the water table and, with this objective, a drainage system was installed consisting of three wells sunk on the north side with radial sub-horizontal drains running into them from beneath the north side of the catino, (Fig. 13). The water levels in the wells are controlled by the level of the outlet pipes. The drainage system was implemented in April and May 2002 and lead to a decrease in the pore water pressure as well as a significant reduction in its seasonal fluctuations, as shown in Fig. 14. The installation of this drainage system induced a further northward rotation of the Tower as can be seen in Fig. 15.

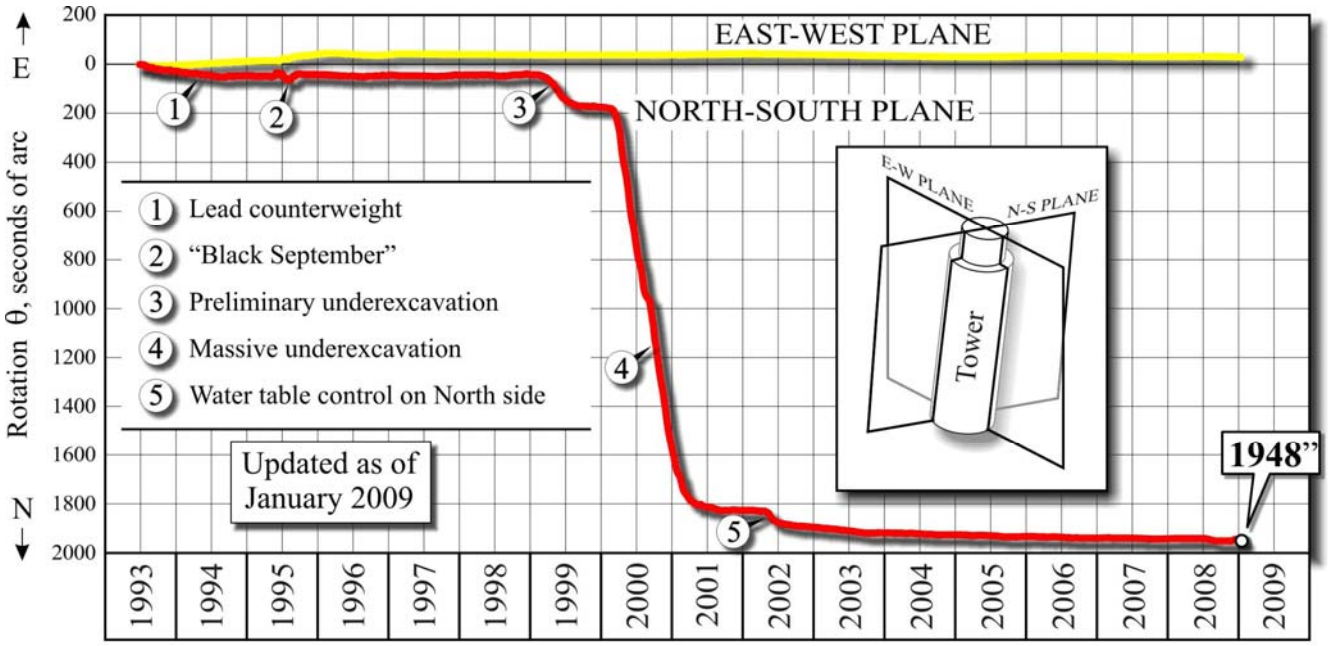
Figure 16. Rotation of Tower foundation as result of stabilization works.

As a result of the full underexcavation and of the implementation of the ground water control in Horizon A, the Tower foundation in mid 2002 had reduced its tilt by 1880 arc seconds - about 10% of the maximum value reached in 1993. In the succeeding six years the Tower has continued rotating northwards at a reducing rate, so that by September 2008 the

accumulated reduction of the foundation tilt reached 1948 arc seconds, see Fig.16. In the two years from September 2006 to September 2008 the residual rate of rotation northwards has reduced to less than 0.2 arc second per year.

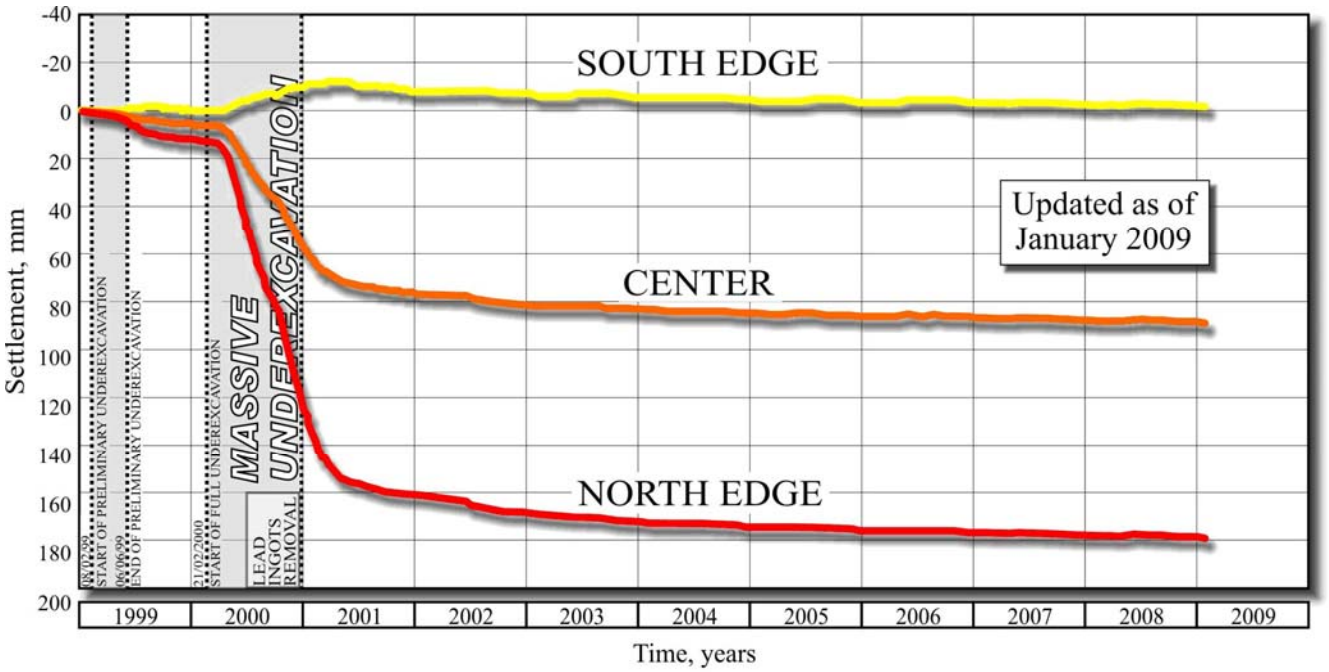
Figure 17. Settlement of Tower foundation as result of stabilization works.

The settlements of the south edge, centre and north edge of the foundation generated by the stabilisation operations, mainly by full underexcavation, are shown in Fig.17. In September 2008 the centre of the foundation had settled around 90mm and is continuing to settle at a rate that, over the last two years, is less than 1.0 mm/year. This is approaching the background rate of settlement of the Piazza due to the general subsidence of the Pisa plain. As regards the South edge of the foundation, it rose by about 15 mm during the underexcavation and has since settled around 12mm. This behaviour indicates that during underexcation, the axis of rotation was located under the imprint of the plinth and that the pressures due to the Tower weight at the south edge had reduced.

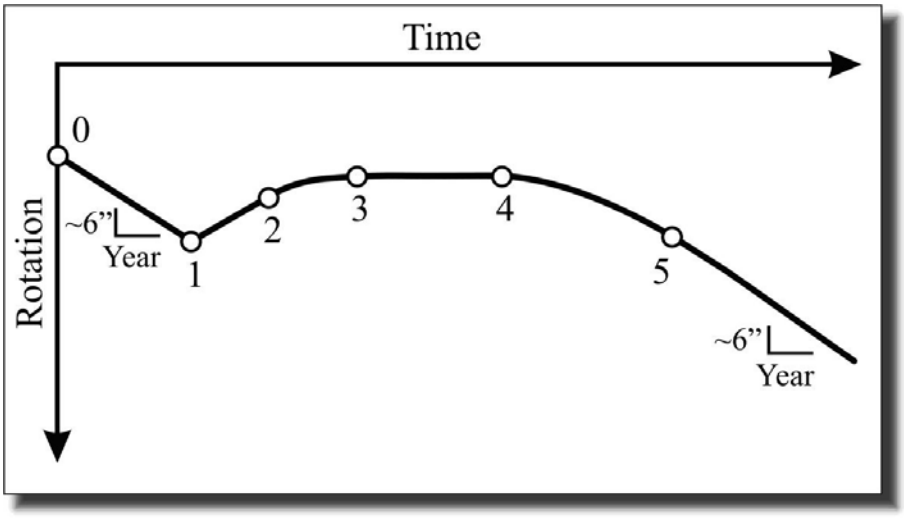
Figure 18. Expected future behaviour of the Leaning Tower of Pisa.

- Pessimistic Scenario. As illustrated in Fig. 18, after the completion of time effects of the underexcavation (period 2-3), the Tower will remain motionless for a period estimated as a few decades (period 3-4), followed by a possible resumption of the southward rotation. Initially this southward rate of rotation will be very much less than the 6 arc second per year that existed before the stabilisation works. However the rotation rate will gradually increase (period 4-5) and may approach again, after a very long time, a value close to 6 arc seconds. In what period of time this will occur is difficult to estimate. However, considering that the stabilisation works brought the Tower inclination back to the situation that existed at the beginning of the XIX century, the authors believe that the period of time for the Tower to return to its 1993 inclination will be at least 200 years.
