Leaning Tower of Pisa: Behaviour after Stabilization Operations

KEYWORDS: Leaning Tower of Pisa, leaning instability, stabilization works

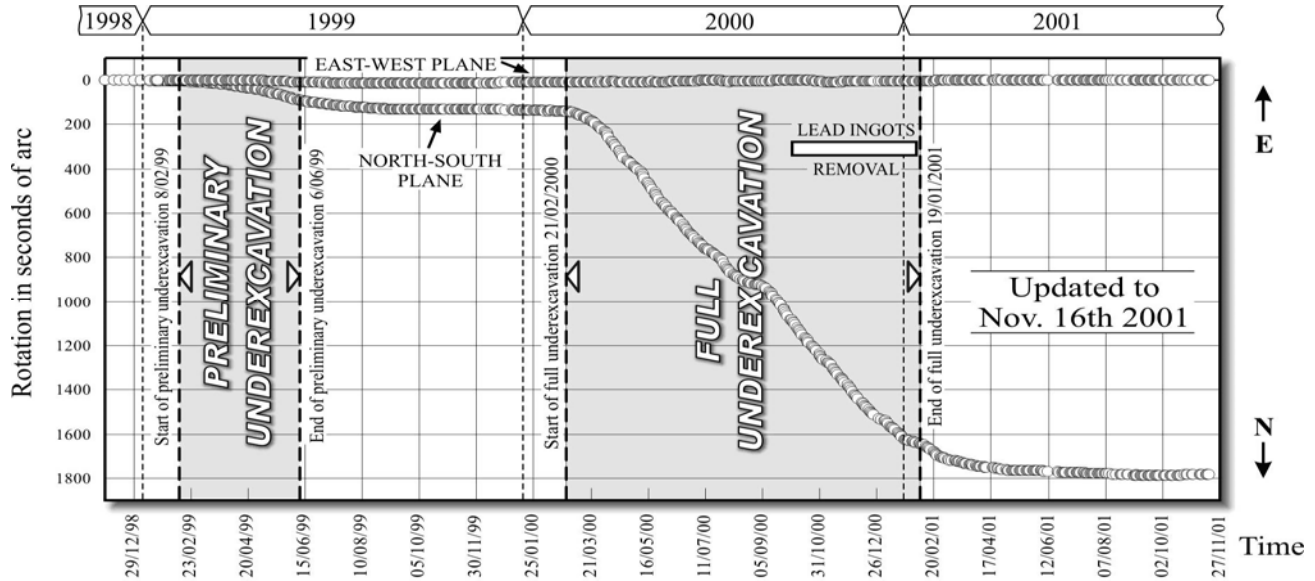
Figure 11. Rotation of Tower plinth during underexcavation.

The success of the preliminary underexcavation persuaded the Committee that it was safe to undertake soil extraction over the full width of the foundation. Accordingly, between December 1999 and January 2000, 41 extraction holes were installed north of the Tower at 0.5m spacing with a dedicated auger and casing in each hole (Fig.10). Full underexcavation commenced on 21st February 2000 and the Tower was steered northwards in a remarkably straight path. Towards the end of May 2000 progressive removal of the lead ingots was commenced. Although this resulted in an increase of overturning moment the soil extraction continued to be effective.
