Mississippi River Levee Failures: June 2008 Flood

Submitted: 27 April 2011; Published: 31 August 2011
Reference: Bernhardt, M., Briaud, J.L., Kim, D., Leclair, M., Storesund, R., Lim, S.G., Bea, R.G., Rogers, J.D., (2011). *Mississippi River Levee Failures: June 2008 Flood.* International Journal of Geoengineering Case Histories, http://casehistories.geoengineer.org, Vol.2, Issue 3, p. 127-162. doi: 10.4417/IJGCH-02-02-03.

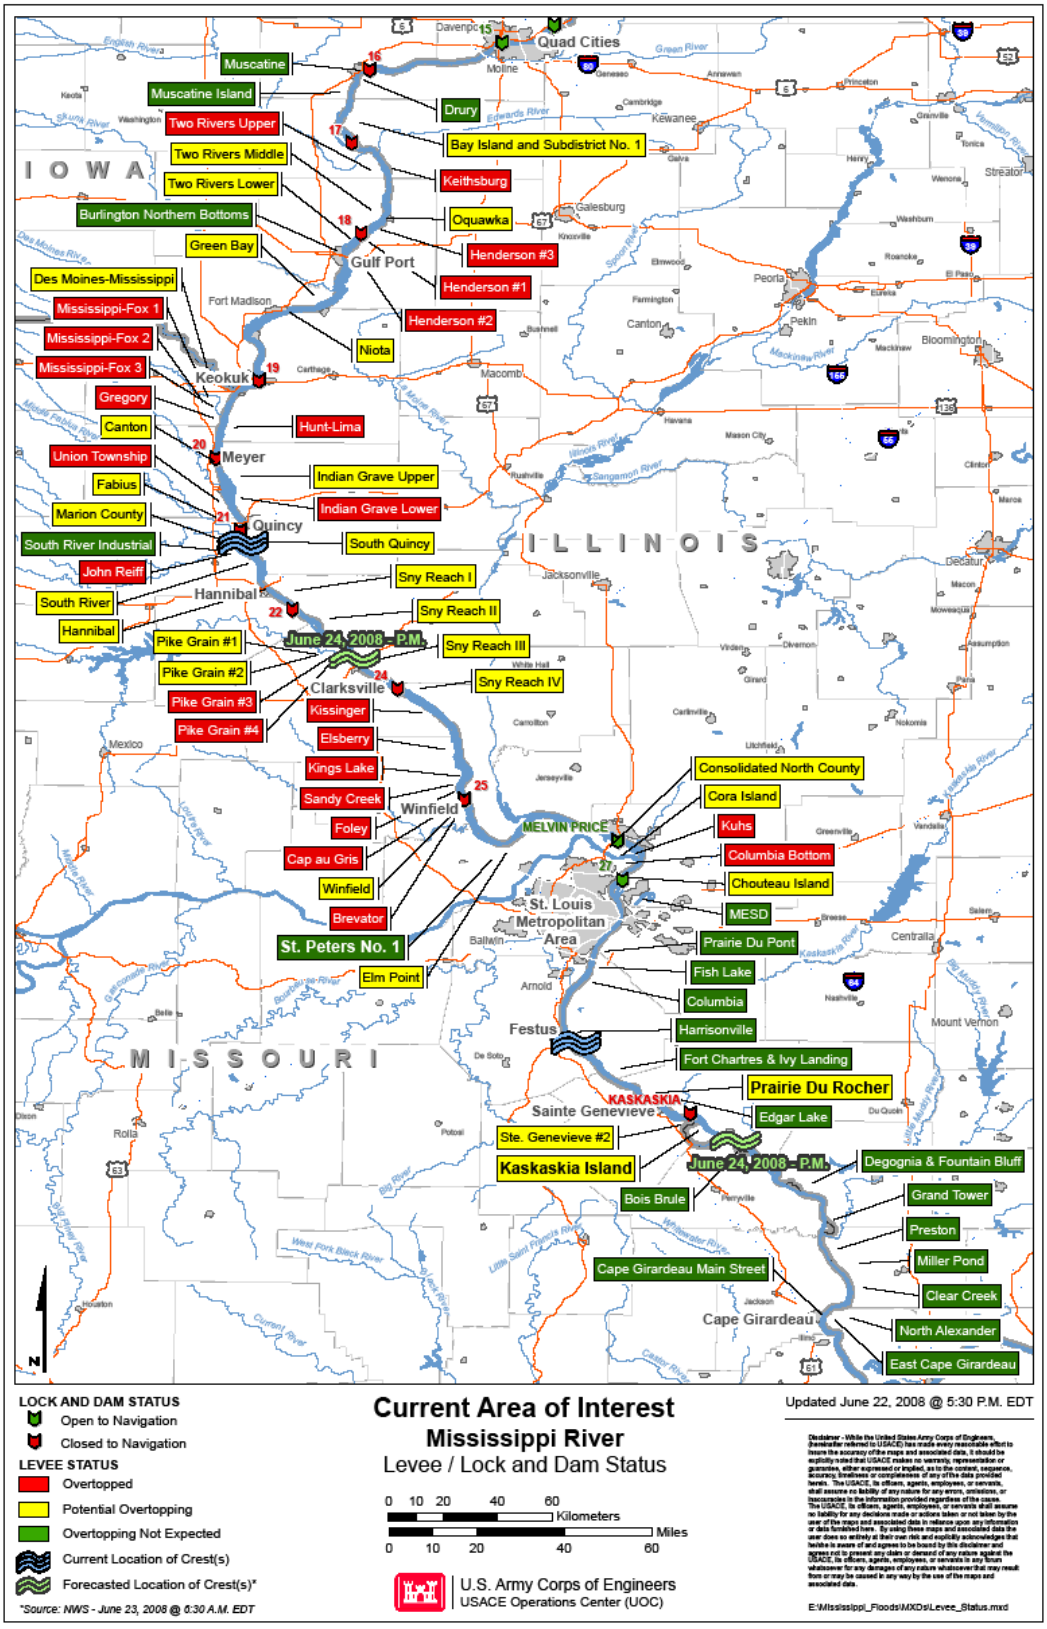
Figure 10. Overtopping status of Upper Mississippi River System (USACE 2008).

Figure 10 shows the US Army Corps of Engineers map of each particular levee system along the Upper Mississippi River System and the corresponding overtopping status during the flooding events as reported on 22 June 2008. The areas tagged in red had already been overtopped while the areas tagged in yellow show levee sections that were still in danger of being overtopped at that date.

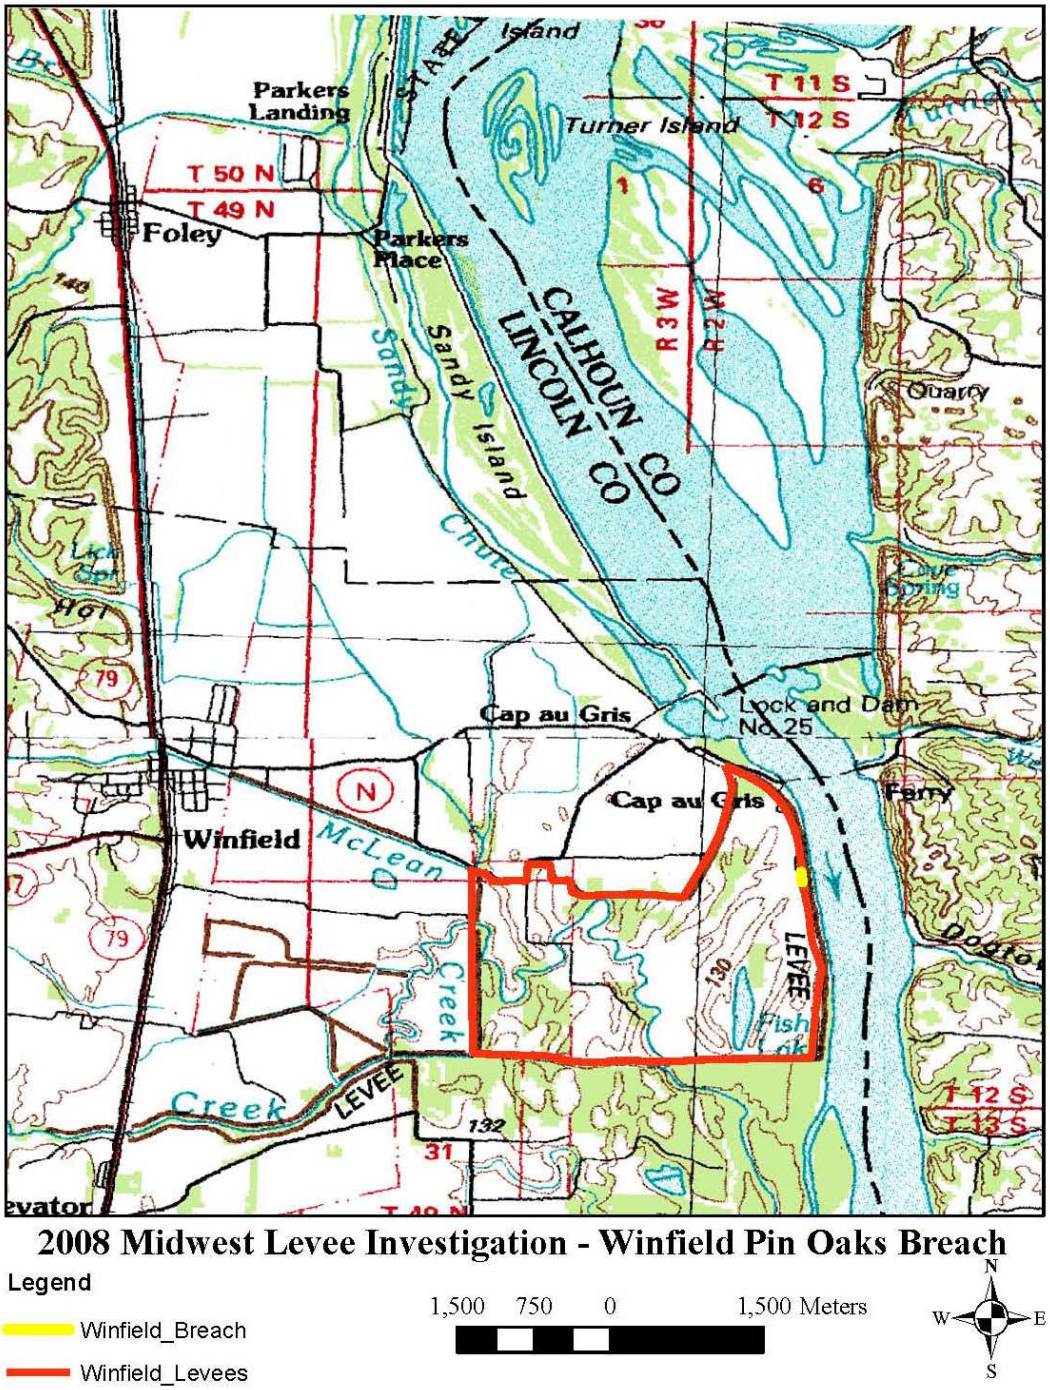
Figure 14. Winfield-Pin Oak levee system and levee breach (Storesund 2009).

The first site visited during the 2008 Midwest Levee reconnaissance was the Winfield-Pin Oak site near Winfield, Missouri. The levee breached on June 18, 2008. A gap approximately 150 m long was created in the levee by the overtopping waters. Figure 12 is a photo taken by the St. Louis District USACE showing an aerial view as two homes were knocked off their foundations by the force of the water. Figure 13 shows the same site on September 29, 2008 during the Midwest Levee reconnaissance. It should be noted that the breach shown in Figure 13 was contained between the blue and white houses shown in Figure 12 even though overtopping was also occurring further down the levee.

The Winfield-Pin Oak levee is maintained by the Cap Au Gris Drainage and Levee District. This levee system is estimated to reduce the risk of flooding of approximately 493 ha up to a 14-year return period flood event on the Mississippi River (Figure 14). This area failed during the 1993 floods, however, the specific location of the breach (or breaches) was not documented (USGS 2006). This site was overtopped for an extended period beginning on June 18th, 2008.

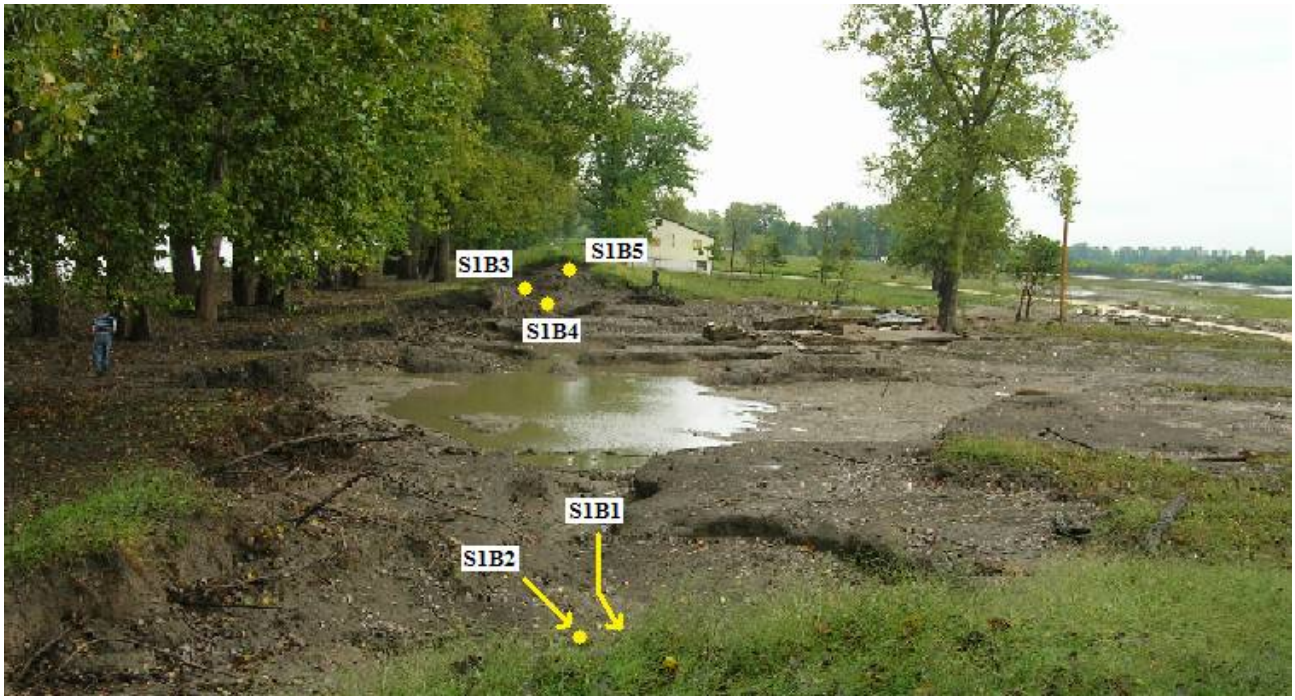
Figure 15. Boring locations Winfield – Pin Oak breach looking south.

Five samples were taken from various locations within the breach (15). Table 3 provides a summary of the sample locations as well as Torvane and Pocket Penetrometer readings. Note that the Pocket Penetrometer gives an estimate of the unconfined compression strength while the Torvane estimate the undrained shear strength directly. Common practice is to take the undrained shear strength equal to 0.3 times the Pocket Penetrometer readings.

Figure 15 shows a pond area around the center of the breach. This was the main contraction scour point resulting from the overtopping waters. After returning to the site two days later, the pond was noticed to be almost dry indicating a somewhat sandy or silty material and quick subsurface drainage.

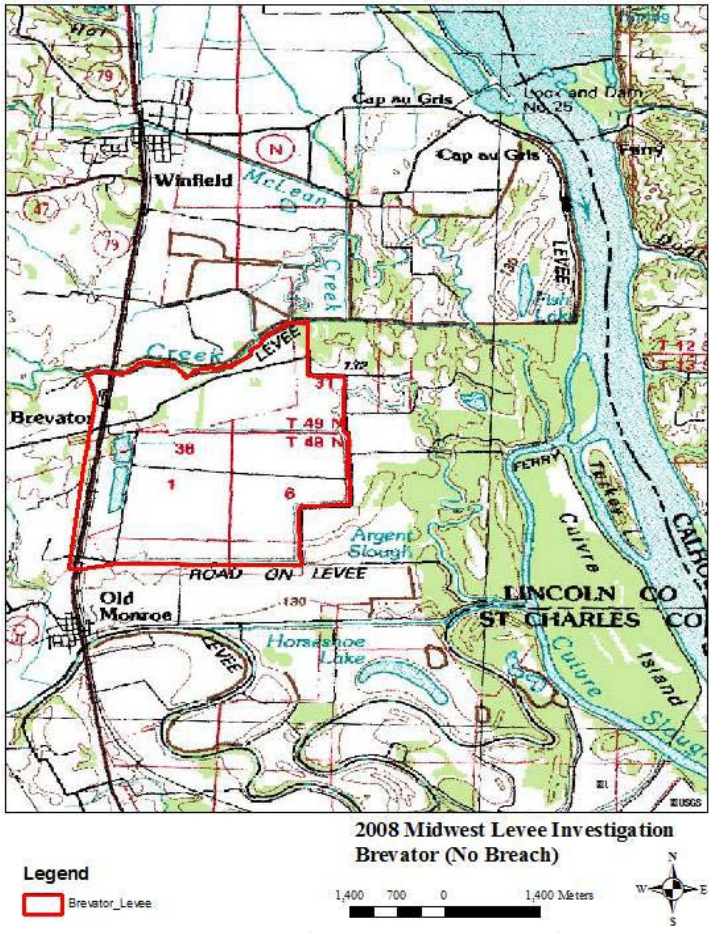
Figure 19. Brevator levee system (Storesund 2009).

This site was unique in the fact that there was no breach in 2008. The only sign of erosion was at a box culvert that was cracked allowing water and soil to seep through. A local resident (Mr. James Pieper) informed the team that the levee was overtopped by nearly 1 m of water for three days and never failed. Four samples were collected from various locations along the levee. Because there was no actual breach, only surficial samples were taken. These samples were much harder to obtain and the soil seemed to be much stiffer than at the previous sites as can be seen by the higher Pocket Penetrometer values (Table 6) obtained at this site compared to the Winfield site. Figure 20 shows the boring locations and Table 6 presents the sample logs for this site.

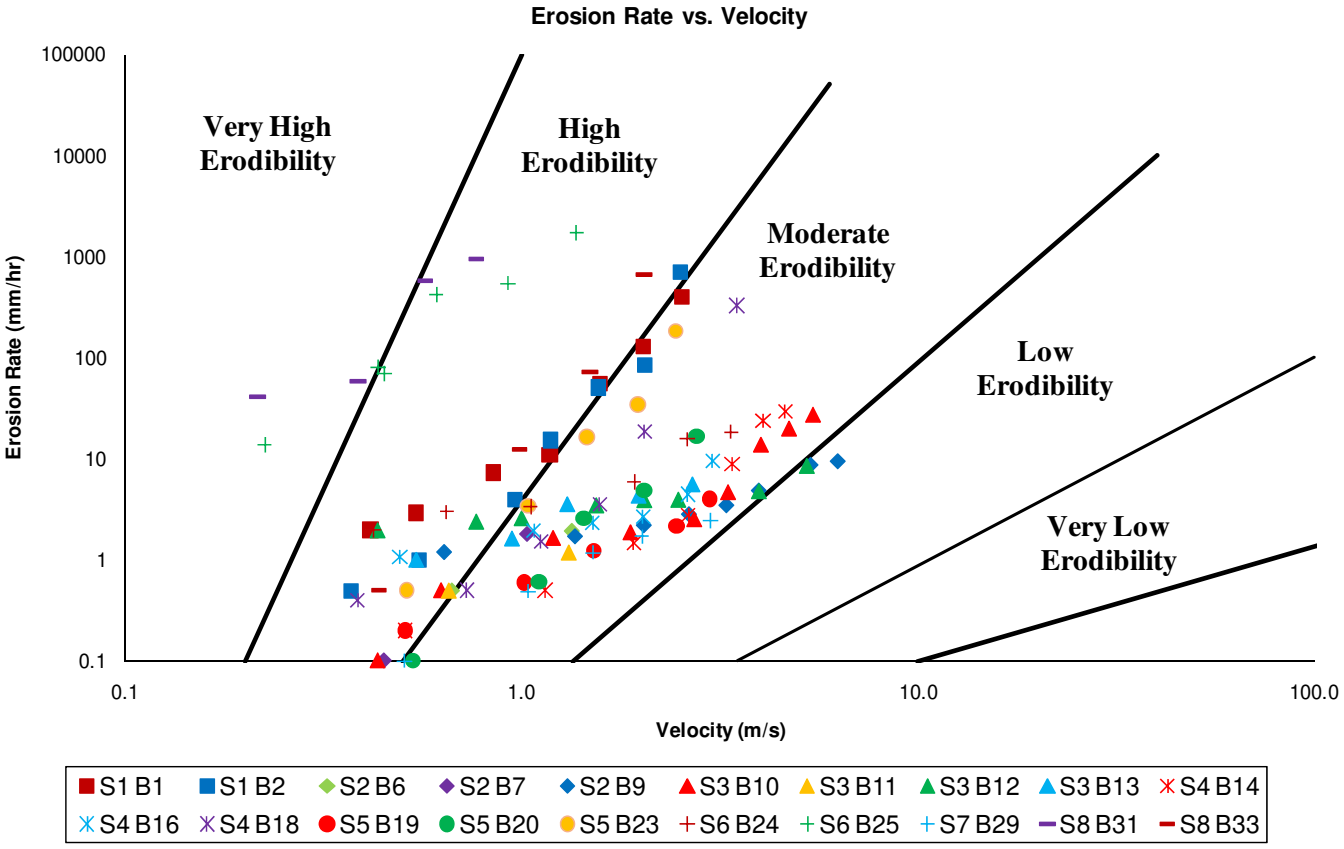
Figure 23. Erosion rate versus velocity for the Midwest Levee samples.

The EFA was used to obtain the erosion functions for 20 Midwest Levee samples. The samples tested were chosen in an effort to encompass a variety of material types, locations within the levee, and erosion performance. In order to compare the erosion functions of the samples, the data points were all plotted on the same graph (Figure 23). This graph also shows the erosion categories developed from previous studies (Briaud 2008). Most of the soils tested show moderate erosion at higher velocity. Please refer to Table 2 for the site identification nomenclature.

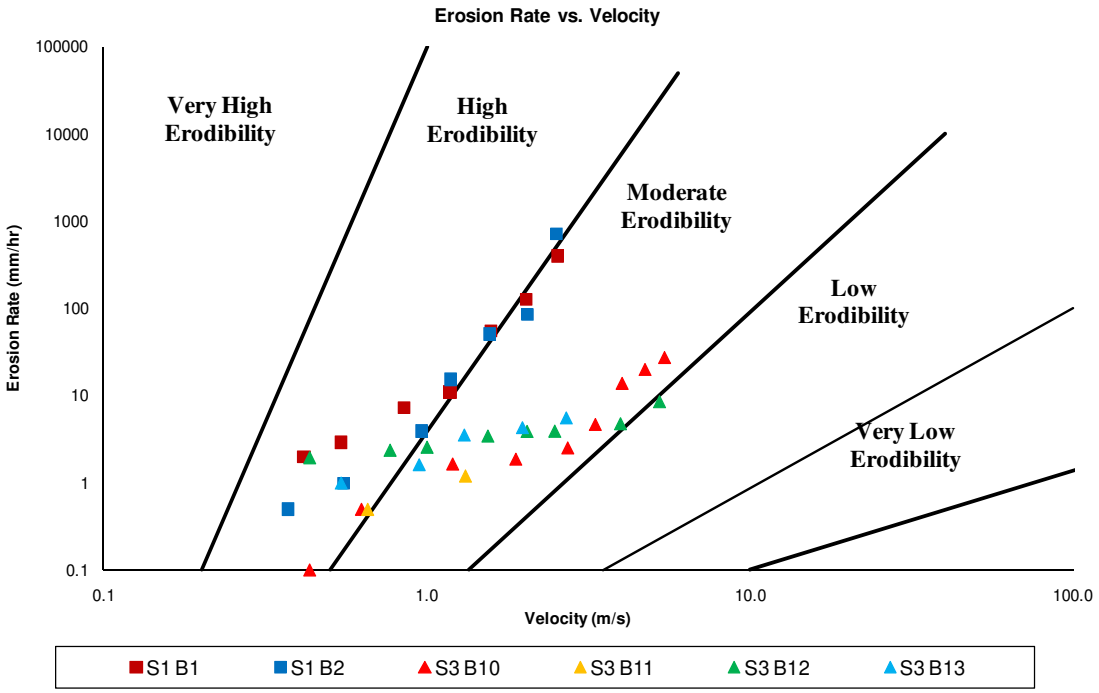
Figure 25. EFA results for Winfield-Pin Oak – S1 and Brevator – S3.

An attempt was made to correlate the erosion resistance with the index properties of the soils tested. The difference in erosion resistance between the two selected sites is clearly seen in Figure 25. Soils from the Brevator site are much more erosion resistant that those from the Winfield-Pin Oak site.

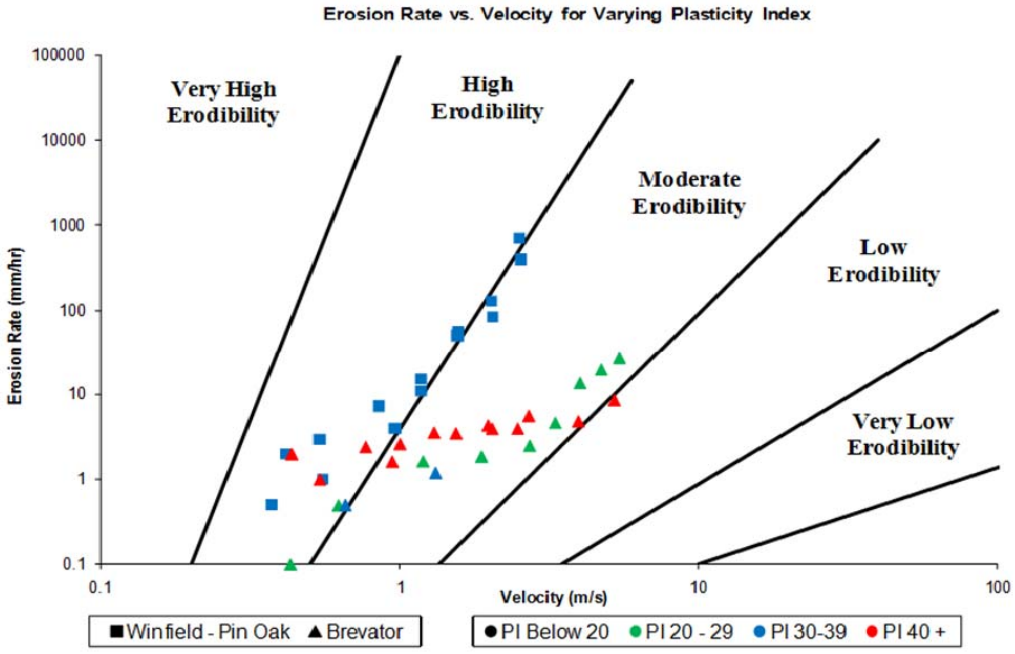
Figure 26. EFA comparison of PI for the Winfield-Pin Oak and Brevator sites.

Laboratory tests were performed to obtain the plasticity index (PI), D_{50} , and percent relative compaction. These soil properties were divided into categories and combined with the EFA results to study the influence of these factors on the erosion resistance of a soil. Figure 26 shows the EFA results for the two sites plotted in different colors based on their PIs. Figure 27 shows the same plot for all of the sites studied.

A weak trend seems to exist with the more erosion resistant soils having higher PIs. The trend is not obvious which indicates that plasticity is not the only factor that influences erosion. It should also be noted that other factors varied for the samples plotted and therefore, the influence of plasticity is not singled out by the graphs shown.

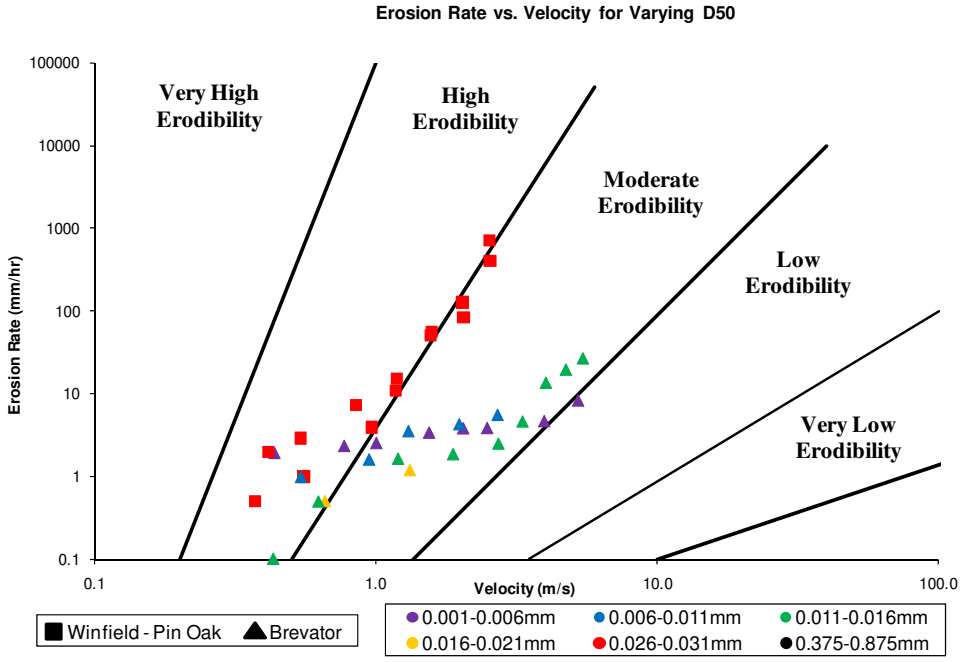
Figure 28. EFA comparison of D_{50} for the Winfield-Pin Oak and Brevator sites.

Again some level of correlation is observed indicating that, within the range of D_{50} tested, the soils with the smaller D_{50} are some of the more erosion resistant. It can be seen in Figure 28 that the Brevator site samples are associated with the smallest particle sizes tested while the samples from the Winfield-Pin Oak site were some of the largest. Figure 30 and Figure 31 show the influence of percent relative compaction (% RC) on the erosion resistance of a soil. Because of the small amount of sample available for compaction, a small volume version of the Modified Proctor compaction test was used. Equivalent energies were calculated and applied to the soil contained in a small volume mold per ASTM D-1557. To verify compatibility, compaction curves for a bulk soil sample obtained from the small volume test were compared with those obtained using the full size mold described in the ASTM specifications. The percent relative compaction was calculated by dividing the dry unit weight, γ_d, measured on the intact samples by the $\gamma_{d,max}$ obtained from the small volume Modified Proctor compaction test. Hassan et al. (2004) showed that the erosion resistance of a given soil increased when compacted at higher water contents and higher degrees of compaction. Figure 30 does not show this trend clearly; however, it should be noted that these graphs do not separate out the effects of other factors on erosion. It should also be noted that the trend described by Hassan et al. (2004) only holds for a given soil independently and is not necessarily true for comparing two different soils.

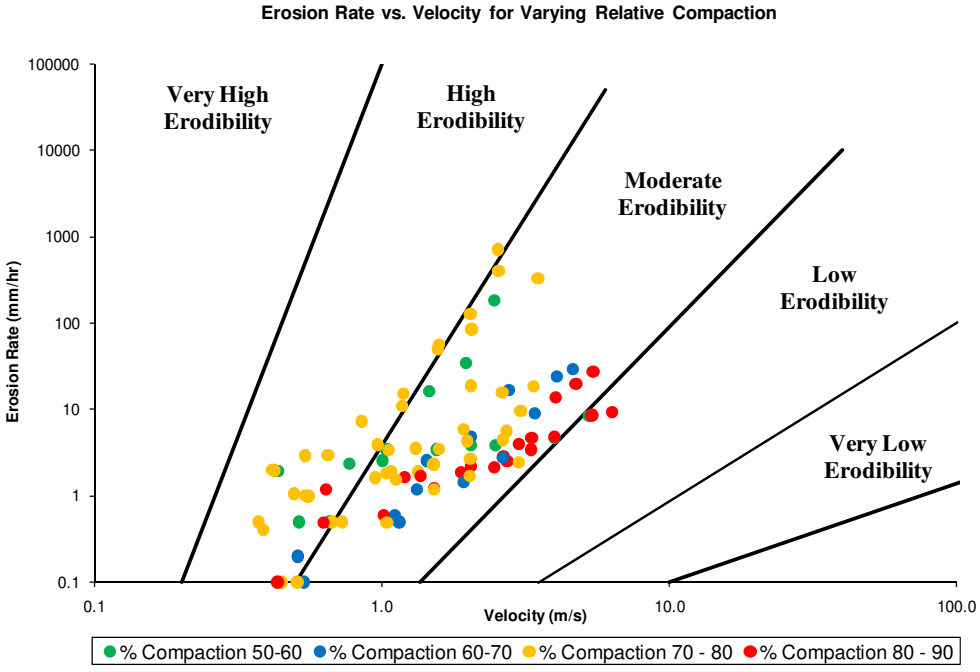
Figure 31. EFA comparison of % RC for all sites.

According to USACE design manual EM 1110-2-1911, the minimum acceptable field density for levee design is usually established as 95 percent of the maximum dry density of the soil found using a test procedure utilizing the amount of energy set by the Standard Proctor Test. The values shown in Figure 31 are for Modified Proctor energy. Note that the ratio of compaction energy between the Modified Proctor and Standard Proctor is 4.5 causing the values shown to be lower than they would be if conducted using the Standard amount of energy. Several of the samples were taken at the surface and are expected to be at a lower compaction level so that grasses will root and spread.

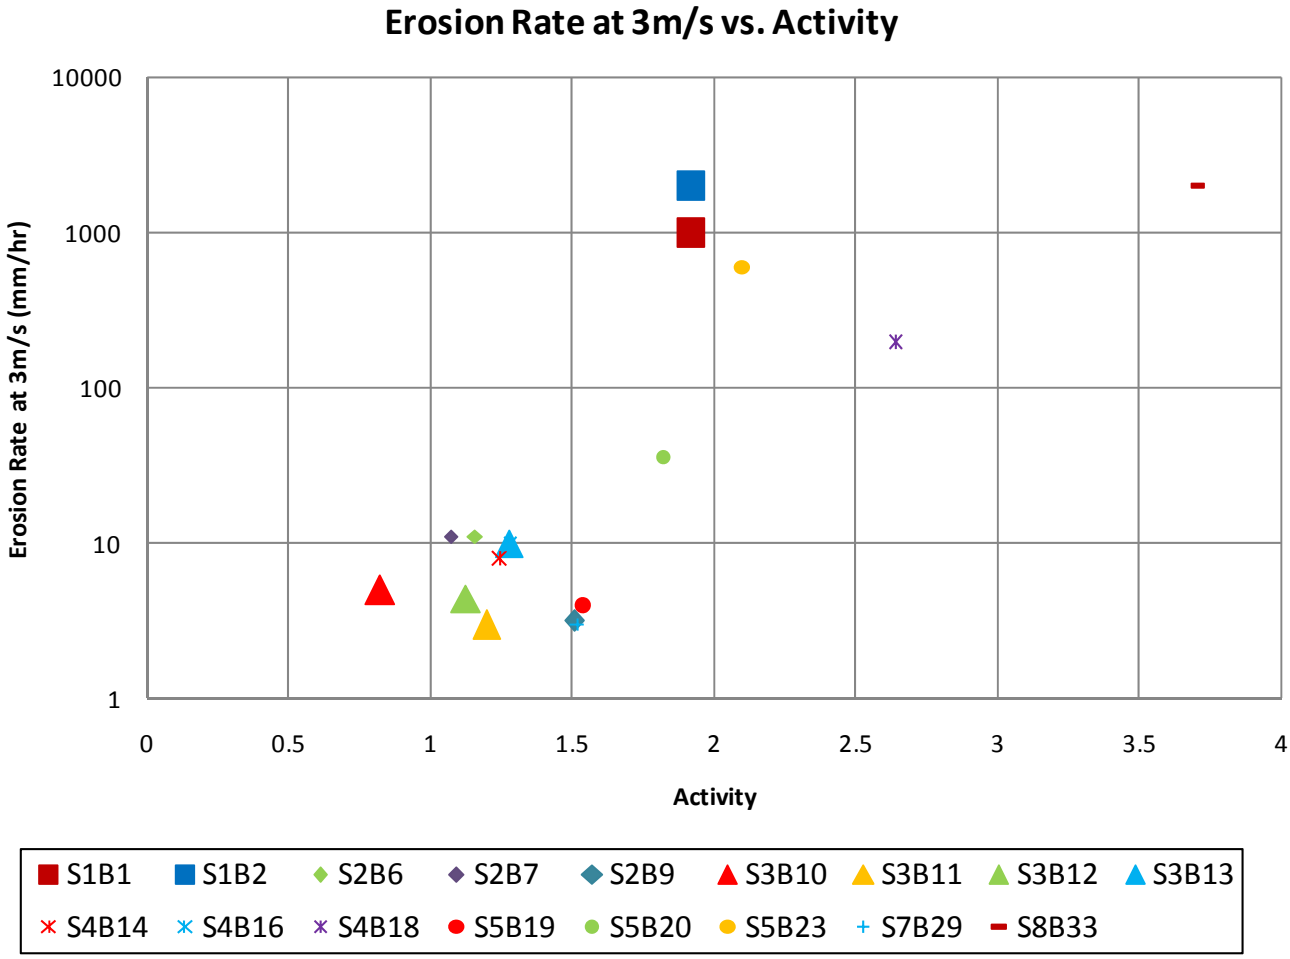
Figure 32. Erosion rate at 3m/s vs. activity.

While most of the correlations did not exhibit a clear trend, it was noticed that as the clay content increased, the erodibility of the soil decreased. A more noticeable trend appeared in the plot of erosion rate versus activity (Figure 32). As activity increases, so does the erosion rate. Activity is the ratio of the Plasticity Index over the percent finer than 2µm (clay fraction).

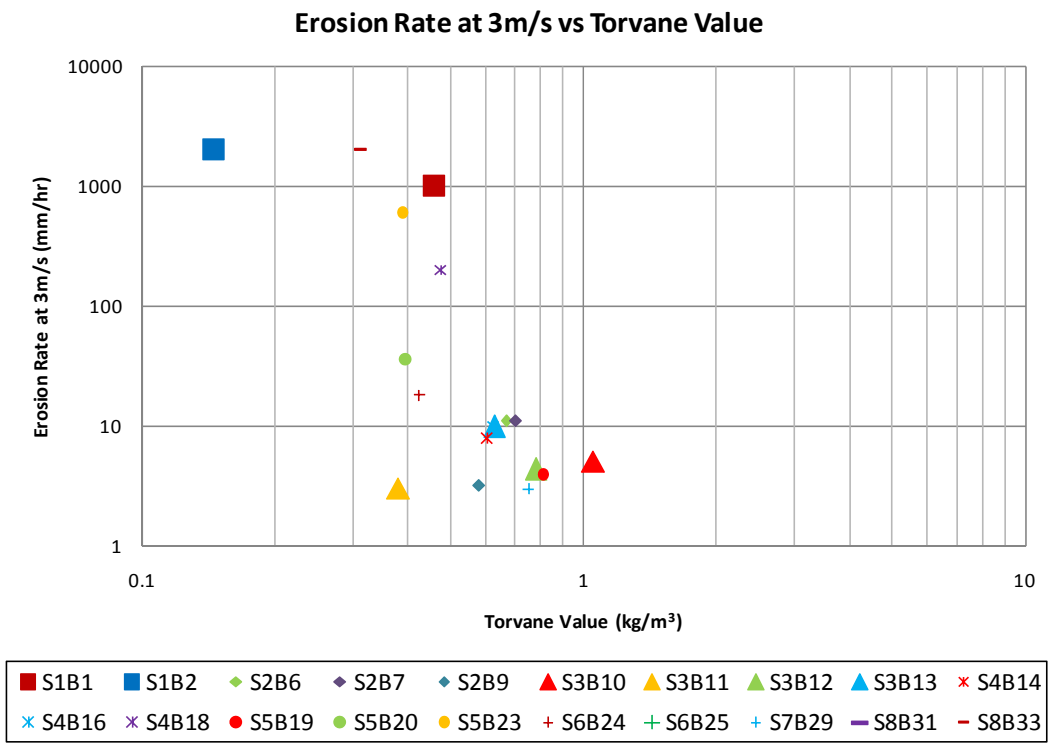
Figure 33. Erosion rate at 3m/s vs. Torvane values.

Figure 33 shows the erosion rate at 3 m/s against the Torvane strength. This graph indicates that as the shear strength increases the erosion rate decreases as may be expected.

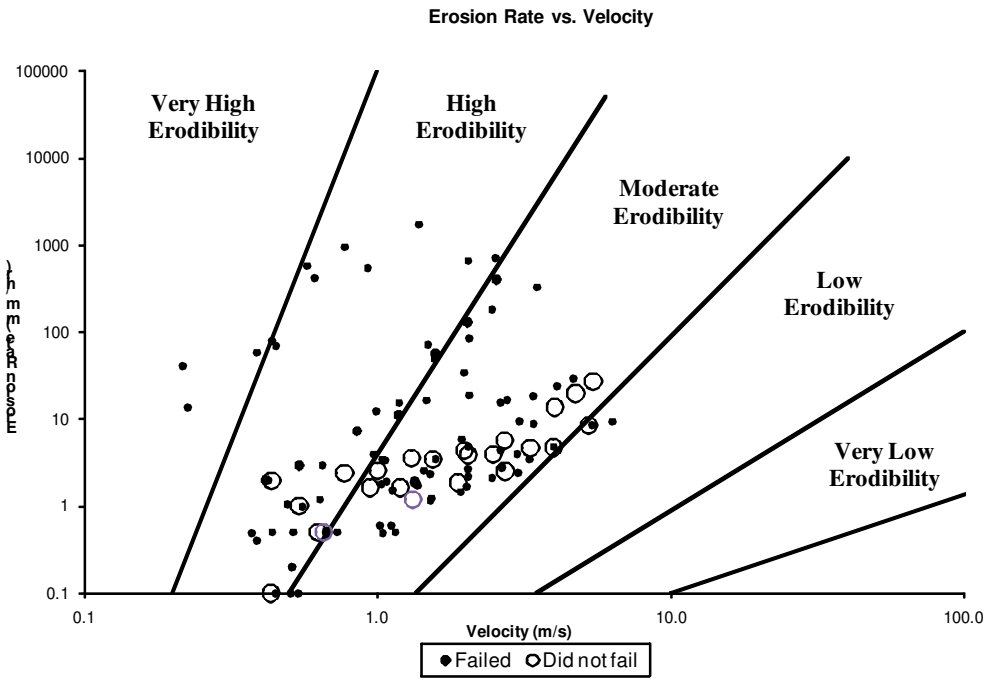
Figure 34. Overtopping comparison of pass vs. fail.

In an attempt to determine a dividing line between the soils that failed due to overtopping and those that passed, the EFA results were plotted with open circles for samples from levees that did not fail and solid circles for samples from levees that failed (Figure 34). Note that the Brevator site was the only site considered to have not failed.

Overall there is no clear division between the two sets of points like what was seen in the Katrina data (Figure 35) given in Briaud et al. (2008). The soils from the Brevator site are among some of the more resistant soils tested; however, there are several sites where the samples are just as resistant yet the sites failed. Comparing the sites that failed to the sites that did not fail based on the plotted points is somewhat deceptive because the EFA tests were limited to the bare soil and did not

account for any of the site conditions, such as vegetation or other variables that may have influenced the sites performance. The strong vegetative cover at the Brevator site would increase the resistance and effectively shift the erosion function towards the low to very low erodibility categories.

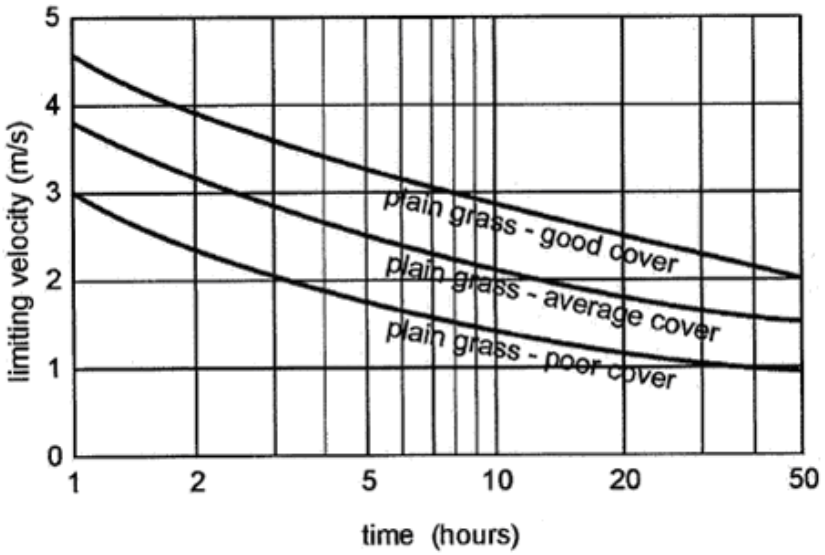
Figure 37. Limiting velocities for plain grass (Seijffert and Verheij 1998).

Temple et al. (1987) also note that soil particle detachment often begins at low enough stresses to be withstood by the vegetation without significant damage. As the particles of soil are removed, the vegetation is undercut and the weaker vegetation is removed, decreasing the density and uniformity of the cover. This increased roughness leads to higher stresses at the soil/water interface and an increased erosion rate. The vegetative cover should be as dense and uniform as possible to prevent this action.
Levee performance under wave action and overtopping has been a major area of interest in the Netherlands after the disaster of 1953 in which many levees failed from inner slope shearing following overtopping. The primary purpose of the vegetation is to prevent erosion caused by hydraulic forces (Seijffert and Verheij 1998). Normal grass cover can resist velocities up to 2 m/s with little or no erosion; however, higher velocities can become problematic (Figure 37). This chart shows the importance of the duration of the overtopping. As the number of hours of overtopping increases, the benefit gained from having increased vegetative cover decreases. For normal flooding events like those experienced in the Midwest it is not unreasonable to assume that the overtopping lasts 20 hours or more. Velocities at the toe of a levee can reach 10 m/s depending on the levee height. This point (20 hours at 10 m/s) plots much higher than the limiting cases shown in Figure 37. Since the Brevator site survived at least 2 days of overtopping, it is likely that Figure 37 is conservative.

The grasses found at the Brevator site seemed to satisfy all of these criteria. The recommended grasses for the Midwest include: Switchgrass, Tall Fescue, Smooth Brome and Reed Canarygrass. A percent coverage of at least 90 percent is desirable. It is also recommended that the grasses on the levee be allowed to grow to taller heights during the flood season (0.5 to 1 m). While most of the erosion prevention depends on the root system, it is not always adequate for the magnitude and duration of flows experienced during overtopping flood events.
