Quarry-Induced Slope Instability at a Broadcasting Transmission Plant near Valcava, Lombardia, Italy

***Monica Barbero**, Assistant professor, Politecnico di Torino (Torino, Italy); email: monica.barbero@polito.it*
***Fabrizio Barpi**, Assistant professor, Politecnico di Torino (Torino, Italy); email: fabrizio.barpi@polito.it*

KEYWORDS: damage, landslide, slope instability, stabilization system, numerical analysis.

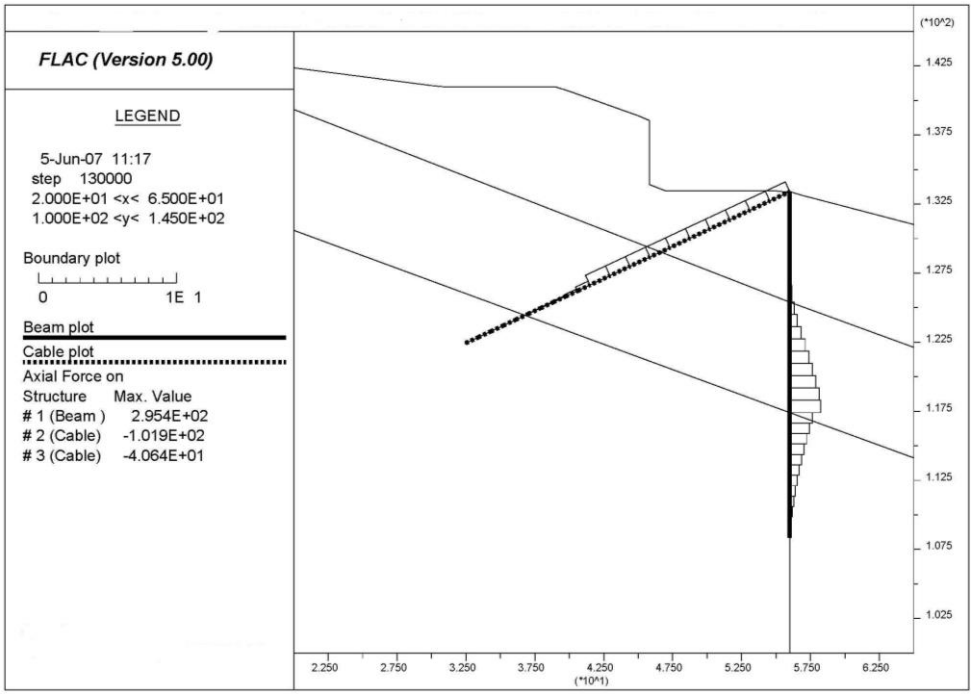
Figure 17. Axial forces acting on micropiles and anchors.

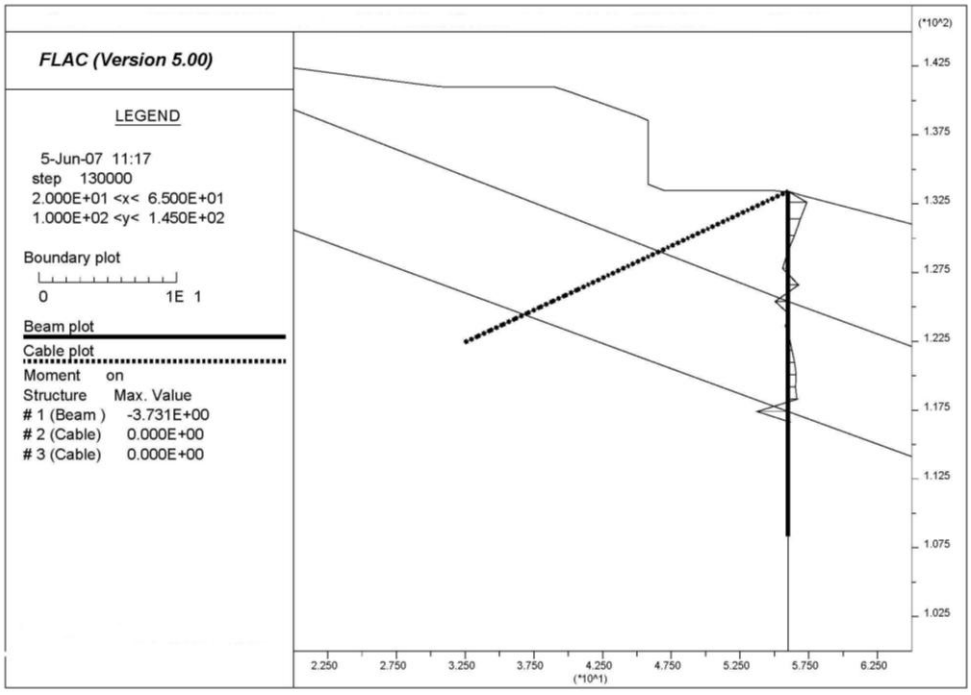
Figure 18. Bending moment acting on micropiles.

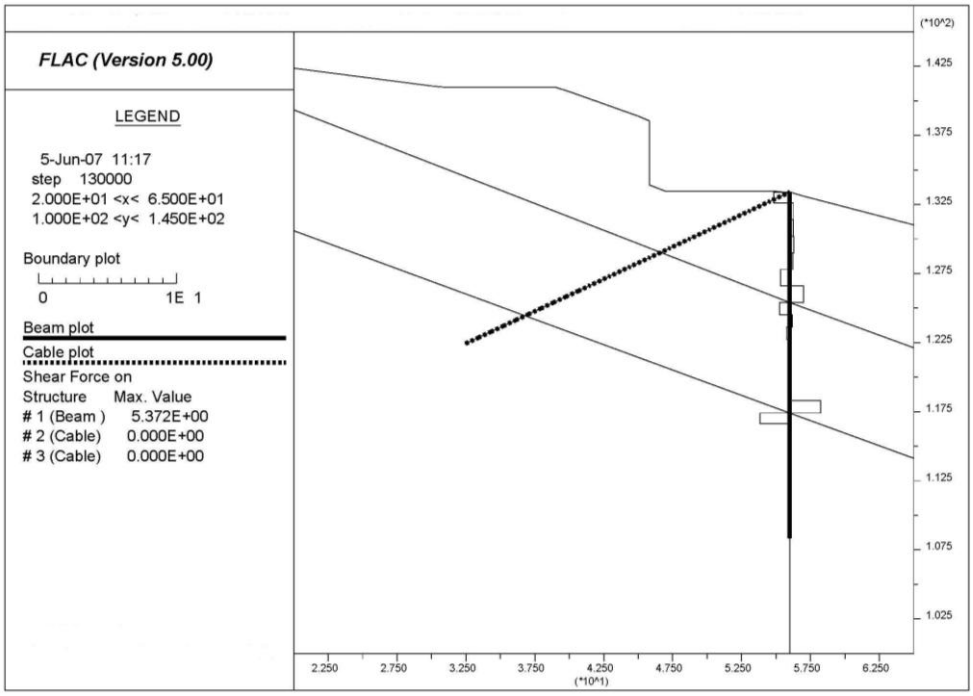
Figure 19. Shear force acting on micropiles.
