Expedient Mitigation of Collapsible Loess in Northern Afghanistan

Christopher T. Senseney, *Assistant Professor, U.S. Air Force Academy, Colorado, 80840-6232, USA; email: christopher.senseney@usafa.edu*

Submitted: 09 November 2012; Published: 24 May 2013
Reference: Senseney, C. (2013). *Expedient Mitigation of Collapsible Loess in Northern Afghanistan* International Journal of Geoengineering Case histories, http://casehistories.geoengineer.org, Vol.2, Issue 4, p.252-257. doi: 10.4417/IJGCH-02-04-01

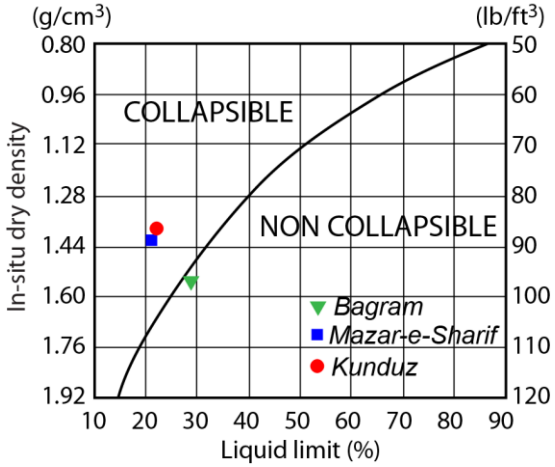
Figure 3. Gibbs and Bara (1962) criteria for determining collapsibility.

Soils from Afghanistan military bases in Kunduz, Mazar-e-Sharif and Bagram were evaluated for collapse using Gibbs and Bara's criteria and Handy's criteria. Sand cone tests were conducted and disturbed soil samples were collected at a depth of 0.5 m (20 in). Three sand cone tests and three samples were obtained from Kunduz and two sand cone tests and two samples each were obtained from Mazar-e-Sharif and Bagram. An average of the soil properties are given in Table 1 and an average of the particle size distributions in Fig. 4, where fine content less than 0.075 mm was determined using a hydrometer apparatus (ASTM 2007). The Kunduz and Mazar-e-Sharif soil exhibit a uniform distribution with particles concentrated in the range 0.01 to 0.06 mm, indicating the soils are loessial and will not compact well. On the contrary, the Bagram soil exhibits a more well-graded distribution, indicating the soil is not loessial and has higher potential for compaction. According to Gibbs and Bara's criteria, the Kunduz and Mazar-e-Sharif soil is collapsible, while the Bagram soil would fall just inside the non-collapsible region (see Fig. 3). According to Handy's criteria, the Kunduz soil has high probability of collapse, the Mazar-e-Sharif soil will probably collapse, and the Bagram soil has less than 50% probability. These results match what military forces have observed. As many as 48 sites in and around the Kunduz Airfield show signs of collapsed soil (SIGAR 2010) and an earthen drainage ditch near the Mazar-e-Shariff Airfield experienced slope failure from collapsible soil. No evidence of collapse has been observed at Bagram. Lutenegger and Saber's collapse test or other collapse tests were not used in this study because the equipment to obtain undisturbed samples and equipment to conduct necessary laboratory tests are not available in Afghanistan.

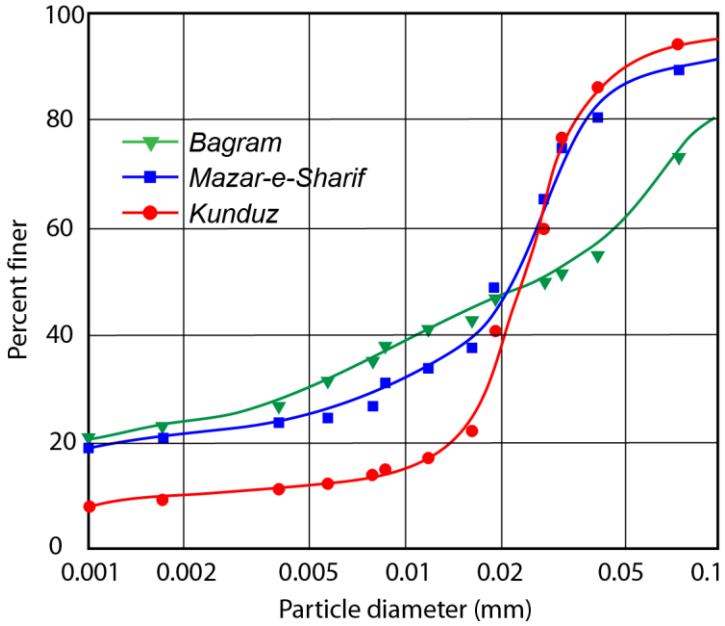
Figure 4. Particle size distributions of Kunduz, Mazar-e-Sharif and Bagram soil.

When density and liquid limit data are not available, an estimate of loess collapsibility may be made on the basis of clay content. Handy (1973) proposed loess collapse probabilities with the following clay contents: < 20% = high probability of collapse; 20 to 30% = probably collapse; 30 to 40% = less than 50% probability; and > 40% = usually safe from collapse.

Because of the high to moderate probability of loess collapse in Kunduz and Mazar-e-Sharif, as well as other areas of northern Afghanistan, military engineers must mitigate collapsible soils in drainage and foundation design. The most cost effective mitigation strategy is drainage. Designs for new military bases in northern Afghanistan must begin with a well-conceived drainage plan. Northern Afghanistan is ringed by 5,000 m (16,400 ft) high mountains that experience a rainy season in the winter and significant snowmelt in the spring. Coupled with a lack of vegetation, excess water can flow quickly over the ground as surface runoff.
