# Mangla Dam Raising: Effectiveness of Seepage Reduction Measures for Sukian Dyke

**ABSTRACT**: *Mangla Dam (Pakistan) is one of the largest Earth Core Rock fill Dam (ECRD) in the world in terms of volume of material used. The Sukian dyke of Mangla Dam Project is 5.33 km (17,500 ft.) in length and is founded on alternate beds of clay and weak (friable) sandstone. Raising of the dam subjected the project area including the dyke to an additional head of about 12.19m (40 ft.) in 2013. Before raising, the maximum seepage in the entire project was observed in the Sukian dyke area. An upstream blanket was selected to control seepage in this area after dam raising. FEM analyses were carried out to determine the efficiency of the upstream blanket in controlling seepage. After raising and impoundment, the FEM results were compared with instrumentation readings and seepage measurements and close agreement was observed.*

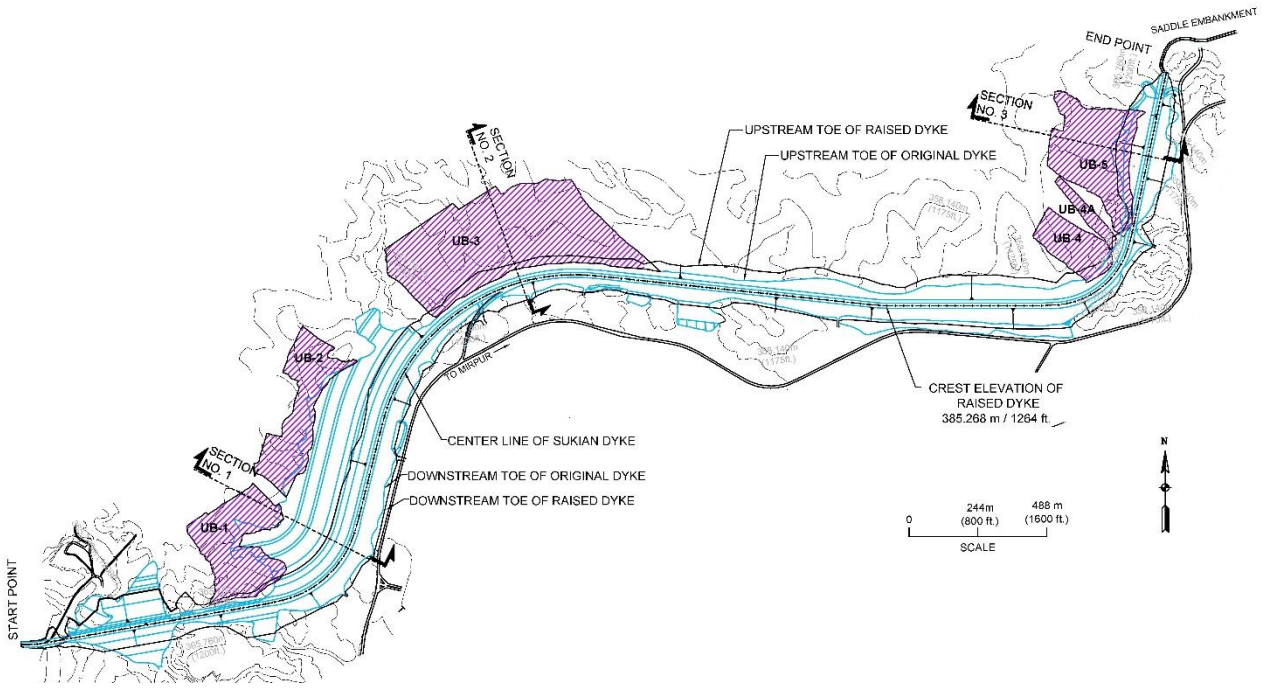
*Figure 3. Layout plan of the Sukian dyke showing cross-sections analyzed and placement of upstream blankets (UB-1 to UB-5).*

Since the data analysis showed that fourteen beds of sandstone were involved in seepage, it was decided to concentrate the efforts on these particular beds. Five (5) impervious blankets (Figure 3) named as UB-1, UB-2, UB-3, UB-4 and UB-5 were constructed to cover these 14 sandstone beds (Mangla, 2004). Impervious blankets and corresponding sandstone beds are given in Table-1. The surface width (along the axis of the dyke) of these blanketed beds ranged from 304.80 m (1000 ft.) to 762.00 m (2500 ft.).

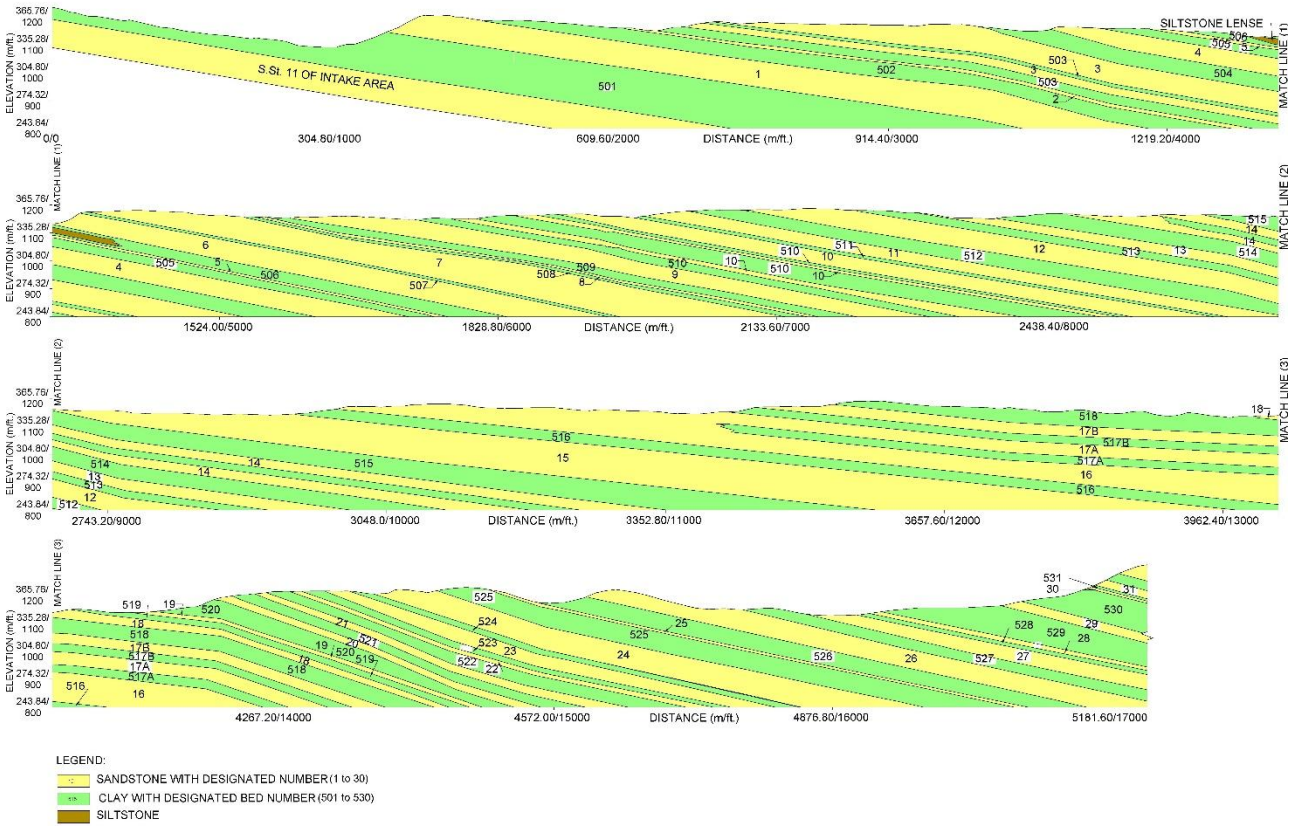
*Figure 6. Geological cross-section along center line of the dyke.*

almost $12^0$. Soon after the completion of the Mangla Dam project, heaviest seepage was reported at Sukian dyke. The seepage associated with the foundation of Sukian dyke was about 80% of all measured seepage loss from the reservoir and measured 0.61 $m^3$/sec (22 $ft^3$/sec). Water seeped mainly through the sandstone beds and its contact with clay beds and created issues downstream of the Sukian dyke including "boil" formation. This tied with the observation of extensive pressure heads that developed beneath the Sukian dyke as observed in piezometer readings and seepage in downstream nullahs (streams). The boils were located in the sandstone beds no. 6, 12, 24 and 27. There was no significant amount of erosion of bed material as suspended solids were in the order of 40 ppm which is negligible. Boils through sandstone beds no. 6 and 12 were emerging about 1371.60 m (4500 ft.) and 579.10 m (1900 ft.) from downstream toe of dyke respectively. The boil through sandstone bed no. 4 was emerging at a distance of about 609.60 m (2000 ft.) from the downstream toe of Sukian dyke. The boil through sandstone bed no. 27 was emerging at a distance of about 396.24 m (1300 ft.) from the downstream toe of Sukian dyke. Seepage quantities were expected to increase when the reservoir level would be raised by some 12.20 m (40 ft.) after dam raising and could be adversely affecting the overall safety of the project. Thus effective measures to mitigate seepage were required.

The result of this study indicated that out of the some thirty (30) sandstone beds under the dyke foundation, seepage was mainly concentrated in fourteen (14) beds. Thus it was concluded that effective measures to mitigate seepage would only be required for these fourteen (14) beds of sandstone i.e. 3 to 7, 12 to 15 and 24 to 28.

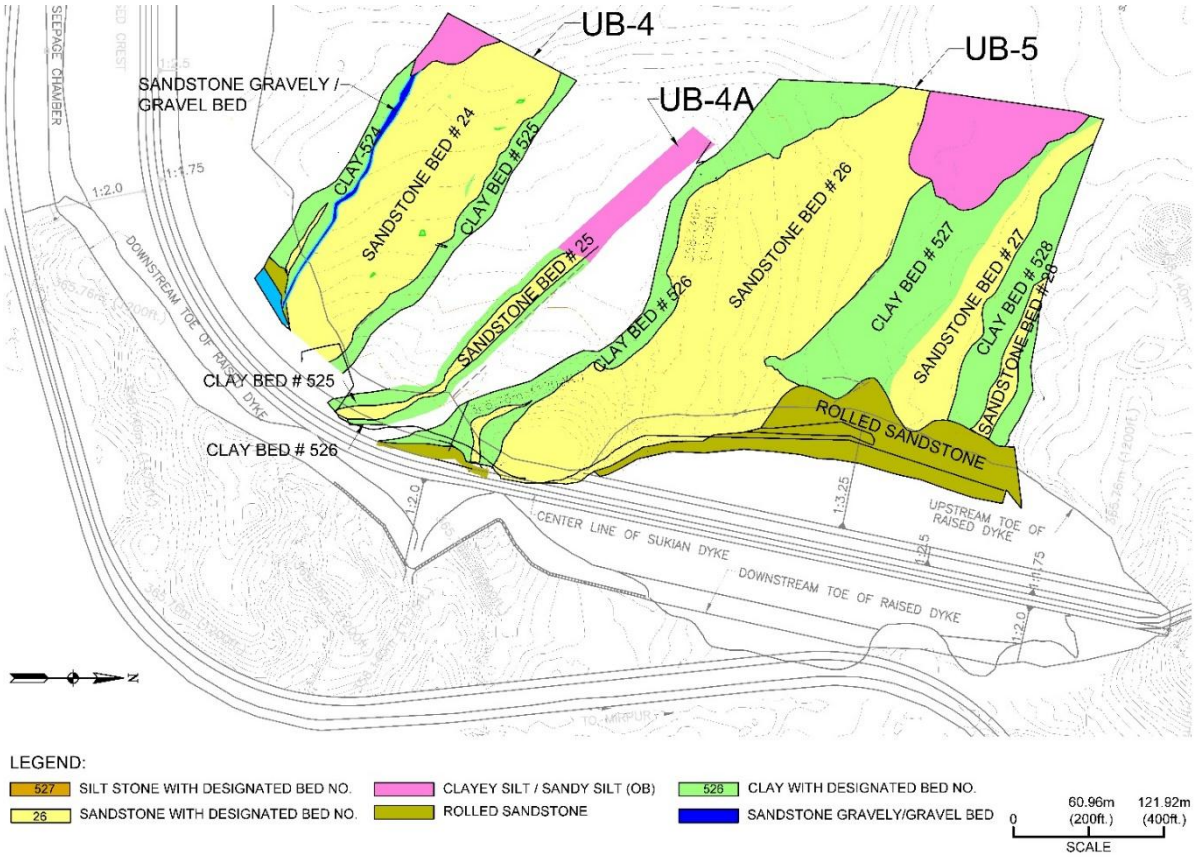
*Figure 7. Sandstone beds covered with impervious blankets UB-4/4A and UB-5 (coloured portion is basically the limits of the blankets).*

During the detailed design stage, sensitivity analyses were carried out to optimize the length of the blanket and it was found that a 2.40 m (8ft.) thick and 304.80 m (1000 ft.) long blanket would be sufficient to substantially reduce the seepage quantity in the downstream area of the dyke. Therefore, a 2.40 m (8 ft.) thick impervious blanket, 304.80 m (1000 ft.) long perpendicular to the upstream toe of the dyke, was designed. Locally available silty clayey material was selected for the blanket which yielded a permeability of 1.02E-6 cm/sec (3.35E-8 ft/sec) in laboratory tests, very similar to the dam core material. The blanket was designed such that selected sandstone beds would be covered with it and the blanket would be tied to the adjacent clay beds on both sides, as the sandstone beds were inter-bedded with clay (Figure 7).

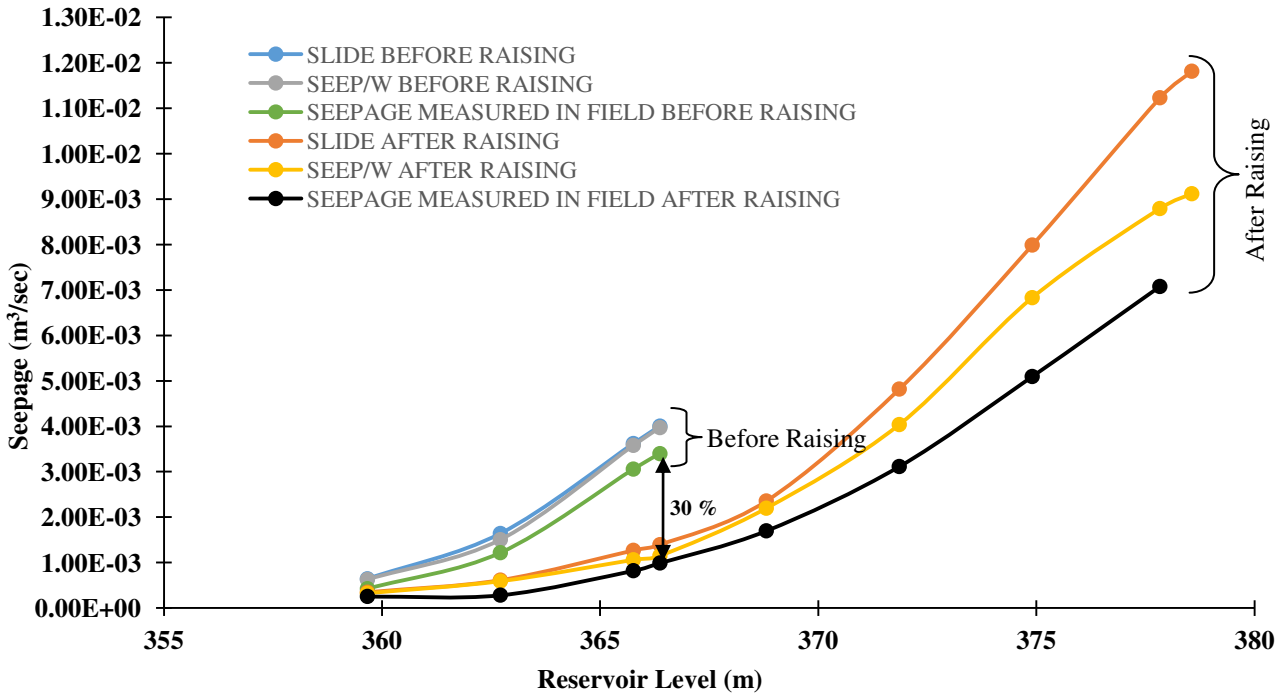
*Figure 14. Total seepage through body of dyke.*

From Table 4 and Fig. 14 and 15, it can be observed that the total seepage from the body of the dyke does not exceed 2% of the seepage from the foundation, at any given reservoir level. This minute quantity of seepage through the dyke corresponds well with the observation from the piezometers that hardly show any change, except reading almost the tip elevation. Similarly, it has also been stated previously that the dyke is built on natural ridge which has an average crest elevation of 359.70 m, and the seepage from the body of the dyke was only observed when the reservoir attained this or higher elevation.

It can be observed from Figure 14 that despite the increase in height of the dyke and higher water head, seepage through the dyke body decreased at reservoir levels ranging from 359.70 m (1180ft.) to 366.40 m (1202 ft.). Since the raising of the dyke was accomplished by widening both the upstream and downstream shoulders and the shoulder material also has low permeability, the longer seepage path is considered sufficient to cause significant reduction (up to 30%) in the seepage through the dyke body.

The seepage quantities through the body of the Sukian dyke measured in the field at various reservoir levels are lower than the values determined through the analyses. This indicates that the dyke performance under raised condition is satisfactory.

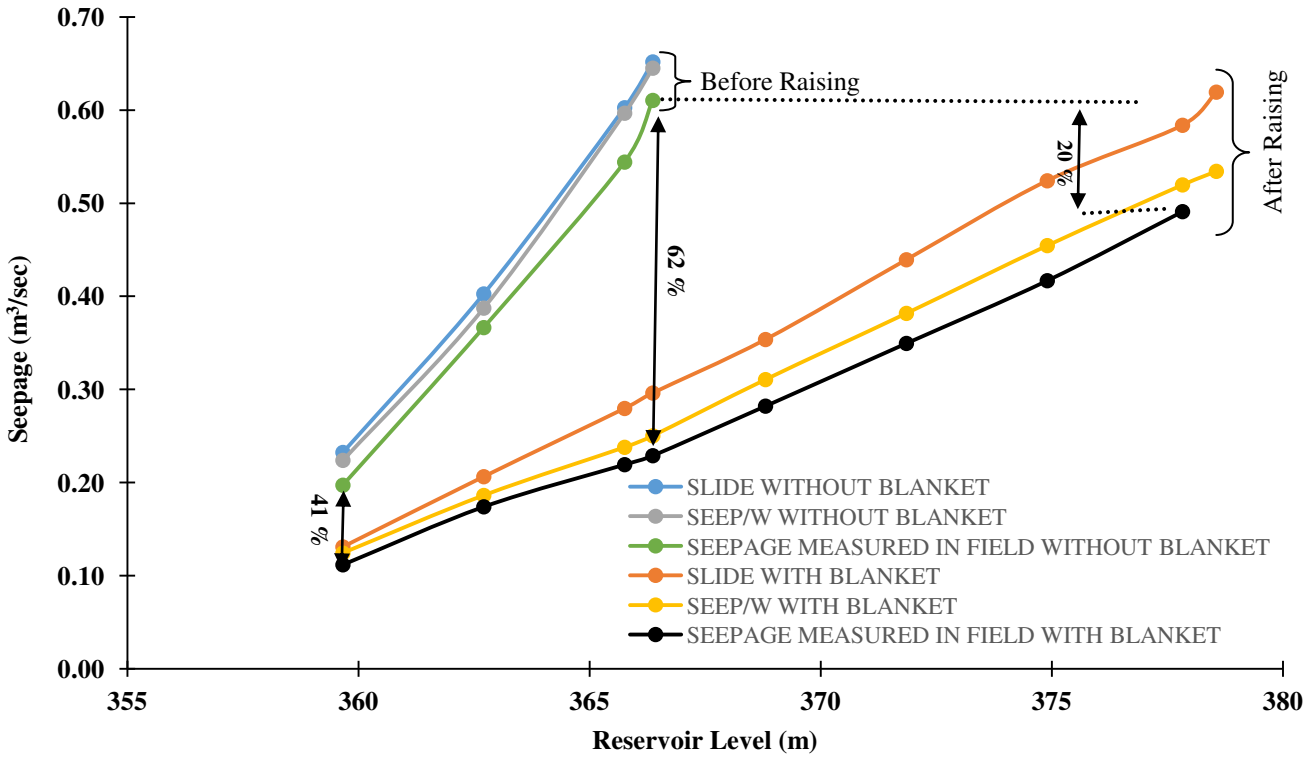
*Figure 15. Total seepage through foundation of dyke.*

Table 6 shows that the seepage through the foundation reduced by 40 to 60% for comparable reservoir levels. As per observed field data, peak seepage discharge through the foundation measured before the construction of blanket was 0.61 $m^3$/sec against the maximum reservoir level of 366.40 m (1202 ft.). After placing the impervious blanket, the peak seepage discharge reduced to 0.23 $m^3$/sec against the same reservoir level. Thus overall reduction of 62% in seepage discharge was achieved by placing the impervious blankets. Almost same percentage reduction was calculated through the software analyses as well.

It can be observed from Figure 15 that before raising (original condition), the observed peak seepage discharge at maximum conservation level of 366.40 m (1202 ft.) was 0.61 $m^3$/sec. After raising, which subjected the Sukian dyke foundation to an additional head of about 12.20 m (40 ft.) i.e. El 377.80 m (1239.60 ft.) in 2013, the observed peak seepage discharge through the foundation was 0.49 $m^3$/sec. Therefore after dam raising and with a higher head (reservoir level) of about 12.20 m (40 ft.), the seepage was 20% less compared to the before raising condition when the maximum reservoir level was 12.20 m (40 ft.) lower. This indicates the effectiveness of the blanket in controlling seepage against the raised reservoir levels.
