Preliminary Field Assessment of Sinkhole Damage in Pokhara, Nepal

ABSTRACT: *Since November 2013, numerous sinkholes have been forming in the Armala area of Pokhara Valley, Central Nepal, posing serious threat to local residents. In order to provide measures aimed at reducing sinkhole risk, investigations into the cause and features of the sinkholes are crucial. This paper presents early research results based on two damage surveys conducted in June 2014 and November 2014 in the Armala area. Comparison of photos, taken in the two surveys, clearly indicates not only the formation of new sinkholes, but also the re-activation of filled sinkholes. By means of dynamic cone penetration tests and surface wave method investigations, qualitative characterization of the soil profile was attained, and shallow weak soil layers which are believed to be the location for future sinkholes could be identified. On the basis of the field investigation results, possible sinkhole formation mechanisms are identified for the Armala area. Furthermore, results of a reconnaissance survey conducted in the Armala area in early May 2015 (following the 2015 Gorkha Nepal Earthquake, which occurred on April 25th

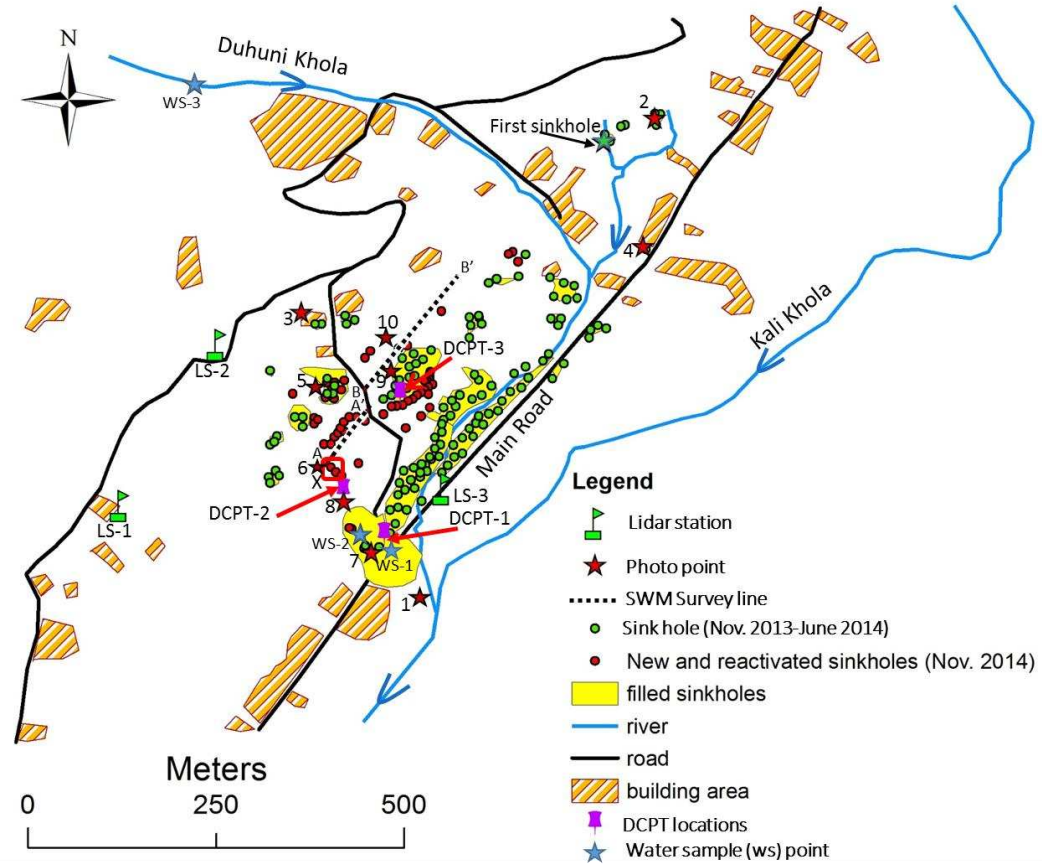
Figure 2. Detailed map of the sinkhole damaged area in Armala.

A detailed map of the study area reporting the location of sinkholes observed in June and November 2014, photo points and field investigations are shown in Figure 2. Topographically, the study area is a low-elevated zone as shown by the bird's eye view presented in Figure 3. This 3D image was obtained by overlapping LiDAR scanning carried out at three different locations (i.e. LS-1, LS-2 and LS-3 reported in Figure 2). There is a very gentle slope in the south-east direction, while a steep slope can be noticed in the north-west part. The black zones enclosed within circles are interconnected sinkholes as observed in November 2014.

During the June 2014 survey, the trace of a number of sinkholes previously formed since November 2013 could be typically observed in both sides of the Duhuni Khola (green dots in Figure 2). All the sinkholes were completely back filled, except for the sinkholes at photo points 7 and 8 (see also Figures 10 and 11). Originally, they had a diameter of about 10m and a depth of about 7 m. However, at the time of the survey, the upper part was already partially filled by sediments, and the measured depth was less than 4 m.

During the November 2014 survey, a number of sinkholes of recent formation (known to have formed in August 2014) were mostly observed in the west side of the surveyed area. In the map shown in Figure 2, it can be seen that the new sinkholes (shown as red dots) are concentrated on the western side of the old sinkholes. Some of the new sinkholes may be old sinkholes re-activated during the rainy season in 2014.

Immediately after the occurrence of the sinkholes, a wide area affected by the cave-in was backfilled by using gravelly soil retrieved from nearby quarries, which is identified by a yellow color filled area in Figure 2. Though, at the time of the first damage survey in June 2014, most of the sinkholes had been fully backfilled (Figure 7a corresponding to photo point 5), the photos taken in November 2014 at the same location clearly show that the backfilling was not an adequate solution as most of the former sinkholes were re-activated (Figure 7b) likely in August 2014 during the peak rainy season in Pokhara Valley.

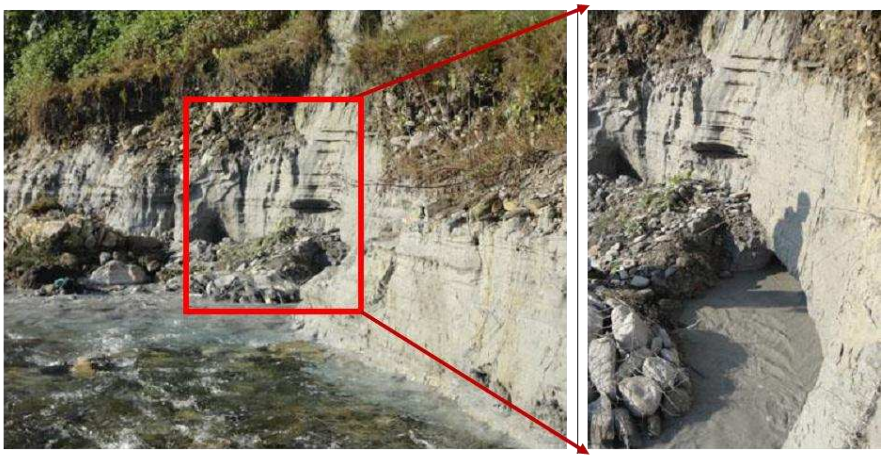
According to local residents, a muddy silty water outlet (shown in Figure 4 corresponding to photo point 1) was observed at the Kali Khola (Small River) riverbank about a week before the first sinkhole appeared in November 2013 (Figure 2). Since then, more than 150 sinkholes developed in this area until June 2014 and more than 200 sinkholes were reported up to November 2014.

Figure 4. Muddy silty water outlet at the riverbank of the Kali Khola (photo point 1) (Photo Courtesy: Technical Research Team, 2014).

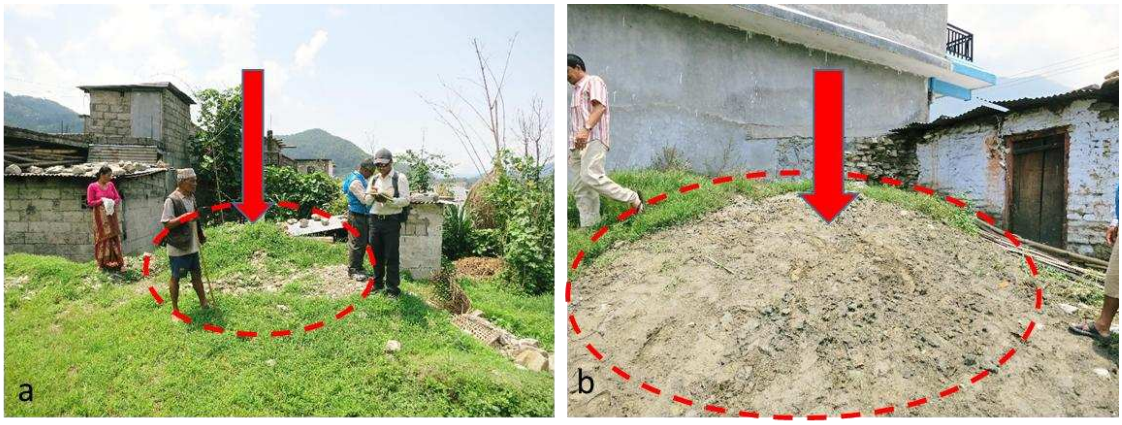
The sinkholes affected not only agricultural farmland. They also caused the collapse of manmade structures like the cowshed shown in Figure 6(a) (corresponding to photo point 3), and the masonry kitchen shown in Figure 6(b) (corresponding to photo point 4). The homeowner reported that about 60 m^3 of filling material were used to fill the sinkhole shown in Figure 6(a).

Figure 6. Typical effects of sinkhole formation on residential properties observed on June 2014 included the collapsed of (a) a cowshed and (b) a masonry kitchen.

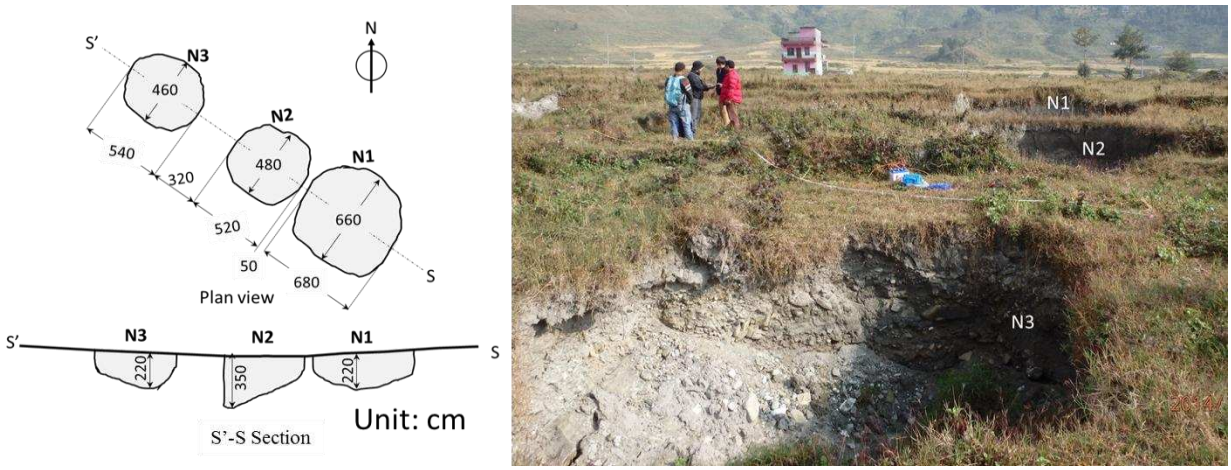
Among many, sinkholes N1, N2 and N3 in the area X shown in Figure 2 were found to be of particular interest. They were developed in a delimited area of approximately 10 m × 20 m, as shown in the schematic map shown in Figure 8. They have a circular pattern and diameters ranging from 4.6 m (N3) to 6.8 m (N1). Their depth measured at the top of the collapsed soil varied from 2.2 m (N1, N3) to a maximum of 3.5 m (N2). According to witnesses, N1 was the first sinkhole to be formed. A few days later, N2 caved-in and finally N3 developed. This progressive formation of several sinkholes along a straight line (moving along the uphill direction from N1 to N3) may suggest that the collapse of N1 caused the complete disruption of underground water flow. Consequently, water started to erode the soil just adjacent to N1 until a new cave-in (N2) was formed. In a similar way, N3 was later developed. The same pattern of sinkhole formation occurred often since November 2013. Most of the newly developed sinkholes are located on the upstream side of the underground water flow.

As mentioned earlier, as an immediate mitigation work, all the old sinkholes were filled by the local government. This practice could disrupt the underground water flow so that ultimately the caving process caused the re-activation of sinkholes. Note that due to loose conditions of backfilled material, it is expected that the development of a re-activated sinkhole is much quicker than that of the original sinkhole where natural compacted soils was gradually eroded by water.

Figure 8. Series of sinkholes appeared in the area X in Figure 2 (photo point 6).

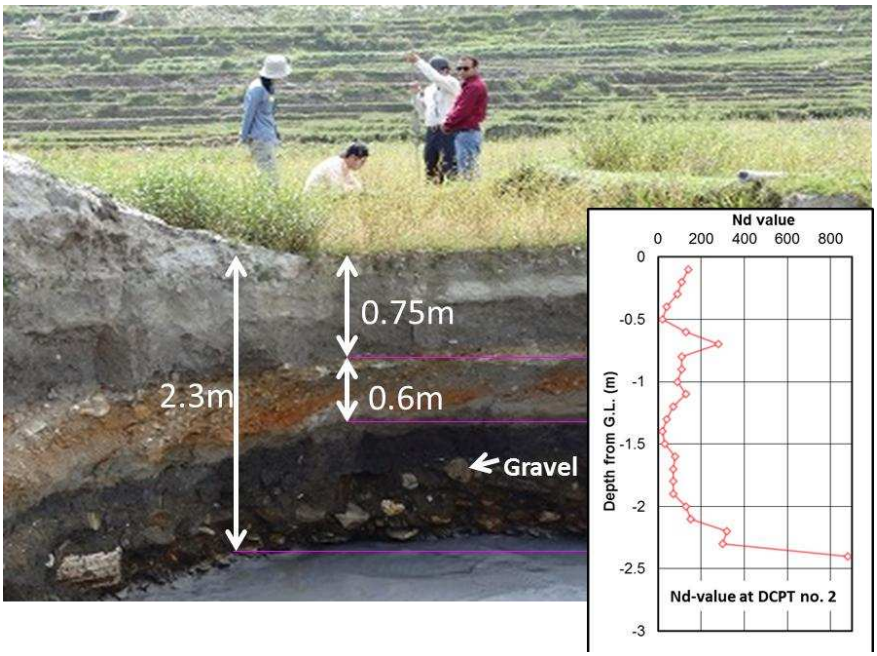
On the other hand, DCPT-2 (Figure 11) was carried out just adjacent to the sinkhole at photo point 8 in Figure 2. The test results were correlated with stratigraphy and structure of the deposits (Figure 11). The converted DCPT N_d-values are plotted in Figure 11. The upper layers of the surface soil could be penetrated until reaching a layer of gravel at a depth of 2.4 m, where even by hitting more than 150 times the penetration process stopped.

Figure 11. Soil profile and DCPT result at DCPT-2 obtained for the sinkhole in photo point 8 (Photo in June 2014).

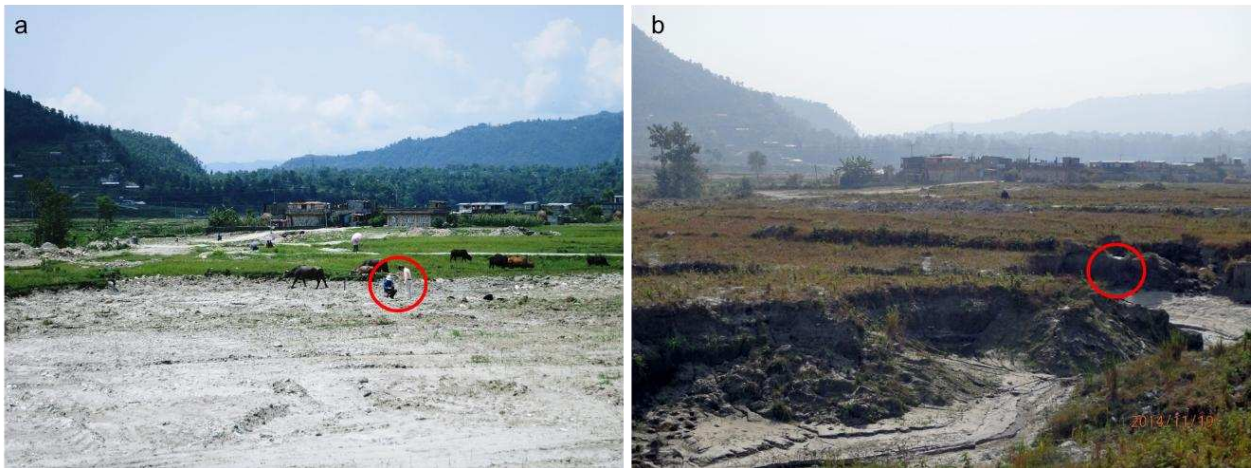
DCPT-3 was carried out at the top of the filled material at photo point 9. As shown in Fig. 12a and 12b, the testing location disappeared due to the collapse of filled material during the rainy season between June and November 2014. From the test results shown in Fig. 13, it is concluded that the used filling materials are sand and gravelly soils. However, the compaction at the surface is not good enough because the N_d-value measurement is low. The DCPT results suggest that the cavity bearing formation is below the gravel layer, and then progressively the cavity size increased and finally the loose upper layer collapsed.

Figure 12. a) Dynamic Cone Penetration Test at DCPT no. 3 (photo point 10) on the filled material (photo taken in June 2014) and b) re-activated sinkhole at the same location (photo taken in November 2014).

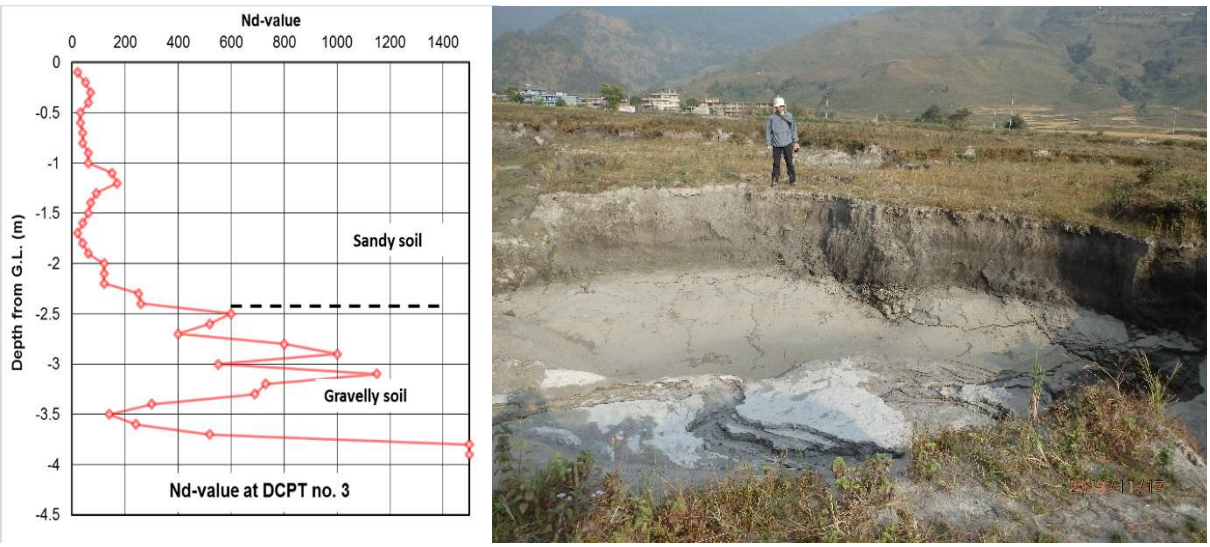
By comparing the N_d -values obtained from DCPT-2 and DCPT-3, it is noted that the filled materials are looser than the natural soil. Therefore, the filled material can be easily caved-in and induce the re-activation of filled sinkholes during the rainy season.

Figure 13 (a) Result of DCPT 3 conducted in June 2014 and (b) its location collapsed after the test.

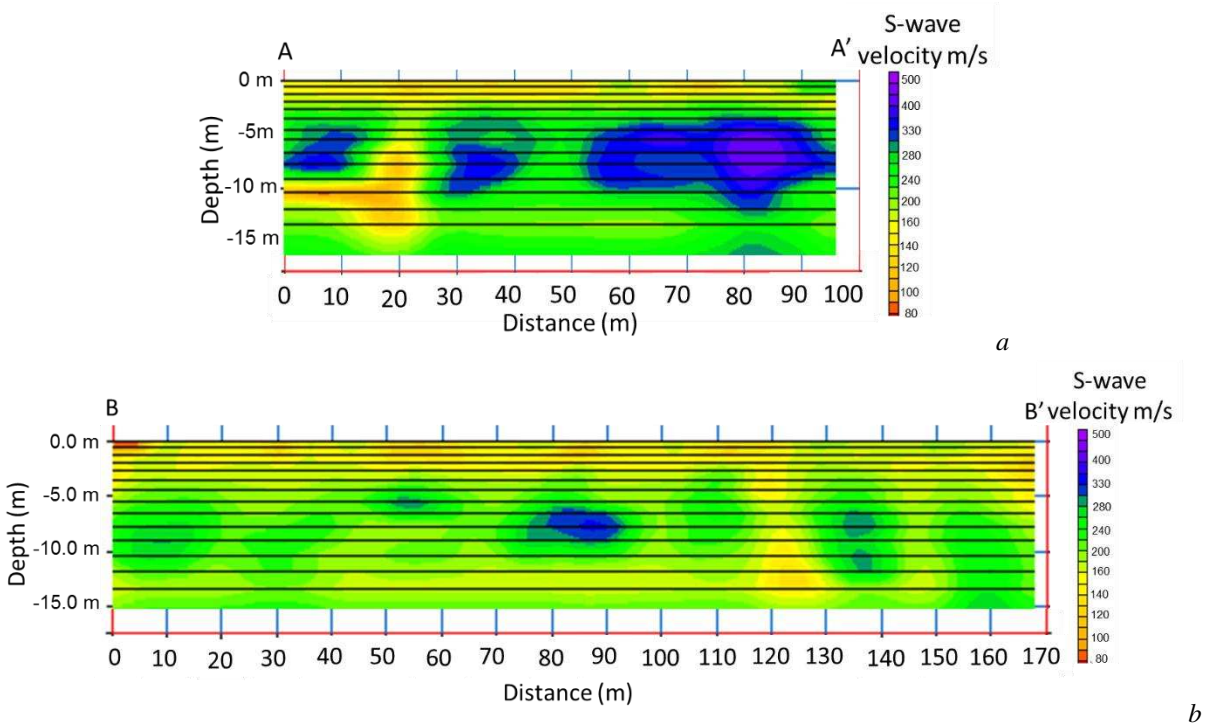
The results of SWM test along sections A-A' and B-B' are shown in Figure 15. It can be seen that the shear wave velocity for the surface layer is in the range of 100-160 m/s, confirming the presence of a loose sand layer of 1.5-m thickness. The underlying gravel has a higher velocity than the surface layer with a shear wave velocity of about 240 m/s. Moreover, the stiff soil below 4 m depth has a shear wave velocity greater than 300 m/s. The velocity of the layer around 10 m depth denotes water flowing path and loose material. A low velocity section observed 20 m far from the starting point in profile A-A' indicates possible cavities in the ground. Similarly, in profile B-B' the loose material at a depth of about 12 m indicates a possible water flowing layer and the weak strata between 120 m to 130 m is a possible future sinkhole.

Figure 15. Profiles of surface wave method: (a) section A-A'; and (b) section B-B'.

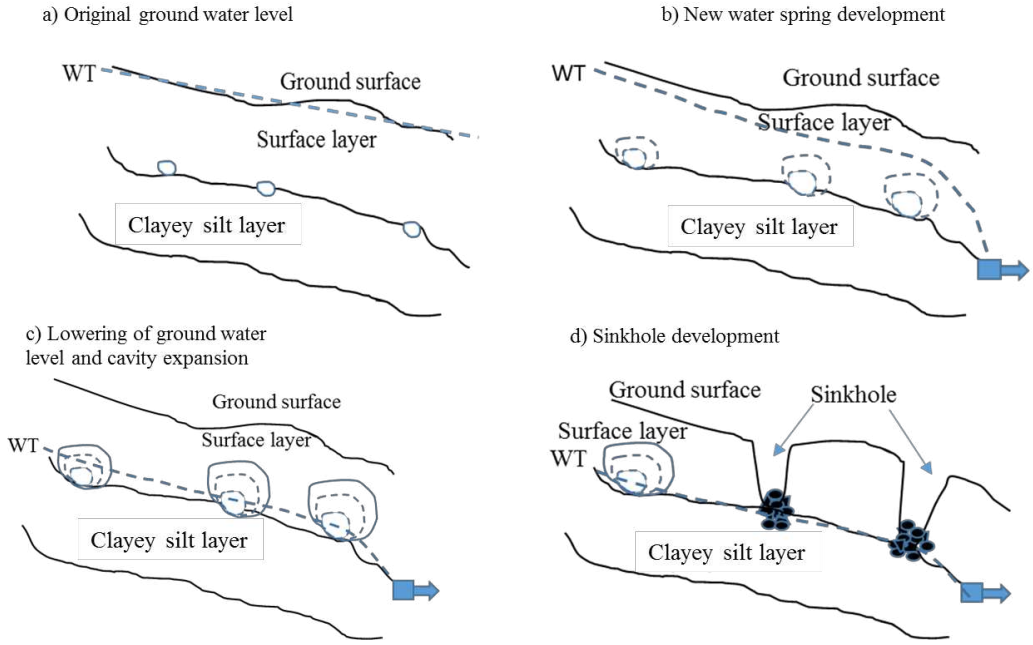
Nevertheless, in November 2013, suddenly, a water spring was observed for the first time by local residents (Figure 4). It was rapidly followed by the formation of a number of sinkholes, as already described previously. The authors believe that the formation of the water spring induced a change in the groundwater level i.e. water table decline (Figure 16(b)). The drastic fall in groundwater level and its fluctuation during rainy season, accelerated the erosion process (as evidenced by muddy water observed at the water spring outlet) and cavity enlargement (Figure 16 (c)). The evidence of the erosion process in the ground is shown in Figure 17. The water sample collected from different points in the study area in June 2014 has different turbidity. The water sample collected at the stream or seepage location (water sample (WS) point 3 in

Figure 2) is clear and has no sediments. On the other hand, water samples collected at WS point 1 and 2 shows high turbidity (Figure 17). This indicates that underground water continues to dissolve the silt and there was a continuous caving process till June 2014. As the process continued, the loose, unconsolidated soil and sand above was gradually washed into the cracks and voids. Depending on how thick and strong the top layer was and how close to the surface the void beneath was, the ground was not able to sustain its own weight. Thus, cavities that before were stable, suddenly became unstable and collapsed (Figure 16(d)).

Figure 16. Probable mechanisms of sinkhole observed in the Armala area.

- prevent irrigation;
- using an effective drainage system and diverting surface runoff;
- remediating existing sinkholes and clogging shallow holes;
- identifying cavities in the soil and filling them by grouting;
- improving the ground by compaction or ground injection to increase the strength and bearing capacity of the soils.
