# Stability Analyses of the 1981 San Luis Dam Slide

**Ashok K. Chugh**, *Civil Engineer, U.S. Bureau of Reclamation, Denver, CO 80225, USA; email: achugh@usbr.gov*
**D.V. Griffiths**, *Professor, Colorado School of Mines, Golden, CO 80401, USA; email: d.v.griffiths@mines.edu*

**KEYWORDS**: analysis; case history; dams; failure; slope stability; two- and three- dimensional numerical analysis

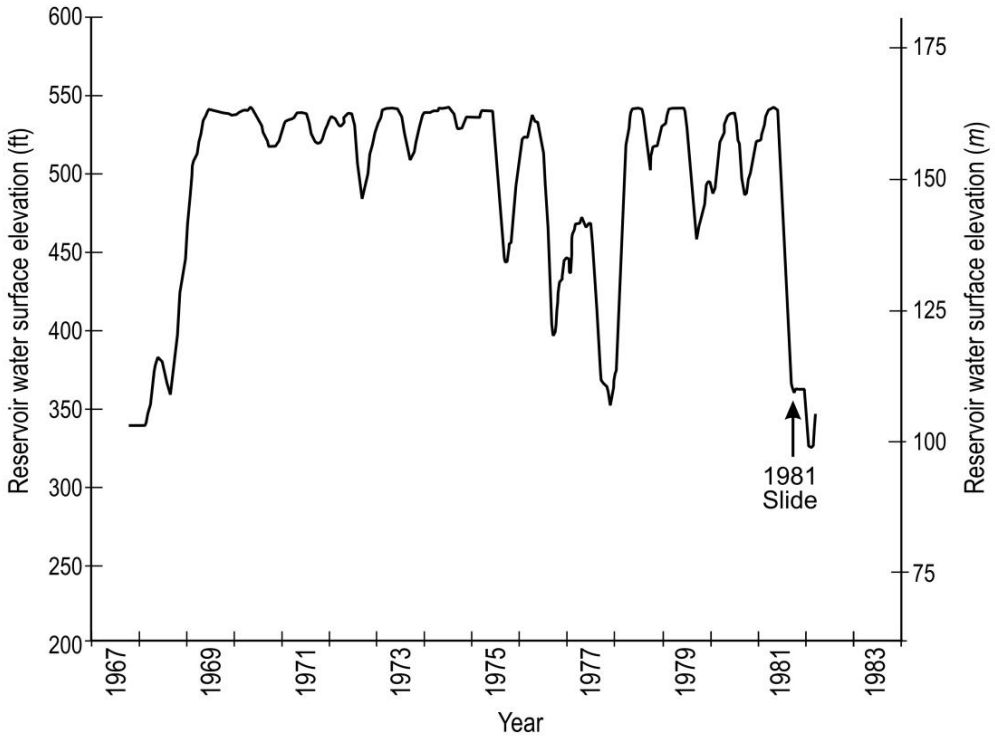
*Figure 1. San Luis Dam site: (a) Elevation view of the 1981 slide; (b) Reservoir operational history.*

*2. Observations of the 1981 slide:* The following field observations of the slide were noted by VonThun (1985) – see Figures 1(a), 2, and 3: First cracking occurred about 30 m (100 ft) down the u/s slope near the crest of an enveloped hill (near station 135) and progressed down the abutment towards more voluminous cross sections. The characteristics and progression of the slide mass are summarized as: (a) began as an arc-shaped crack, with ends of the arc parallel and perpendicular to the dam axis; (b) progressed from the initial length of about 150 m (500 ft) to an ultimate length of about 450 m (1475 ft); (c) took about two months to fully develop and stabilize; (d) formed a distinct pressure ridge at the toe moving over a portion of the toe of the dam for a distance of about 10 m (30 ft); and (e) moved on the order of 20 m (65 ft) with a 15 m (50 ft) vertical scarp. In view of the size of objects in Figure 1(a), the 15 m (50 ft) dimension for the vertical scarp seems to be in error (an over-estimate) – it is listed as 7.6 to 9.1 m high in Penman (1986) and 10 m high in Duncan and Wright (2005).

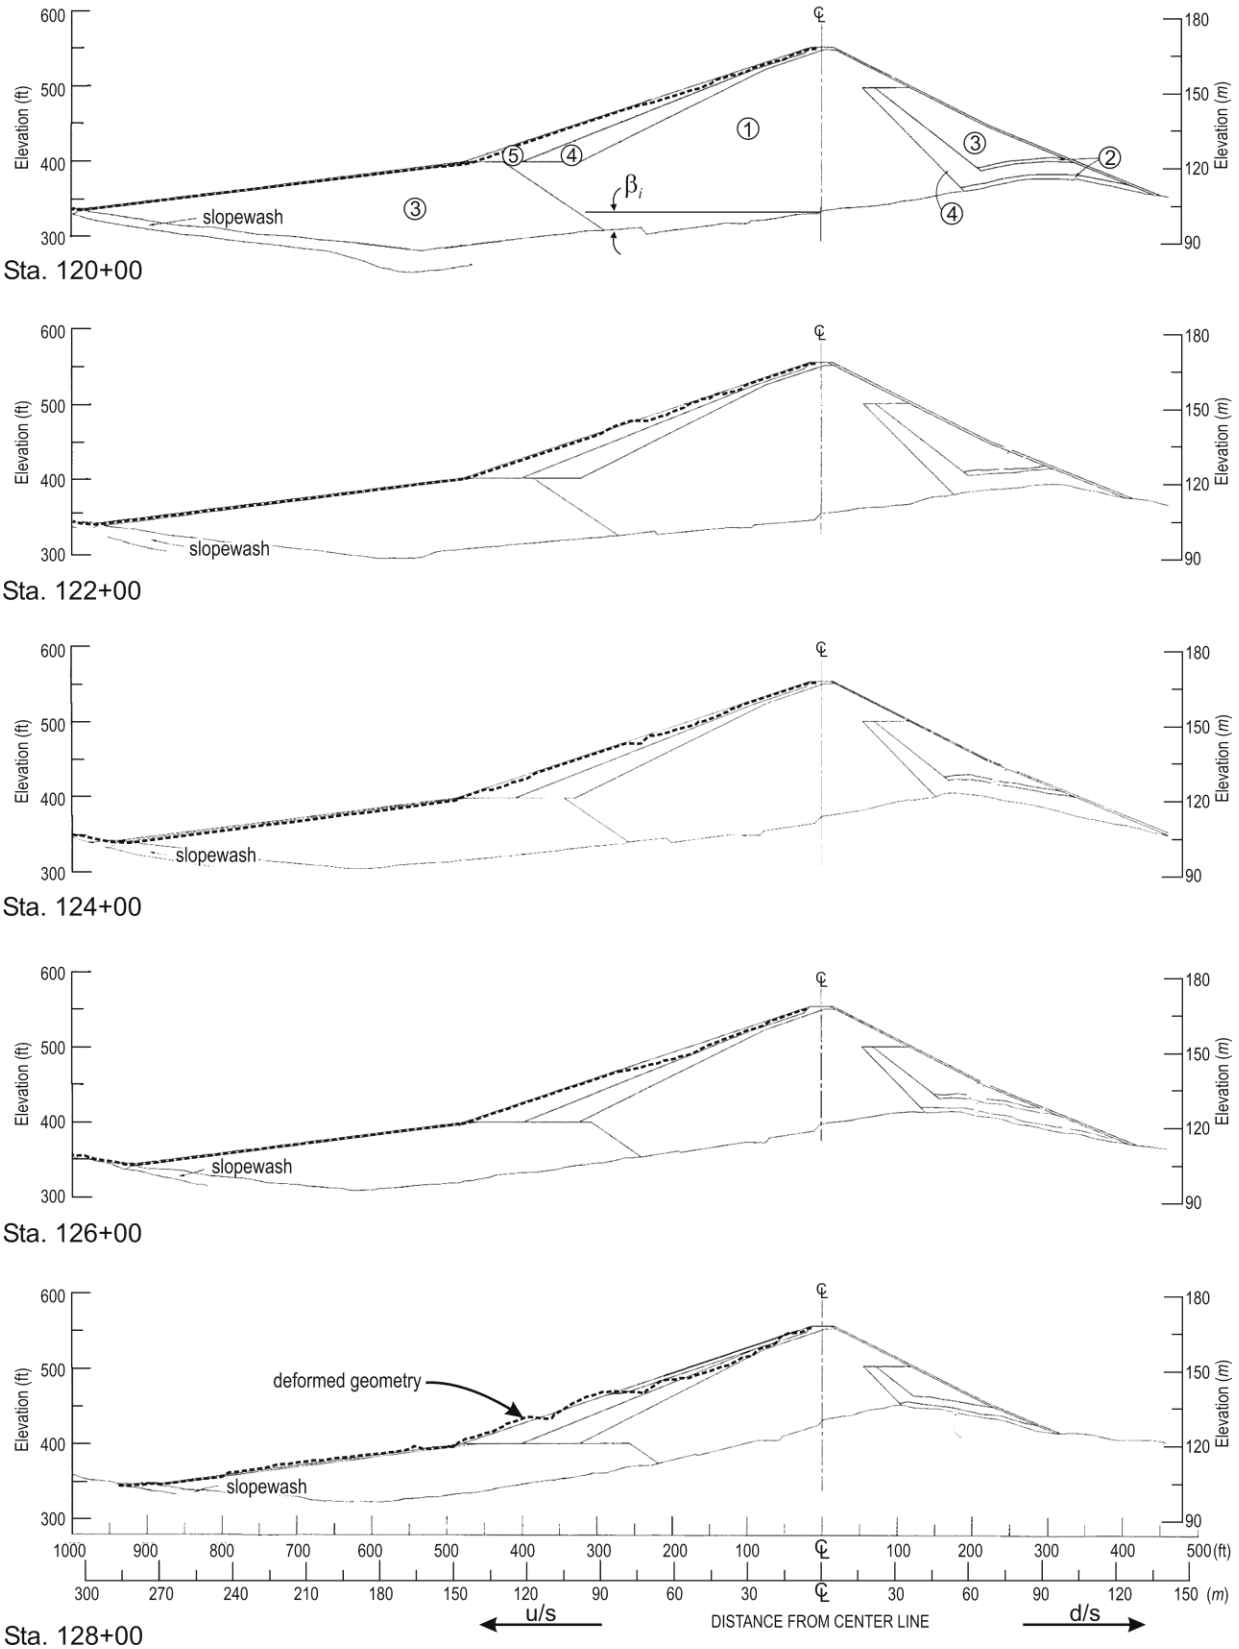
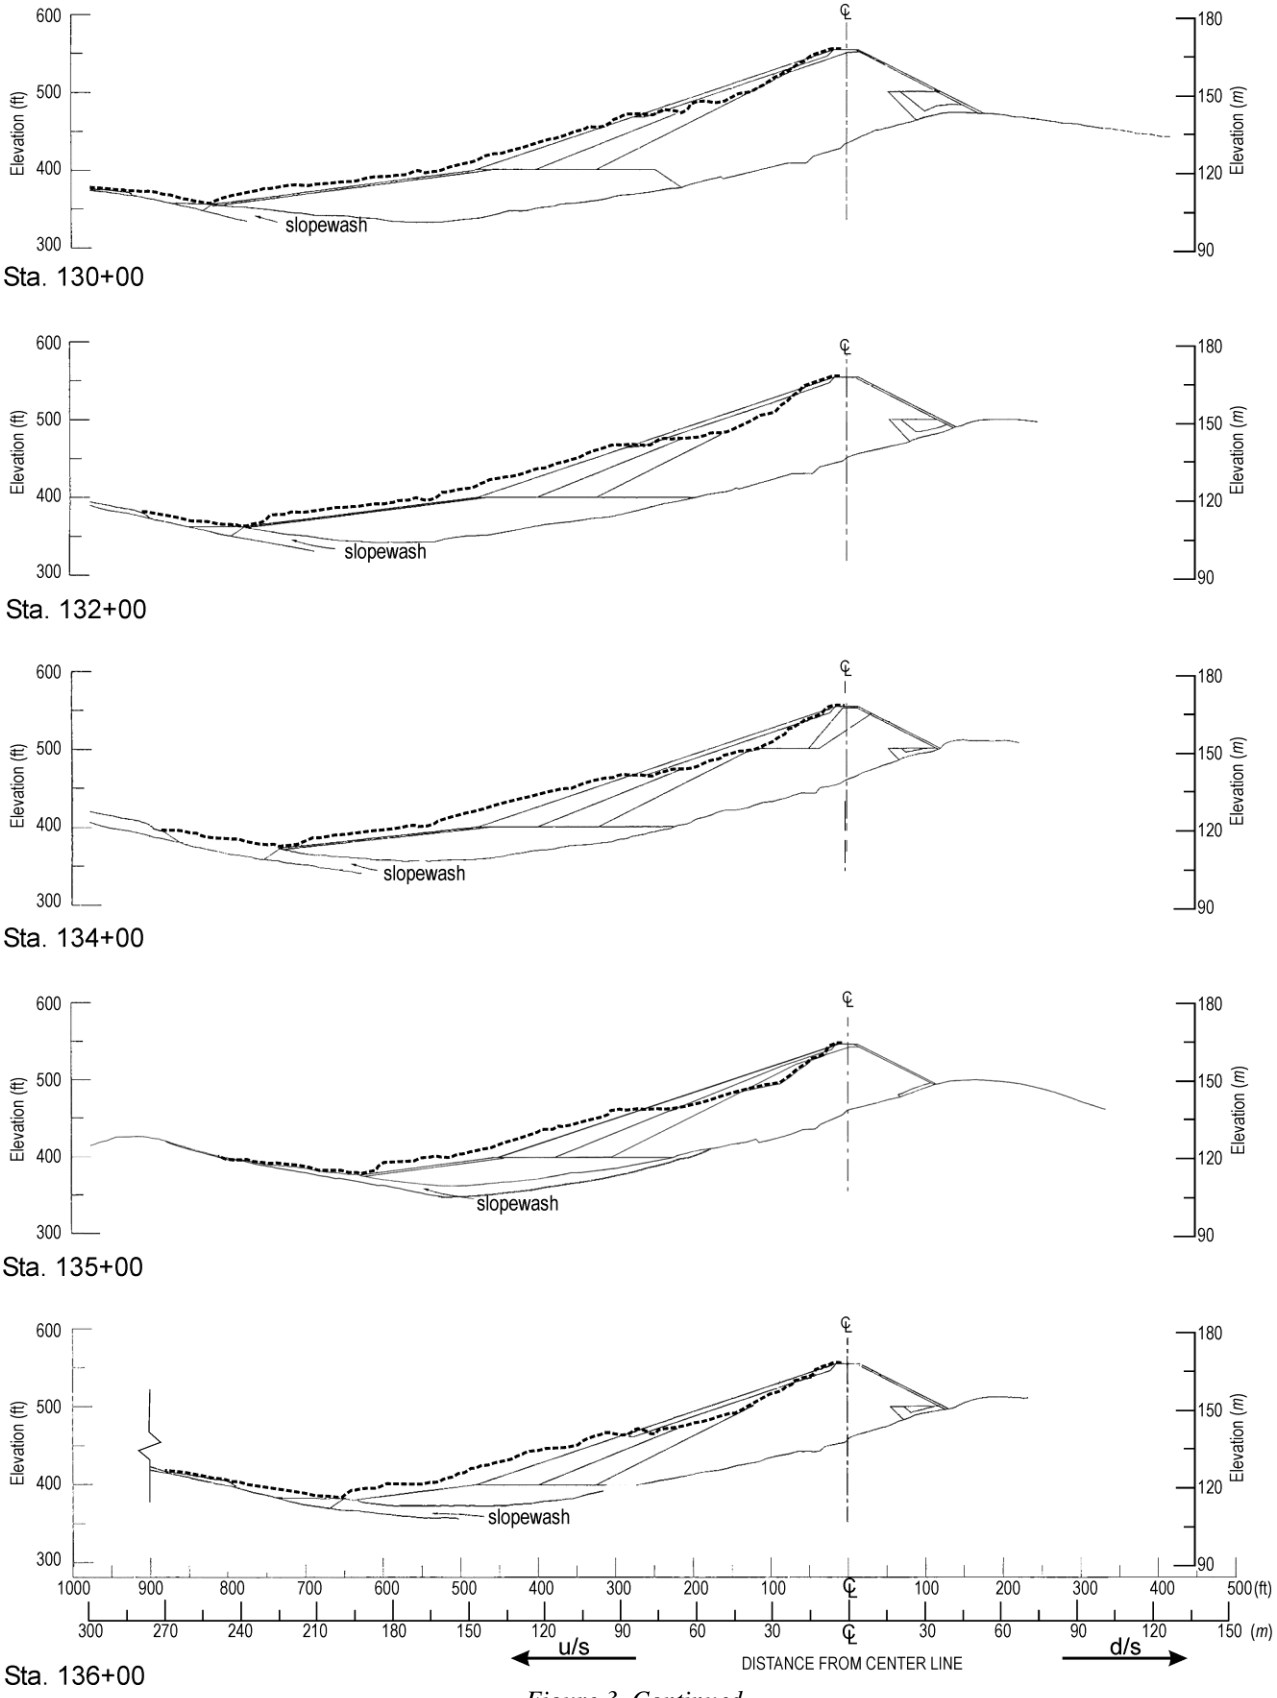
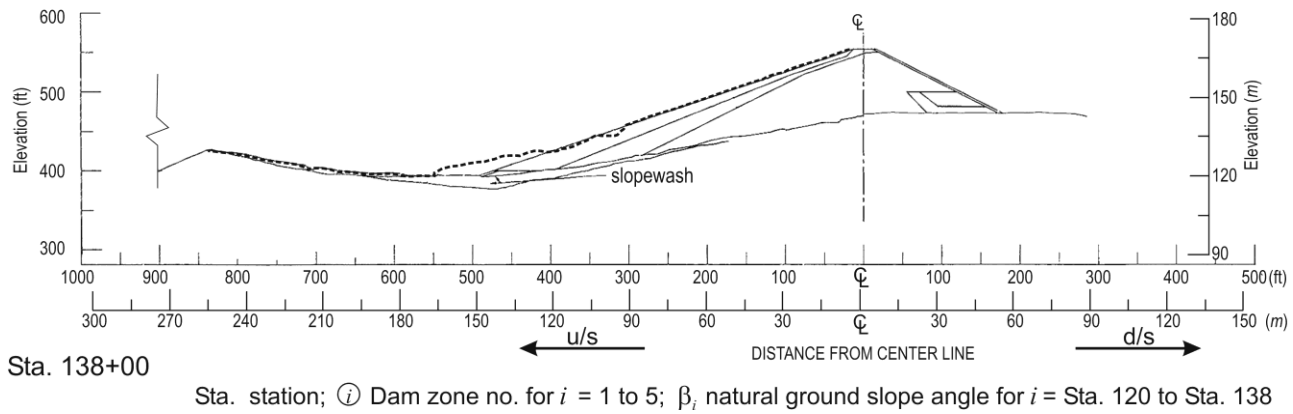
*Figure 3. Cross section views of the San Luis Dam from station 120 to station 138 showing the original and deformed configuration of the dam.*

The dam zones are identified on cross section at Station 120 in Figure 3, the same zoning identification applies to all cross sections included in this figure. All materials were placed in lifts and compacted with appropriate equipment typical of the period (1963 - 1967).

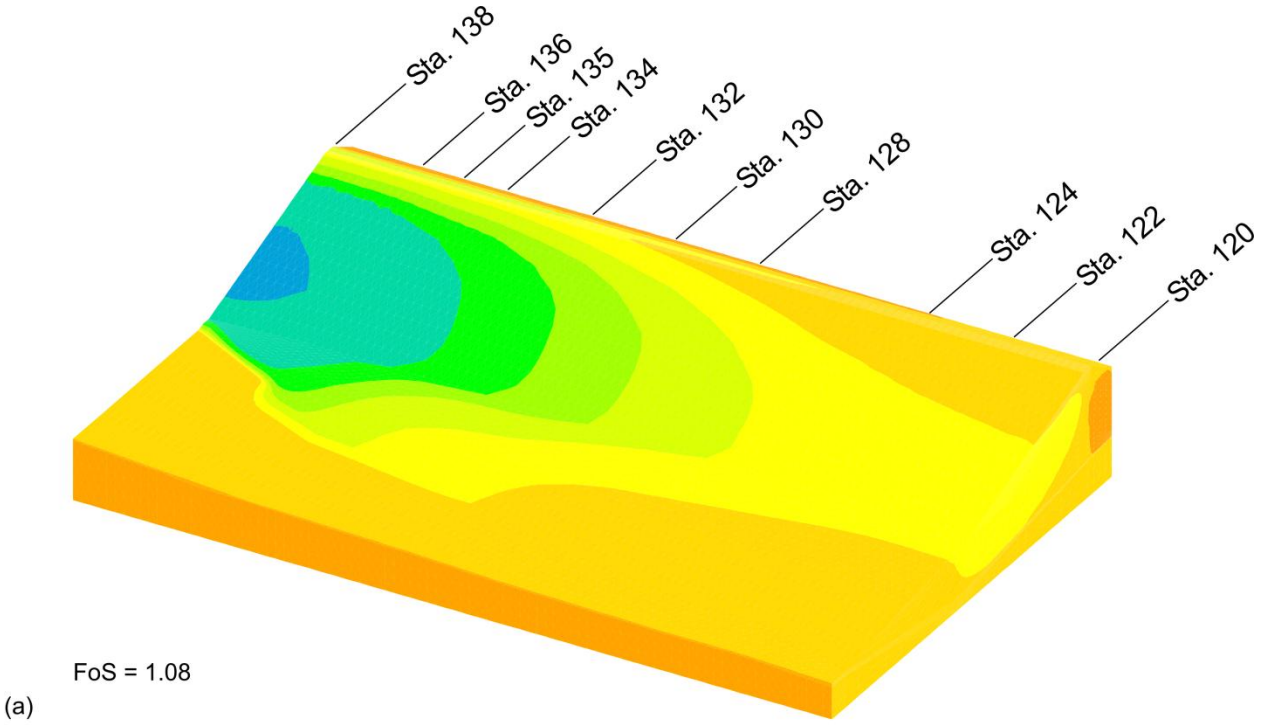
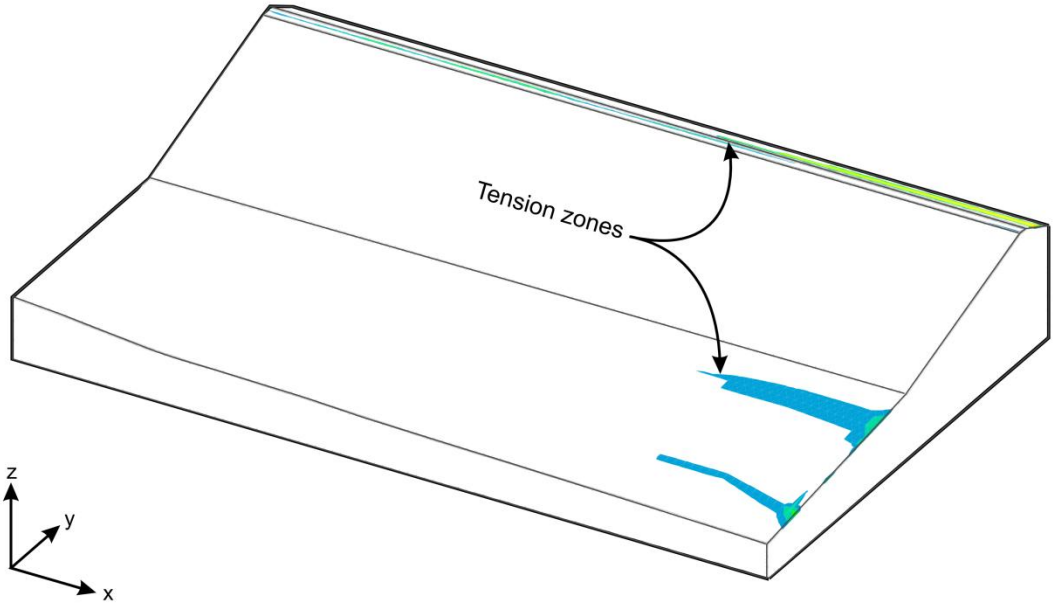
*Figure 9. Slope stability analysis results of three-dimensional continuum model between stations 120 and 138. Reservoir water level is 110 m (360 ft), angle of internal friction for slopewash is 22°, and the slip surface geometry is determined by the continuum-mechanics-based computer program FLAC3D. (a) Spatial distribution of y-displacement contours; (b) Spatial distribution of surface cracks in longitudinal direction; (c) Planar views of slip surface geometry from station 120 to station 138.*

(b) For RWL = 110 m (360 ft) and adjusted shear strength (c' = 0, φ' = 22°) for the slopewash, the factor of safety is 1.08 which is close to 1.0. For the 3-D factor of safety to be unity, the shear strength of slope wash is estimated from Figure 11(d) to be about (φ′ = 20°, c′ = 0). This estimated shear strength for the slopewash was checked via an additional 3-D analysis which resulted in a 3-D factor of safety = 1.01. The middle portion of the slip surface is located in the slopewash and the active and passive wedges pass through the zone 1 and zone 3, respectively. The tension zones develop near the centre of the dam crest and the scarp is arch shaped. These results compare well with the field observations and support the back-calculated value of slopewash material to be c' = 0 and φ' = 22° (or the slightly lesser value of 20° from 3-D) at the onset of instability (FoS = 1.0). The difference between (φ′ = 22°, c′ = 0) and (φ′ = 20°, c′ = 0) as being representative shear strength for the slopewash is considered minor given other uncertainties and assumptions necessary in these back-analyses.
