Reclamation and Safety of High Cantilever Strong Box Pipe Pile Seawall in Marine Clay

Submitted: 05 November 2015; Published: 10 October 2016
Reference: Soh, K.K., Wai, T.T., Yeo, L., and Lim, P.K. (2016). *Reclamation and Safety of High Cantilever Strong Box Pipe Pile Seawall in Marine Clay*. International Journal of Geoengineering Case histories, http://casehistories.geoengineer.org, Vol.3, Issue 3, p.176-189. doi: 10.4417/IJGCH-03-03-04

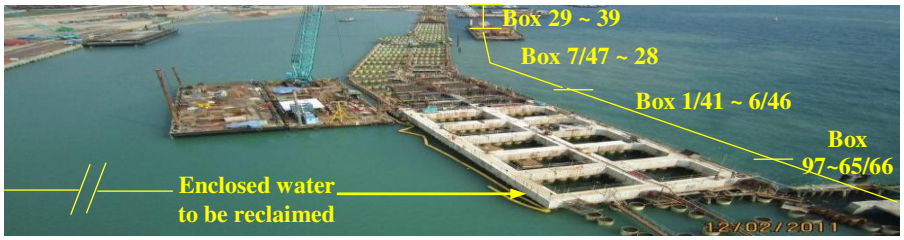
Figure 1. Photograph showing the enclosed water to be reclaimed.

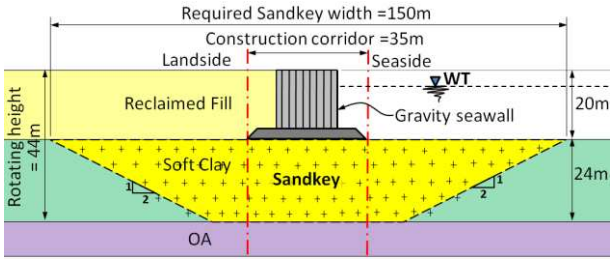
(b) Ground improvement using grouted stone column or deep soil mixing.

* 150 m wide and 44 m deep sandkey is necessary to cut off the deep slip failure plane.

The applicable strong box seawall that is buildable in these physical circumstances are detailed by Soh et al. (2014). The high rotating height and the construction corridor of 35 m limit the seawall solutions. A cellular cofferdam is not able to resist the deep seated failure as shown in Figure 3(a). Ground improvement such as stone column or deep soil mixing are impossible to construct in the marine condition and also likely to fail by tensile breakage as shown in Figure 3(b).
