A Large Scale Landslide in a Coal Mine in Marly Formations: Evaluation, Analysis and Rehabilitation

KEYWORDS: Landslide, marl, progressive failure, coal mine, rehabilitation

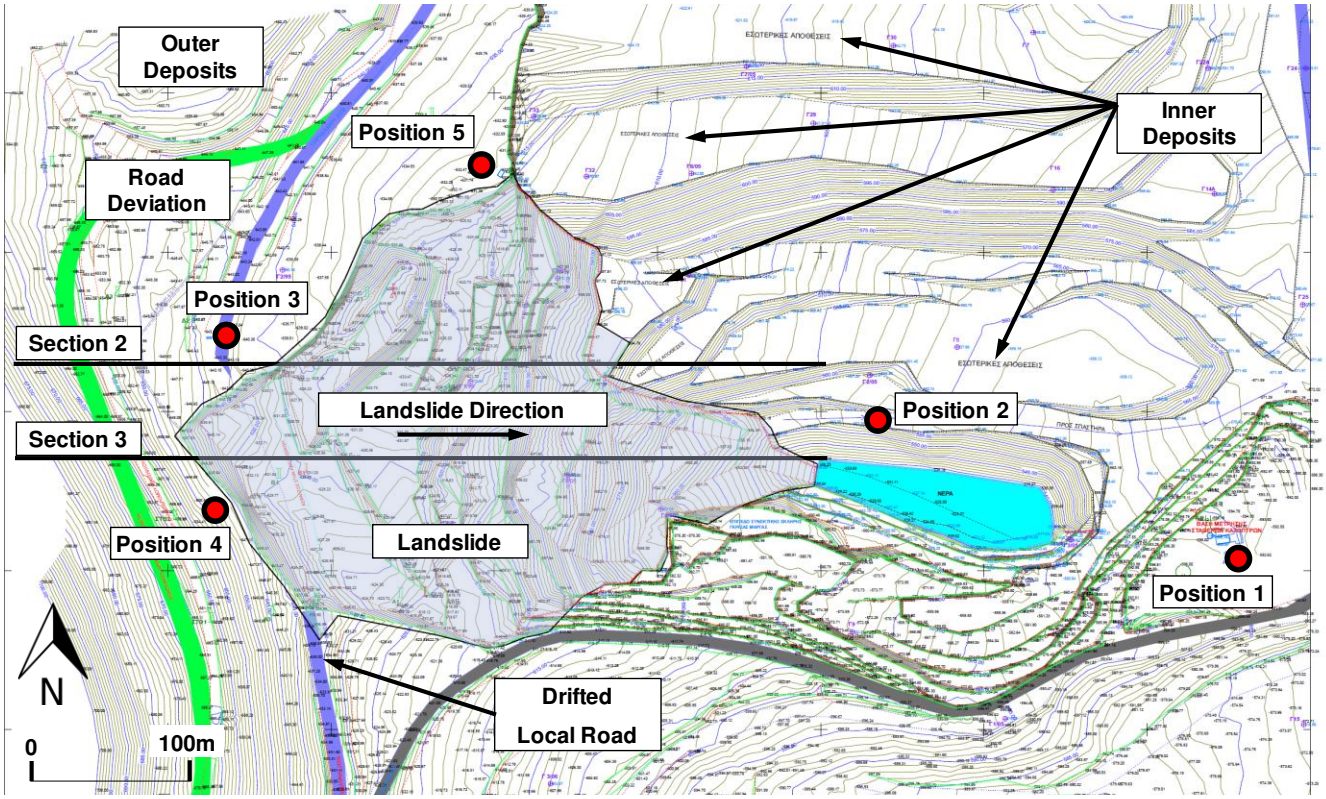
Figure 2. Topographic mapping (plan view) of the coal mine after the landslide with demarkation of some key features

Figure 2 shows a plan view of the landslide area, with demarkation of the main features of the incident, as mentioned or referred to in the present paper. After examination of historical, geometrical and geotechnical data provided by the exploitation contractor, in-situ inspections and evaluation of the available information, it was concluded that the factors that played an important role in the initiation and triggering of sliding movement and the evolution of the landslide were:

1. The period of stoppage of works, which enhanced instability phenomena, allowing the action of environmental agents, in combination with the initial small scale displacements and cracking that are inevitable in earthworks of such dimensions within soft rocks, due to stress relief.

2. The systematic and constant action of rain water. In addition to causing deterioration of upper marl quality, water also contributed by a gradual increase of pore pressure along various preceding sliding surfaces, after infiltrating in the generally impermeable formation through open and constantly widening cracks.

3. The existence of a distinct weak contact surface between the weathered and the underlying compact marl. This specific interface has been often shown to contribute to failures as a common sliding surface, not only from similar incidents in the area (Prountzopoulos et al., 2010) but also from statements of the on-site engineers of the specific project who attested that this surface had caused small scale failure incidents in the same coal mine before the specific landslide.

4. The clayey, weak nature of marl, especially in shallow depth, as well as its sensitivity to the action of environmental agents. The progressive transition of marly formations to residual strength conditions, due to combination of the action of water and small scale displacements, has been repeatedly reported in the Greek territory and has been related to landslide phenomena (Cavounidis & Sotiropoulos 1980, Dounias 1988, Prountzopoulos et al. 2014).

5. The important height of the mine slope cuts (>60 m), which was not timely retained through deposition of non-comercial excavation materials, due to the stoppage of works with adjudication.

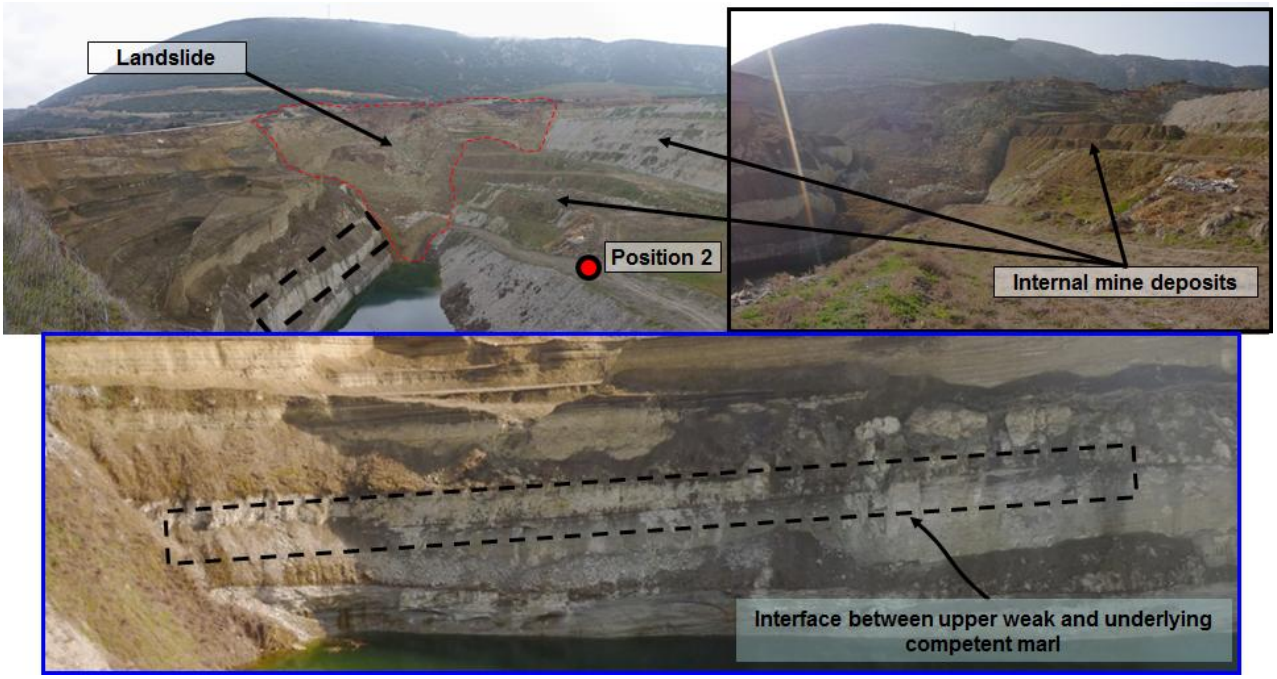
Figure 3 illustrates a general aspect of the landslide from its E and NE side (Positions 1 and 2 in Figure 2) and a view of the contact surface between the weak and the competent marl, which played a major role in the landslide manifestation. Figure 4 illustrates various aspects of the landslide and its main features.

Figure 3. Aspect of the coalmine and the landslide from Position 1 (upper left), the landslide from Position 2 (upper right) and the contact surface between the weak and the competent marl (bottom)

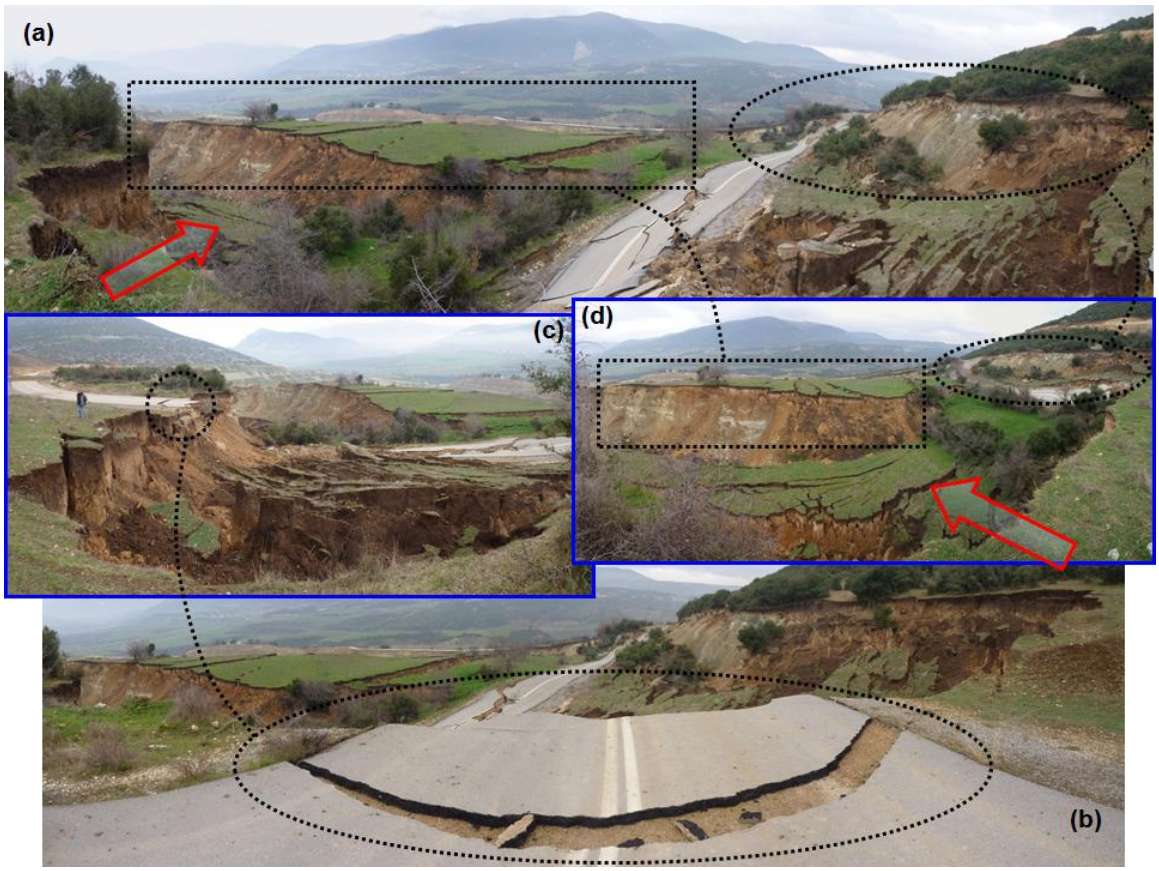
The landslide had a clearly three dimensional character, due to the lateral "constraints" posed by the non-commercial deposits of the mine at its north part and the exploitation limit at its south part. The failure surface at the landslide crest at its NW boundary had a considerable (subvertical) inclination and was steeply dipping towards the weak contact surface between the weathered and the underlying compact marl (Figure 4a left and 4c). On the contrary, at the west boundary of the landslide crest, the failure surface had a milder inclination (Figure 4a and 4b right) and seemed to have travelled a considerable length within the shallower weak marl formation. Within the landslide, large blocks of the marly formation were almost monolithically displaced (see Figure 4a and 4d) with limited cracking and detachments within their mass, giving the impression of a combination of rock slide and typical rotational landslide to the incident.

Figure 4. Aspect of the landslide from Position 3 (a & b), Position 4 (c) and Position 5 (d), the landslide crest (oval shape in a & d), the block that moved almost monolithically downstream (rectangle in a & d) and the mass that sank behind the block (arrow in a & d).

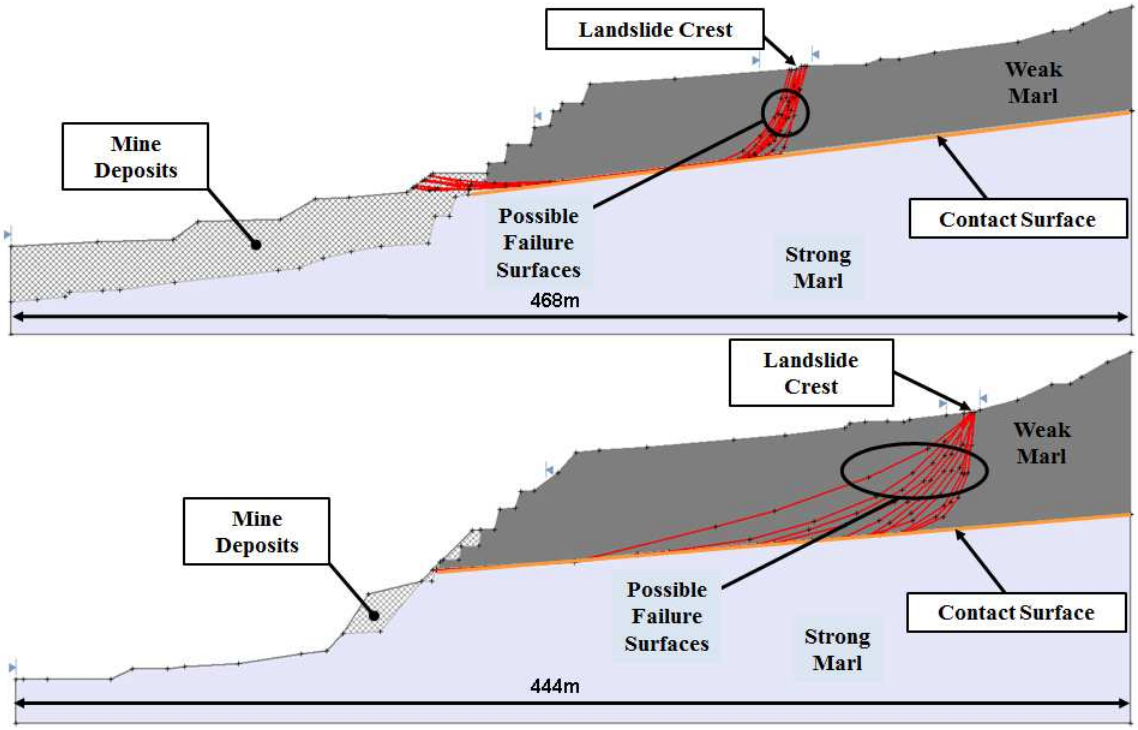
Figure 5. Analysis Section 2 (up) and 3 (down). Slide software model.

Given the three dimensional character of the landslide, as mentioned earlier, two analysis sections were systematically checked (Sections 2 and 3) so as to estimate some rational parameters for the assessment of rehabilitation proposals. Figure 5 illustrates the analysis sections along with their main features. The process that was adopted is summarized in the following steps:

1. After in-situ inspection and study of available surveying mapping, conclusions were reached concerning the general shape of the failure surface along Section 2 (subvertical near the crest) and Section 3 (with more gentle slope near the crest). Based on these conclusions, a set of possible failure surfaces was considered for each Section, with varying inclination and part of the surface passing through the weak marl formation and along the contact surface between the weak and the competent marl.

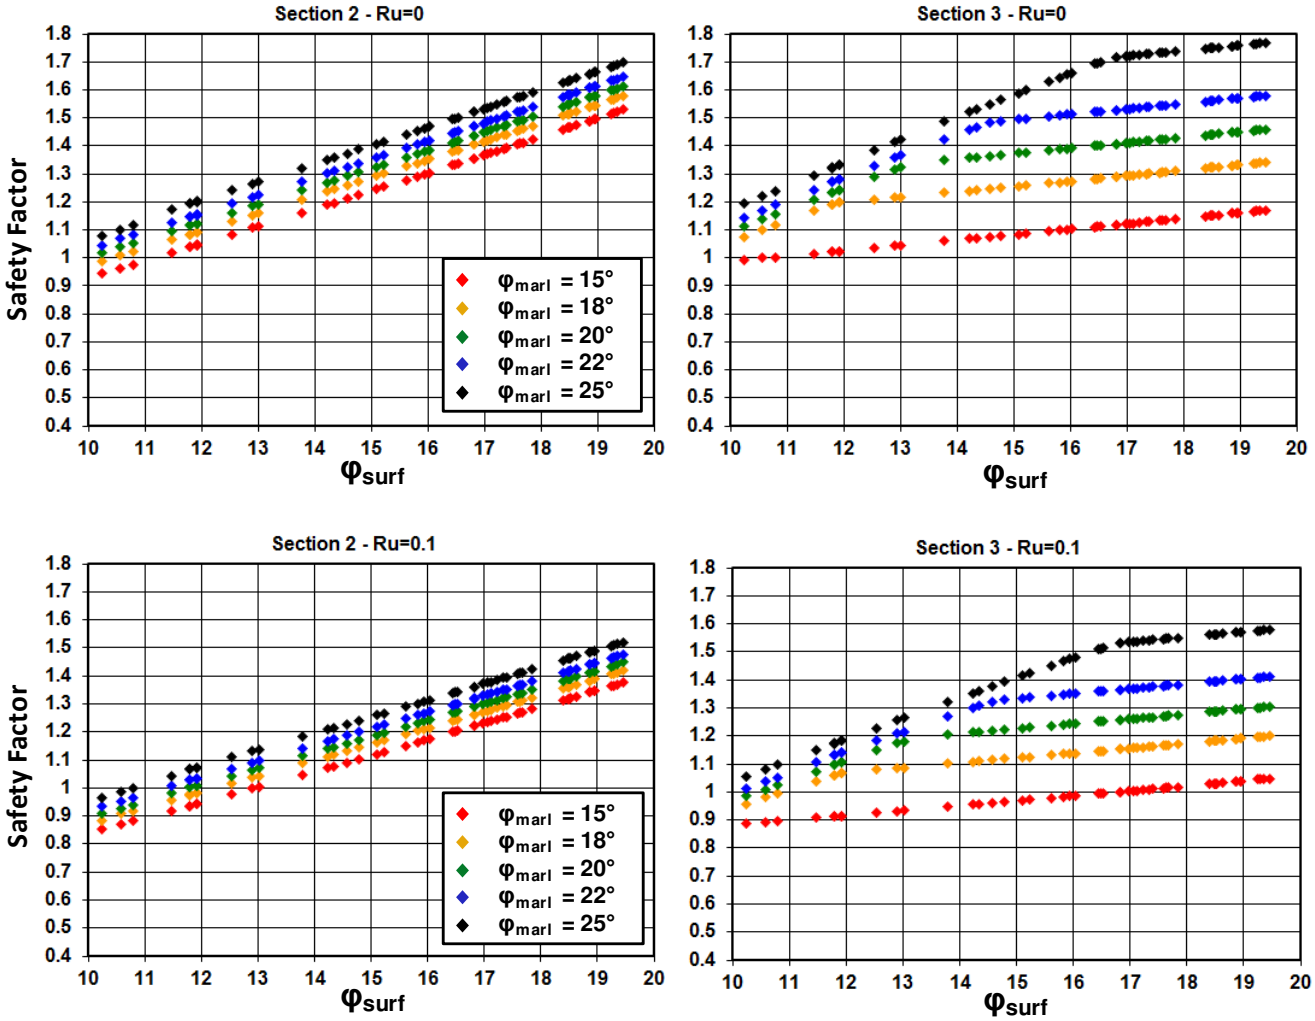
Figure 6. Variation of safety factor for different values of φ_{marl} and φ_{surf} for R_u=0.0 (up) and R_u=0.1(down), as computed for Section 2 (left) and Section 3 (right)

2. Values of the safety factor for values of pore pressure ratio R_u=0-0.1 generally lie above unity for both Sections analyzed (see Figure 6), especially for φ_{surf} >13° and were therefore excluded. This result was actually anticipated, since water seemed to have had a major role in the landslide triggering.

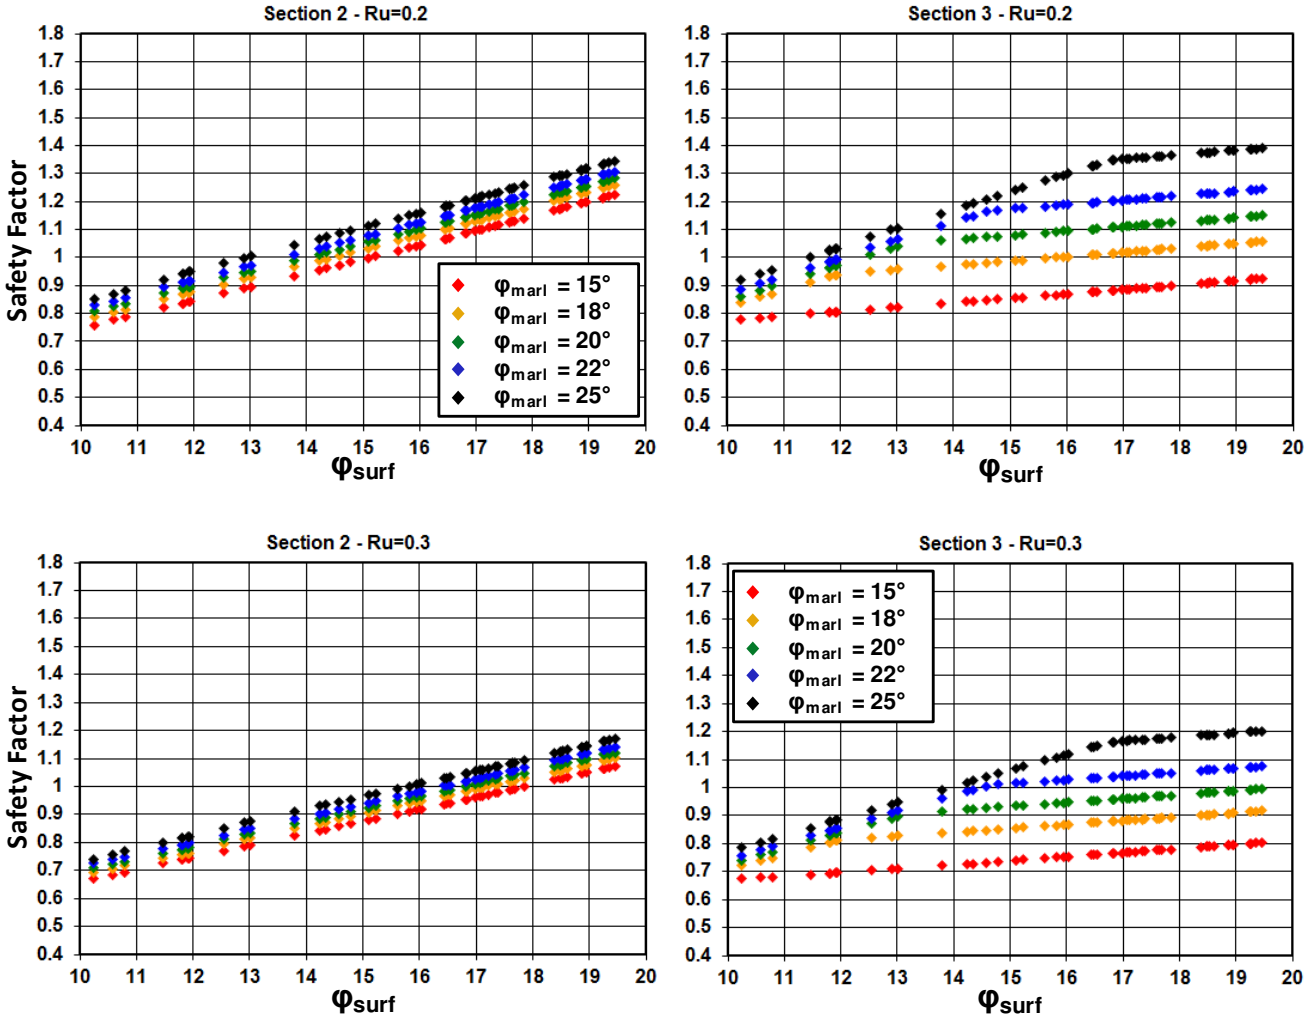
Figure 7. Variation of safety factor for different values of φ_{marl} and φ_{surf} for R_u=0.2 (up) and R_u=0.3(down), as computed for Section 2 (left) and Section 3 (right)

Section	R_u ratio	φ_{surf}(°)	φ_{marl}(°)
2	0.2	13-15	18
	0.3	15-17	18-20
3	0.2	14-16	18-20
	0.3	15-16	22

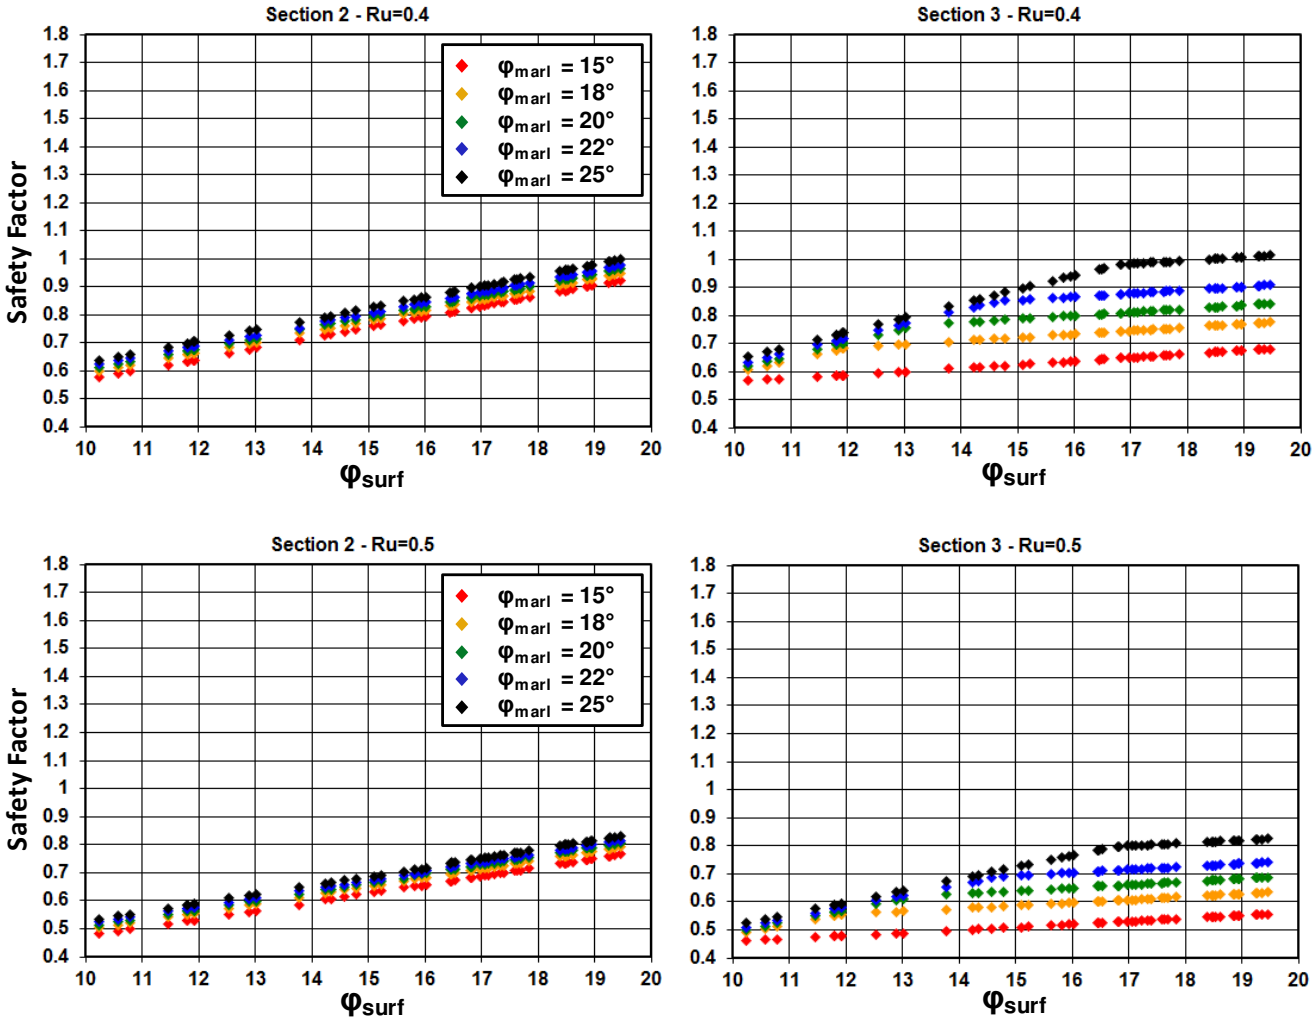
Figure 8. Variation of safety factor for different values of φ_{marl} and φ_{surf} for R_u=0.4 (up) and R_u=0.5(down), as computed for Section 2 (left) and Section 3 (right)

3. Values of the safety factor for values of the pore pressure ratio R_u=0.4-0.5 were generally well below unity for both analysis Sections (see Figure 8), especially for φ_{surf} <17°-18° and were not considered likely. Values of the safety factor for φ_{surf} >18°, given the nature of the specific surface and the fact that are assumed to refer to residual strength, were not considered reasonable.

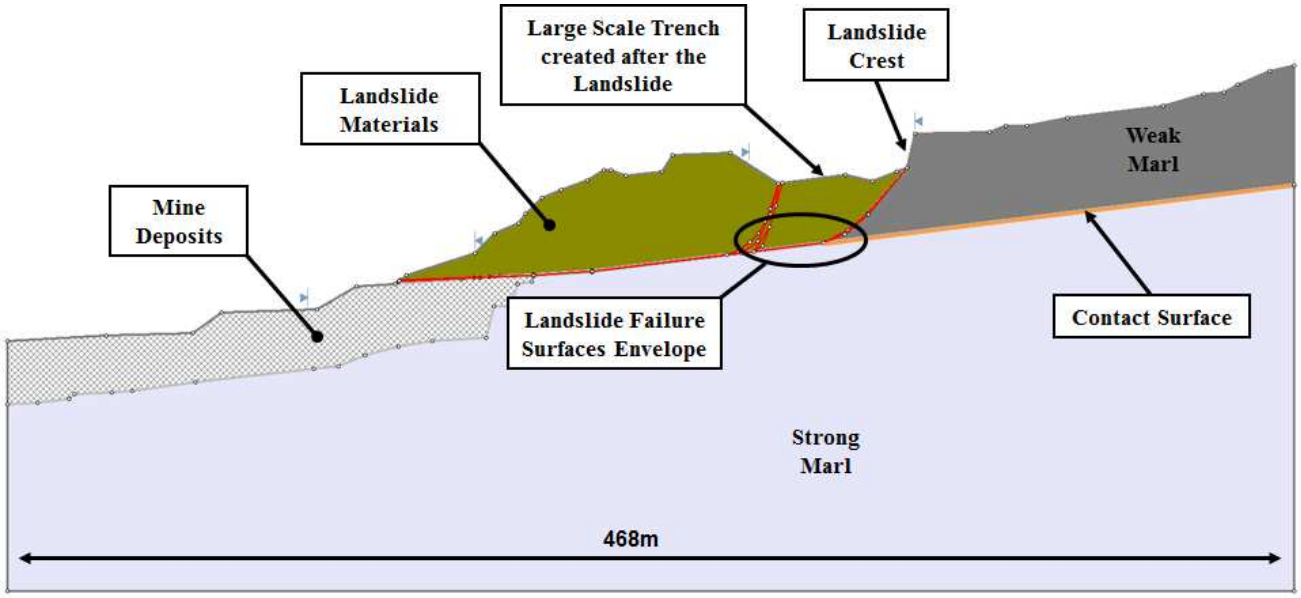
Figure 9. Analysis Section 2 after the landslide

The relevant analyses yielded results of the safety factor between 1.06 and 1.11, which were considered marginal, given the possible further deterioration of the shear strength of the materials involved in the slides, due to ongoing movements, especially during the rainy season in the area. Specifically, analyses of Section 2 resulted in a minimum value of the safety factor equal to 1.11, whereas the corresponding minimum value from Section 3 was 1.06. Analyses with free selection of surfaces by the software were not performed, as these would yield unrealistically low values of the safety factor (considerably <1), under the assumption that the total mass included in the landslide envelope had been downgraded to its residual strength (zero cohesion and low friction), which was not the case due to monolithic, undisturbed blocks existing within the slid mass. The fact that the resulting safety factor values were rational, i.e. marginally larger than unity, indicating a temporarily stable situation after a main landslide event, enhanced our confidence in the assumptions that were made.

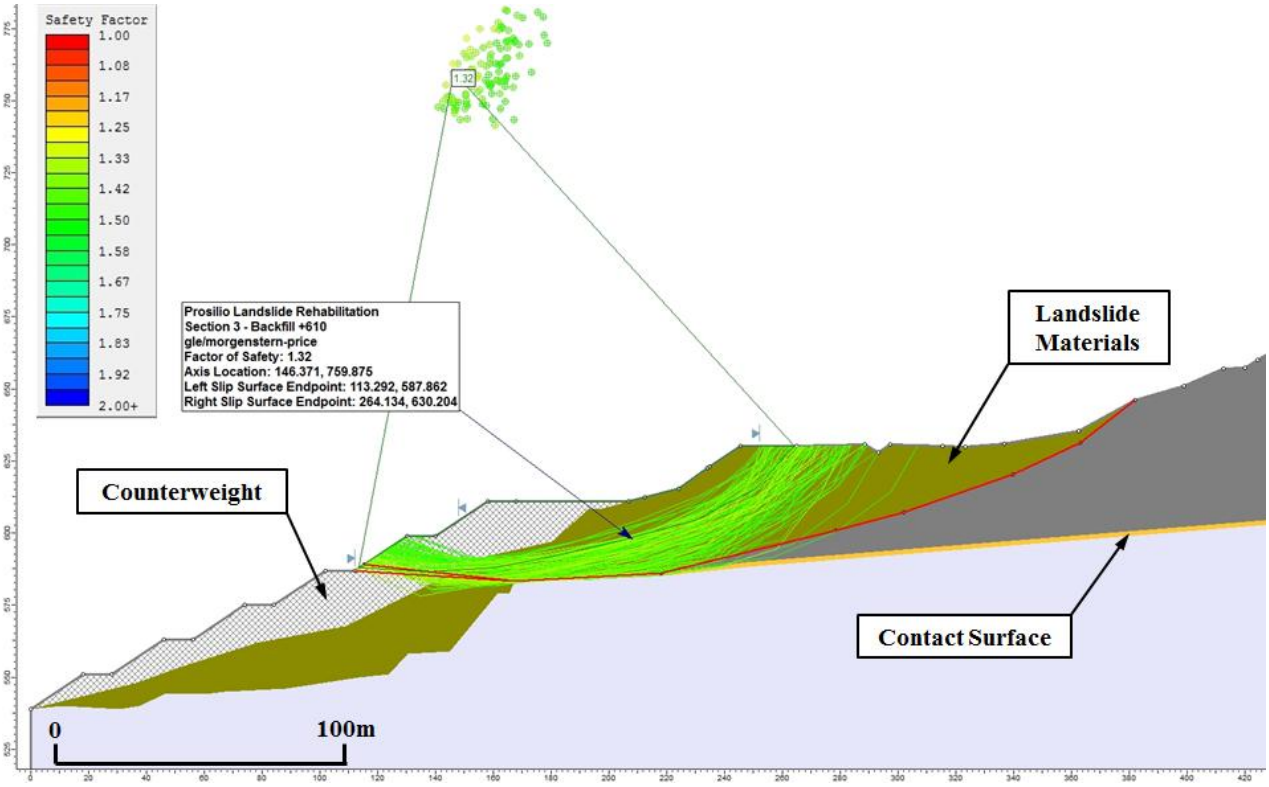
Figure 11. Analysis Results for Section 3 with backfill at the toe up to elevation +610 (F.S. = 1.32)

1. Placement of non commercial deposits at the toe of the landslide up to an elevation approximately 25 m above the contact surface between the upper weak and the undelying competent marl (~+610 m absolute evelation), significantly increased the safety factor. Specifically, considering the envelope of the landslide or surfaces along obvious large scale movements within the total landslide mass as potential failure surfaces, the computed values of the safety factor ranged between 1.52 and 1.63. Assuming that any failure surface within the total landslide envelope was possible (a quite conservative approach, since residual shear strength parameters were assigned in the analysis model) the safety factor ranged between 1.32 and 1.56. These values, even with the second, conservative approach, were considered adequate.

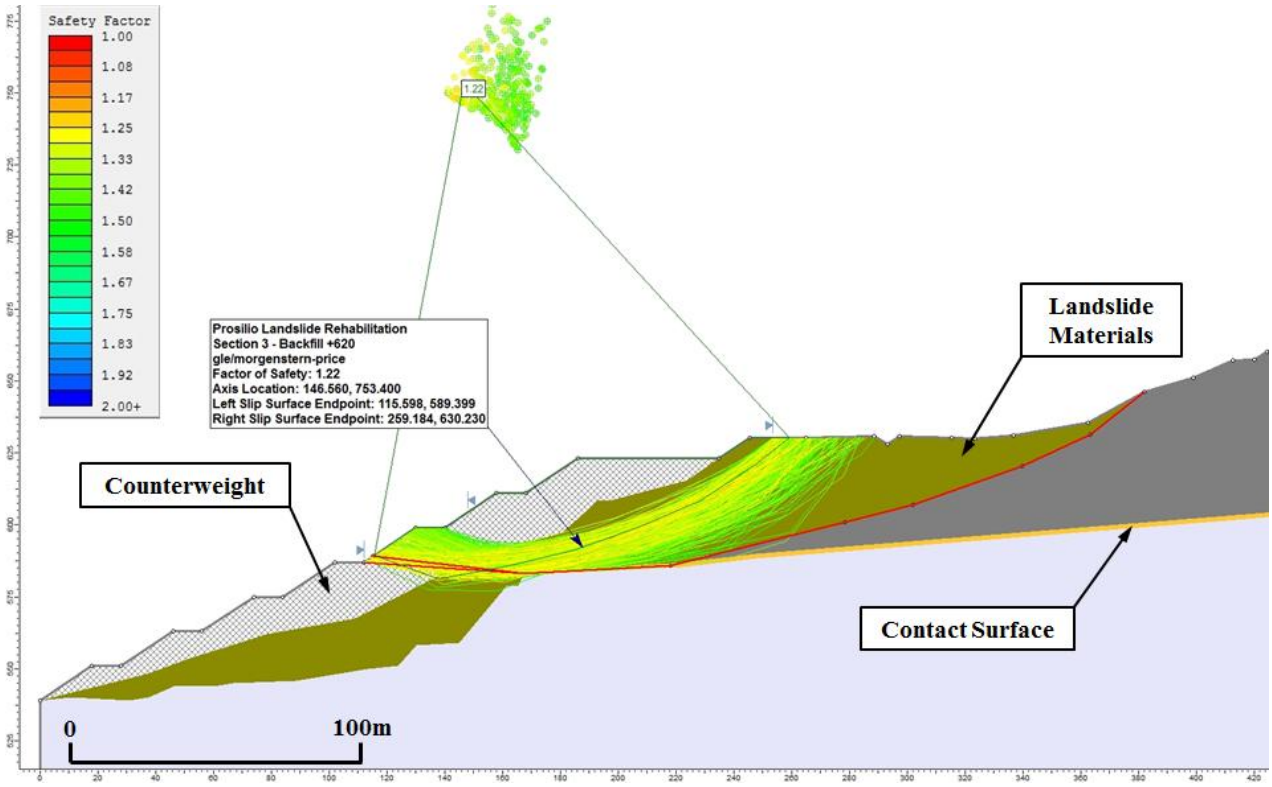
Figure 12. Analysis Results for Section 3 with backfill at the toe up to elevation +620 (F.S. = 1.22)

2. Placement of non commercial deposits at the toe of the landslide up to an elevation approximately 35 m above the contact surface between the upper weak and the undelying competent marl (~+620 m absolute evelation), did not significantly differentiate the safety factor. Specifically, considering the envelope of the landslide or surfaces along obvious large scale movements within the total landslide mass as potential failure surfaces, the computed values of the safety factor ranged between 1.56 and 1.70. Assuming that any failure surface within the total landslide envelope was possible, the safety factor ranged between 1.22 and 1.57. Therefore, it was shown that the additional placement up to the specific level was only to facilitate the landslide removal and exploitation procedures and was not necessary for the stabilization of the landslide. In fact, locally, due to the existing geometry and morphology of the landslide, this additional placement could somehow reduce the available safety factor, as part of the deposits would actually increase the sliding moment for certain potential failure surfaces (pose additional loading to the landslide - see Figure 12 above).

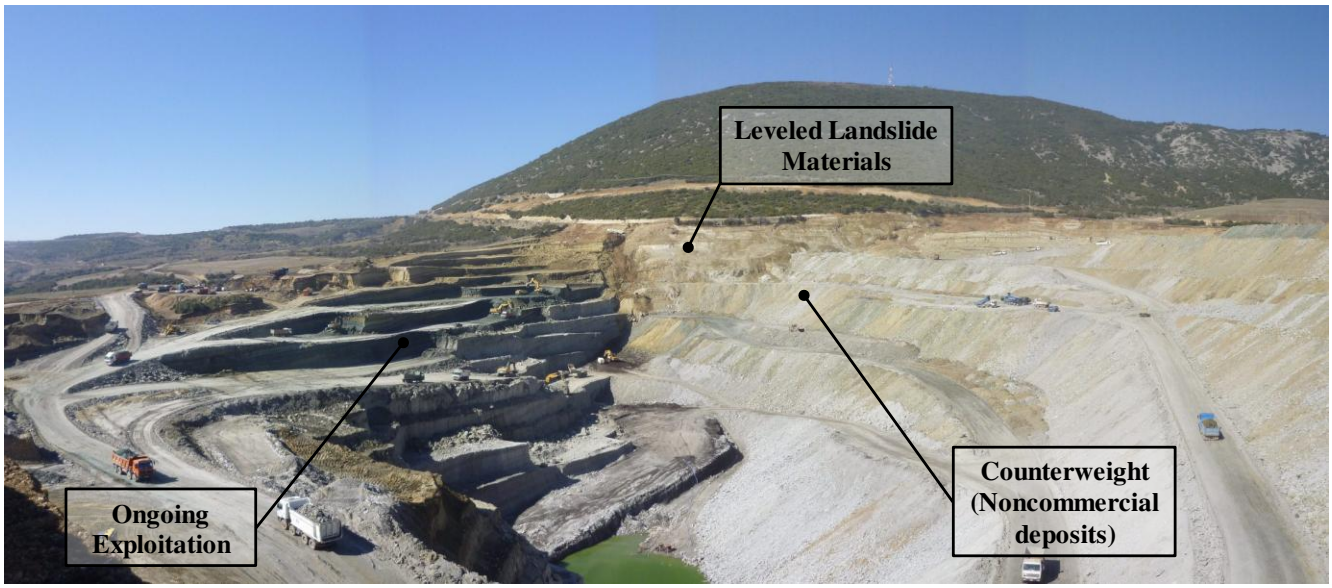
Figure 13. Aspect of the coal mine area after completion of counterweight construction and leveling works (March 2012).

The proposed rehabilitation scheme was succesfully applied in order to stabilize the landslide before any intervention to its mass. The operation of the coal mine has continued without significant instability incidents ever since. The following figures show an aerial photo of the coal mine area and an aspect of the same from within the mine area, after completion of landslide counterweight construction and leveling of the landslide materials.

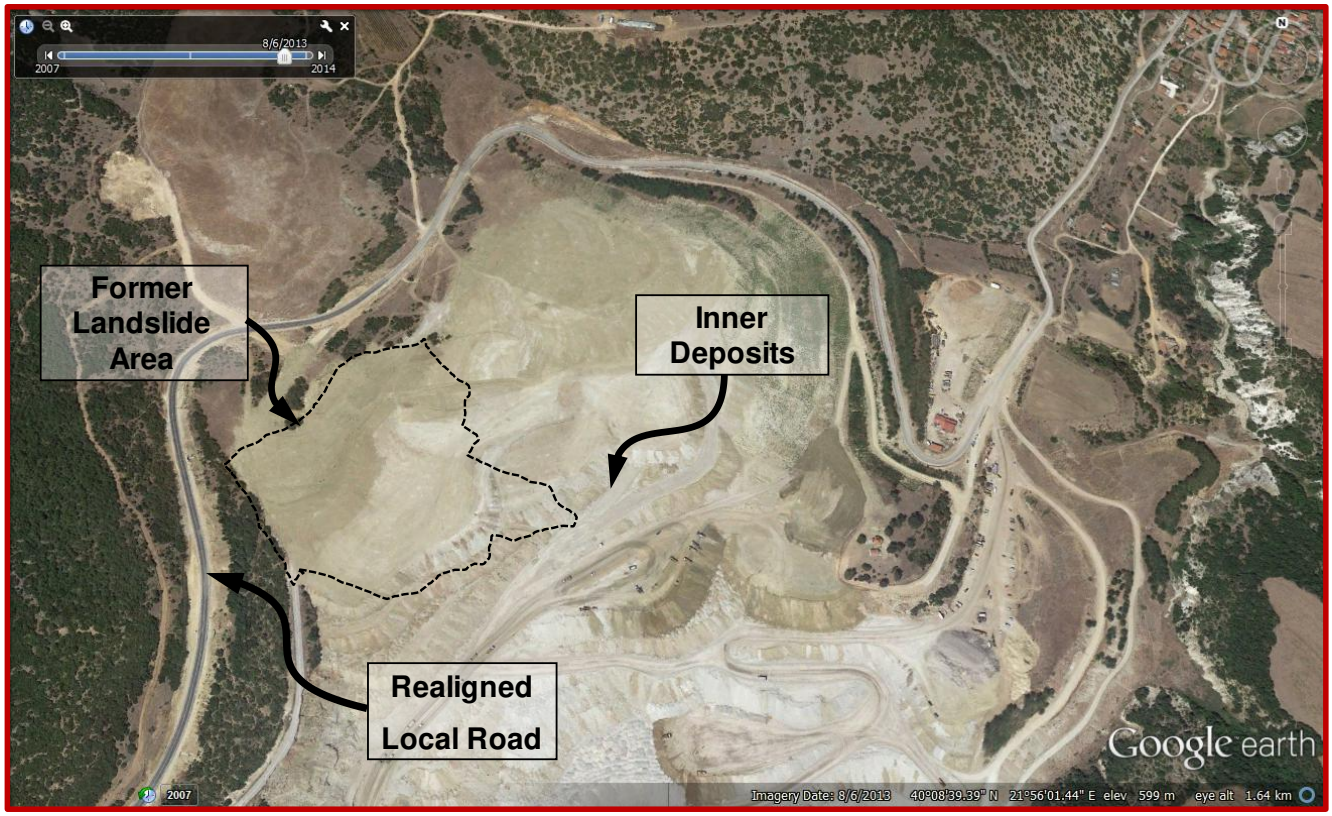
Figure 14. Aerial photo of the coal mine area after completion of counterweight construction and leveling works.
