A Large Scale Landslide in a Coal Mine in Marly Formations: Evaluation, Analysis and Rehabilitation

ABSTRACT: *This paper describes a large scale landslide in a coal mine in Servia area in Kozani, Greece, which occurred in February 2011. The landslide, of ~250m width and ~350m length, took place in marly lacustrine sediments. The main factors for the manifestation of the landslide were a temporary interruption of works, the existence of a specific weak surface, the clayey nature and the sensitivity of marl to environmental agents, the action of water and the large slope height. Due to the magnitude and the position of the failure, a geotechnical solution was proposed that involved rearrangement of ground masses. The proposed solution led to successful rehabilitation and unimpeded continuation of the exploitation process.*

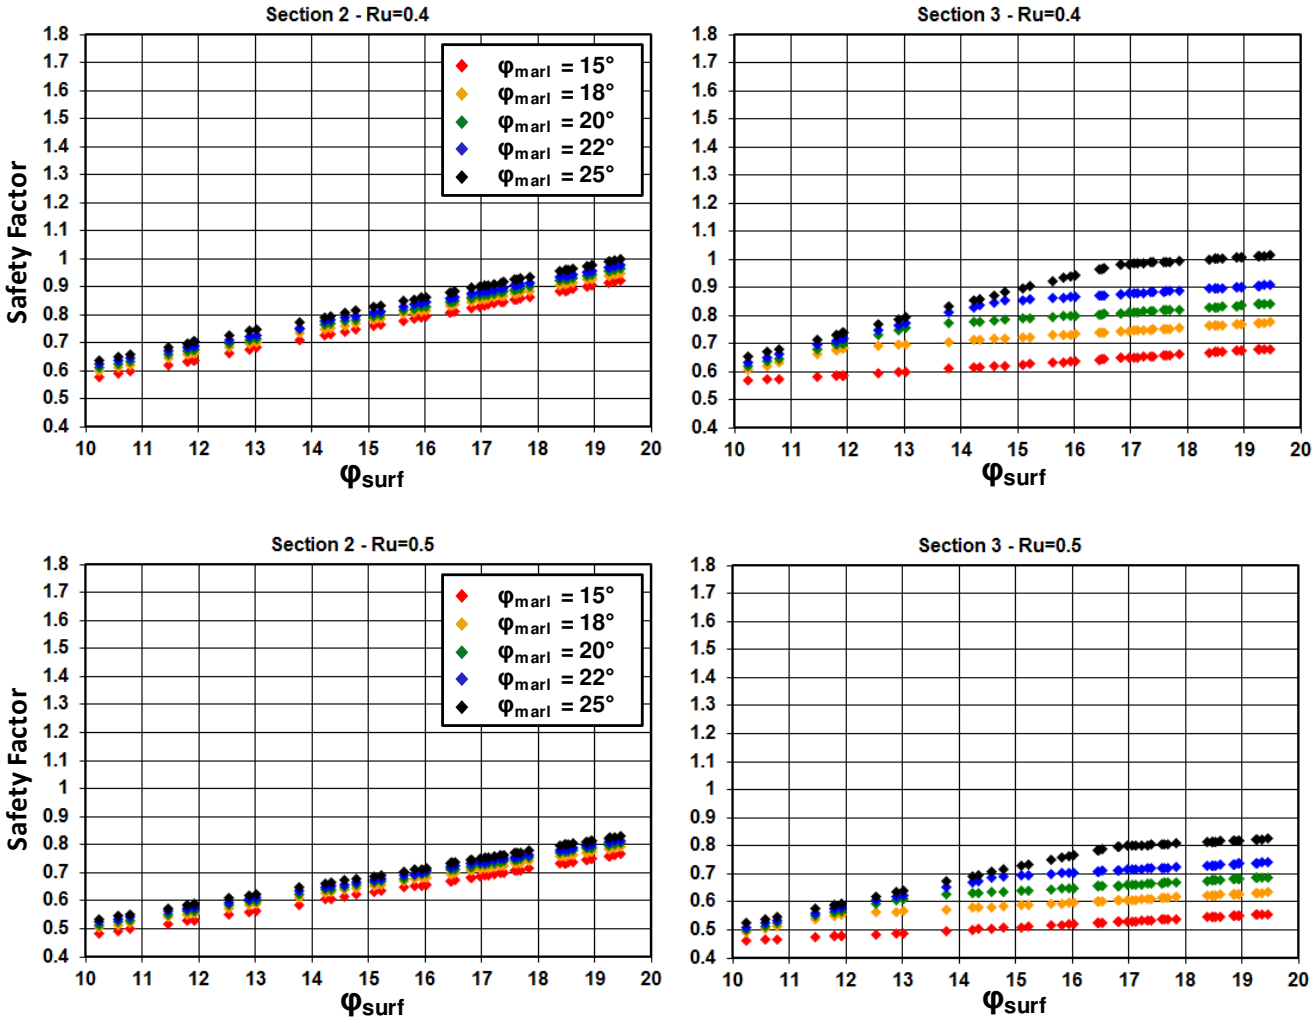
Figure 8. Variation of safety factor for different values of φ_{marl} and φ_{surf} for R_u=0.4 (up) and R_u=0.5(down), as computed for Section 2 (left) and Section 3 (right)

3. Values of the safety factor for values of the pore pressure ratio R_u=0.4-0.5 were generally well below unity for both analysis Sections (see Figure 8), especially for φ_{surf} <17°-18° and were not considered likely. Values of the safety factor for φ_{surf} >18°, given the nature of the specific surface and the fact that are assumed to refer to residual strength, were not considered reasonable.
