Estimation of the Hydroconsolidation Susceptibility of the Anthropogenic Fill of the Historical Center of Thessaloniki, Greece

Submitted: 18 May 2015; Published: 16 December 2016
Reference: Hatzigogos, N.P.T., Makedon, T.K., Tsindaris, G.E., Tsotsos, S.C. and Christaras B.C. (2016). *Estimation of the Hydroconsolidation Susceptibility of the Anthropogenic Fill of the Historical Center of Thessaloniki, Greece*. International Journal of Geoengineering Case histories, Vol.4, Issue 1, p.46-56. doi: 10.4417/IJGCH-04-01-04

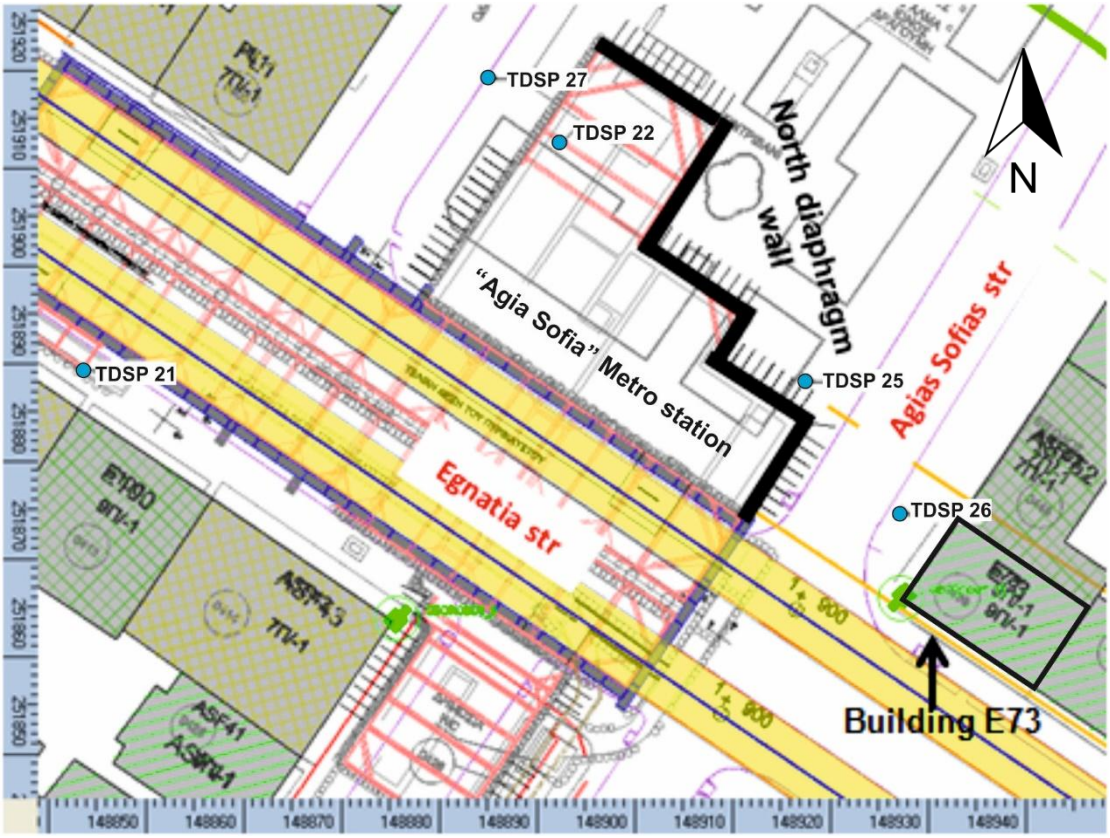
Figure 3.Planar view of the construction of diaphragm walls and piezometers (TDSP 21-27) in "Agia Sofia" Metro Station, along with building E73.

The area of investigation is adjacent to the construction site of the "Agia Sofia" station of Thessaloniki's Metro. During the construction of the station's north diaphragm walls displacements were observed on an adjacent block of flats at the corner of Agia Sofia and Egnatia streets (building E73). The displacements resulted in the deflection of the building towards SW. Systematic measurements of the displacements on the foundation ground were carried out to investigate the phenomenon as well as measurements of the groundwater level in piezometers of the construction area as shown in Figure 3.

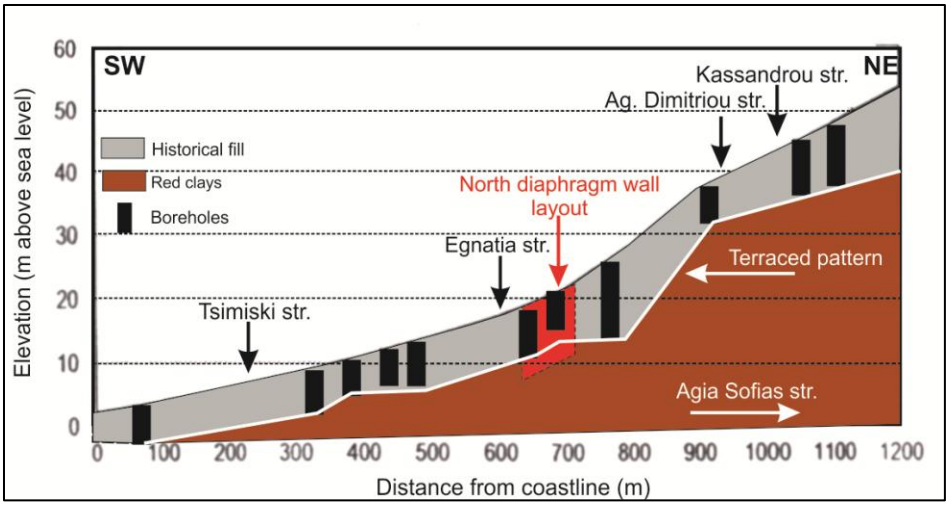
Figure 4. Cross section along Agias Sofias street indicating the terraced pattern of the soil strata underneath the historical fill (modified from Chatzigogos et al, 2006).

The general stratigraphy of the area comprises of the red clays formation which underlies the recent Quaternary deposits and the historical fill, which is the foundation layer of the majority of the buildings in the historical centre of the city. This layer is an extremely heterogeneous formation of substantial thickness that has been formed by anthropogenic activity and consists generally of soil, building materials as well as backfill. The layer's thickness varies locally from 2-13 m without a specific pattern. The layer's characteristics pose serious problems in the assessment of its mechanical properties in terms of construction design parameters. It is classified as SM-CL according to USCS, has a relatively high void ratio (0.65-1.1) and moisture content ranging 15%-25%. The Neogene red clays formation is the main geological formation overlying the gneisses and green-schists of the bedrock. As shown in Figure 4, the clays follow a terraced pattern parallel to the former (natural) coastline of the city, which is due to the NW-SE faults of the bedrock (Chatzigogos et al, 2006).

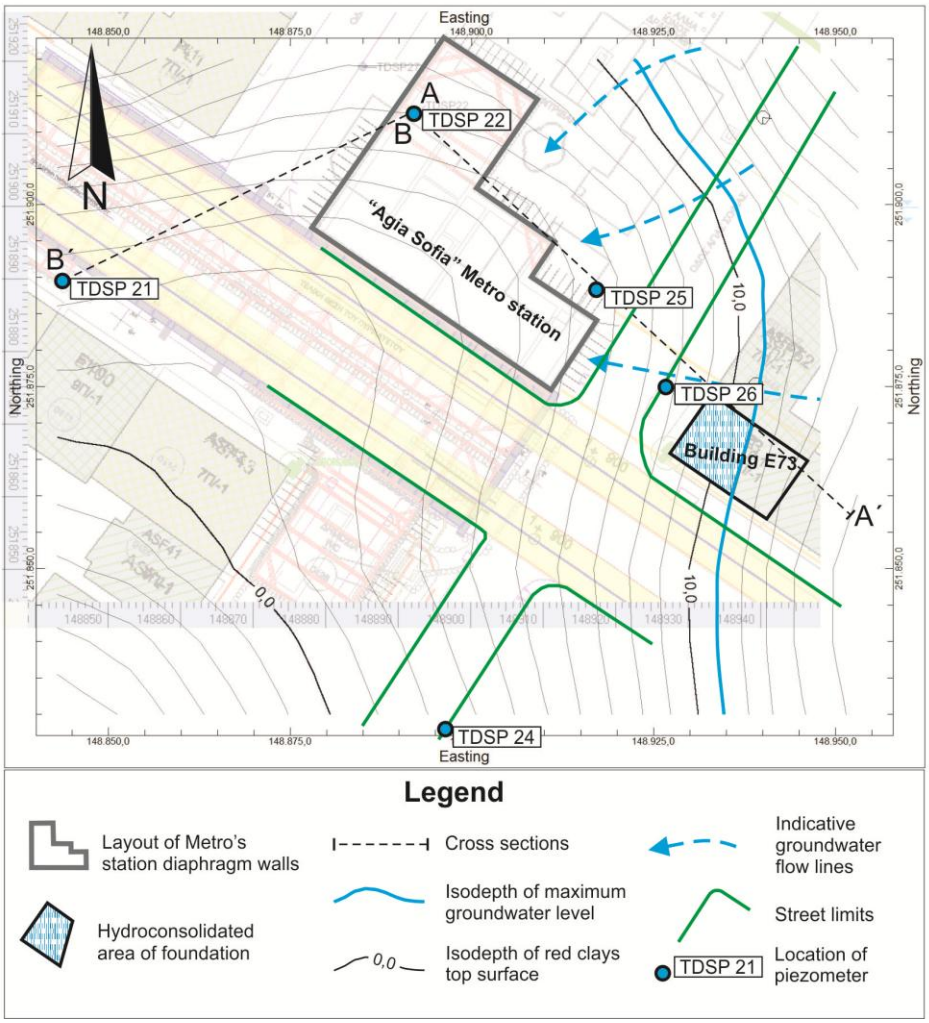
Figure 5. Map of the investigation area with the isodepths of the red clays.

The data used in the analysis were obtained by exploration boreholes that were drilled for Thessaloniki's Metro in the study area. Based on these data the historical fill has a local thickness of 9-10 m whereas the Quaternary deposits that are encountered only at the western part of the study area overlying the red clays have a thickness of 3 m. This stratigraphy forms a perched water table in the historical fill as shown in Figures 5 and 6, with an underground flow direction NE-SW that follows the morphology of the red clays. The underground flow is oriented by a backfilled underground flow network formed on the red clays that were in the past, before urbanization, the surface level formation. Figure 5 shows a map of the isodepth curves of the red clays formation which is the natural boundary of the historical fill. The groundwater level presents insignificant seasonal changes due to the existing structure that prohibits surface water percolation. As a result an unsaturated zone of significant thickness is created above the groundwater table and the geo-materials of this zone have not sustained any wetting during the past.

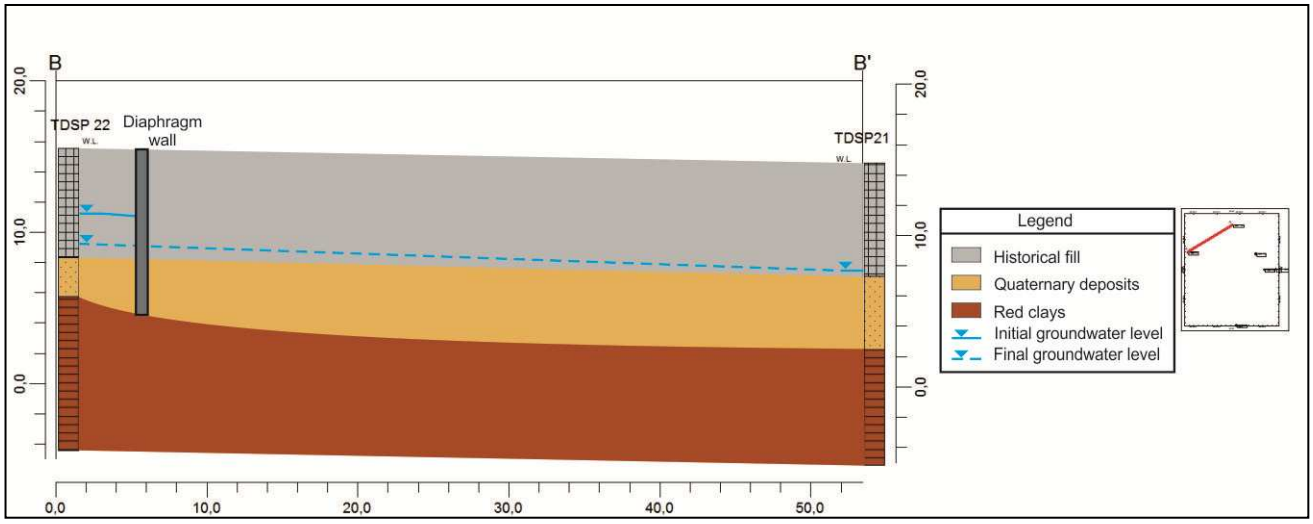
Figure 6.Geological cross section in NE-SW direction along boreholes TDSP22-TDSP21.

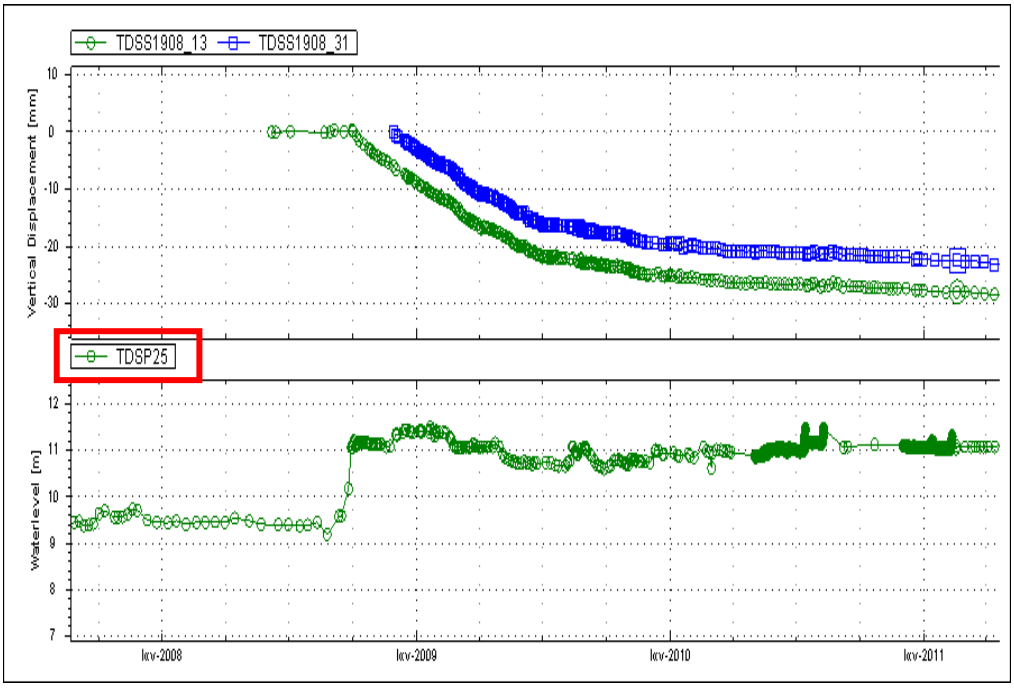
The works in the station begun with the construction of the northern side diaphragm walls. This created a cutoff barrier to the underground flow of the perched water table resulting to a significant local rise in piezometers TDSP22, TDSP25, TDSP26 and TDSP27 shown in Figure 7, as water flow is bypassing around the diaphragm walls. After the bypass to the SW the water level drops back to the normal level and that is why no rise is detected in piezometers TDSP21 and TDSP24 that are located S-SW of the diaphragm walls. The total rise reached 1.5 m and displacements - settlements were simultaneously observed on the aforementioned building (E73) at the corner of Egnatia and Agia Sofia streets. These displacements resulted in a deflection (inclination) of the building towards Egnatia str. (the free face of the building). The displacement reached 30 mm in a time period of 3 years starting from September 2008 (Figure 8). An additional issue that required interpretation was that the displacements did not affect equally the entire area of the building foundation but only its W-SW section and they were observed during a rise and not a drop of the groundwater level.

Figure 7.Settlement in building E73 following the rise of the water table (borehole TDSP25).

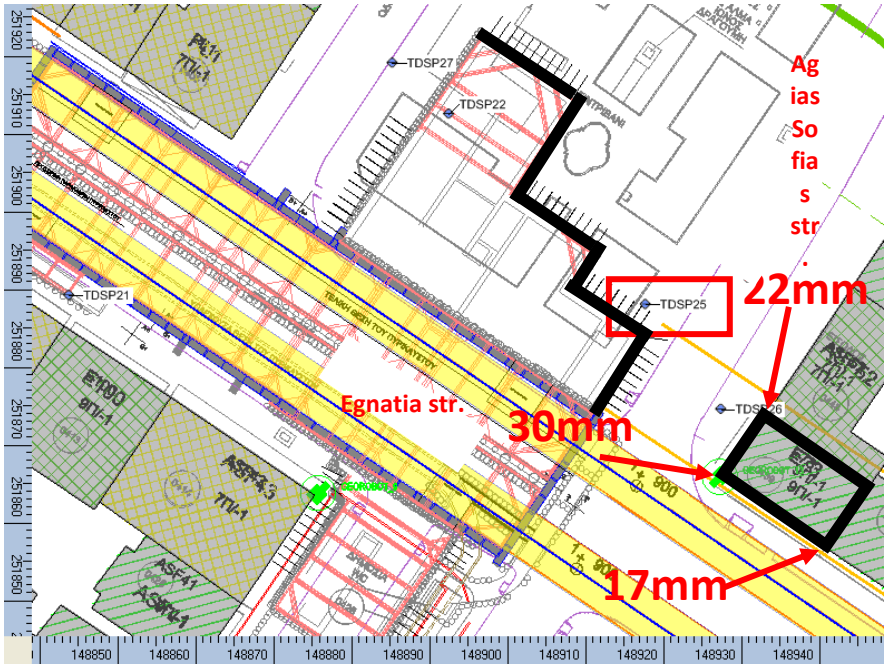
Figure 8.In situ measurements of vertical displacements .

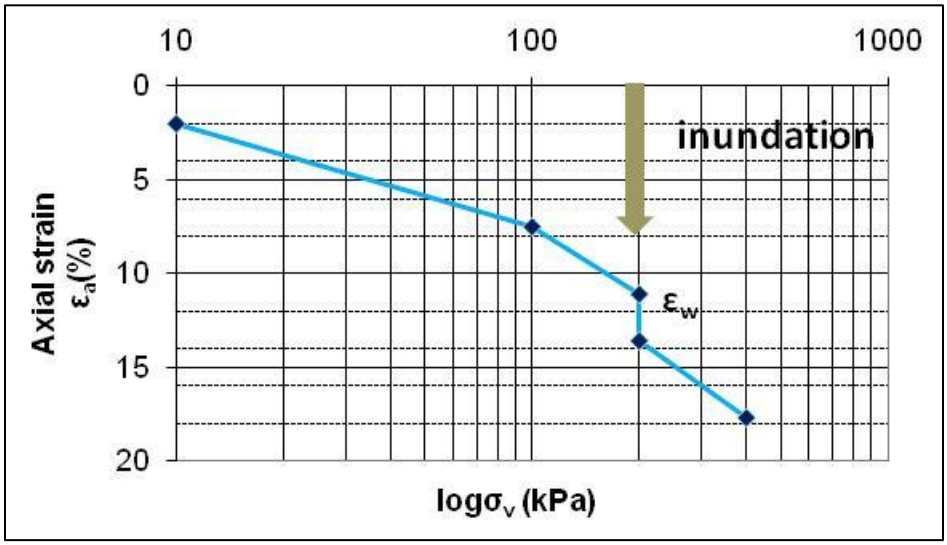
The test program was carried out for samples from the historical layer and Table 1 presents the results for ε_w values due to wetting of the samples under constant load. Figure 9 shows the change of void ratio due to hydroconsolidation of sample 4 for constant load (200 kPa) during wetting. The results of Table 1 produced the characteristic hydroconsolidation curve of the studied layer as seen in Figure 10, which describes the volume change behavior of the layer after wetting under constant load. There is swelling of the layer for stress <95 kPa and volume decrease for stress >95 kPa. As an example, the volume change calculated due to wetting under constant stress of 400 kPa is ε_w=4.1%.

Figure 9.Axial strain due to wetting under constant load of 200 kPa.

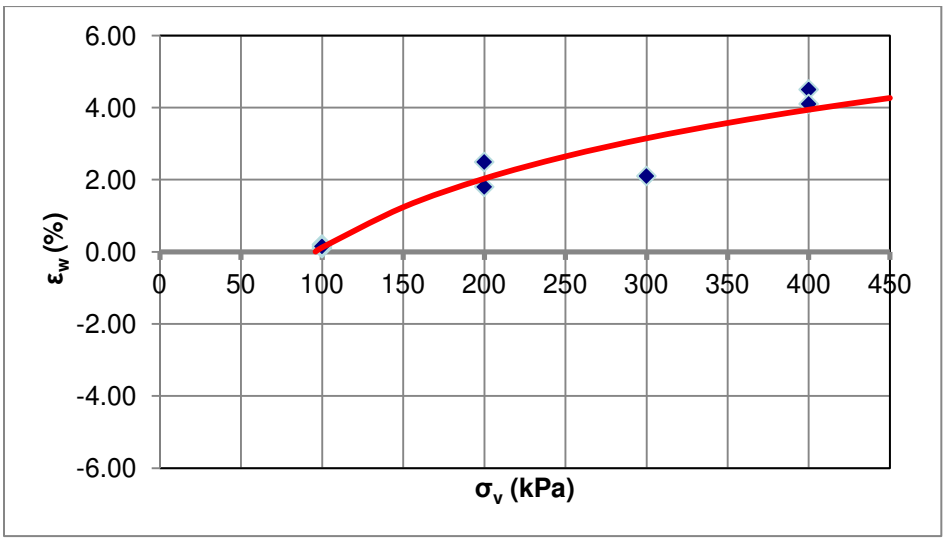
Figure 10.Axial strain due to wetting of Thessaloniki's historical fill at different stresses

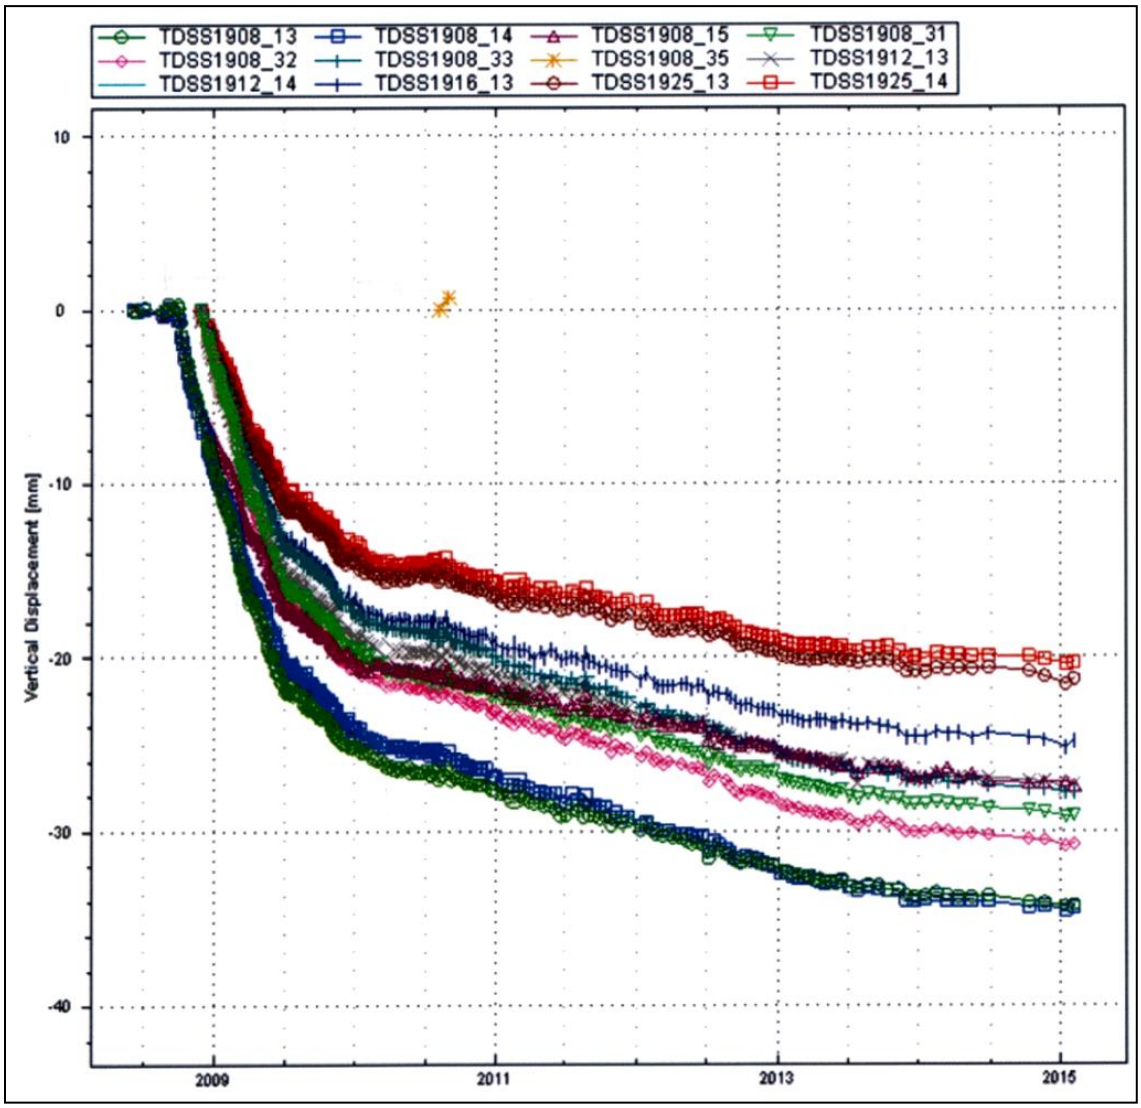
The in situ measured displacements shown in Figure 11 correspond to a maximum deformation of approximately 2.25% due to hydroconsolidation for a groundwater level rise of 1.5 m. The maximum displacement measured at the SW corner of the building for a time period of more than 5 years is 34 mm and still increases. Despite the fact that all measuring points show different magnitude of displacement they all produce displacements of relatively high rate for the initial 9 months and then the rate decreases dramatically. The same mechanism is displayed in the displacement-time curves after inundation in the laboratory tests in Figure 12. An initial deformation at high rate takes place representing the collapse of the structure after wetting and then the soil is consolidated at a much slower rate.

Figure 11. In situ measurements of vertical displacements in the perimeter of building E73.

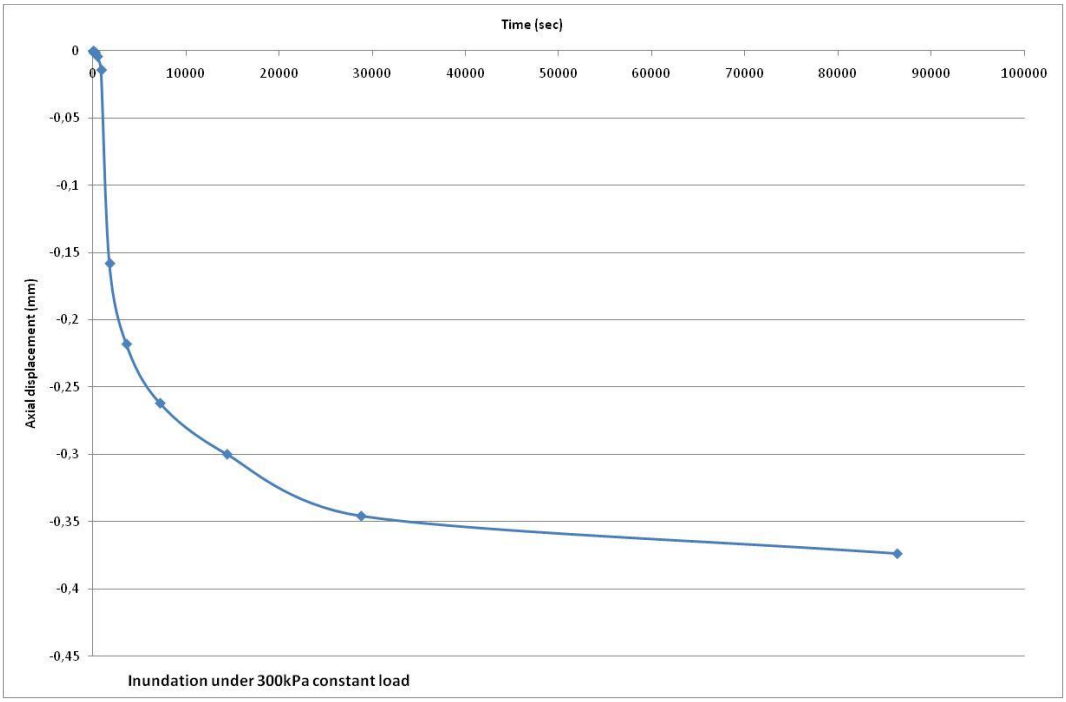
Figure 12. Laboratory displacement-time curves after inundation.

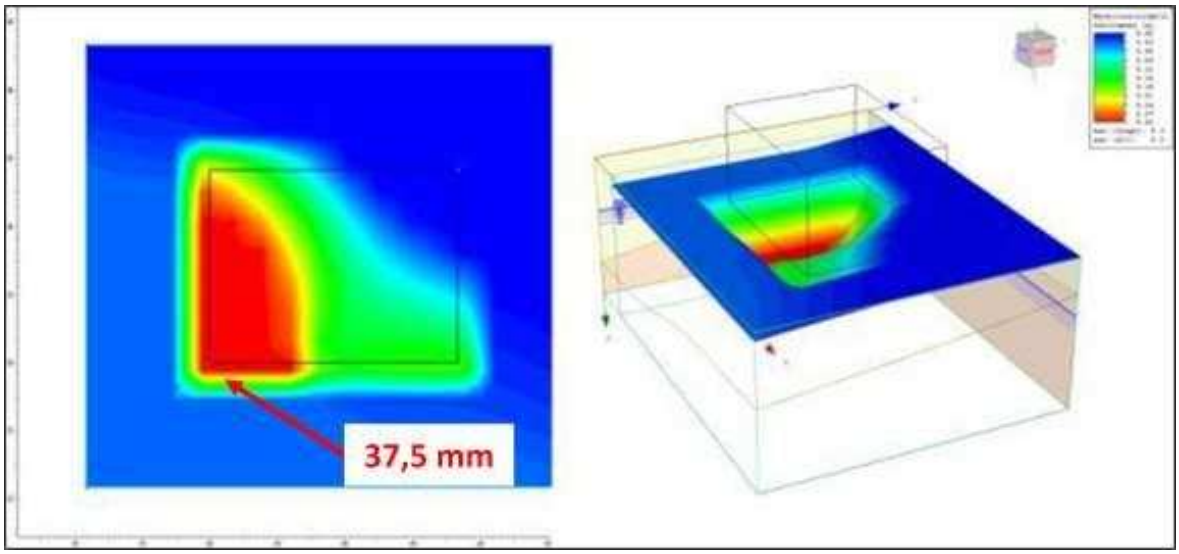
In comparison to the in situ measurements, the anticipated settlements were calculated introducing the layer parameters from the geological model, the groundwater lever rise and the hydroconsolidation characteristics of the layer estimated from the laboratory tests in Settle 3D and the results are shown in Figure 13. As seen from the results there is an uneven distribution of settlements with increased values for the Agia Sofia str. side of the building with a maximum value of 3,75 cm on the SW corner (Figure 13). The Egnatia str. side shows decreasing values of displacements towards E. The calculations correspond to the in situ measurements which also show a gradual decrease of the displacements on the building from SW to NE.

Figure 13. 2D and 3D analysis of hydroconsolidation settlement in building E73.

The differential distribution of settlements is due to the fact that the thickness of the susceptible historical layer (which experienced a maximum groundwater level rise of 1.5 m) is uneven because of its SW dip. Therefore the layer is located

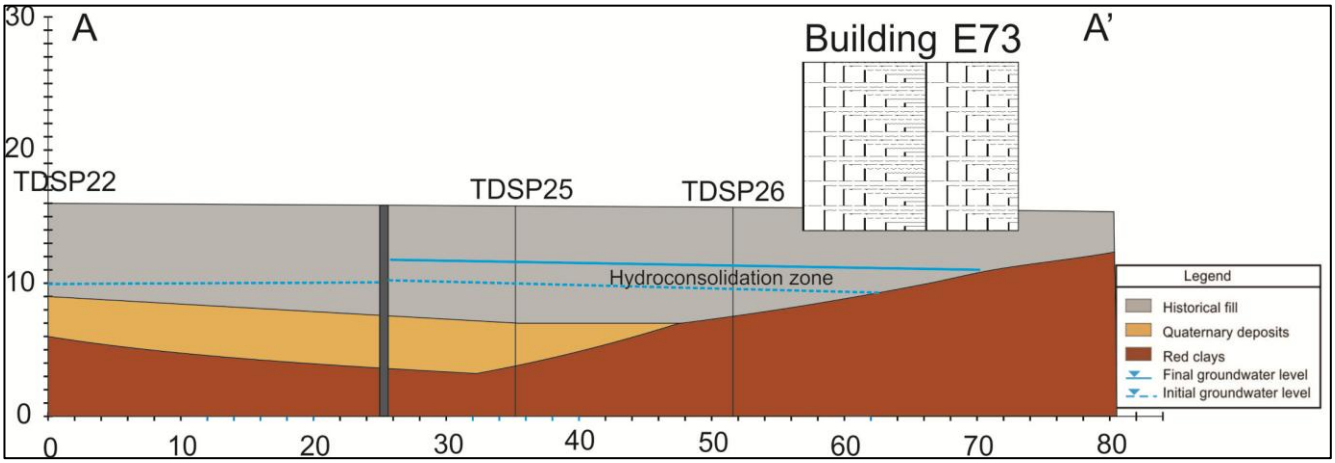
higher towards the NE in respect to the groundwater level and consequently the hydroconsolidated part of the layer becomes less at this direction. Figure 14 shows a characteristic cross section of NW-SE direction that depicts the hydroconsolidated area below the building.

Figure 14. A-A' geological cross-section pointing the hydroconsolidation region.
