Remediation of The Pissouri Landslide in Cyprus

Submitted: 15 May 2015; Published: 16 December 2016
Reference: Alexandris, A., Griva, I.K. and Abarioti, M. (2016). *Remediation of The Pissouri Landslide in Cyprus*. International Journal of Geoengineering Case histories, Vol.4, Issue 1, p.14-28. doi: 10.4417/IJGCH-04-01-02

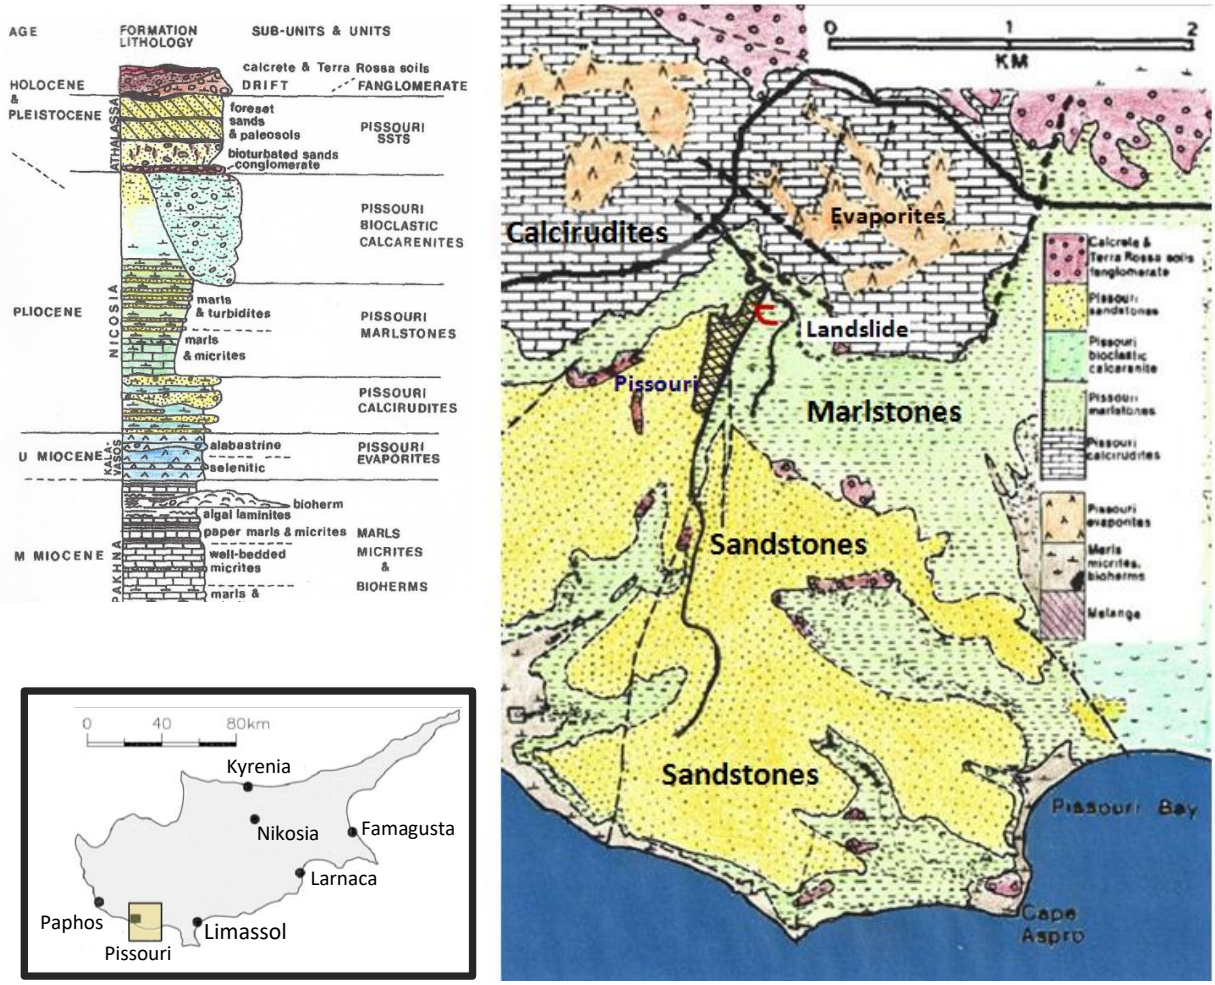
reddish - brown rock which in places disintegrates into a compound of marl blocks within a matrix of stiff fissured silty/clayey soil. The regional distribution of the aforementioned sedimentary units is depicted in Figure 3 (after Stow et al., 1995). The location of the landslide is also noted on the map.

Figure 3. Regional Geology of the Pissouri area. The village is developed on sandstones (yellow) underlain by the Pissouri marls (olive green). Geology after Stow et al., (1995)

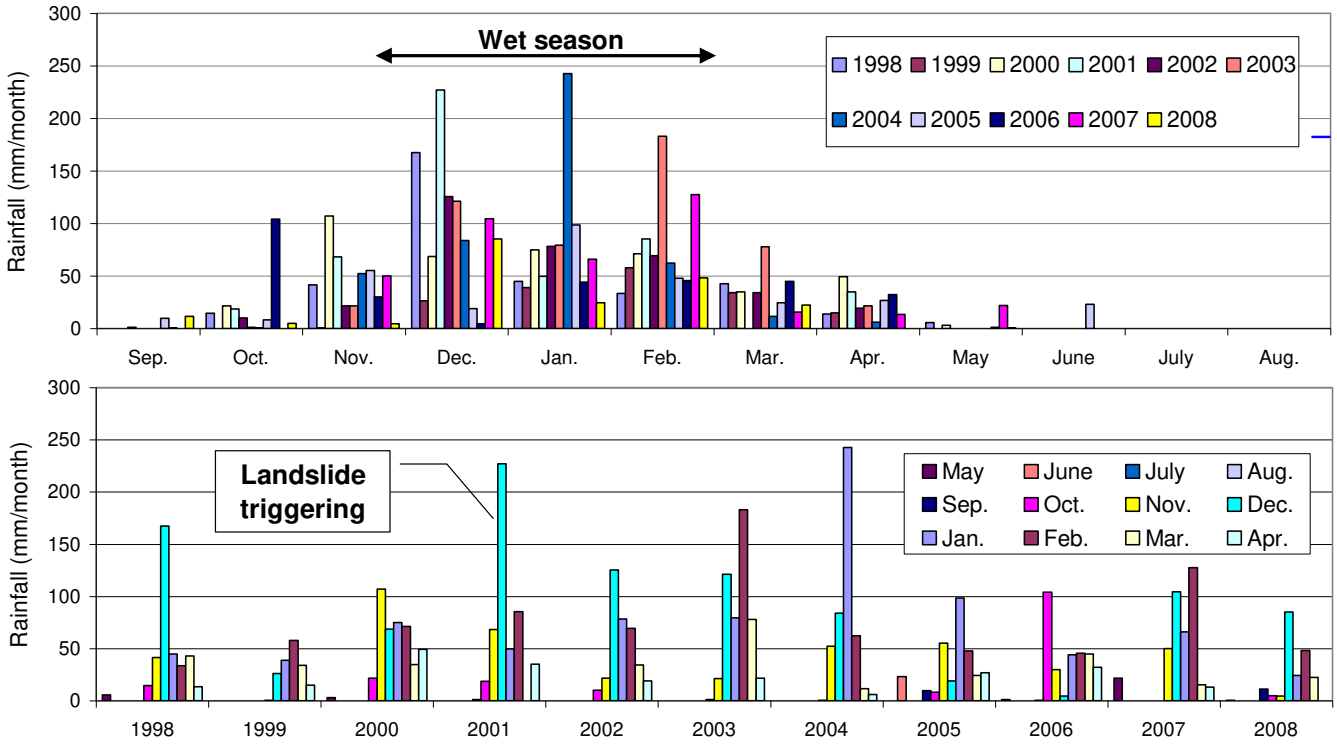
In the Limassol prefecture in particular, the annual precipitation is low, averaging 300-400 mm per year. The monthly rainfall time series retrieved by the Pissouri meteorological station during the 1998-2008 decade is presented in Figure 4. It is observed that during the December of 2001, when the Pissouri landslide was mobilized, precipitation was indeed high, exceeding 230 mm, but not a unique event in the decade. High precipitation undoubtedly triggered the landslide, but the contribution of other factors to slope instability should also be investigated. The high precipitation of December 2001 is associated with subsequent landslide events that took place in other parts of the island, as reported by Hadjigeorgiou et al., (2006) and Kyriakou & Hadjigeorgiou (2008).

Figure 4 Seasonal (upper figure) and annual (lower figure) distribution of monthly precipitation for the decade 1998 ~ 2008. Data from the "Pissouri" meteorological station.

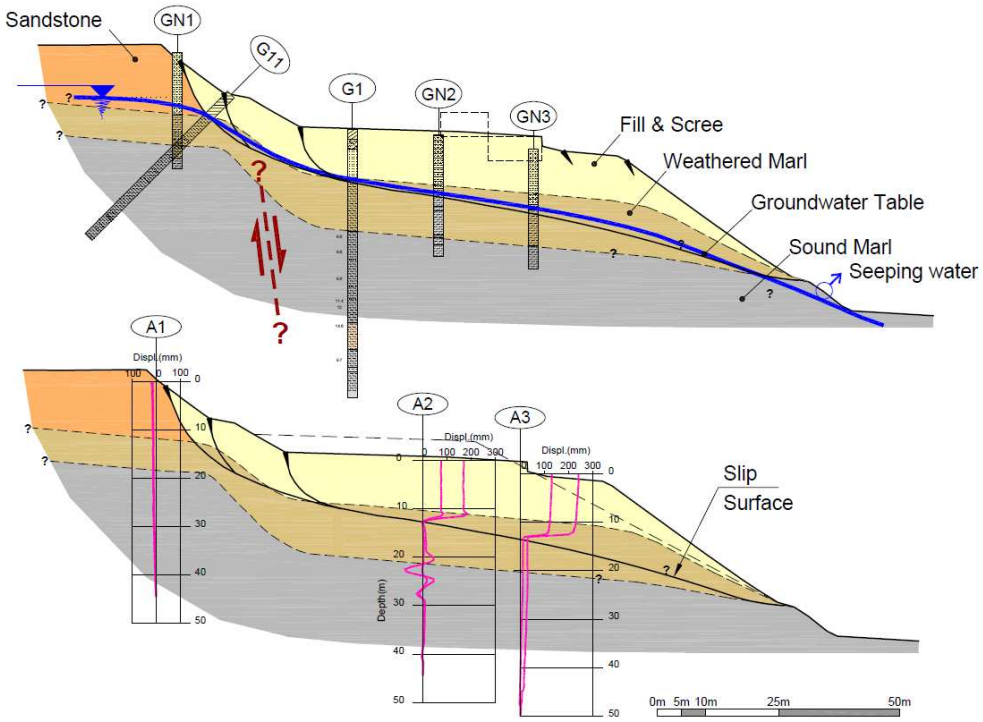
Figure 5. Geotechnical section along the sliding mass. Top: Exploratory boreholes Stratigraphy and ground water table Bottom: Inclinometer readings and location of slip surface.

The slip surface was located by combining the monitoring data from the two inclinometer tubes (A2 & A3) installed within the sliding mass and the careful mapping of slope breaks and cracks, visible on the ground (in some cases), on the cracked pavement of the distorted road, the houses and the paved ground around them. The third inclinometer tube which had been installed further upslope did not show signs of movement (as shown in figure 5) and allowed the identification of the back scarp of the slide with confidence.

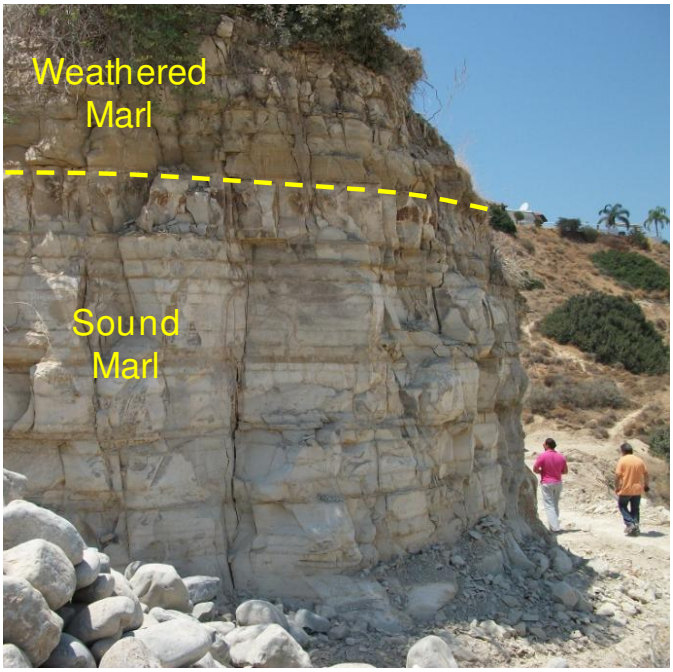
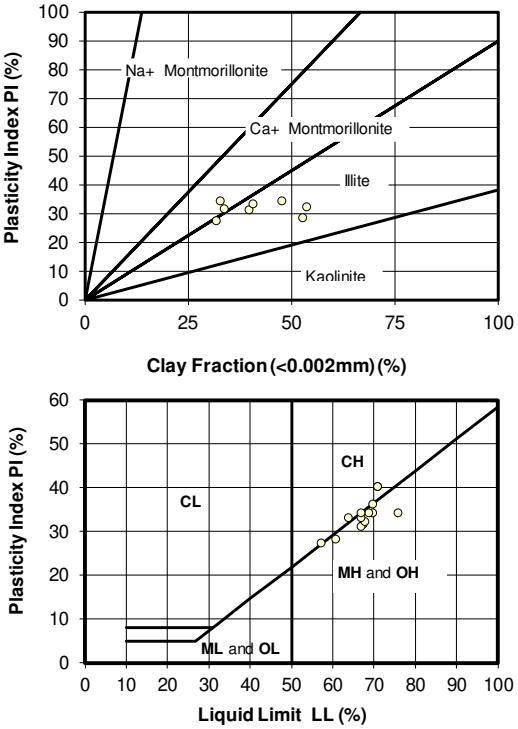
The bedrock is a low strength yellowish calcareous marlstone (UCS≈10 MPa), fairly undisturbed, but marked by a medium to thick bedding (l0 - 100 cm) dipping with a low angle to south-southeast. Stress relief lead to the development of sub-verical joints and fissures and water circulation gradually resulted to the development of a capping weathered crust. Weathering is associated with oxidization and decalcification of the marlstone, the gradual increase in pore volume (further promoting seepage) and subsequent intact strength degradation to that of a stiff soil. In the landslide site the thickness of the weathered marl crust is 5 to 10 meters and the material was encountered in places disturbed and sheared by the landslide movement. The succesion of sound and weathered marl is depicted on the photograph of Figure 6, where the weathered material is noted by the distinct brownish color and its intense fissility. Soil samples obtained from the weathered zone are classified as CH-MH with a plasticity index (PI) ranging from 20% to 35% and clay fraction (CF) between 30% and 60%. Natural water content of the weathered marl does not exceed 30% and the material is generally stiff with SPT values ranging from 25 blows/ft to refusal. Typical classification test results from this zone are also presented in Figure 6.

Figure 6. Left: Typical appearance of the bedded calcareous marl and the overlying weathered crust. Right: Typical soil classification test results performed on samples retrieved from the weathered marl zone.

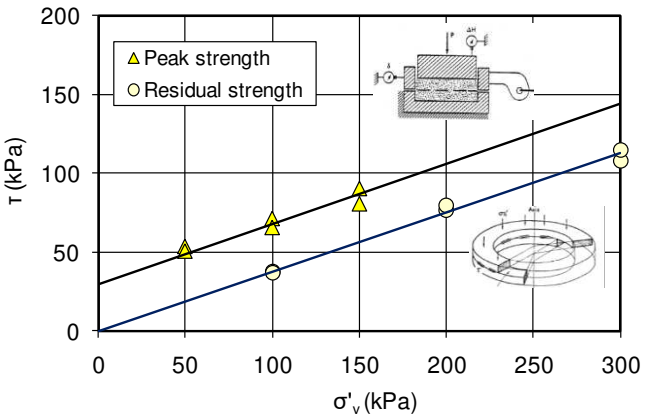
The shear strength parameters of the weathered marl, where the slip surface eventually developed, was investigated in the laboratory by means of a few slow (drained) shear box tests, which averaged to c'=30 kPa and φ'=21° as shown in figure 7. Residual shear strength parameters, were obtained from ring shear tests (Broamhead ring shear apparatus) which yielded values of c_r'=0 and φ_r'=21°. The values of the residual angle of shearing resistance determined directly by the ring shear tests are compared with the dataset presented by Skempton (1985) (Figure 8) and are found to be in the upper bound of the scatter. This is probably due to the fact that the particular ring shear tests were carried out on fairly silty samples (classified as MH) and not on clayey ones.

Figure 7. Shear box and ring shear test results on soil samples from the weathered marl horizon. Peak strength c'=30 kPa, φ'=21°. Residual strength c_r'=0 kPa φ_r'=21°.

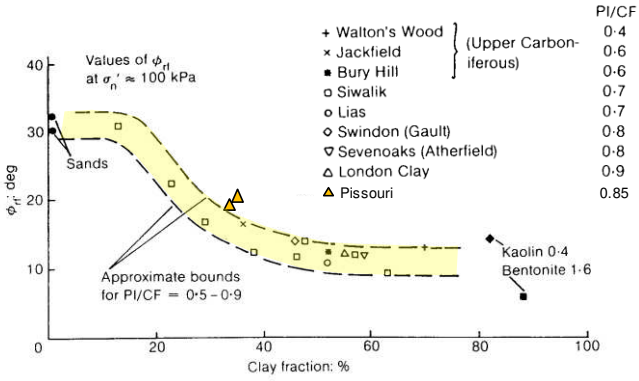
Figure 8. A comparison of the residual angle of shearing resistance of the weathered Pissouri marl with the dataset presented by Skempton (1985).

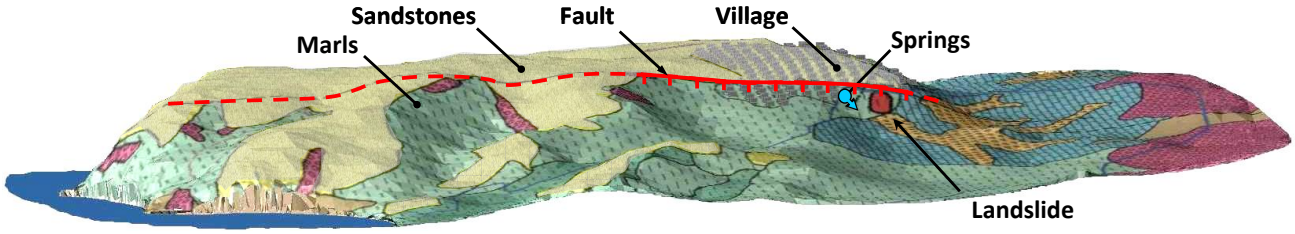
Figure 9. Hydrogeologic setting of the Pissouri area. Geological units (after Stow et al., 1995) are projected on the distorted relief of the Pisourri hill (exaggerated vetical scale H/V 2:1). Location of the landslide and the springs with respect to the major hydrogeologic units are also noted.

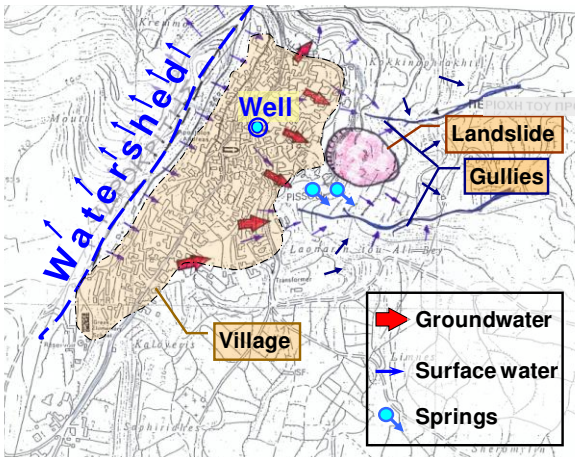
sandstones with the impermeable underlying marls, as shown schematically in Figure 10. A few seasonally discharging springs and water collecting wells have been located at the southeastern edge of the hill, near the landslide site (see Figure 11), which are exploited by local farmers for irrigation. A probable fault trending NNE-SSW, mapped by Stow et al. (1995), is running parallel to the eastern boundary of the village and dissects the sandstone layer. This fault is believed to control the steeper slopes of the Eastern side of the hill and is probably associated with the presence of the water springs down slope.

Figure 10. Surface and subsurface drainage patterns. Arrows indicate surface and subsurface water flow. Springs and wells are also noted.

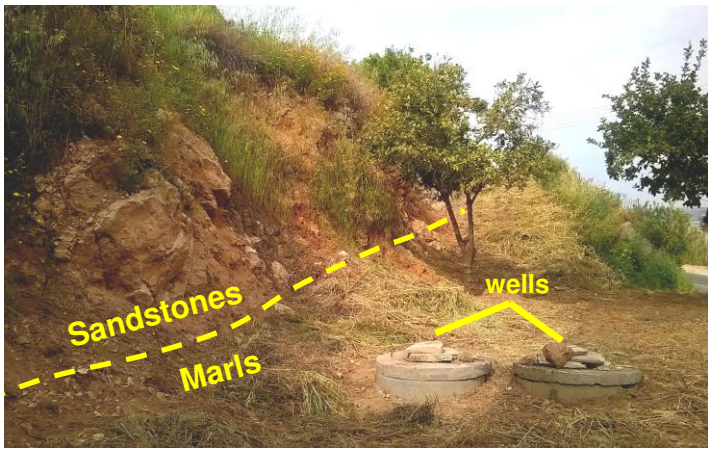
Figure 11. Wells collecting groundwater springing out freely in the sandstone-marl contact area were located a few hundred meters south of the landslide area.

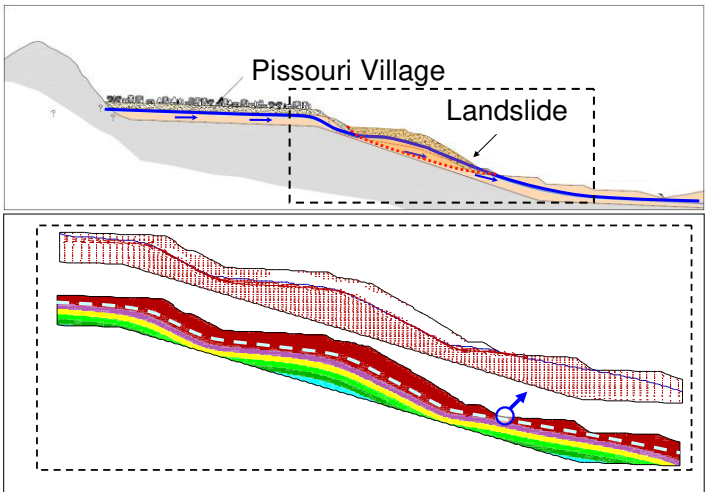
Figure 12. Typical results of the seepage analysis (flow vectors and pore water pressures).

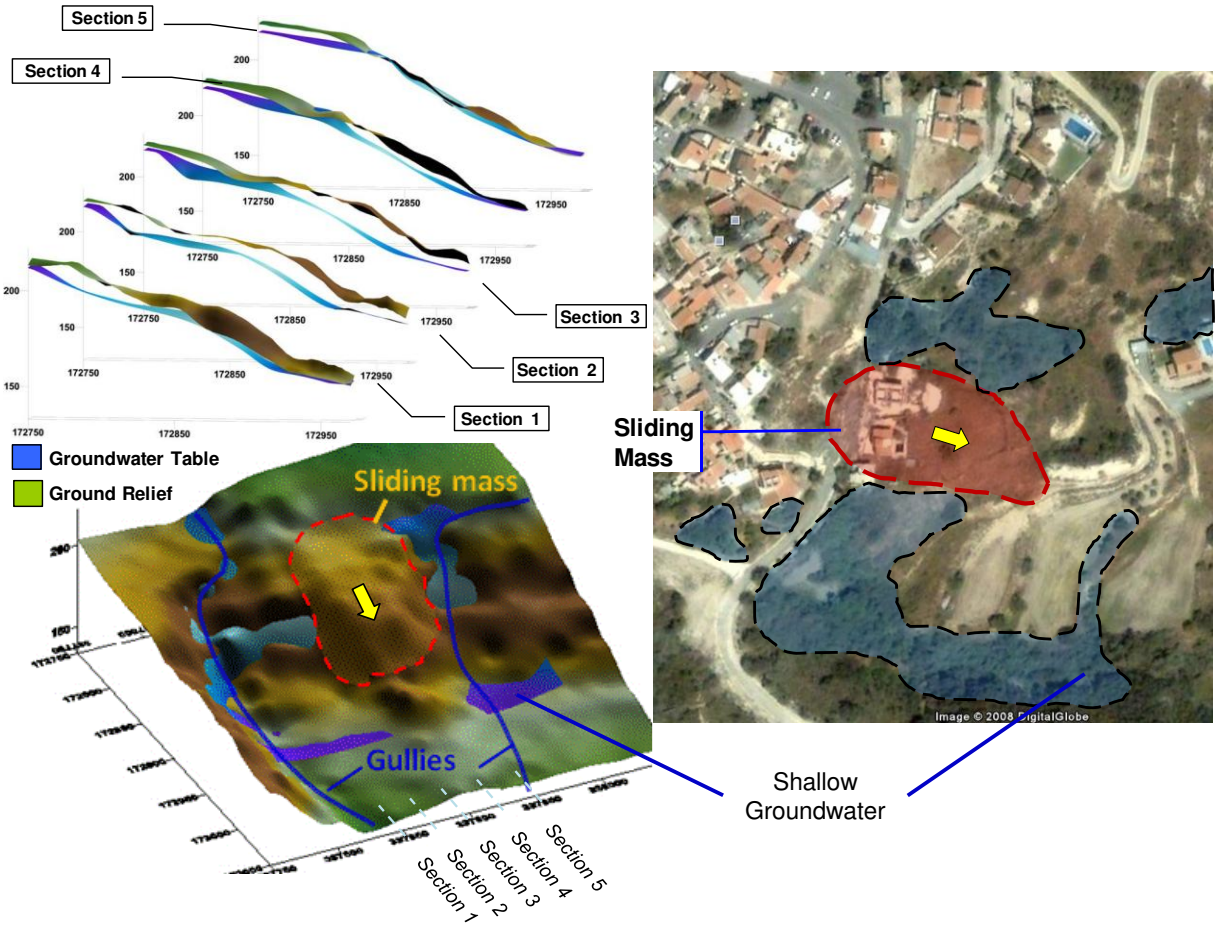
photographs, (Figure 12) and compares well with groundwater level measurements from piezometers installed in the vicinity of the landslide. The piezometric surface of Figure 13 represent the average dry season water table. During a wet season the water table within the landslide mass is expected to rise significantly and the development of a perched water table during thunderstorms should also be considered.

Figure 13. Left: A digital elevation model of the landlide area, overlain to the surface of the computed groundwater table. The groundwater table geometry is also presented as a series of sections in the upper figure. Right: Blue areas in satelite image indicate areas where the ground water table is at shallow depth and coincide with the most densely vegetated areas.

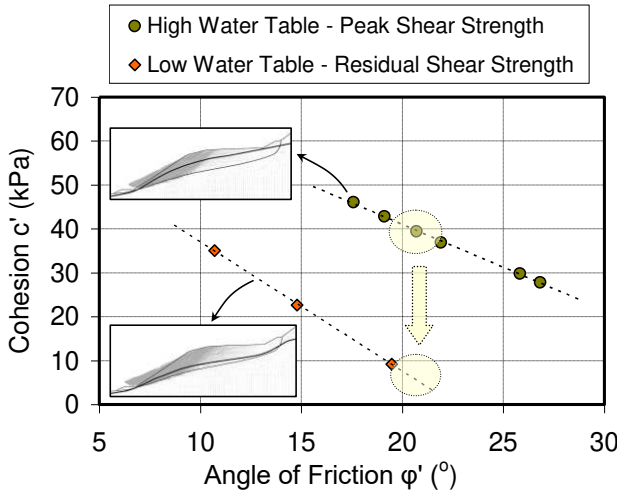
These analyses manifested the fact that an elevated water table can mobilize the weathered marl crust with operational shear strength parameters close to the peak values, as they were determined by the shear box tests performed on the soil samples. They also show that the slide remained mobile after water table lowering, (dry season) if the operational strength values of the weathered marl crust at the failure surface were close to the residual strength values, determined by the ring shear tests. It is concluded that most likely we deal with a new slide, which was brought in the verge of failure due to gradual loading of the upslope area with scree and manmade fill and the gradual progression of the weathering process. The development of high water pressures triggered an already mature slide, which continued to be active even during the dry seasons due to the drop of the shear strength values from peak to residual.

Figure 14. Back analyses results. Estimated mobilized shear strength parameters for a higher and lower water table coincide with the transition of shear strength values from peak to residual.

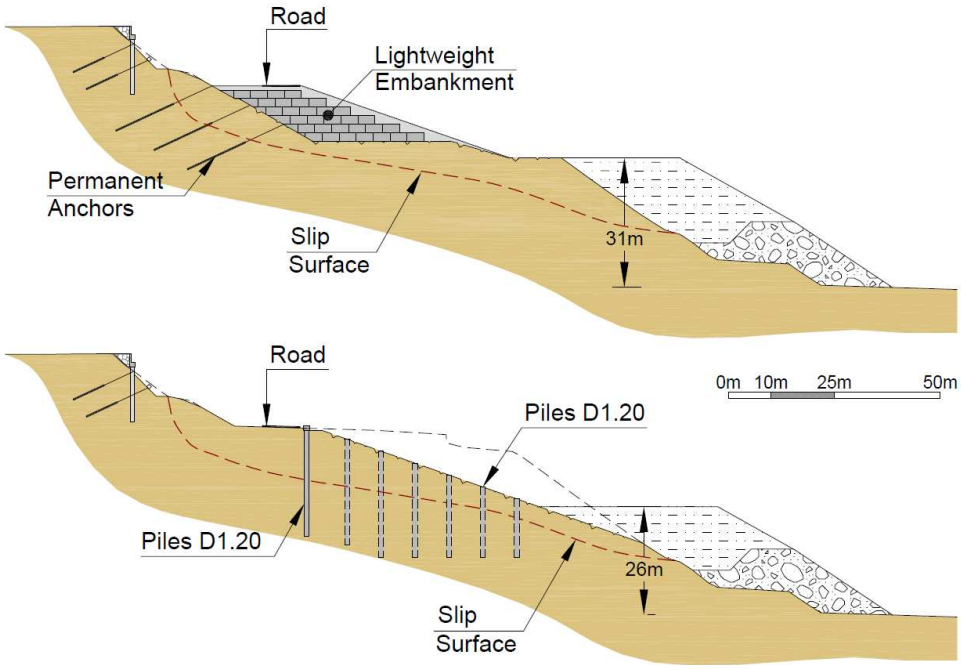
Figure 15. Landslide remediation - Alternative design solutions.

In order to develop a robust remediation strategy and to meet the value engineering requirements set by the district administration, alternative stabilization strategies were considered, coherent design options were developed, and subsequently evaluated in terms of economy, constructability and environmental compatibility. A wide spectrum of alternatives was investigated. An initial thought to completely abandon the site and deviate the road did not prove to be feasible. Stabilization of the slide solely by a high and massive toe stabilizing buttress proved also impracticable. Consequently the construction of a modest toe buttress and the simultaneous reduction of ground weight at the upper part of the sliding mass via ground removal and its replacement by lightweight material (EPS geofoam) was the first option developed. A second option involved the construction of a medium sized toe buttress, the trimming of the upper part of the sliding mass to remove as much of its weight as possible and the dowelling of the remaining soil mass, by means of large diameter bored concrete piles. Outline design of the two alternatives are presented in figure 15.

The last option proved to be more robust, reliable, cost effective, and better fit to the constructability requirements, since it required materials, equipment and expertise available locally on the island. It was also found that it had a smaller impact to the landscape and the environment in general. After deciding to adopt this solution, the design was further developed, the construction procedure was studied more thoroughly and every construction stage was checked by means of detailed stability calculations. The layout of the adopted solution is presented in figure 16. The lower part of the landslide is stabilized first by means of a toe buttress fill resting on a drainage blanket, to allow for unobstructed drainage of the natural ground behind it. For the existing gullies running along the two sides of the sliding mass, erosion protection works (lining of the stream courses with gabions) were foreseen to protect the native soils and the toe buttress. Bored piles 1.20 m in diameter were placed in a staggered, 12×12 m pattern further up on the trimmed slope, to dowel the existing slide surface, but also to prevent shallower slides on pre-sheared surfaces from being mobilized, especially during the anticipated development of perched water tables during the more intense rainfall events anticipated. Along the downslope borderline of the road, a row of bored piles, 1.20 m in diameter at 3.0 m spacing, was designed, to reduce the amount of fill necessary for resetting the road pavement at its initial elevation and to ensure the integrity of the road pavement from ground movements. Sewage pipes running under the road pavement were carefully constructed to ensure that no leakage would escape and infiltrate within the sliding mass. The back scarp area which was left by the landslide movement as a degrading steep slope was protected and stabilized by means of a permanent anchored wall. This intervention fulfilled also the requirement to protect the buildings situated on the upslope crest. Groundwater within the remaining sliding mass was decided to be controlled by constructing a trench drain at the back scarp area of the landslide, which would collect the water seeping from the uphill area and discharge it towards the neighbouring gullies.

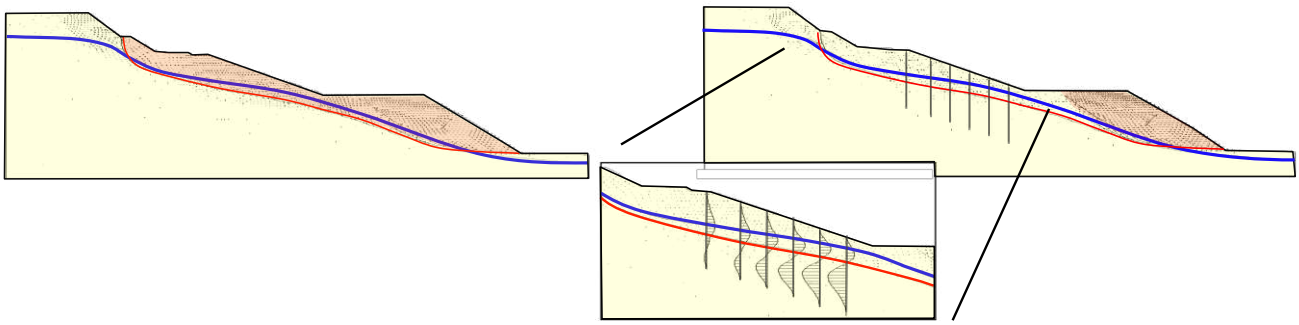
The construction of the toe buttress and the trimming of the upslope area of the landslide, lead to sufficient factors of safety (FOS=1.6) under normal conditions (low water table, static conditions), which though drop to low values with an elevated water table and very low values under seismic conditions. It was also observed that these low factors of safety are associated with mobilization of the entire sliding mass. The dowelling effect of the bored piles isolates and stabilizes the upper part of the sliding mass, while the lower part may remain more critical but still with sufficient FoS. Figure 17 depicts the critical sliding mode with and without the dowelling piles. In this case the raised water table yield a FOS = 1.6 and the seismic analysis a FOS=1.15.

Figure 17. Stability analysis of the remediated slope. Left: Without the stabilization piles the entire sliding mass mobilizes as a single body. Right: With the addition of the piles the toe buttress is more critical.

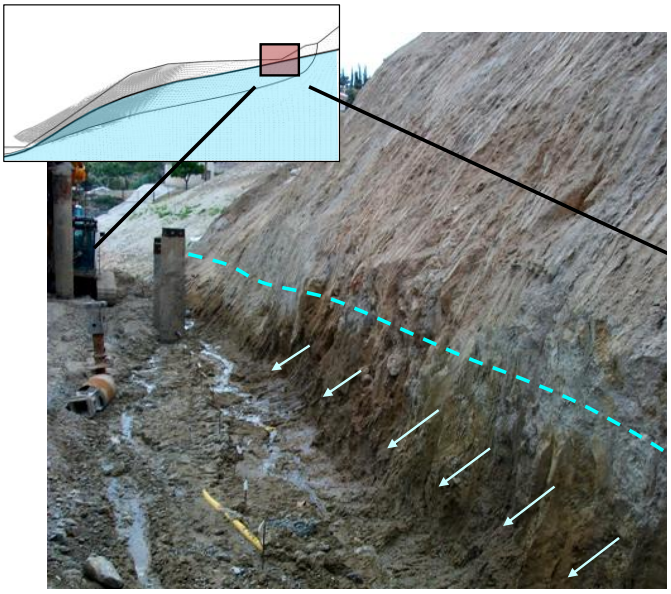
Figure 20. Water seeping out of the marl at the landslide back scarp

Figure 21. Trench drains filled with cobles wrapped in geotextile filter collect and dispose the groundwater.
