Geotechnical Damage Caused by the 2016 Kumamoto Earthquake, Japan

KEYWORDS: 2016 Kumamoto earthquake, damage survey, liquefaction, embankment, landslide, volcanic soil

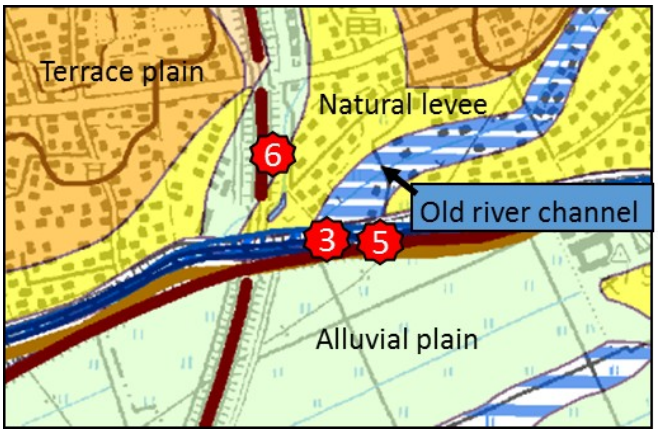
Figure 7. Landform classification map and location of the damaged sites (Modified from GSI's map).

Figure 6 shows the typical liquefaction-induced damage to a river levee (site 3). Large settlement and lateral deformation was found at the levee along Akitsukawa-River. According to a landform classification map for flood control, provided by Geospatial Information Authority of Japan (GSI) shown in Fig. 7, the damaged levee is located at the old river channel, which suggests that a shallow soft deposit liquefied, inducing lateral spreading toward the river. Kyushu Regional Development Bureau of MLIT (2016) reported damage of variable severity to the levees of the Midorikawa-River and Shirakawa-River. They identified a total of 171 sites, however, their emergency restoration was almost completed as of middle of May. The settlement of levees, for example, caused a large gap between the embankment and bridge girders leading to a transportation problem (Figure 8, site 4). As of the end of April, such problems have occurred at many locations, however, they have been temporally solved by the installation of a filled slope (Figure 9, site 5). Although the locations of liquefaction are widespread in Kumamoto City (Wakamatsu et al., 2016), there have been no official report of serious liquefaction-induced damage; there are neither collapse of buildings nor washout of levees due to liquefaction.

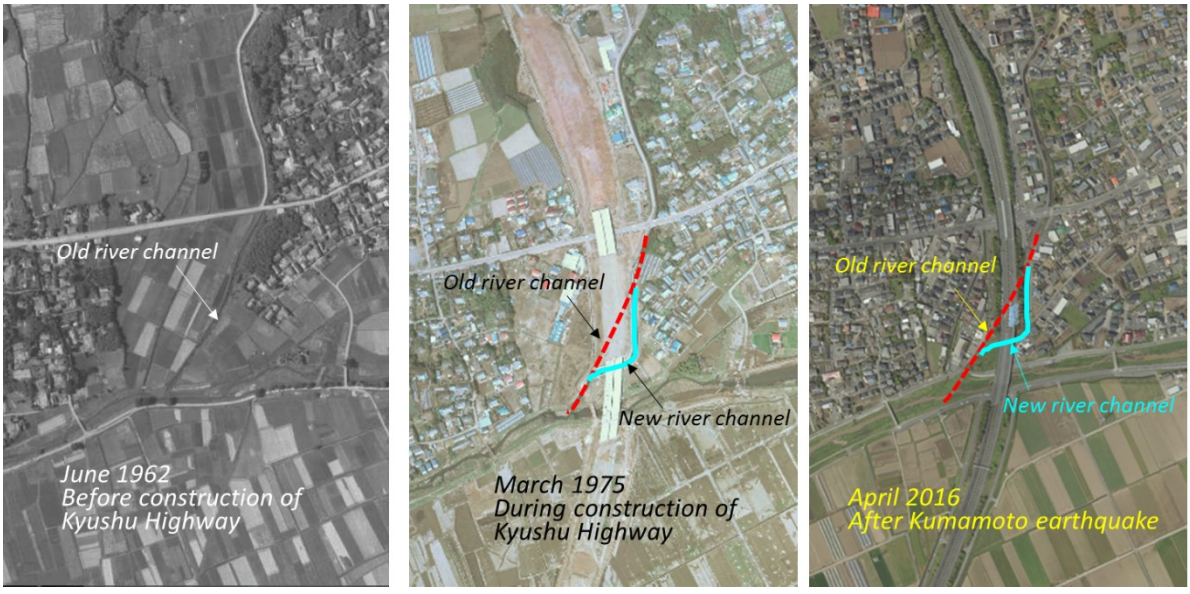
Figure 11. Aerial photo of damaged highway embankment before and after the 2016 Kumamoto earthquake (Modified from GSI aerial photo).

At site 6 in Fig. 3, a 50 m-long embankment on one side of Kyushu Highway, which connects Fukuoka to Kagoshima, suffered from significant damage (Fig. 10). The damage was caused by the earthquake on the 14th of April, in the form of subsidence and lateral flow. The highway was closed to traffic until the end of April, which disrupted emergency distributions in the affected areas. According to the land classification map (Fig. 7) and old aerial photos taken before the construction of the highway provided by GSI (2016) (Fig. 11), the exact location of the damaged embankment use to be a small river channel, which suggest that the process of liquefaction of saturated loose filled soil was the potential cause of damage to the embankment. In fact, the residential house near the damaged embankment suffered from large tilting as shown in Figure 10, indicating a bearing capacity lowering of foundation ground due to liquefaction.

Since the other side of the embankment survived the earthquake, as an emergency response, the number of driving lanes at the damaged embankment was temporary reduced to one in each direction, and only the one-lane reopened from the 29th of April. Due to the critical importance of the Kyushu Highway, however, careful investigation shall be conducted to thoroughly understand the cause of the damage observed and to propose effective countermeasures for the conclusive restoration of the embankment.

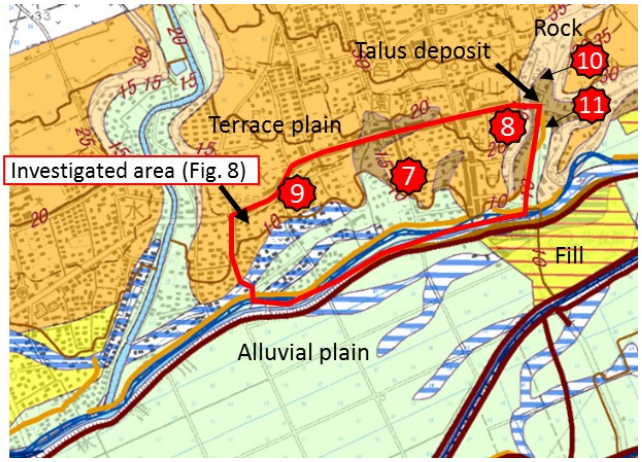
Figure 14. Landform classification map around the survey area in Mashiki Town (Modified from GSI's map, c.f. Fig. 12).

According to the landform classification map in Fig. 14, the significantly damaged area (yellow-colored in Fig. 12) consists of terrace plain (late Pleistocene), talus deposit and alluvial soil. The area is also gently sloping to the south, thus different site amplification effects due to the different soil conditions and residual deformation of sloped ground may be expected. There were some reported cases following recent earthquakes in Japan where residential houses in a developed area of sloping ground suffered from significant damage due to ground deformation associated with a large scale landslide (Mori et al., 2012). A walk-through survey was therefore conducted to understand the effects of ground deformation on the damage to houses in this area.

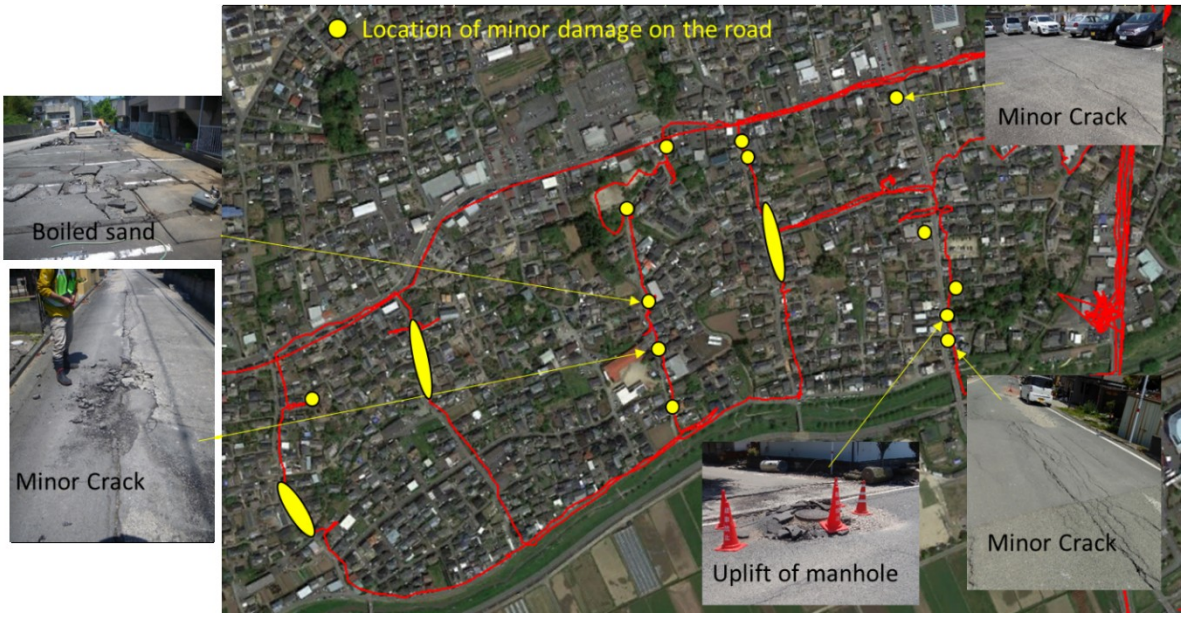
Figure 15. Result of survey on ground deformation of sloped residential area in Mashiki Town (c.f. Figs. 12 and 14).

Figure 15 shows the result of the authors' quick survey. The spatial distribution of the collapsed houses was concentrated in the sloped area which consists of terrace and talus deposits, whereas ground deformation observed on the roads near the damaged houses was limited, therefore a large scale landslide might not have occurred. The cause of significant damage to the houses in this area was likely due to earthquake motion and the residual displacement of the entire sloped ground had an insignificant effect on the damaged houses. Although some houses were found to be damaged by ground deformation, as shown in Fig. 16 and 17 (sites 8 and 9), they were likely caused by localized failure of filled soil. On the other hand, the damage to the houses in the alluvial deposit area was limited whereas evidence of liquefaction was found frequently as shown in Fig. 15. It is inferred that the liquefied soil incidentally behaved like a seismic isolation system for the residential houses in this area.

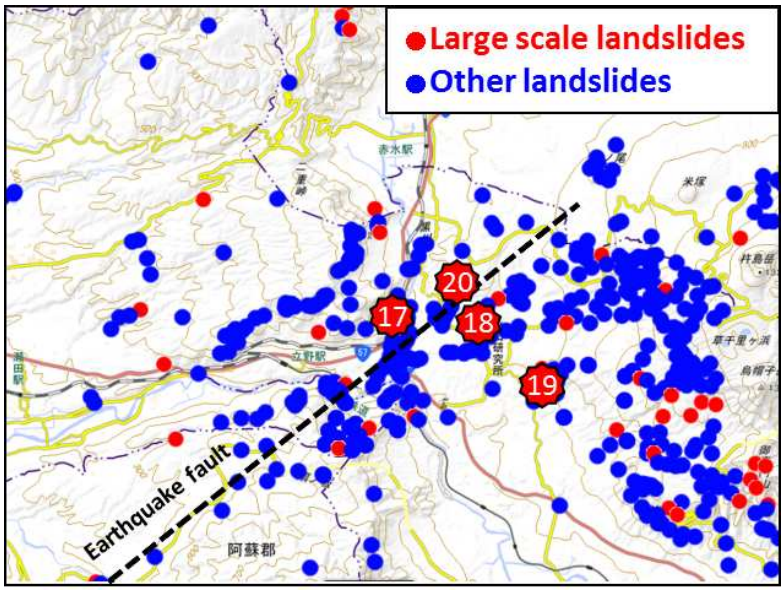
Figure 27. Positional relationship between fault and landslides in and around Aso Caldera area (Modified from landslide map of GSI, 2016).

A large number of natural slopes and road embankments failed in Aso Caldera area. Figure 27 shows the positional relationship between earthquake fault and landslides caused by the Kumamoto earthquake. The landslides in the figure were mapped by GSI (2016), and the data is available on their website. Aerial photos taken before and after the earthquake were used to generate this map. A spatial distribution of earthquake-induced landslides is affected by the fault mechanism (Hasi et al., 2011). The map shows that the landslides are on both sides of the seismic fault. This may be because a strike-slip component was the dominant fault movement of the earthquake.

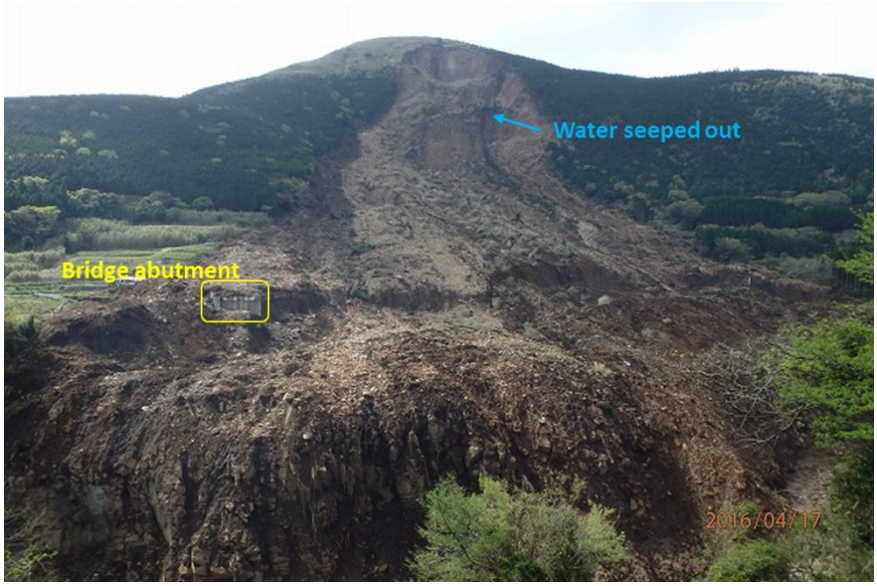
Figure 28. Landslide near Aso Ohashi Bridge (site 17 in Fig. 26). (32° 53'0.02"N, 130° 59'22.80"E).

Figure 28 shows a shallow landslide near Aso Ohashi Bridge caused by the main shock on the 16th of April (site 17). The landslide had a height of about 300 m (measured from the road level to the scrap) with an inclination angle of about 50 degrees at the top and about 25 degrees at the middle and bottom of the slope. The debris was a mixture of middle Pleistocene volcanic soils and boulders (tuff breccia); Route 57 and JR Hohi Main Line (railway) was also covered by it. The debris travelled a distance exceeding 800 m and fell into the Kurokawa-River along with Aso Ohashi Bridge. Evidence of mud debris was found on the opposite side of the river which is thought to have travelled along the bridge before its collapse. For this reason, the cause of bridge failure is considered to be the impact force and/or weight of debris that flowed down from the landslide source. Moreover, in Figure 28, taken one day after the event, water seeped out from the failed surface, which may explain the reduction of shear strength of the slope ground due to increase in excess pore water pressure during the intense earthquake.

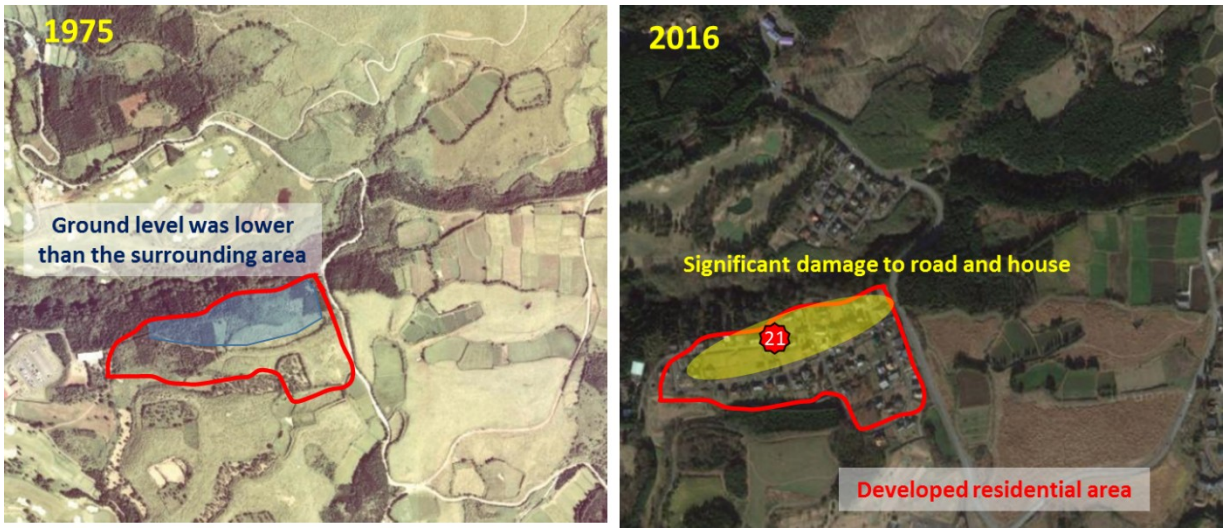
Figure 34. Aerial photo of damaged residential area in 1975 and after the 2016 Kumamoto earthquake (Modified from aerial photo of GSI, 2016).

Figure 32 and 33 show damage of the road and house at site 21. Although this area reportedly survived the earthquake on the 14th of April, significant distortion of subsurface ground occurred during the main shock on the 16th of April. The spatial distribution of damage was severe at the northern part of the residential area. Figure 34 shows a comparison of aerial photos taken in 1975 and in 2016 (GSI, 2016), indicating that the damaged area use to be a paddy field but had subsequently been infilled during the construction of the housing estate. The filled soil in the damaged area is a local volcanic ash soil. Tanoue et al. (2005) reported that it is usually hard to construct a stable embankment from the ash deposited in the Central Kyushu area. It seems from Fig. 34 that the ground level of the northern part of the residential area was comparatively low in 1975, the filled soil might have been thicker for the northern side than the southern side. This might be why the earthquake-induced damage to the land was found to be severe in the northern side, however, structural damage to the residential houses in this area was negligible despite large ground deformation.
