St. Isaac Cathedral (St. Petersburg, Russia): A Case History

ABSTRACT: *St Isaac's Cathedral in St. Petersburg was completed in 1858 after 40 years of construction; it is today the fourth largest domed Cathedral in Europe. The underlying soil is a relatively soft saturated sediment and carries this 3155 MN structure that is 100 meters high with an imprint of 92 m by 100 m. It is founded on a 7.5 m thick mat of granite and limestone blocks resting on relatively short timber piles of different lengths. The Cathedral has progressively experienced significant deformation including differential settlement causing cracks in the pillars and tilting of the porticoes. The paper summarizes the available geotechnical engineering and engineering geology aspects of the soil on which the Cathedral is built as well as classical issues such as foundation ultimate capacity and settlement analysis through simple calculations and numerical simulations. It also includes some less classical issues such as the influence of microbial activity on the behavior of the Cathedral through the changes the microbes and their activity create in the engineering properties of the soil and in the groundwater compos

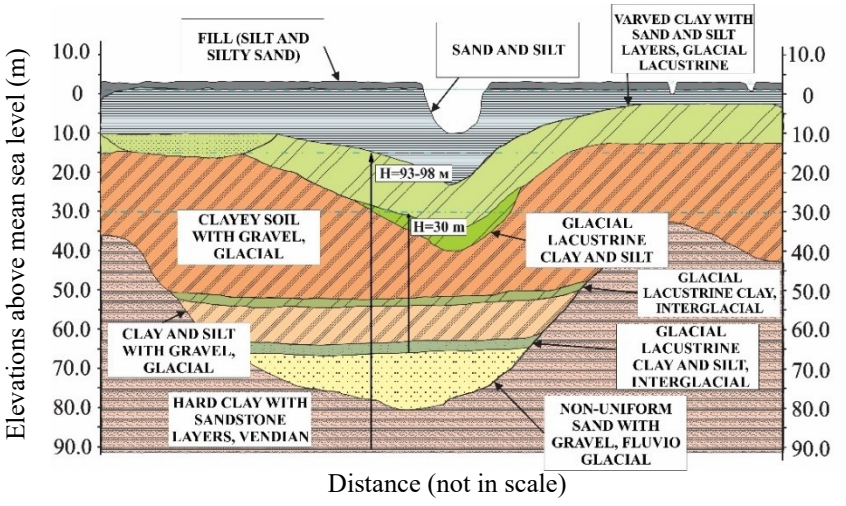
Figure 2. Soil stratigraphy below the downtown St. Petersburg.

Fig. 2 shows a typical soil profile through downtown St. Petersburg. The two main strata from the geological point of view are surficial non-lithified saturated sand-with-clay deposits of quaternary age which are about 400,000 years old underlain by an older lithified clay strata called the Upper Vendian clay which is about 600 million years old. The quaternary soils were deposited during a series of periods including three glacial periods, two interglacial periods, an upper glacial period and a post glacial period. The thickness of the quaternary deposits varies from 20 m to 120 m and the elevation of the top level of the lithified Vendian clay depends on the erosion depth of the ancient rivers into the lithified Vendian clay. The thickness of the quaternary deposits is 20-25 m outside the buried river valleys and 20-120 m inside the buried valleys.

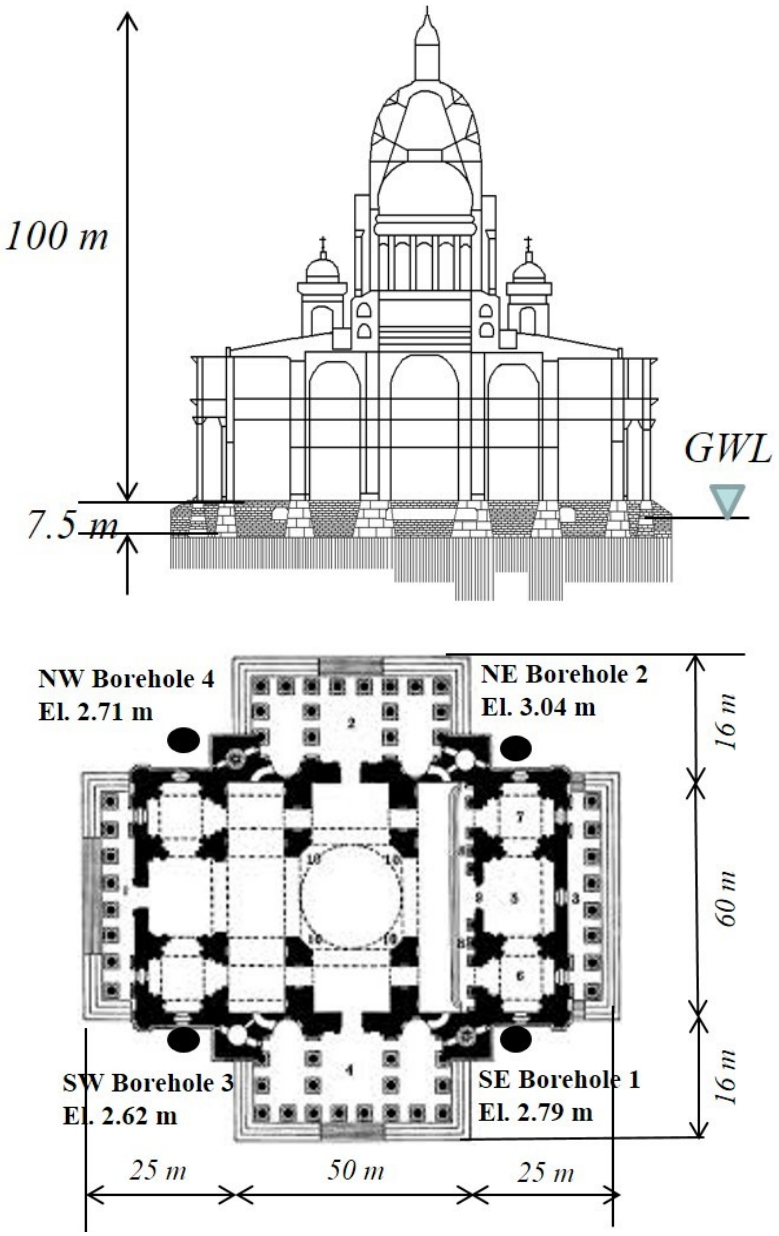
Figure 3. Cross section and plan view of St. Isaac Cathedral

The pile cap consisted of a full-size mat made of massive granite blocks under the most heavily loaded elements, with limestone masonry for the remainder of the foundation. The mat was 7.5 m thick and rose 2.5 m above the ground level. In the 7.5 m thick mat, 2.5 m by 2.5 m galleries were constructed. The weight of the mat is estimated to be 997 MN (Sotnikov, 1986). The total height of St. Isaac Cathedral is 100 m (Fig. 3). The overall length of the Cathedral with porticoes is 100 m, and its width is 92 m. The total weight of the Cathedral structure above the mat is 2158 MN for a total weight on the soil below the mat of 3155 MN. This makes St. Isaac Cathedral the heaviest building in Saint Petersburg. The outside dimensions of the mat are 100 m long by 92 m wide. The mat is in the shape of a cross (Fig. 3) and has a total area of 7600 m^2. The average pressure under the mat is therefore 415 kPa. The weight of soil removed for the 5-m deep excavation using a unit weight of soil equals to 20 kN/m^3 is 760 MN and the corresponding pressure is 100 kPa. Therefore, the net pressure for the Cathedral is 315 kPa.

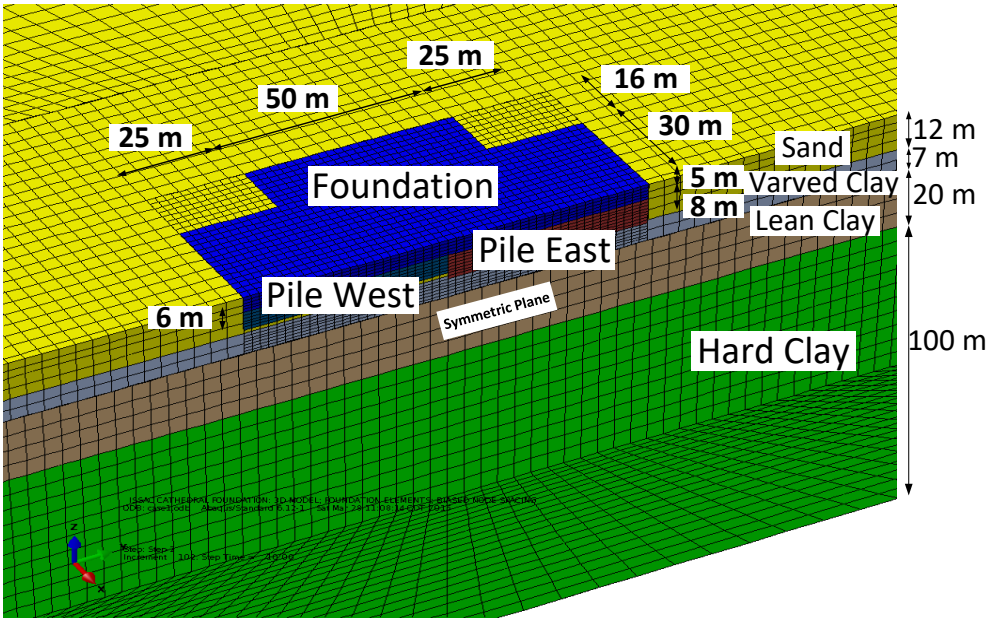
Figure 17. Mesh dimensions, Cathedral dimensions and soil stratigraphy.

A numerical simulation of the behavior of the Cathedral was conducted using ABAQUS 3D (ver. 6.12, 2012) to better understand the behavior. The simulation domain included the soil mass, the pile foundation, and the mat on top of the piles with an applied distributed pressure to represent the load from the Cathedral. The mesh representing the soil mass was 700 m long, 400 m wide and 140 m deep. The stratigraphy was a 12-m thick layer of sand, a 7-m thick layer of varved clay, a 20-m thick layer of lean clay, and a 100-m thick layer of hard clay (Fig. 17). The plan view of the foundation was selected to match the records. The piles under the Cathedral are longer under the East side than under the West side (Fig. 5); they were represented by an 8-m deep block under the East side and by a 6-m deep block under the West side (Fig. 17). The mat is 7.5 m thick with 5 m below the ground surface; it was represented by a 5-m thick block while the 2.5 m above ground were added to the weight of the structure. In total the mesh contained 243,700 eight-node brick elements with reduced integration (C3D8R) [ABAQUS, 2012]. All the nodes on the vertical boundaries of the soil mass were fixed in the horizontal direction and free to move in the vertical direction; the nodes on the bottom boundary were fixed.

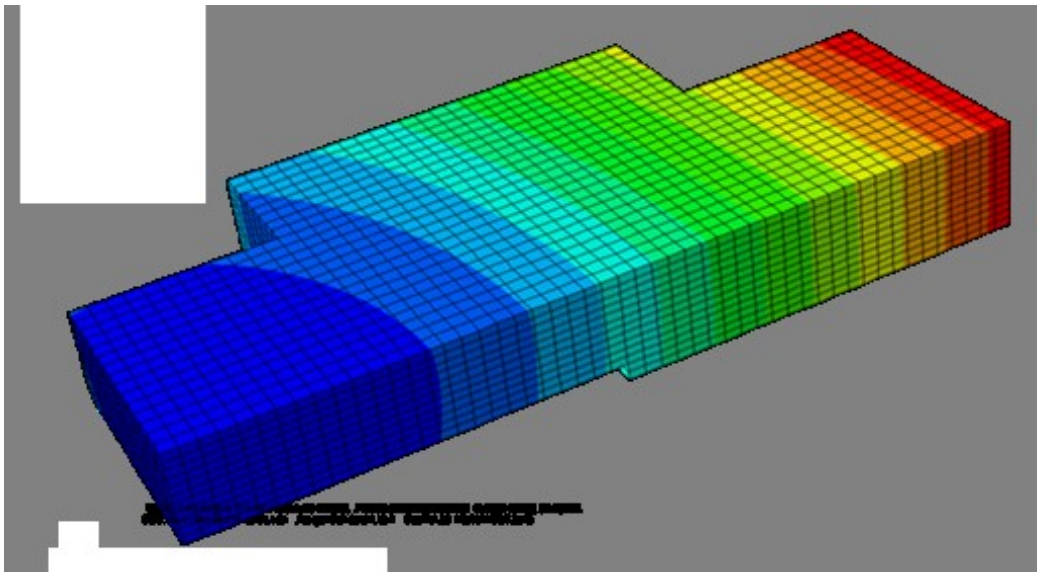
Figure 19. Contours of vertical settlement of the foundation (m).

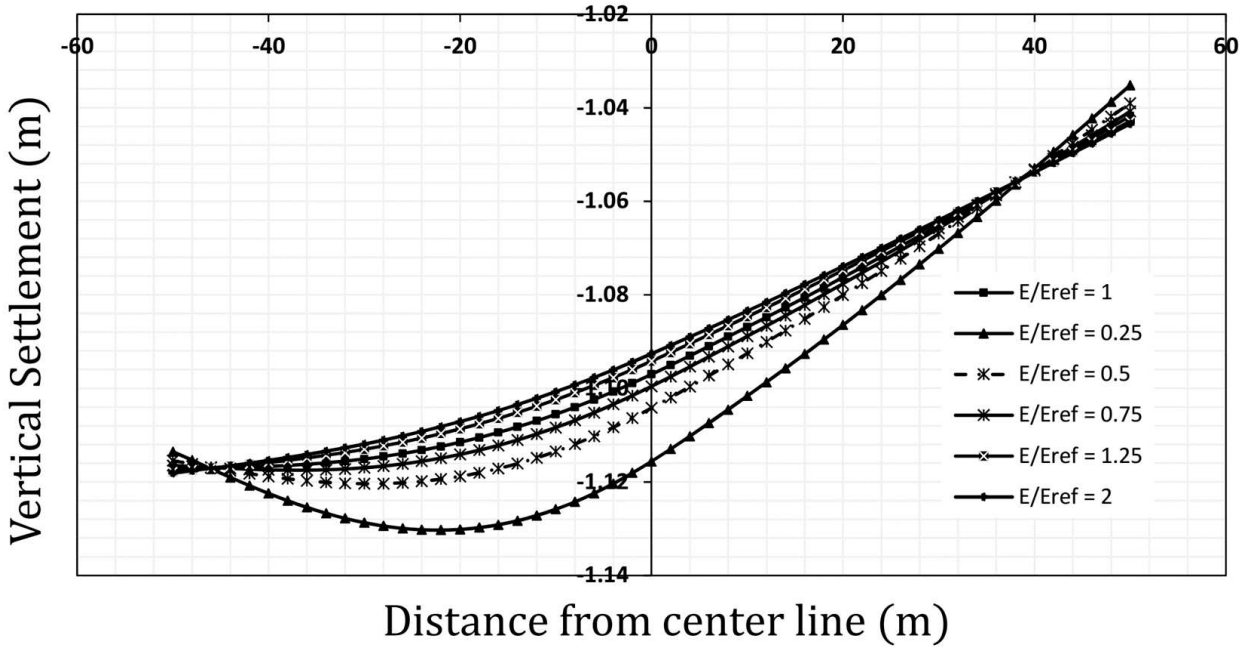
Figure 20. Bending of the mat foundation for different assumed moduli of the stone mat foundation (E_{ref} = 20 GPa).

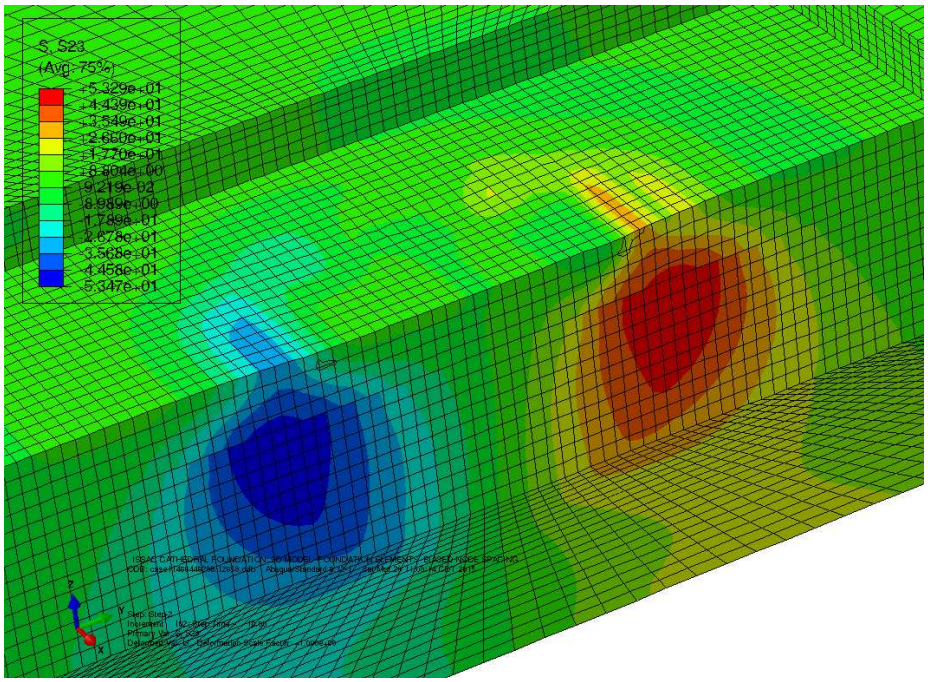
Figure 23. Zones of plastification at the edges of the Cathedral foundation.
