Flooding Vulnerability Lessons Learned in Assessing the Effects of Flooding Caused by the Canterbury Earthquake Sequence

Mark Taylor, *Civil Engineer, Tonkin & Taylor Ltd, Auckland, New Zealand; email: mtaylor@tonkintaylor.co.nz*
Tim Fisher, Dr, *Water Resources Engineer, Tonkin & Taylor Ltd, Auckland, New Zealand; email: tfisher@tonkintaylor.co.nz*
KKS Ng, *Water Resources Engineer, Tonkin & Taylor Ltd, Auckland, New Zealand; email: kng@tonkintaylor.co.nz*
Mark Pennington, *Water Resources Engineer, Tonkin & Taylor Ltd, Tauranga, New Zealand; email: mpennington@tonkintaylor.co.nz*

Submitted: 4 September 2017; Published: 9 November 2018
Reference: Taylor, M., Fisher, T., Ng, K.K.S. and Pennington, M. (2018). *Flooding Vulnerability Lessons Learned in Assessing the Effects of Flooding Caused by the Canterbury Earthquake Sequence*. International Journal of Geoengineering Case Histories, Vol.4, Issue 4, p.242-253. doi: 10.4417/IJGCH-04-04-02

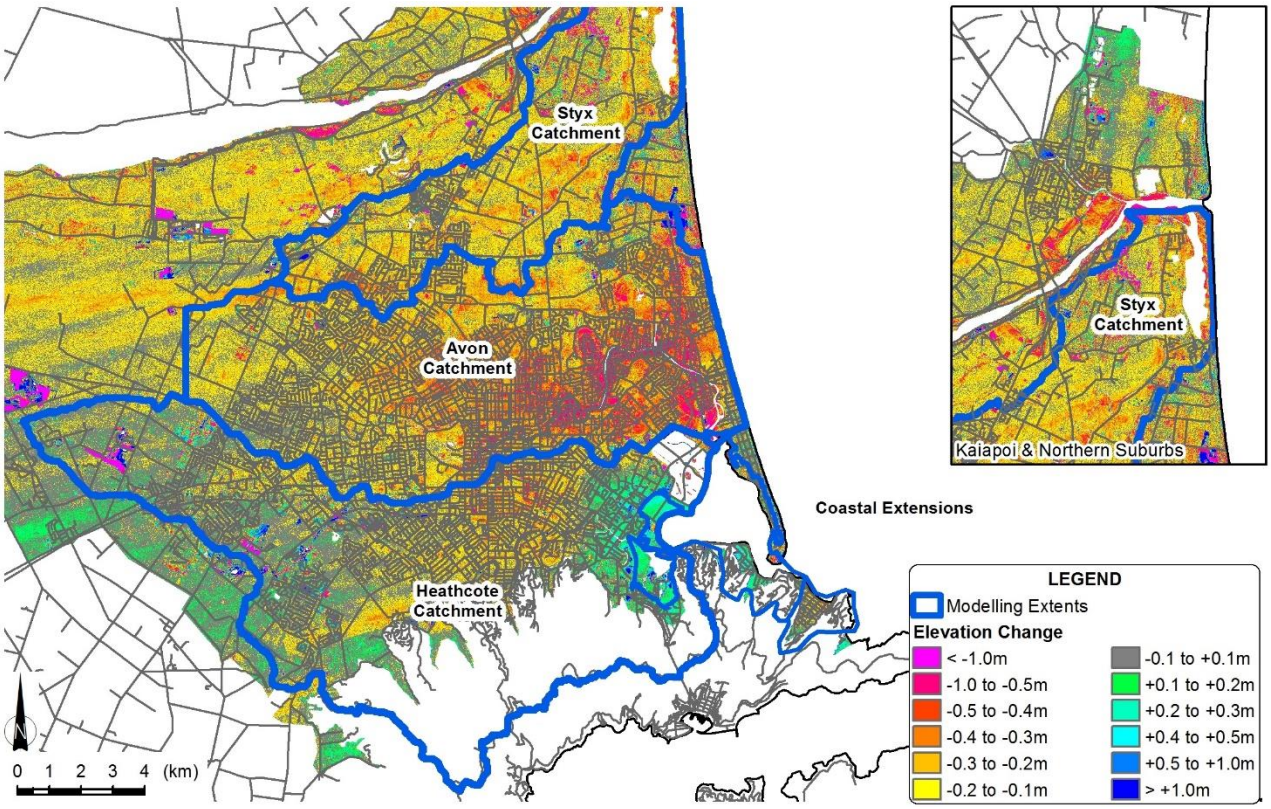
Figure 2. Cumulative earthquake subsidence Pre September 2010 to Post December 2011.

Figure 2 showed that the majority of the subsidence followed the Avon River, with the most severe subsidence occurring generally east of the city CBD. This was evident to the residents of Christchurch of course, but also was evident from the extensive land damage mapping that was undertaken. Some 65,000 residential properties were visited and the land damage on them recorded by a team of approximately 400 engineers, geologists and scientists managed by T+T over a two year period (T+T, August 2014). This information has been used extensively not just for the assessment of IFV, but also for other forms of land damage and is also available for use by academics and professionals on the Canterbury Geotechnical Database.

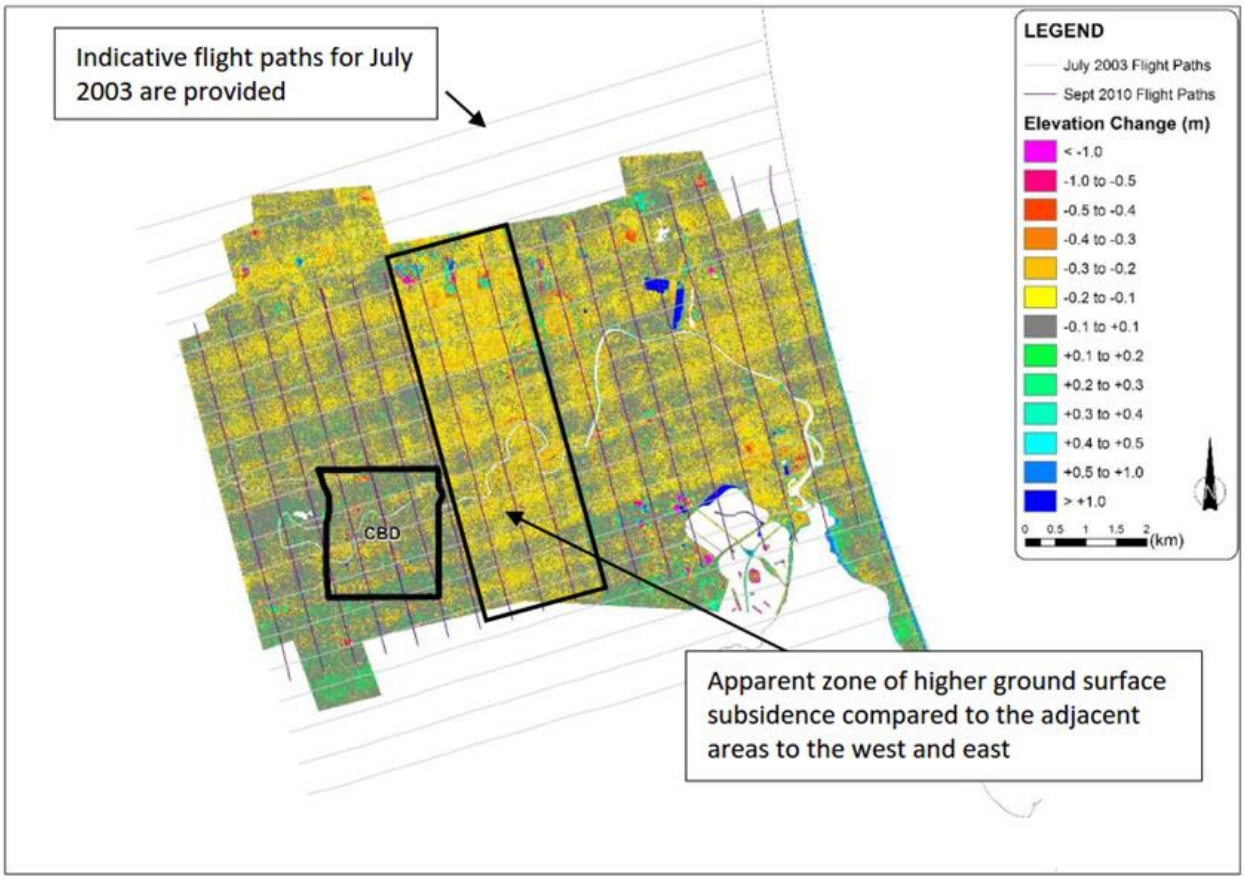
Figure 3. Banding related to LiDAR flight paths, T+T (2015).

2. "Banding" of large swathes across Christchurch observed in the LiDAR surveys (Figure 3). This banding was believed to be caused by various issues related to the flight paths and sweeps of the laser when the aerial surveys were undertaken.

Both of the issues described above led to significant work throughout the IFV development and assessment process to determine the effect of flood models using the LiDAR derived Digital Elevation Models (DEM) and was the subject of both peer review and also challenge in the New Zealand High Court.

1. Consider how LiDAR will be used in scoping any specification before the survey is flown (in this case the Christchurch City Council did not know that an earthquake would occur and that this data would be relied upon in this way)
2. Understand survey data available, its accuracy and limitations
3. Consider alternative methods and data and any issues that may limit their use
4. Educate the general public about what LiDAR is, how it is used, who obtained it, and its limitations.

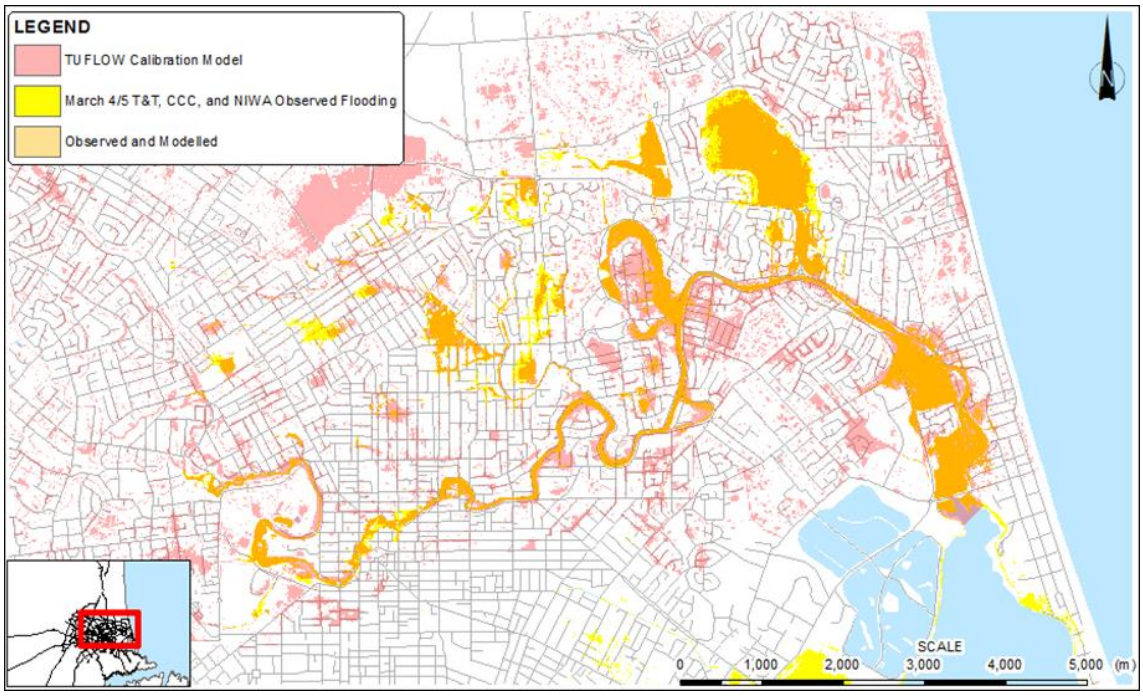
Figure 6. Calibration run of maximum depths compared to a combined T&T, CCC and NIWA observed flooding map for the 4 and 5 March 2014 event.

The usefulness of the increase processing speed became apparent following the 4 and 5 March 2014 flood event. At the time of the flood event occurring (which T+T hindcast as between a 20 and 50 year Average Recurrence Interval (ARI) river flood event as measured in the Avon at the Gloucester Street gauge), the IFV model was in the final stages of completion. However, the model had not (because there was no data available) been verified or calibrated to actual flooding. The event provided an opportunity to undertake this. Again, the value of rapid mapping proved extremely useful. Teams involving T+T, EQC, NIWA and CCC independently mapped flood extents. CCC also collated flood reports from residents. This mapping together with river and rain gauge data was used to calibrate the model. We consider (and the International Peer Review Panel agreed) that the resulting Overland flow model was appropriate for the use of IFV. A comparison of the calibrated model and the observed mapping for the Avon catchment is shown in Figure 6. A similar comparison is shown for a badly affected area known as the Flockton Basin in Figure 7.

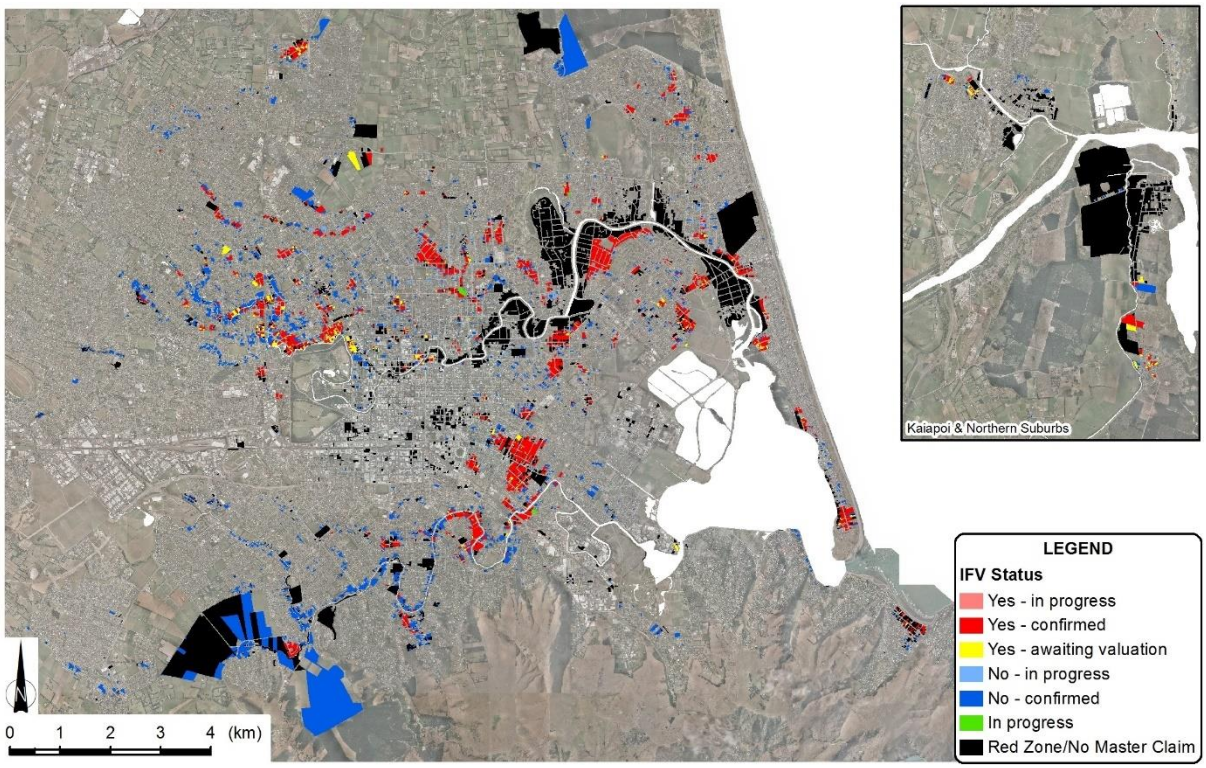
Figure 8. Map showing engineering IFV status of the properties at May 2016.

Approximately 18,000 properties were identified as having potential IFV across Canterbury (including in Sumner and Kaiapoi). Whilst a large number of these properties either had no valid insurance claim lodged with EQC or were located in the Red Zone, over 11,000 properties still required site specific assessments to determine their engineering IFV status. Figure 8 shows the engineering IFV status of the properties at May 2016 with approximately 6,000 properties being confirmed as having IFV from an engineering perspective.
