Forensic Analysis of Levee Failures: The Breitenhagen Case

KEYWORDS: forensic analysis, slope instability, hindcasting, river levee, levee breach

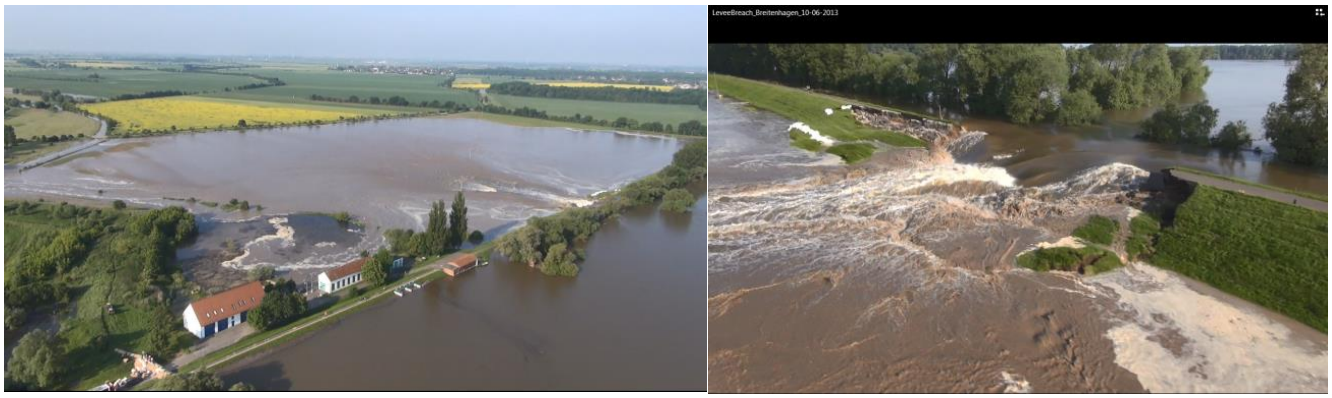
During the floods of the Saale River in June 2013, the east embankment breached near Breitenhagen (Saxony-Anhalt, Germany) (Figure 1 and Figure 2) (Grubert, 2013). The breach of the levee caused a lot of economic damage that was financially covered by the state of Saxony-Anhalt (Drews, 2017). The failure appears to be the result of slope instability due to the long lasting high water level in both the Elbe and the Saale (Drews, 2017; Grubert, 2013). Historical documents indicate that the levee was built in the second half of the 19th century (Sixdorf, 2016). The overview photo shows a grassy levee with a paved road on top of the levee which can be used by heavyweight traffic (Figure 2). Trees grow along the length of the levee in the floodplain of the Saale. The overview photo also shows a pond near the location of the breach at the river side of the levee (Figure 2).

Figure 1 Left: Overview photo of the landside while the flooding evolves, Right: Overview photo of the breach on June 10th 2013 (Weichel, 2013).

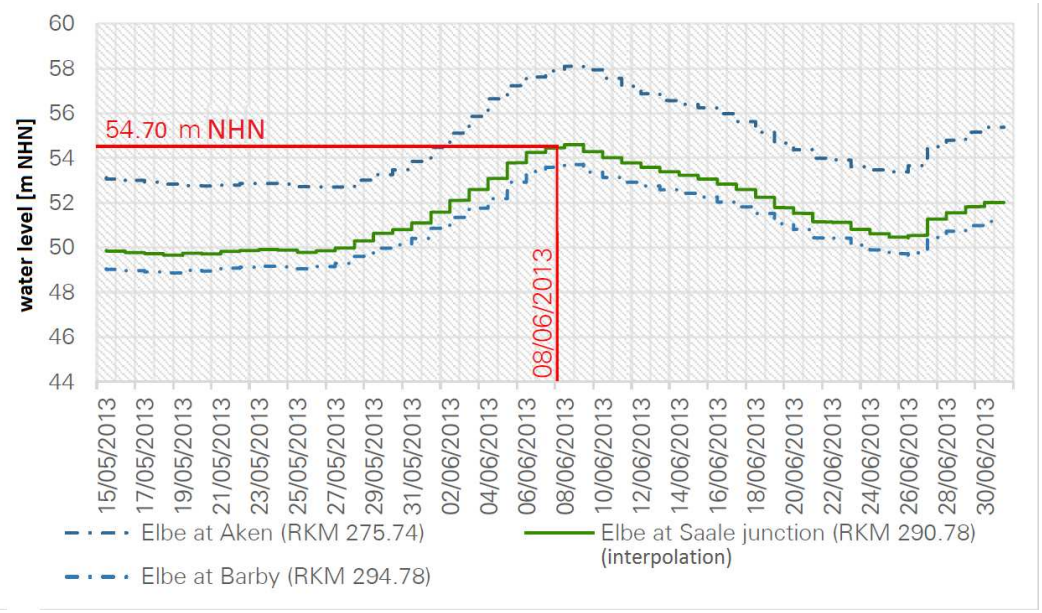
In the summer of 2013 both the Elbe and the Saale river experienced high water levels due to heavy rainfall upstream. The peaks of the high water levels met each other at the intersection of the Saale and the Elbe near Breitenhagen. The actual water height was not measured at the location of the breach, but the water levels were measured at the nearest upstream and downstream measurement station and the levels at Breitenhagen were interpolated (Figure 3) (Drews, 2017). The elevation of the (water) level is expressed as a standard reference level called the NormalHohenNull (NHN) which is approximately equal to mean sea level. The breach occurred just at the moment that the water levels in both rivers reached their peak on June 8th, 2013. It appeared that the water levels of 2013 were the highest water levels ever measured in both the Saale and the Elbe (Drews, 2017). Both water levels have a return period of 100 to 200 years (Drews, 2017; Elbe, 2014).

Figure 3. Graphs with water levels over time of the Elbe and Saale near Aken and Barby. Water level at Elbe and Saale junction, RKM 290.8, is NHN+54.7 m (Drews, 2017; Grubert, 2013)

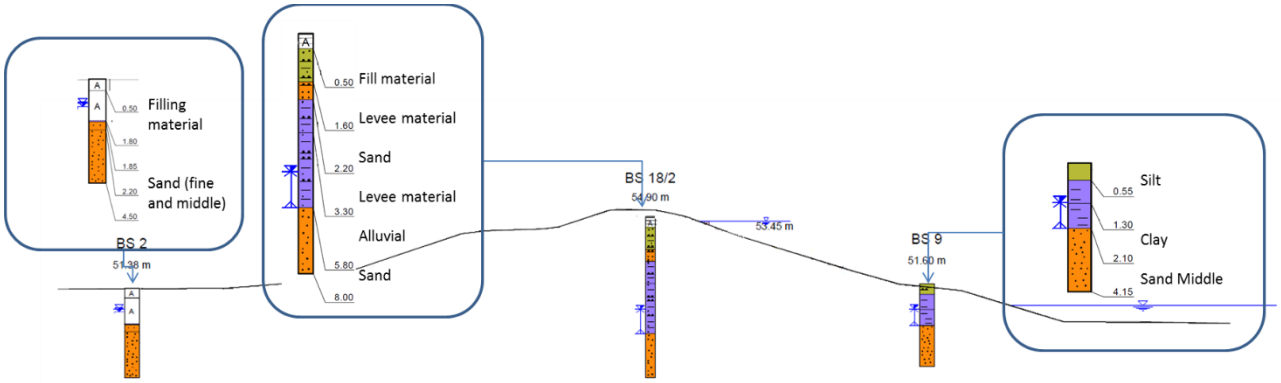
Figure 4 Cross-section of the levee (right is riverside) near the location of the breach (length marker +590 m), with the water levels, groundwater levels and the results of the borings (titled BS2, BS18/2, BS9 taken about 10 m in distance of the start of the breach (Grubert, 2013). The borings were taken both before and after the breach of 2013.

The cross-section generally consists of two layers (Figure 4 and Table 2) (Grubert, 2013). The top layer of the levee consists of largely homogeneous cohesive material (clay-like). A few inclusions of locally mixed-grained soils are identified. The bottom layer consists of a sand layer that can be found throughout the cross-section at an approximate elevation of NHN+49.5 m about 5.5 m deep from the surface (Table 2). This layer likely functions as an aquifer. The identified soil types are characterised by the typical characteristic parameters listed in Table 3 (Grubert, 2013; Schneider & Albert, 2014).

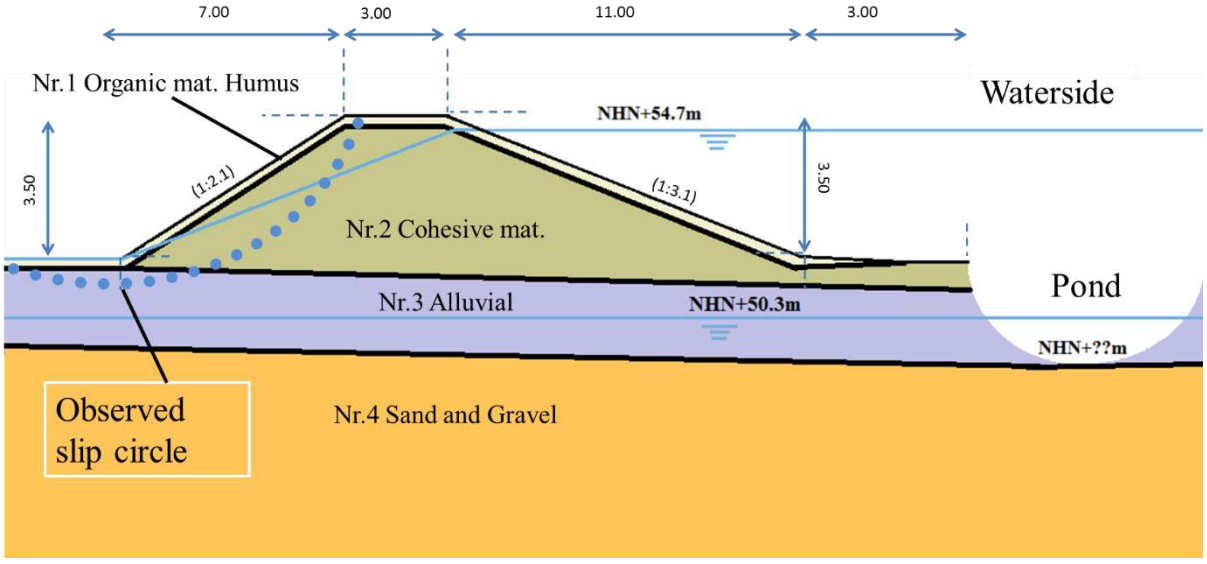
The dimensions of the cross-section of the levee are mapped at the location of the breach (Figure 5). The measurements show that the levee is about 3.50 m high with a crest width of 3.00 m. The landside slope is 1:2.1 and the waterside slope is 1:3.1. The distance between the waterside toe and the pond is about 3.00 m.

Figure 5. Dimensions of the Breitenhagen levee including simplified soil layering flood level and assumed aquifer level (pre-failure, left side is landside, right is the waterside). The 2013 high water level is NHN+54.7 m, the measured groundwater level is NHN+50.3 m. The soil modelling is based on the forensic engineering report (Grubert, 2013), incorporated with maximum occurred flood level, and soil types (Grubert, 2013).

The data collected prior to the breach provide an indication of the condition of the levee prior to the breach. The overview photo shows a pond in front of the levee possibly caused by an earlier breach (Figure 2). This indicates the possibility of a direct connection between the outside water level and the aquifer below the levee. The photos show a row of trees at the riverside toe of the levee which might influence the conductivity of the levee due to the intrusion of the roots inside the levee, or might indicate the presence of a more conductive layer inside the levee (Figure 2). The slope of the levee is very steep (about 1:2.1 vertical to horizontal) with a gradient that exceeds the friction angle of most soil types. The slope at the landside is prone to instability (Figure 5).

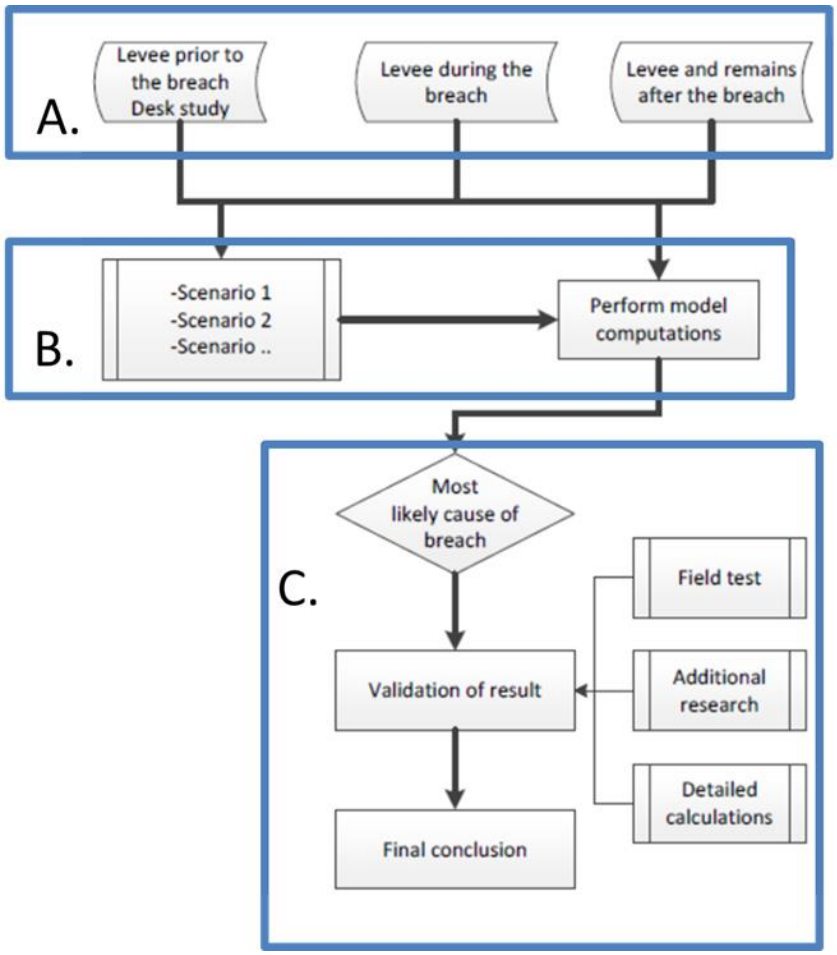
To identify the most likely cause of a levee failure, a systematic approach for forensic analysis of levee failures is suggested. In order to make the generic forensic analysis approach more applicable to levee failures, the standard three steps of forensic engineering as proposed by TNO (see section 3.1) are adapted into three more specific steps for levees (A, B and C, see Figure 8).

In step A, the collected data that are typically relevant for levee breaches, are sorted in three ways, i.e. data collected prior, during and after the failure as shown in Figure 8. This provides a clear overview of which data are relevant in terms of factors that are of influence on the performance behavior and a first impression on the performance behavior of the levee during extreme circumstances. A distinction is made between input parameters (which are considered as possible causes e.g. pore water pressures and shear strength of the soil) and model choices (e.g. LEM and (un)drained soil behavior). With the data during and after the failure, possible failure scenarios are determined and the behavior of a levee is studied.

In step B, a sensitivity analysis is used to validate or eliminate possible causes contributing to the levee failure (hindcasting) (Figure 8). Using the data and additional literature, the best estimate scenario and expected values for the input parameters are modelled (further referred to as "base model"). During the process of developing a "base model", all the individual uncertainties are identified and introduced as scenarios (in terms of input parameter and modelling choices). During the sensitivity analysis, the expected values of the still uncertain input parameters are replaced one by one by realistic upper and lower limit boundary values.

Figure 8. Generic approach for levee forensic analysis based on Borsje, et al. (2014) Step A.: Collecting information for exploring possible scenarios; Step B.: Evaluate with a computational model; Step C.: When results do not identify the cause, additional information can be gathered.

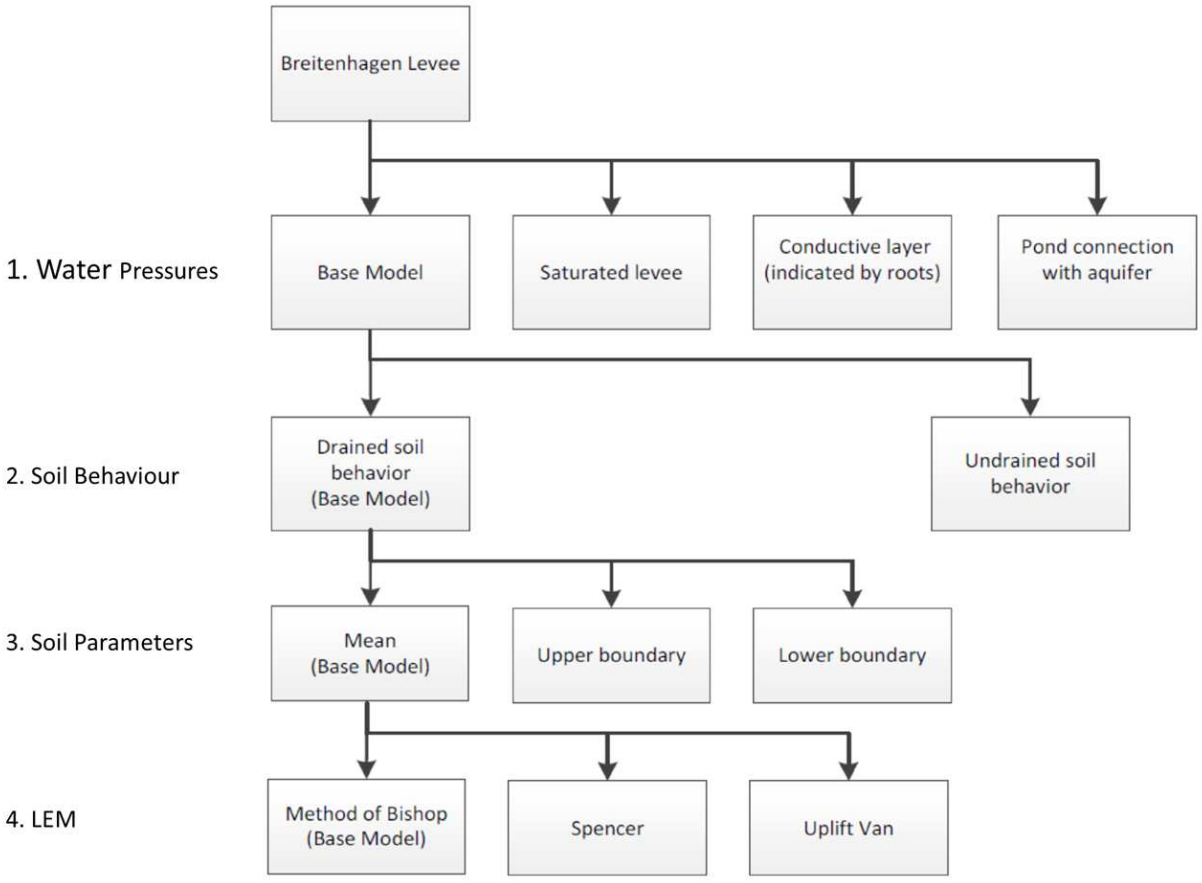
Figure 9. Overview of all factors of influence to vary in the sensitvity analysis one by one. Level 1.: Water pressure scenarios. Level 2.: Soil reaction behavior scenarios. Level 3.: Soil parameter scenarios. Level 4.: LEM scenarios.

In this section, the scenarios of water pressure and hydraulic head in the subsoil, soil strength in terms of soil parameter, soil reaction behavior scenarios, or LEM as shown in Figure 9, are further elaborated and quantified.

The "base model" (scenario A) represents the best estimate scenario with the expected values of input parameters. The "base model" functions as the basis of the sensitivity analyses (Figure 9). The LEM calculation is executed using the Bishop method and drained soil behavior. The Bishop method is used as best-estimate since this method reflects the circular observed slip circle relatively well. The results of the simulation of the best estimated situation show a FoS=1.61 [-], which is considered stable (FoS>1.0). The shape of the slip circle shows realistic similarities with the actual slip circle (Figure 11). However the slip circle starts at the riverside of the top of the levee, instead of the landside. Also the slip circle intersects the sand layer, which is not considered realistic.

The FoS of the individual causes and additional analyses with combinations of scenarios on the stability of the levee are presented in Table 6. The results are presented in terms of upper, best-estimate and lower boundary values of FoS (Table 6). Four types of uncertainties are considered i.e., water pressures, soil reaction behavior, soil parameters and LEM (Figure 9).

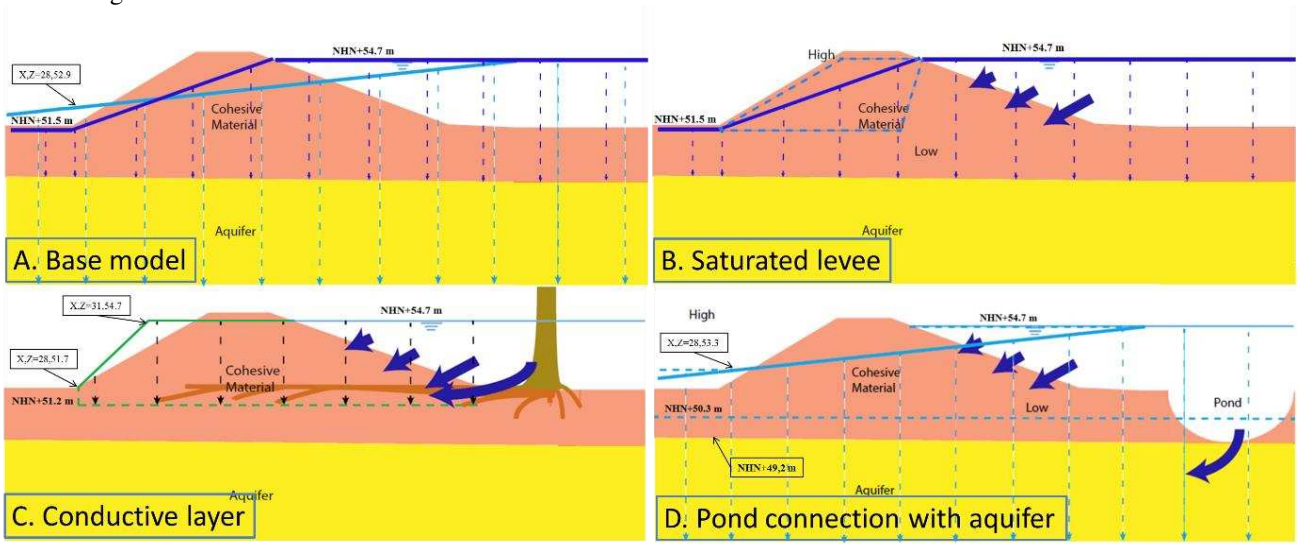
Figure 10. View of the four possible scenarios derived from the data analysis. ScenarioA: Best estimate of phreatic line inside the levee (solid dark blue) and best estimate hydraulic head in the aquifer (solid light blue), called "Base model". The river head (NHN+54.7m) and localy heightened polder head (NHN+51.5m). Scenario B: Infiltration of water through the levee slope which is called "Saturated levee" (dashed light blue lines); Scenario C: Infiltration through a conductive layer related to the tree roots which is called "Conductive layer, indicated by the tree roots" (situated at NHN+51.2m)(the hydraulic head in green is the head at the location of the roots, the phreatic line is the same as the Base model. Inside the levee, water pressures in the levee are interpolated between the phreatic line and the green line); and Scenario D: Infiltration through the connection between the outside water level and the aquifer which is called "Pond connection with aquifer" (polder head of NHN+51.5m) with an upper and lower head (dashed light blue lines);.

In the scenario of the "Saturated levee" (scenario B), the only phenomenon that is taken into account is the development of the phreatic line in the levee body (Figure 10). The development of the phreatic line in the levee itself is caused by the infiltration of the high water wave from the river in the levee body. Due to the low permeability of the cohesive material, the infiltration of the water in the levee is a relatively slow process. The intrusion length of the high water wave is limited by the width of the levee. The extreme low and high boundary of the phreatic line are based on standard phreatic models to represent infiltration (upper extreme boundary) and transient (lower extreme boundary) flow are suggested by literature (TAW, 2004). The models incorporate the influence of the dominant factors that influence the phreatic lines, i.e. infiltration and groundwater flow in order to simulate the transient flow and the different possiblities of steady state flow.

In the scenario of the "Conductive soil" (scenario C.), the roots inside the levee indicate a more conductive layer due to a relatively large permeability (Figure 10). Therefore, the intrusion length of the water wave is increased in this layer. This causes a local increase in water pressure. Moreover, the velocity of the high water pressure wave in the conductive layer is relatively fast compared to the levee body. In this area, the water potential equals the outside water level. At the inside toe of the levee, the potential inside the rooted area is limited by the covering soil. The analysis of Scenario C. is executed as a direct relation to Scenario B. to show its influence on the upper, mean and lower bound of the phreatic line. The water pressure inside the levee is interpolated between the phreatic line and the hydraulic head inside the conductive soil layer.

In the scenario of the "Pond connection with aquifer" (scenario D), the pond in front of the levee might introduce a connection between the aquifer layer and the outside water level (Figure 10). This causes a local increase in water pressure in the aquifer compared to the water pressure corresponding to the phreatic line. Because of a relatively large leakage length of the outside water level, the water pressures inside the aquifer might cause a shear strength reduction at the landside. The weight of the blanket layer limits the hydraulic head in the aquifer. The water pressure inside the levee and the blanket layer is interpolated between the phreatic line and the (limited) hydraulic head at the interface between sand and clay.

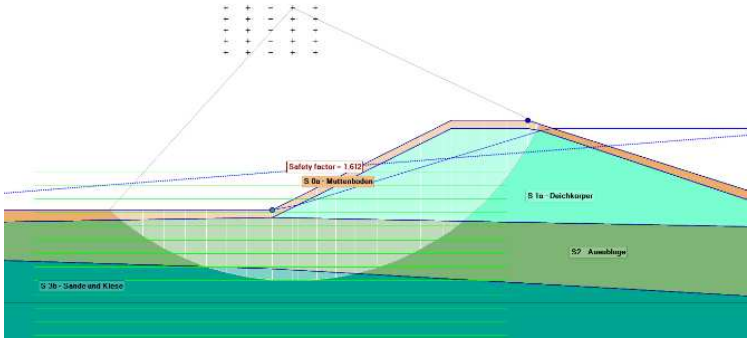
Figure 11 View of the LEM calculation using Bishop stability model with drained soil behavior (FoS=1.61).

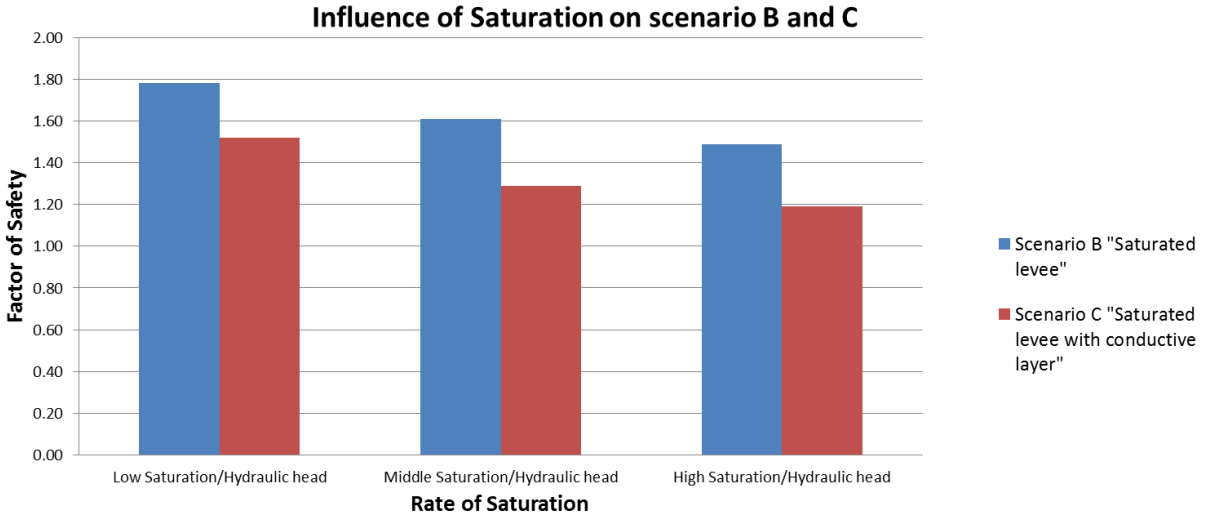
Figure 12. Blue: Influence of the saturation of the levee on the FoS. Red: Influence of the saturation when the local high water pressures in the conductive layer are introduced.

The FoS is negatively correlated with increase in water pressures, because the effective stresses are reduced, which in turn causes the shear strength to decrease. Due to the rising phreatic line, the range of FoS is in between 1.78 and 1.49 (Figure 12). The analysis of the increased potential head in the conductive layer around the tree roots results in FoS of 1.52, 1.29 and

1.19. The lowest factor of safety is found for the highly saturated cross-section in combination with the conductive layer. All models, yield safe values for the FoS.

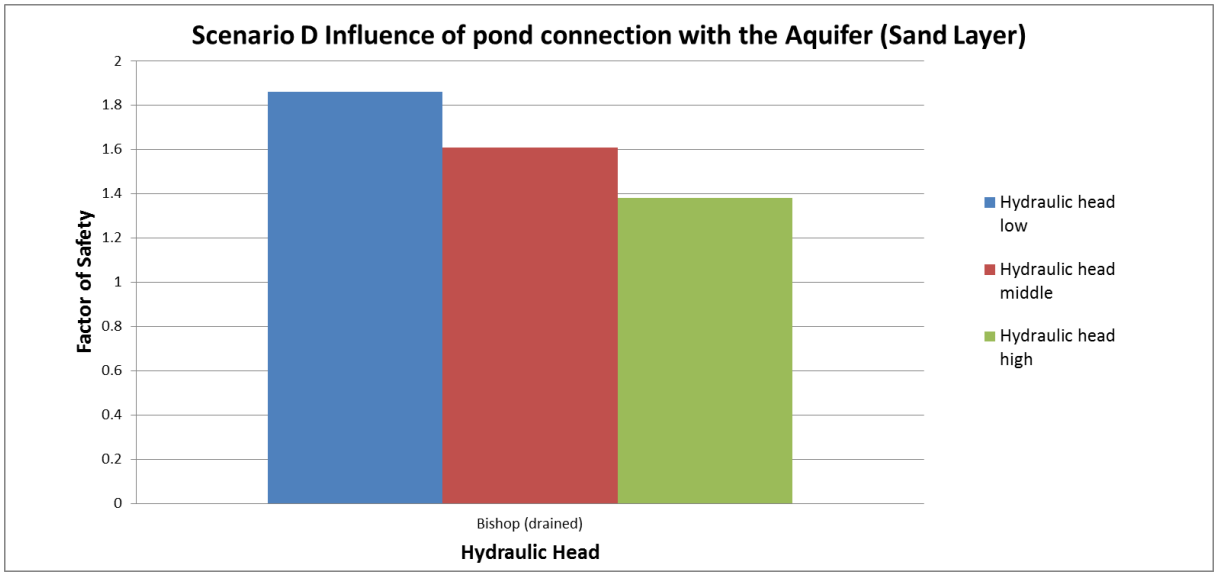
Figure 13. Influence of the rise of the hydraulic head in the aquifer with three different levels in hydraulic head in scenarios D.

Due to the rise of the hydraulic head in the aquifer, the range of the FoS overall is between 1.86 and 1.38. The shape of the slip circle shows realistic similarities with the actual slip circle. However the slip circle still intersects the levee crest instead of starting from the landside of the levee.

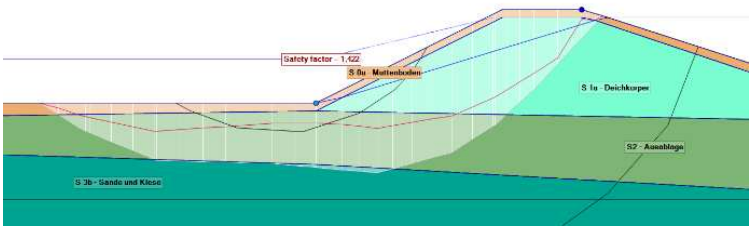
Introducing undrained soil behavior for the clay, scenario D, results in FoS between 1.66 and 1.28. The slip circle of the actual failure (Figure 6) and the calculated slip circle (for example with the use of Bishop with undrained soil behavior and Spencer with drained soil behavior) differ in geometry. The slip circle of the Spencer method seems to show more realistic geometry of slip circle than the Uplift Van method and Bishop's method in case of low effective soil pressures at the interface between sand and clay (Figure 14).

Figure 14 View of scenario D: "Pond connection with aquifer" output. The high hydraulic head is included and the Spencer model is used (with drained soil behavior) which results in FoS=1.42.

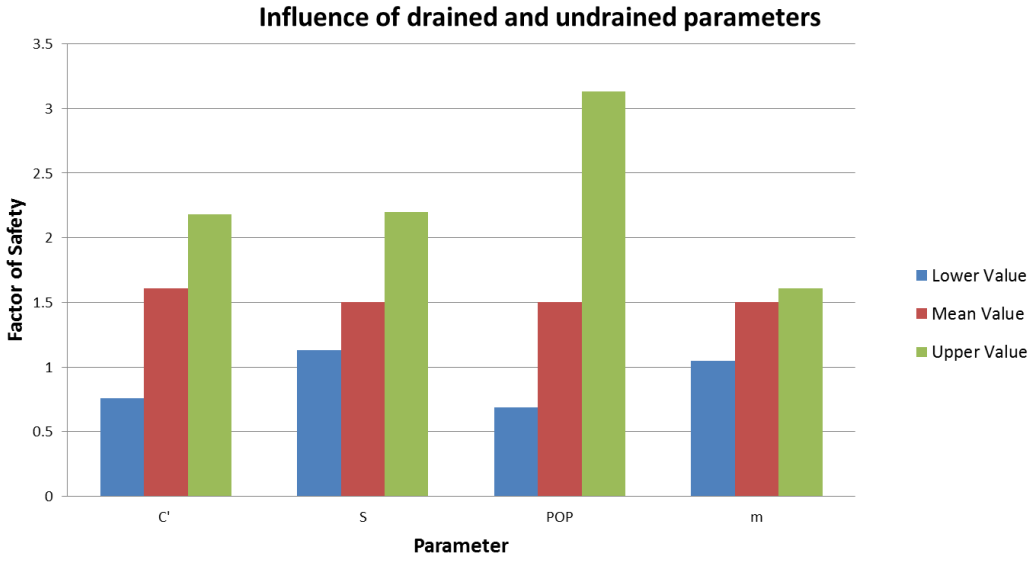
Figure 15. Results of the sensitivity analysis of drained parameter cohesion and undrained parameters.

Varying the cohesion, which is the dominant parameter of the drained soil model, the FoS covers a range between 0.76 and 2.18 (Figure 15). The undrained shear strength has a high variability, due to the uncertainty of the previous stress history and related overconsolidation state (the POP, pre-overburden presure, was used to describe this uncertainty). The results of the calculations greatly reflect this uncertainty in the calculated FoS ranging from 3.13 and 0.69. The parameters S and m, used to model undrained shear strength, result in large variation in FoS, but do not result in values below 1, which would represent failure of the levee. The calculation using the low cohesion values and the Bishop model show similarities with the actual slip circle and do not reach the sand layer underneath the cohesive layers (Figure 16).

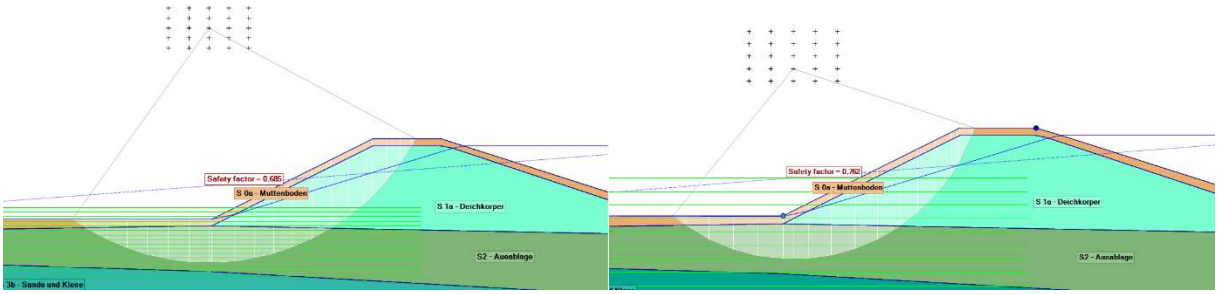
Figure 16 Left: View of scenario A. "Base model" using the Bishop slip circle and low values of POP resulting in FoS=0.69 (undrained soil behavior). Right: Scenario A. "Base model" using the Bishop model and low values of cohesion resulting in FoS= 0.76 (drained soil behavior).

The additional calculation run with a combination of low values of cohesion with high water pressures in the aquifer results in a FoS of 0.55, using Bishop's LEM. The resulting slip circle seems shallow compared to the actual observed failure surface.

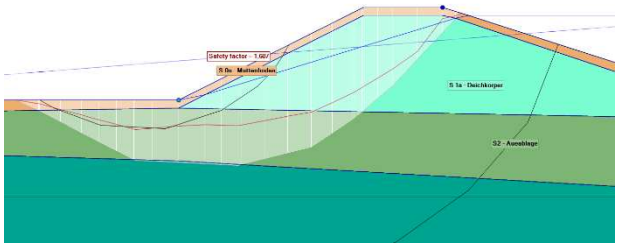
Three different LEM are used in the assessment on the levee strength, i.e., Bishop, Uplift Van and Spencer (Figure 9 level 4) in the D-Geo Stability software (Deltares, 2016). All three LEMs are applied to the "base model". The sensitivity analysis is used to establish the influence of different LEM. The FoS determined with the help of the Bishop, Uplift Van and Spencer model covers a range between 1.55 and 1.61. All models result in approximately the same slip circle (Figure 11, Figure 17). The Spencer method shows the most realistic geometry of the slip cirlce (i.e., the slip circle doesn't intersect the sand layer).

Figure 17 View of scenario A. "Base model" using the Spencer method presenting the calculated critical slip circle (FoS=1.61).
