Geotechnical Observations of Dams Failed During the 2015 Historic Flooding in South Carolina

ABSTRACT: *This paper presents a description of post-flood reconnaissance and geotechnical investigation of four earthen dams that were breached or damaged following an extreme flooding event in South Carolina in 2015. As a result of unprecedented rainfall and flooding that occurred during a five-day period at the beginning of October in 2015, a total of 51 earthen dams failed and nearly 200 were damaged. Many of these dams failed due to overtopping that led to a breach of the dam. Among the four dams investigated, full breach was observed at three dams; two of which were overtopped, and one was not. The fourth dam was not breached but was severely damaged. For each of these dams, the paper documents background information, pre-flood conditions, post-flood field observations and measurements, and laboratory testing results of collected soil samples. Impacts of vegetation on the dams and the effects of dam failure on critical infrastructure are also presented. The detailed descriptions and geotechnical investigations of the dam failures presented herein serve as case histories that can be u

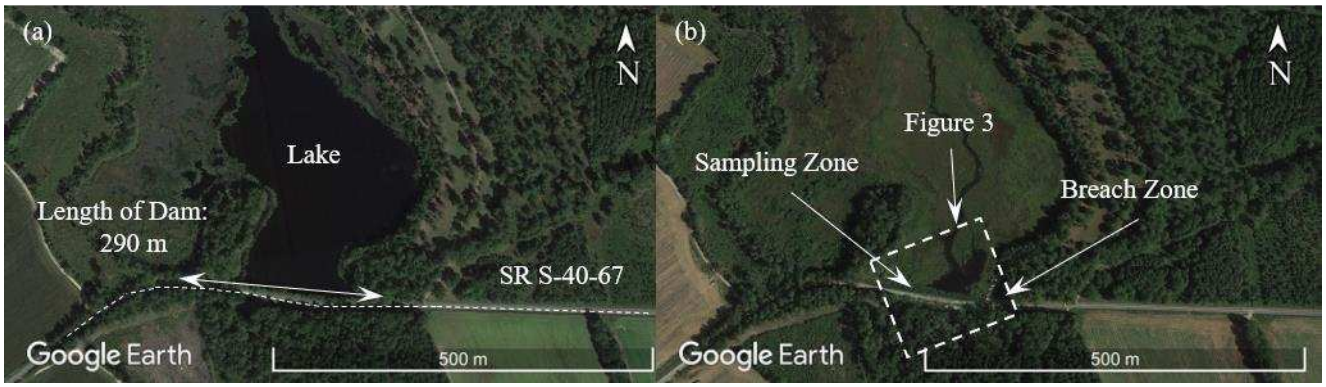
Figure 2. Dam A (a) before and (b) after failure (Google Earth, accessed on April 8, 2018).

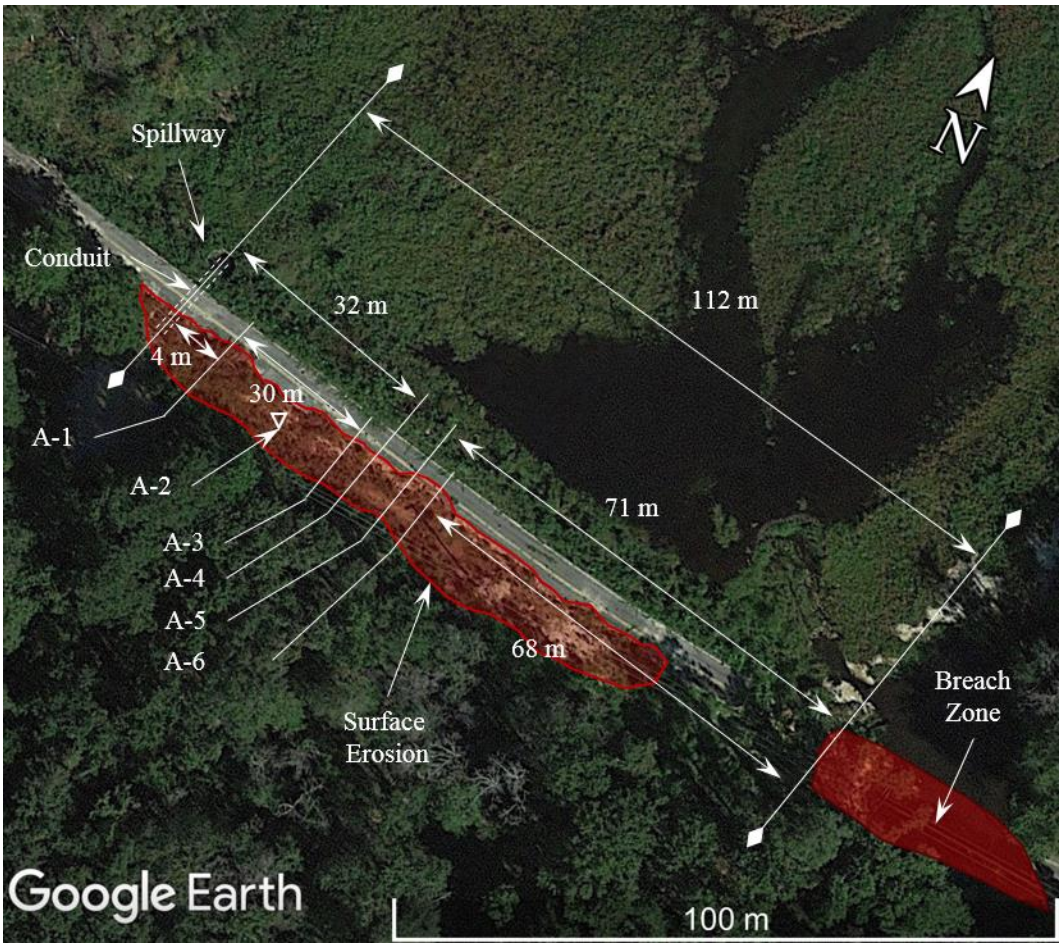
Figure 3. Location of spillway, surface erosion, breach, and sampling locations in Dam A (Google Earth, accessed on April 8, 2018).

The spillway structure of this dam is located on the west side of the dam and about 112 m from the breach zone, as shown in Figure 3. Sampling locations relative to the spillway and the breach zone are also presented in this figure. The spillway is a conduit made of a 1.2 m diameter concrete pipe, as shown in Figure 4a, with a maximum discharge capacity of approximately 17 m^3/s (USACE 2016). The soil above the pipe on the downstream side was washed out, as shown in Figure 4b. It is unknown whether this structure worked as the primary spillway of the dam, or if an additional spillway structure existed before the breach.

Damage to this dam includes a complete breach and a large zone of surface erosion separate from the breach, as shown in Figure 3. The breach is located near to the east end of the dam. The breach extended approximately 50 m of the total 290 m length of the dam, and nearly 7,300 m^3 of material, including soil and pavement, were washed out (see Figure 6). In the breach zone, several trees on the upstream side slope tipped over the road in the direction of water flow (see Figures 6 and 8), which provides some evidence of overtopping. In the surface erosion zone, the soil erosion along the downstream side slope extended over 60 m parallel to and 20 m perpendicular to the road, as shown in Figures 3, 5b and 7b. As shown in Figure 7a, part of the asphalt shoulder and roadway collapsed above the zone of surface erosion.

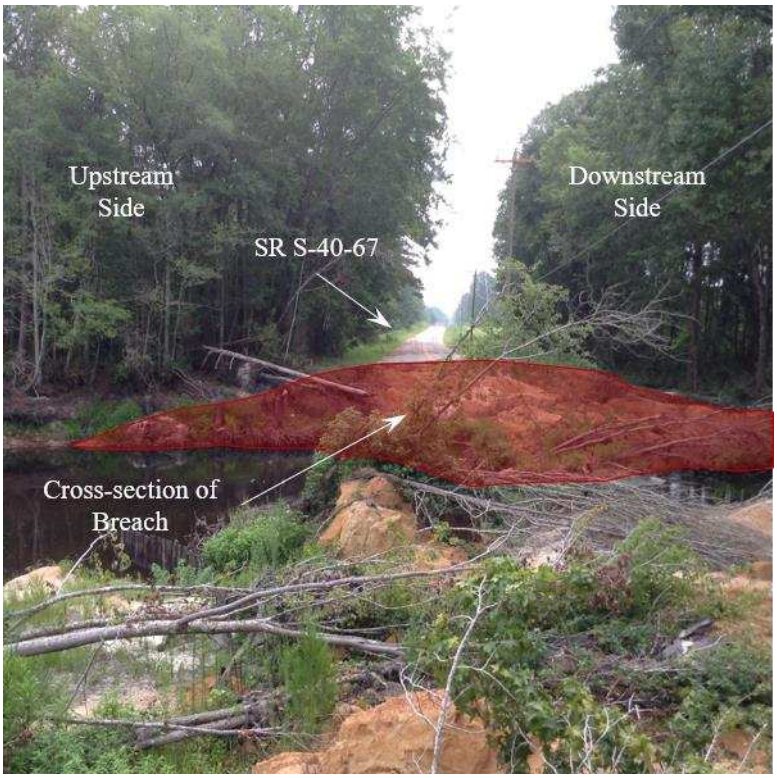
Figure 6. Cross-sectional area of breach in Dam A (east view from SR-40-67).

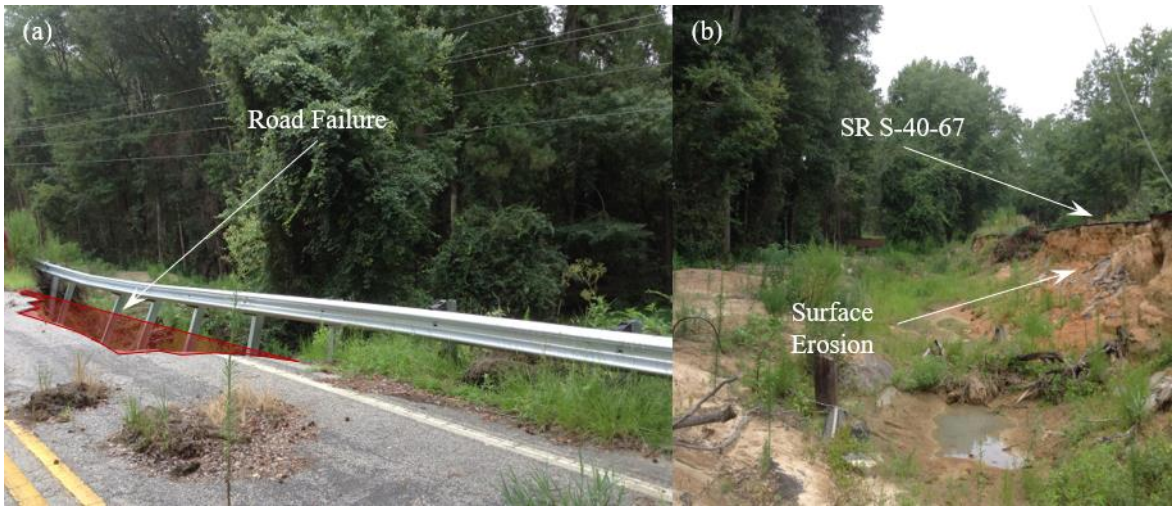
Figure 7. Failure of Dam A: (a) road failure of State Road S-40-67 (southeast view from S-40-67), and (b) surface erosion due to overtopping (west view from downstream).

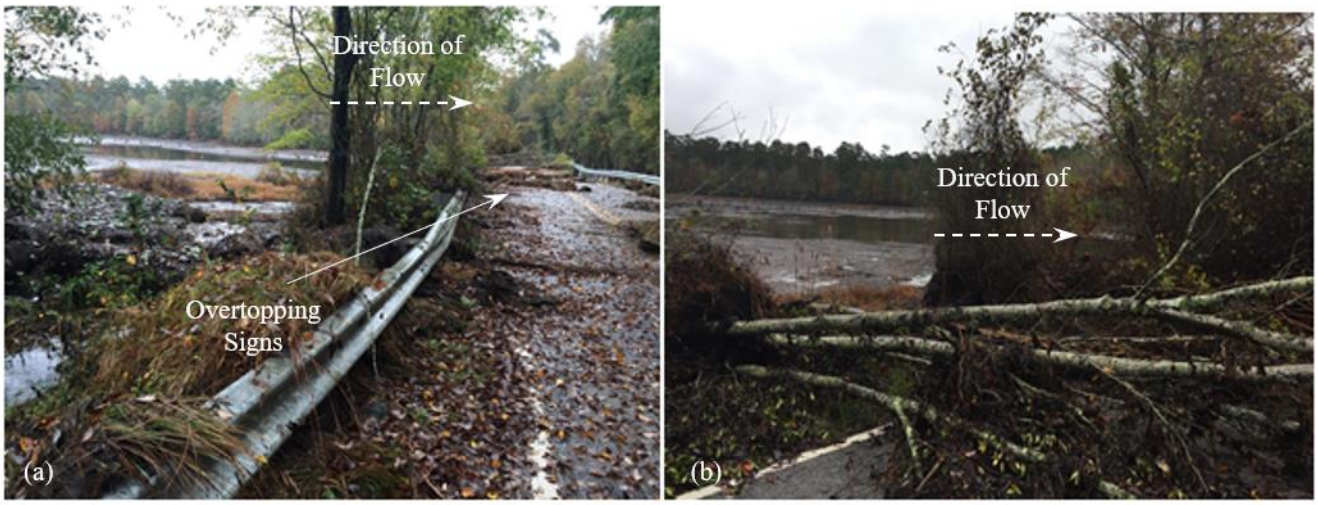
Figure 8. Evidence of overtopping during the flood for Dam A: (a) eroded vegetation and debris on the crest (east view from SR-40-67); and (b) fallen trees on the crest (north view from SR-40-67).

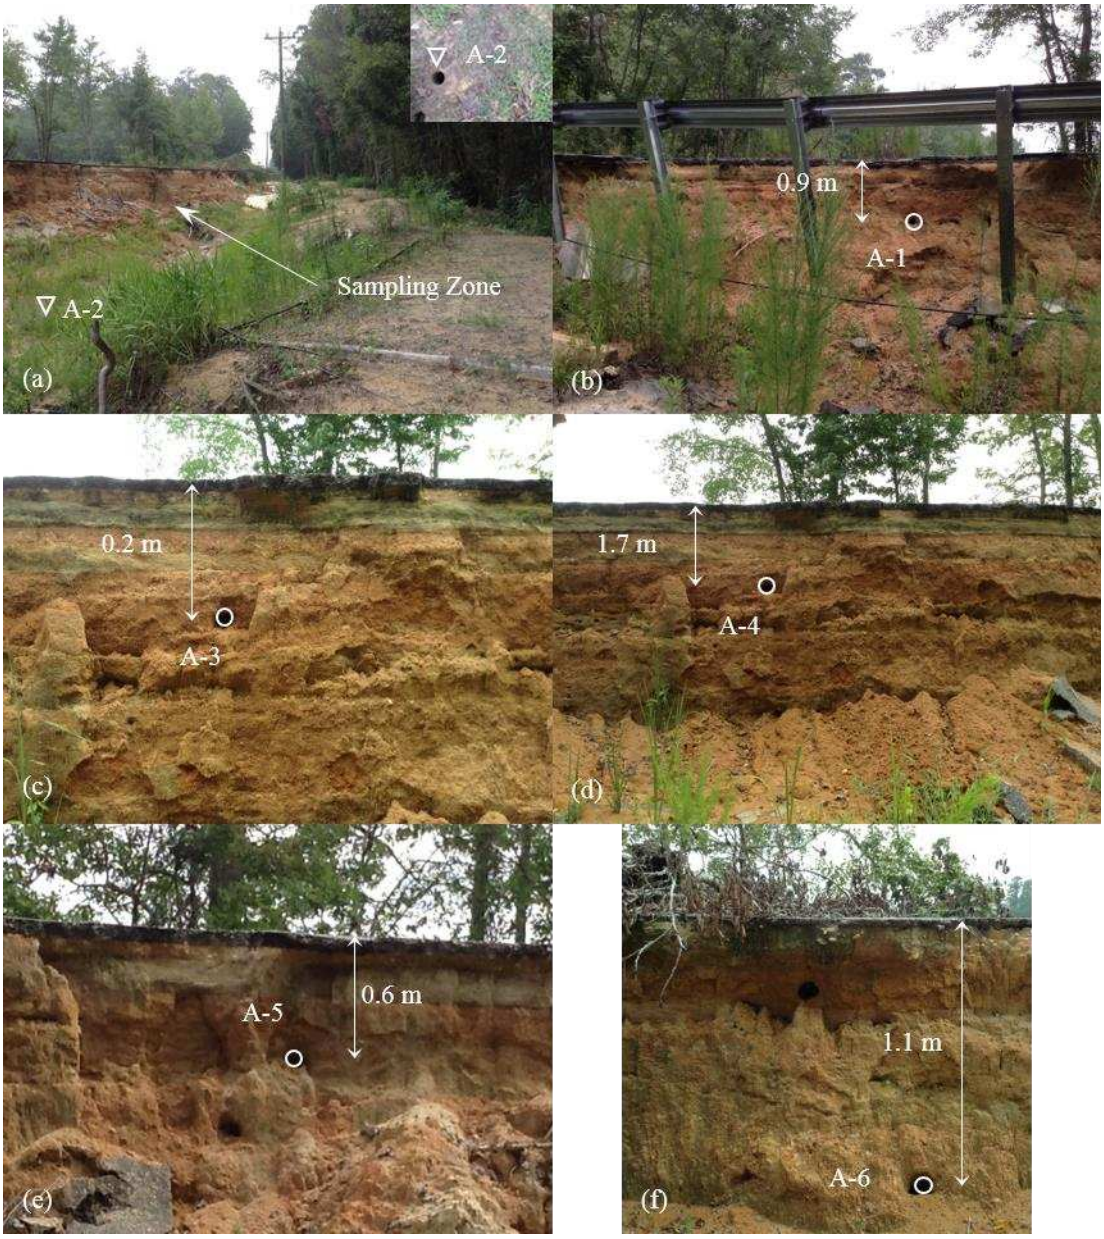
Laboratory testing results from soil samples collected at six locations from the downstream side slope of the dam are presented in Table 1. Approximately half of the road lane collapsed due to slope failure; therefore, the samples were collected relatively close to the center of the embankment. The samples were obtained in the area where surface erosion and slope failure occurred except for sample A-2, which was obtained from the foundation soil. The distance from the crest of the dam to the sample locations is presented in Figure 9, and the sampling depth for each hole is presented in Table 1. The distance of sampling locations relative to the breach zone are shown in Figure 3. The dam materials are mostly silty to clayey sands with 23% to 42% low plasticity fines. The foundation soil (A-2) at a depth of approximately 56-81 cm also appears to be silty sand. Based on these test results and the visual field observations of the soils along the length of the exposed embankment, the dam material appears to be relatively consistent (SM or SC) with no definable core. The coefficient of permeability is low to very low (10^{-4} to 10^{-6} cm/s). Based on the soil characteristics in Dam A, internal erosion would occur moderately to extremely rapidly in the presence of cracks or hydraulic fractures (Wan and Fell 2004).

*Figure 9. Sampling locations in Dam A: a) east view from downstream side, and b), c), d), e) and f) north view from downstream side (**∇**: vertical sample, **O**: horizontal sample).*

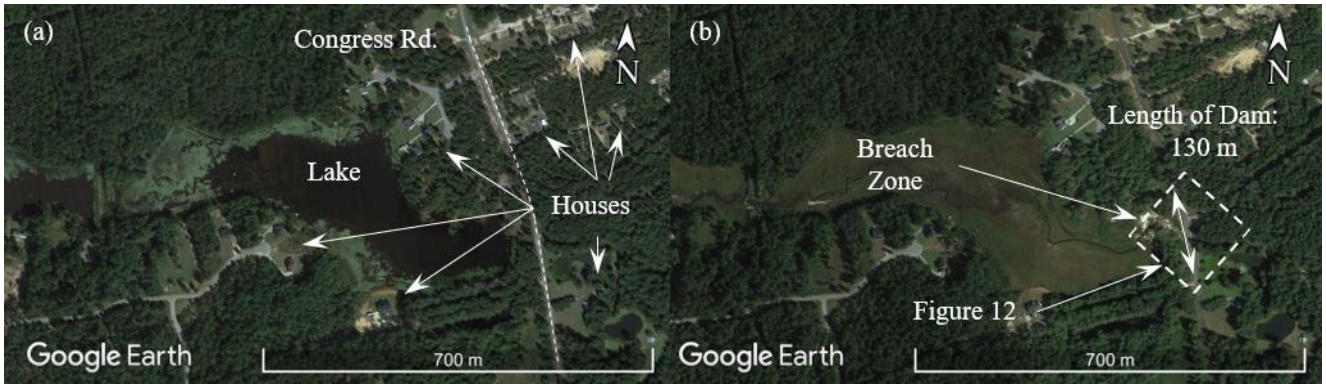
Figure 10. Dam B (a) before and (b) after failure (Google Earth, accessed on April 8, 2018).

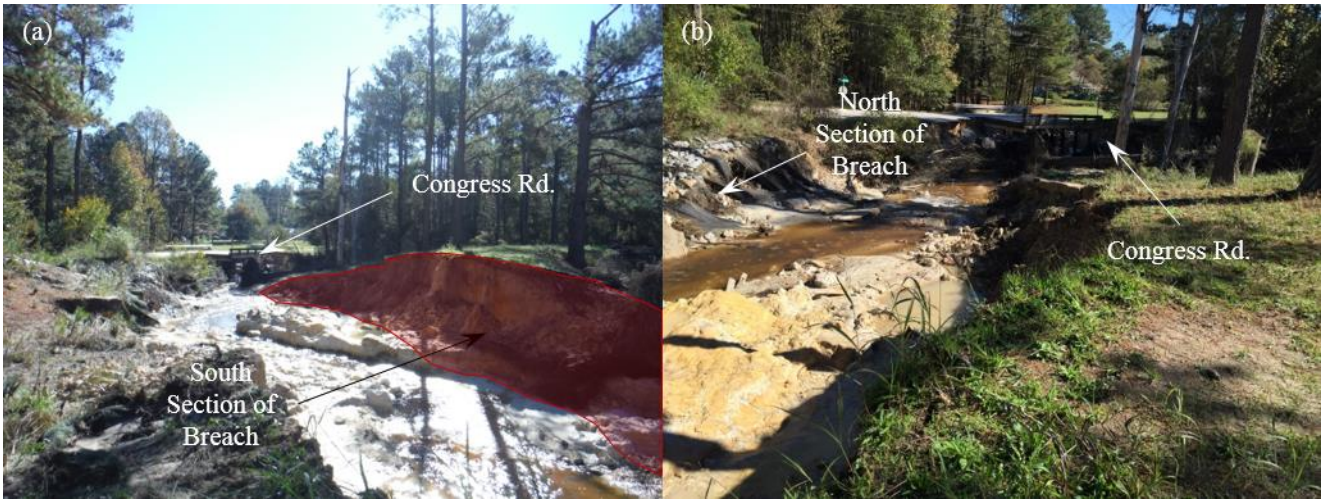
Figure 11. Breach section in Dam B: southeast views from (a) the north section of breach and (b) the south sections of the breach.

The dam was completely breached during the flood as shown in Figure 11. The location of the breach (see Figure 12) was close to the north end of the dam and close to the supposed original location of the second spillway riser pipe. The breach was approximately 15 m of the total 130 m length of the dam. Nearly 1,050 m^3 of embankment material was washed out during the flood event. Surface erosion was observed along the downstream side slope extending along the entire length of the dam, as shown in Figure 16. Trees on the downstream side slope of the dam were partially or fully tipped over and some appeared to be displaced (Figure 15b). These observations might indicate overtopping of the dam.

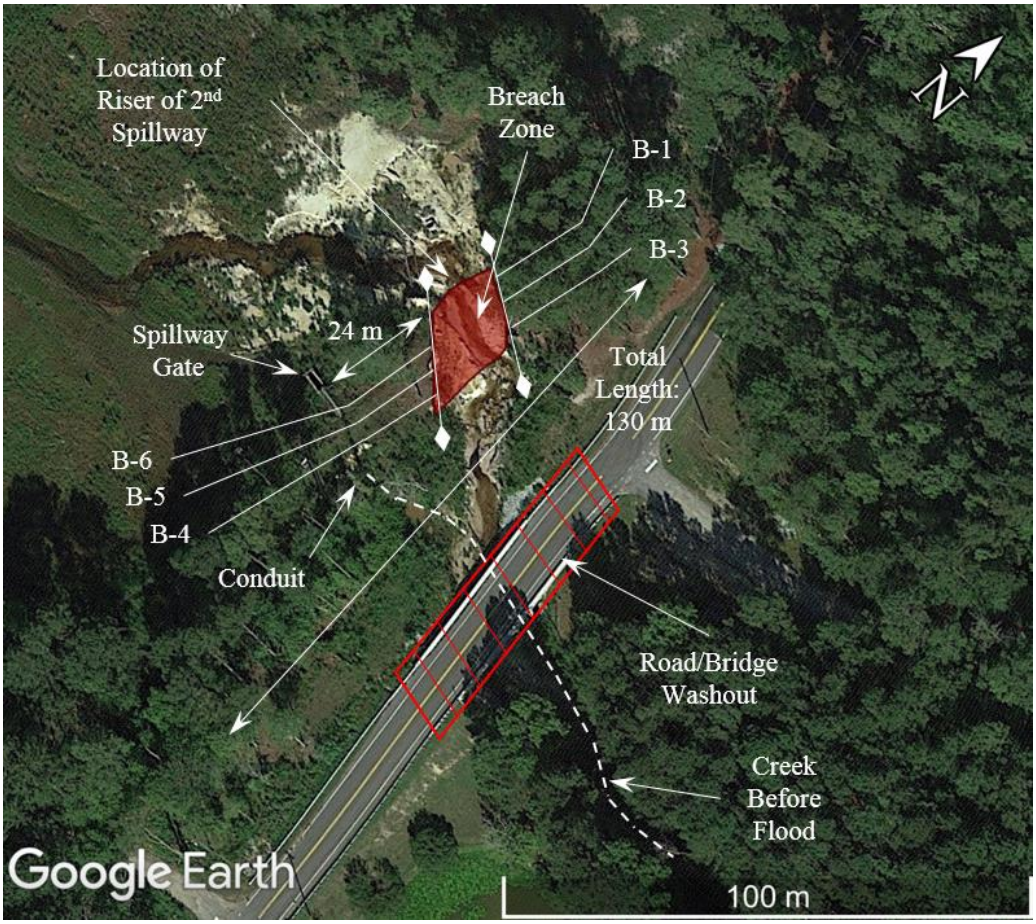
Figure 12. Location of spillways and breach in Dam B (Google Earth, accessed on April 8, 2018).

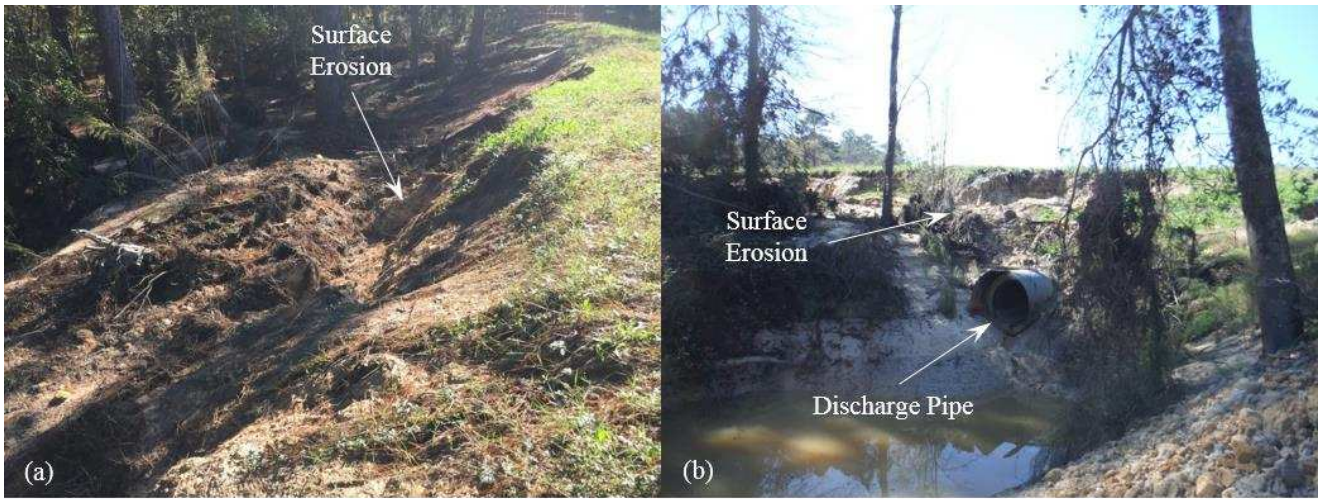
Figure 16. Surface erosion on downstream side slope of Dam B: a) south view from the crest of dam and b) west view from downstream.

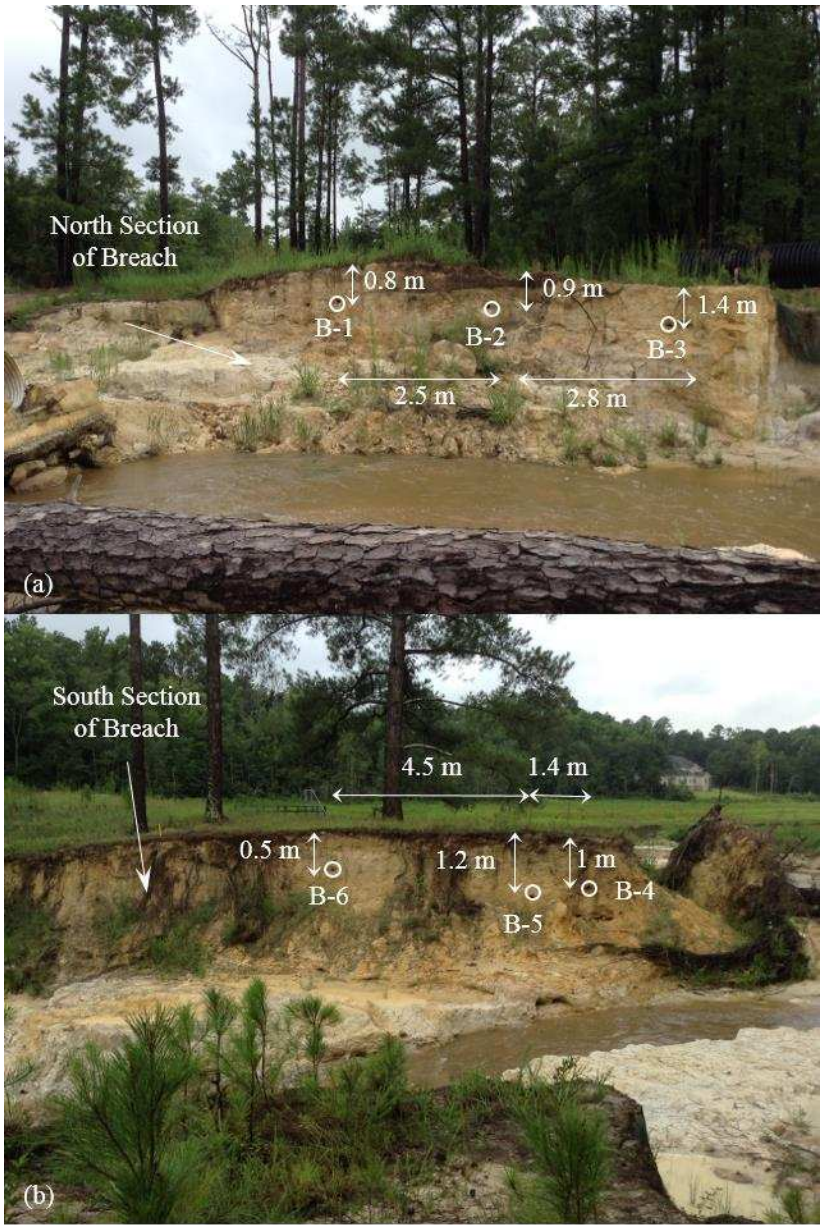
Laboratory testing results from soil samples collected at six locations from the breach section of Dam B are presented in Table 2. The sampling locations were selected to acquire soils representative of the full cross-section of the dam. Figure 17 shows the sampling locations viewed from the crest of the dam. The locations relative to the spillway, Congress Road, and the dam length, are also shown in Figure 12. Soils collected from the north and south sides of the breach are different. Samples B-1 and B-3 collected from the north side of the breach are classified as low to high plasticity clays and silts (MH and CH, and ML and CL, respectively), while the remaining soil samples were classified as silty or clayey sands (SM or SC). It is possible that because samples B-1 and B-3 were obtained from the north end of Dam B, there were natural materials scattered among the dam fill, or two different material types were used in the construction of the dam. In either case, there was no evidence of a dam core. Based on the results of samples taken closer to the middle section of the dam (B-4, B-5, and B-6), the dam material is mostly clayey sand with low plasticity fines. The fines content ranges from 15% to 49 %. The erosion rate, based on the characteristics of the soils in this dam, is moderately rapid (Wan and Fell 2004). The presence of roots through the dam may result in significant increments of the erosion rate.

Figure 17. Sampling locations for Dam B, (a) north wall of breach section (north view from crest), and (b) south wall of breach section (south view from crest).

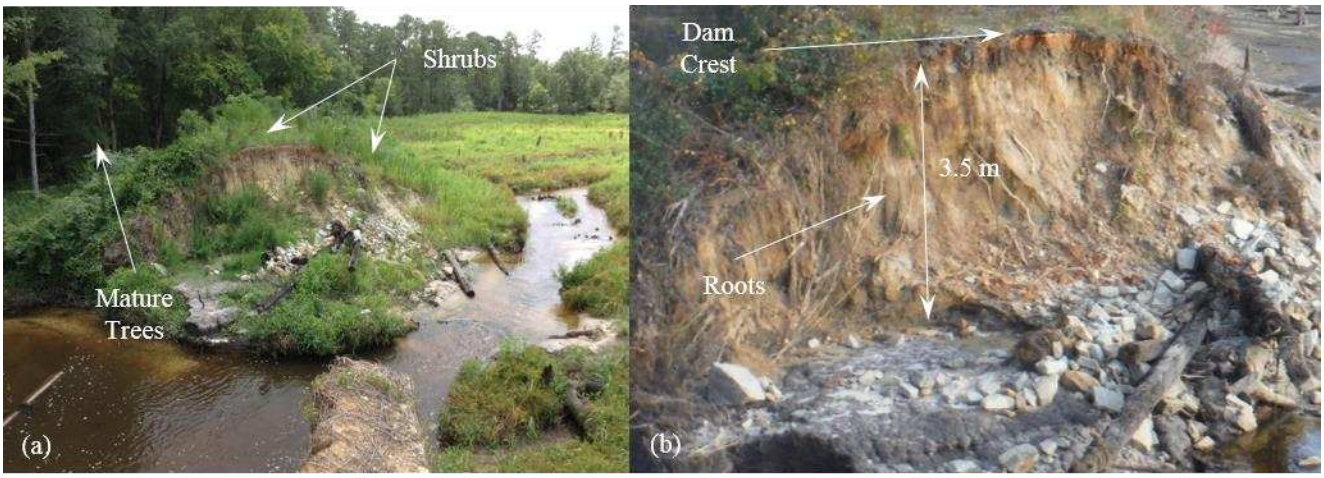
Grass and shrubs with heights up to 1 m were observed over the surface of Dam C (see Figure 21). Mature trees with heights of nearly 15 m were also observed in the area between the downstream toe of the dam and the road (see Figure 21a). Vegetation on the downstream side appears to be part of the natural ecosystem of the area (see Figure 20 and 21a). Roots growing through the dam were exposed in the breach zone (see Figure 21b), with depths of nearly 3.5 m penetrating into the 4 m height of the dam. According to a 2010 SCDHEC inspection report (SCDHEC 2016), vegetation on the downstream side should have been removed to allow inspection of the dam. An inspection report from 2014 indicates that vegetation was partially cleared from the dam, but the presence of trees on the downstream side should have been evaluated for seepage problems. The condition of the vegetation in the crest and side slopes of the dam, before and by the time of the flood event, is unknown.

Figure 21. Vegetation on Dam C: southeast views from crest of a) crest of dam with tall grasses and small shrubs (taken 10 months after breach), and b) exposed deep root structures at southeast breach wall (taken 1 month after breach).

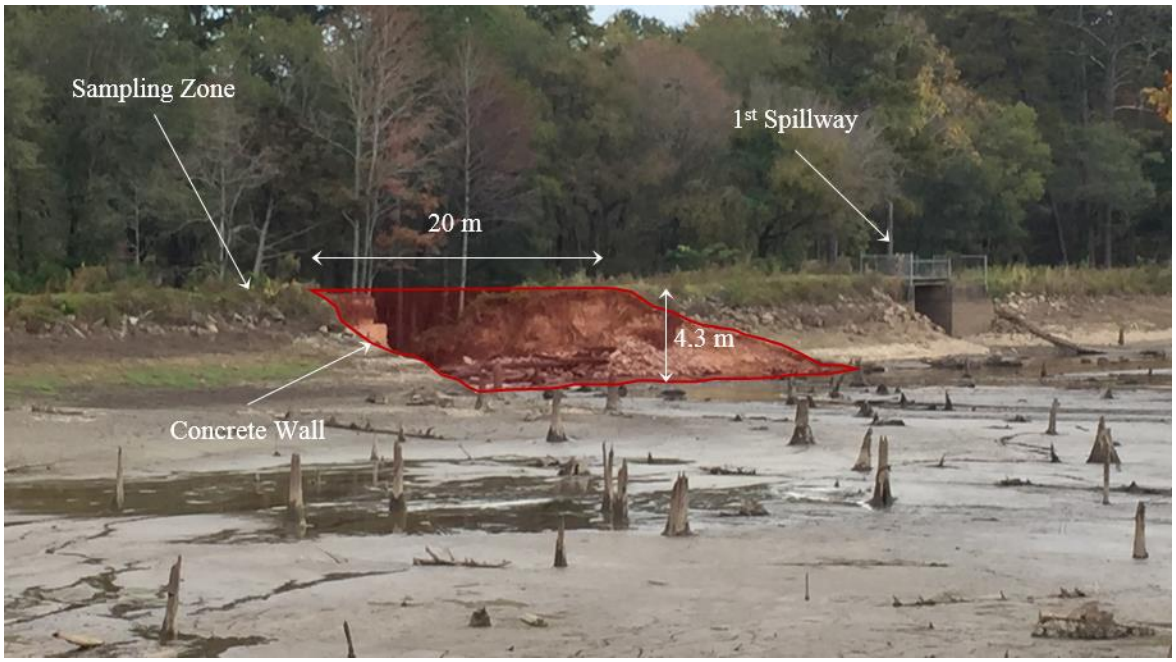
The dam was completely breached during the flood event as shown in Figure 22. The breach was located near the middle of the dam, 46 m northwest from the location of the first spillway gate (see Figure 19). The length of the breach was approximately 20 m of the total 191 m length of the dam, and nearly 900 m^3 of soil were washed out. Eyewitnesses during the flood event indicated that overtopping did not occur. Subsequent field observations did not find evidence of surface erosion on the downstream side slope or near the spillways.

Figure 22. Picture of the breached section of Dam C (northeast view from subdivision). Drained pond in the foreground.

A concrete wall about 4 m high and 0.5 m thick (see Figure 23) was observed at the location of the breach (see Figures 19 and 22). The wall appears to run parallel to the dam crest, within the upstream side slope, but does not extend the entire length of the dam. The purpose of this structure, the actual dimensions, and whether the wall was built before or during the construction of the dam, are unknown. As shown in Figure 23, soil near the wall was washed away during the flood event. According to a SCDHEC inspection report from 2014 (SCDHEC 2016), part of the wall protruded from the dam and had an attached fence that was used as a fishing fence. This fence was no longer attached to the wall at the time of the reconnaissance. The inspection report also highlighted several signs of deterioration in the dam including cracks in the spillway structures

and animal burrows. It is possible that internal erosion near the concrete wall initiated the breach of the dam. Cracks in the wall or gaps between the wall and the surrounding soil due to animal activity may result in concentrated flow initiating internal erosion (Bonelli 2013).

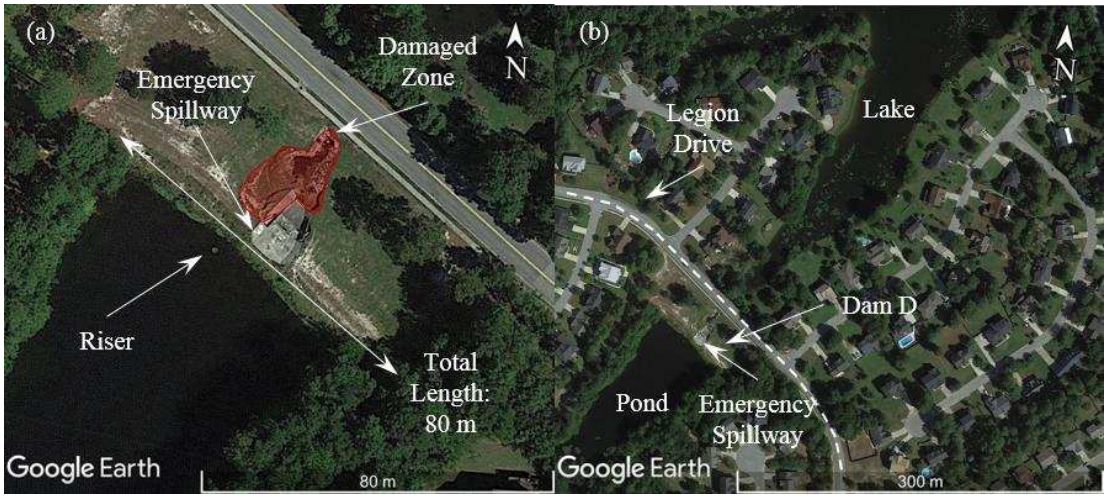
Figure 25. Aerial views of Dam D: a) geometry, draining structures, and damaged zone, and b) location relative to surrounding community (Google Earth, accessed on April 8, 2018).

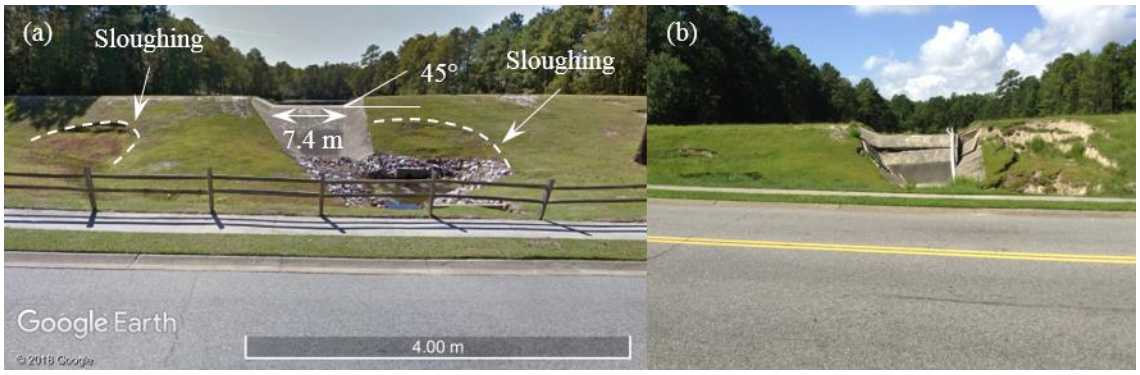
Figure 26. Southwest views of downstream side of Dam D, from Legion Drive: (a) before (Google Earth accessed on January 27, 2016) and (b) after 2015 flood event.

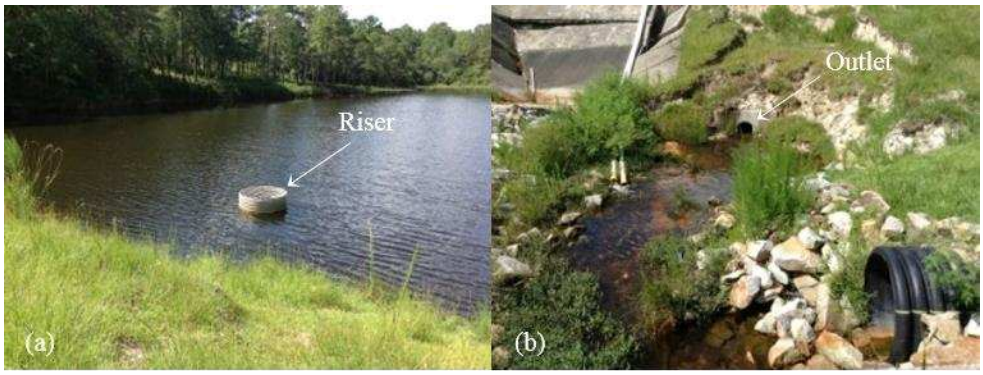
Two spillway systems were found at Dam D. The primary spillway is composed of a corrugated-metal riser used as an inlet (see Figure 27a), and a conduit made of a 0.6 m diameter concrete pipe used as an outlet (Figure 27b). The inlet is located nearly 10 m west of the crest of the dam, while the outlet is located at the toe of the downstream side slope. The second spillway is an emergency (overflow) spillway made of a trapezoidal-shaped concrete channel located in the middle of the dam (see Figure 28). The channel is 7.4 m in length at the base and has side slopes of nearly 45° (see Figure 26). From the photograph in Figure 26a (taken in October 2014), the concrete spillway appears to have been in good condition prior to the heavy rainfall event. After the event, two additional 10 cm diameter PVC pipes were installed on the emergency spillway to lower the water level in the pond (Figure 28a and 28b). All discharge water is directed toward a 1.5 m concrete culvert pipe located below Legion Drive that drains to the lake located downstream (see Figure 25b and 28b).

Figure 27. Primary spillway in Dam D: a) riser structure (southwest view from crest); and b) outlet pipe (southwest view from downstream).

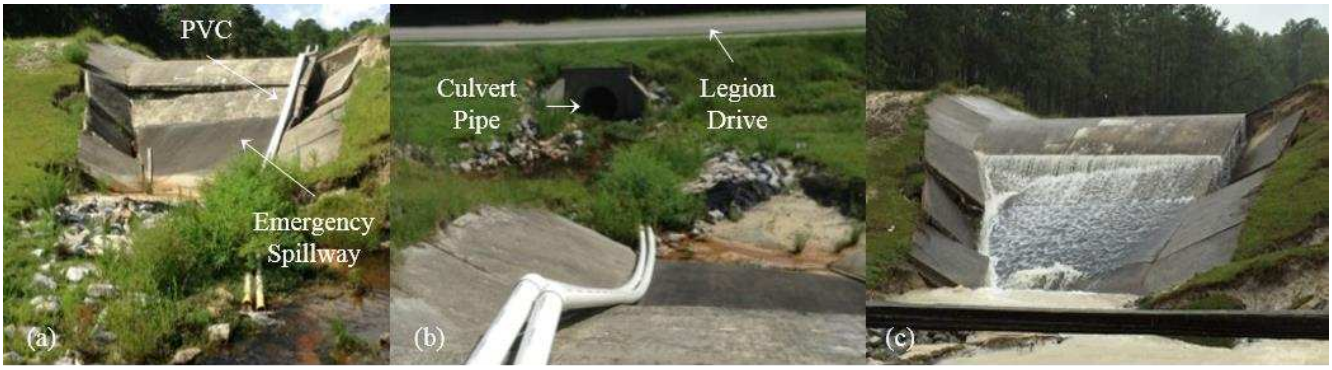
Figure 28. Emergency spillway and PVC drainage pipes at Dam D a) southwest view from downstream; (b) culvert pipe below the two-lane road (northeast view from the crest); and (c) failed concrete spillway during the heavy rain event (southwest view from downstream).

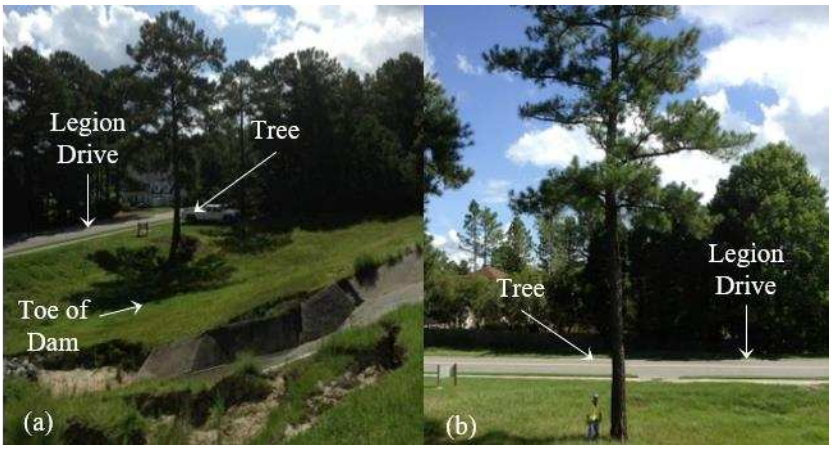
Figure 29. Vegetation on Dam D: a) east view from the crest showing short grasses and trees growing along the roadway near the downstream toe of the dam, and b) north east view from the crest showing a tree near the roadway on the southeast end of the dam.

The crest of the dam and the upstream and downstream side slopes, except for the concrete emergency spillway, are covered by grass with height approximately 0.1 to 0.2 m (see Figure 29). Otherwise, there was minimal intrusive vegetation observed over the surface of the dam. Six mature trees with heights between 10 and 18 m were observed downstream, between the toe of the dam and the road. Trees were not observed to be growing on the dam and roots were not visible within the failure zone.

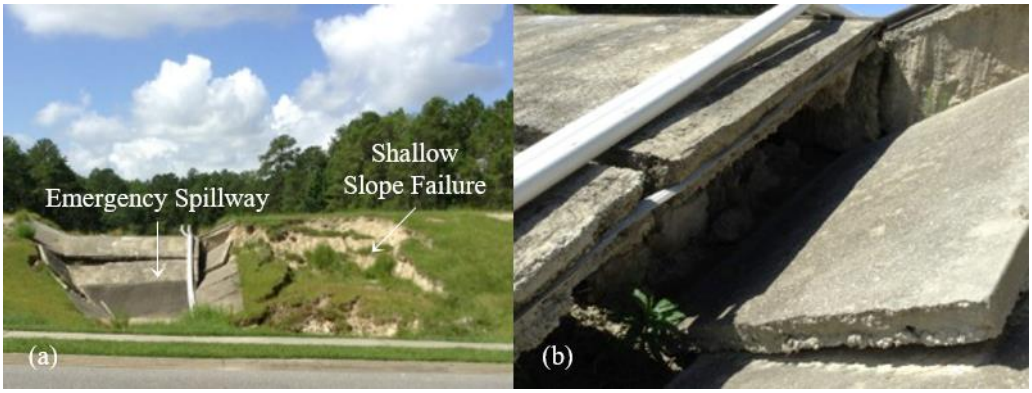
Dam D did not breach during the flood event but was severely damaged. A shallow slope failure, which was observed to be 15 m in length and 9 m in width, developed adjacent to the emergency spillway (see Figure 30a). The scarp of the slide indicates a vertical displacement of nearly 1 m. Right next to the slide, the concrete panels for the emergency spillway were detached and displaced from the side of the channel. Some cracks were observed in the concrete panels and there were voids between the panels and the soil beneath them. These voids (see Figure 30b) are evidence of erosion at the interface between the base of the concrete slabs and the supporting soil. While the specific mechanism(s) cannot be determined from the visual evidence, field observations and information provided from an eyewitness indicate that the crest of the dam was not overtopped. Thus, erosion was most likely caused by either surface water or subsurface water flow at sufficiently high velocity to undermine the soil support. The undermining and displacement of concrete panels may have contributed to the the shallow slope failure. Furthermore, a high volume of high velocity water flowing over the emergency spillway could have diverted onto the downstream side slope, enhancing the erosion in this area. Surface erosion was also observed near the toe of the downstream side slope where the primary and emergency spillway systems converge (see Figure 27b).

Figure 30. Failure of Dam D: (a) shallow slope failure in the downstream side slope and damage to the emergency spillway (southwest view from Legion Drive), and (b) close up view of voids under concrete slabs due to erosion below the slabs.
