Geotechnical Effects and a 6-Year Outlook of the 2012 Hurricane Sandy in the Eastern United States

ABSTRACT: *Hurricane Sandy was the deadliest and most destructive event of the 2012 Atlantic hurricane season. It originated as a storm off the coast of West Africa that turned into a tropical wave in the southwestern Caribbean Sea, and then into a hurricane that moved slowly north along the United States East Coast. Numerous regional coastal communities and urban centers in New Jersey (NJ) and the New York City (NYC) metropolitan area experienced widespread flooding, extreme winds, and heavy damage that disrupted daily life and business in Lower Manhattan, the world's financial capital. Consequences with great geotechnical engineering interest include: (i) modification of the regional coastal geomorphology due to storm surge, with the birth of new inlets, erosion, scour of soil at the shorelines; (ii) damage in coastal communities that revealed the vulnerability of residential building foundations not designed according to modern flood protection standards; and (iii) interruption of service of buried structures and below ground infrastructure due to flood damage to non-structural co

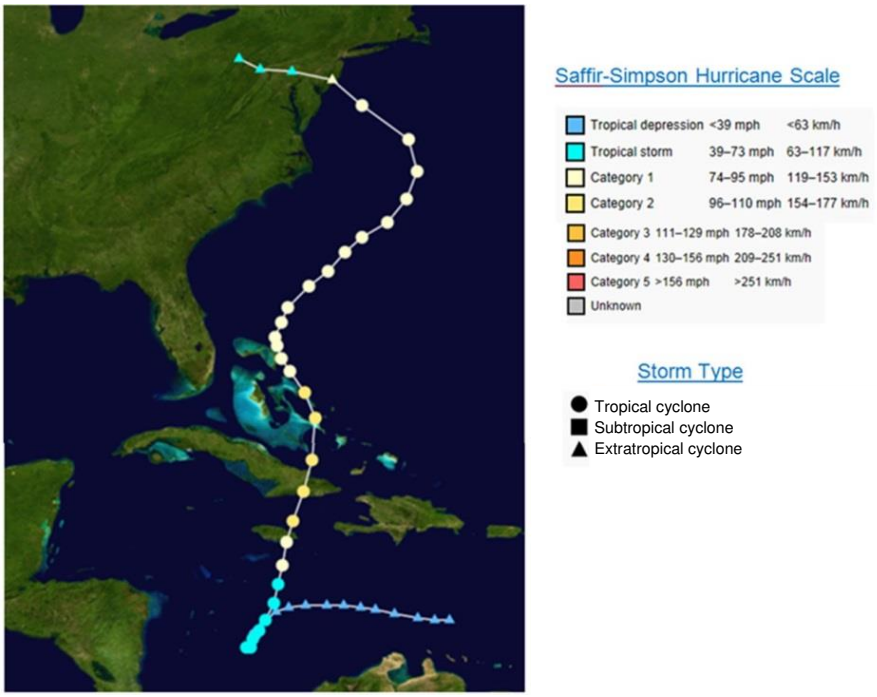
Figure 1. Map of Hurricane Sandy at six-hour intervals. Peak sustained wind speeds are colored per the Saffir-Simpson scale. The shape of points reflects the nature of the storm (based on Cyclonebiskit map with NOAA data and NASA background).

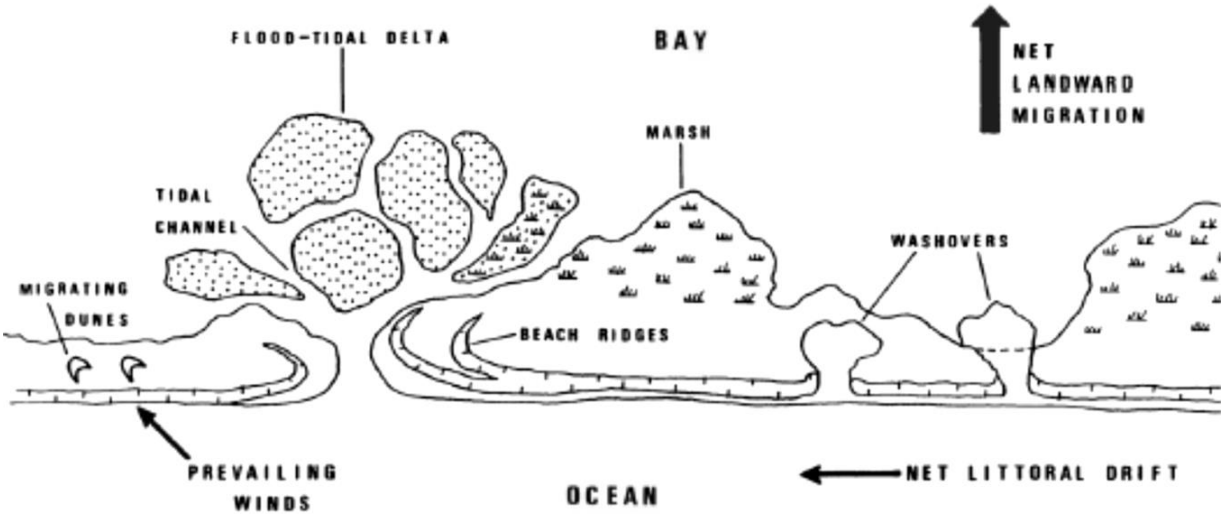
Figure 5. Geologic processes that build up a barrier island, allowing landward migration with sea level rise (Johnson, 1982).

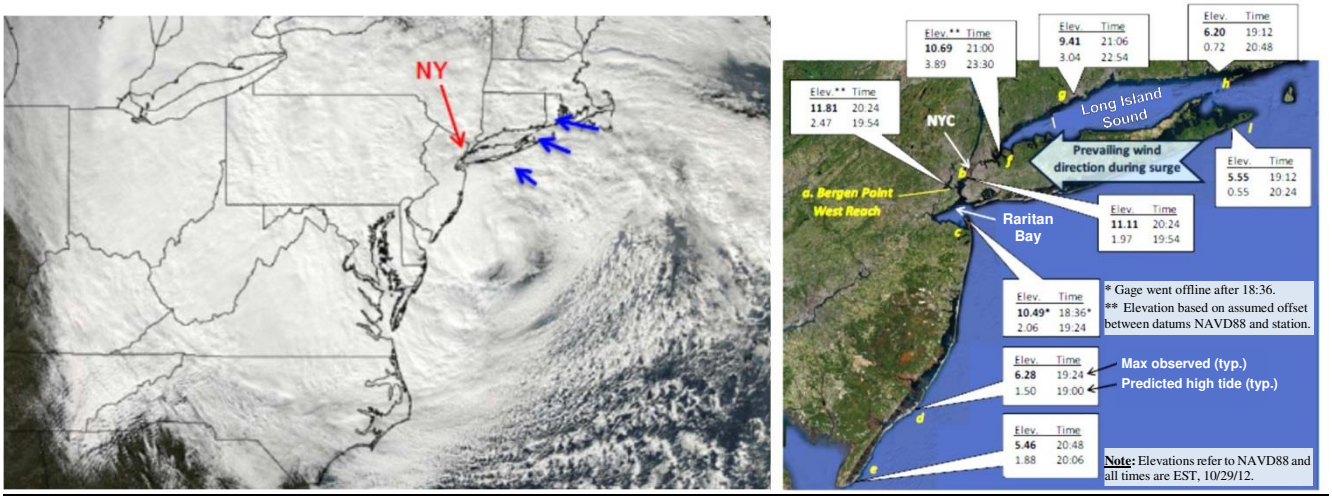
Figure 6 depicts the wind direction, fetch, coastline shape, and normal tidal cycle. The counterclockwise wind currents caused an eastern high velocity wind direction over LI and NYC. This pattern was verified by the GEER team's observation that many of the thousands of fallen trees in LI fell to the west. The following factors contributed to an increase of the surge:

Figure 6. Hurricane Sandy's circulation on 10/29/12 at 2:20 pm EDT; blue arrows show wind direction close to landfall in southern NJ (left; nasa.gov/ hurricanes/ h2012_Sandy). Observed and predicted tide from NOAA stations (right).

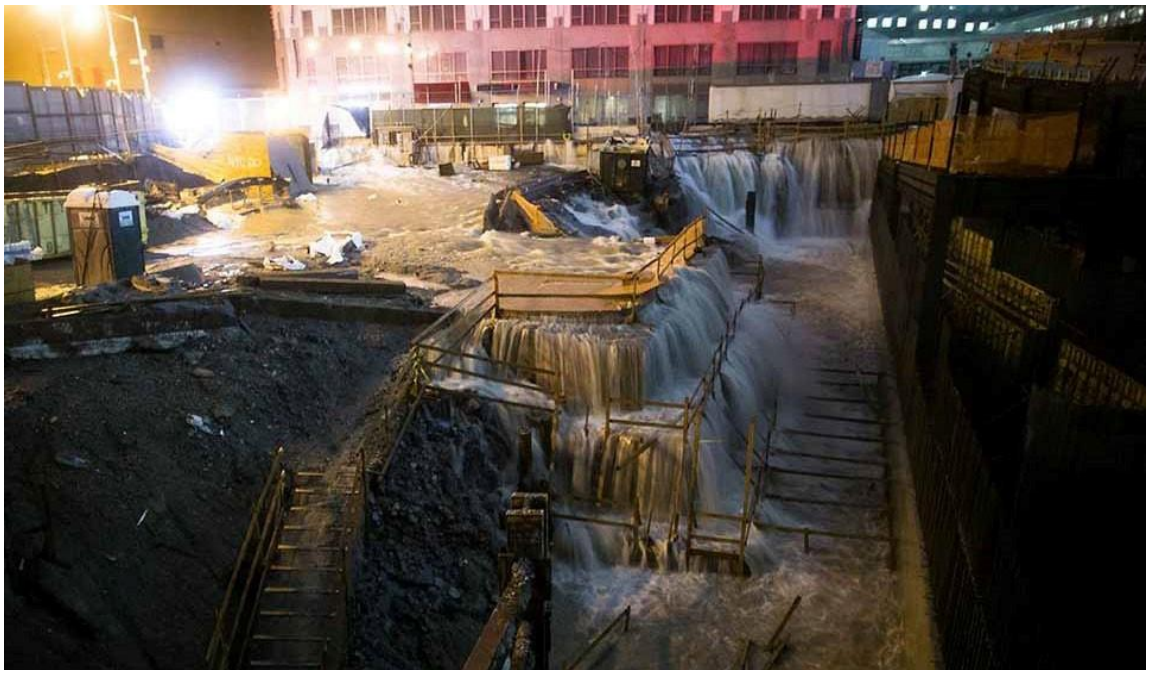
Damage in the dense urban NYC area of lower Manhattan was primarily related to flood inundation. High water marks and evidence of flood damage to approximately 1.2-2.1 m (4-7 ft) above street level were observed throughout low-lying neighborhoods (e.g., South Street Seaport) and water front areas (Fig. 12). Below-grade subway stations, tunnels, parking garages, and excavations experienced widespread flooding. While access to many of these locations was restricted to the GEER team due to ongoing recovery work, evidence of flood inundation was visible from the surface, e.g. at the Battery Park underpass and Bellevue Hospital. Based on reports in the days and months following the storm, the flooded tunnels included the Brooklyn Battery, Holland, and Queens-Midtown highway tunnels, the PATH rapid transit tunnels, NJ Transit / Amtrak / LI Railroad Hudson and East River rail, and seven subway tunnels. Several subway stations and open excavations were flooded, including South Ferry, which flooded to the ceiling, as well as an excavation at the World Trade Center site (Figs. 13-14).

Figure 14. Open excavation flooding at the World Trade Center site (Photo: Associated Press).

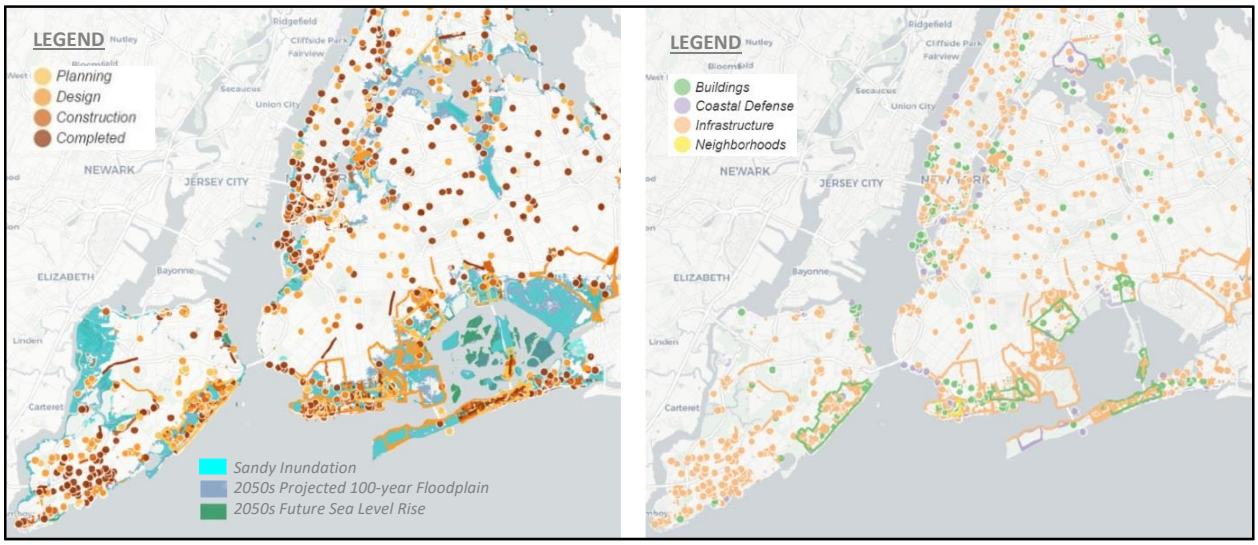
Figure 28. NYC Mayor's office map (maps.nyc.gov/resiliency/) of Recovery and Resilience OneNYC projects (NYC, 2018).

In 2015, NYC released the strategic plan for inclusive growth and climate action: "One New York: The Plan for a Strong and Just City", the first U.S. city resilience strategy with four visions that contain several goals and initiatives. The 2018 project status for buildings, coastal defense, infrastructure, and neighborhoods is shown in Fig. 28, along with Sandy's inundation and the 2050s projected 100-year floodplain and sea level rise (NYC, 2018). Proposed barriers have varied from berms and walls (extending along the edge of lower Manhattan) to barricades protecting the entire NY Harbor (using movable gates sized

appropriately so as to not impede shipping, like the Dutch barricades). Barricades would be needed across the lower NY Harbor near the Verrazano Bridge, west of SI at the East River near Throgs Neck Bridge, to prevent river flow from backing up and causing flooding upstream. Some barricades at tunnel entrances were installed, with solutions for subway entrances and ventilation openings (Hill et al., 2013).

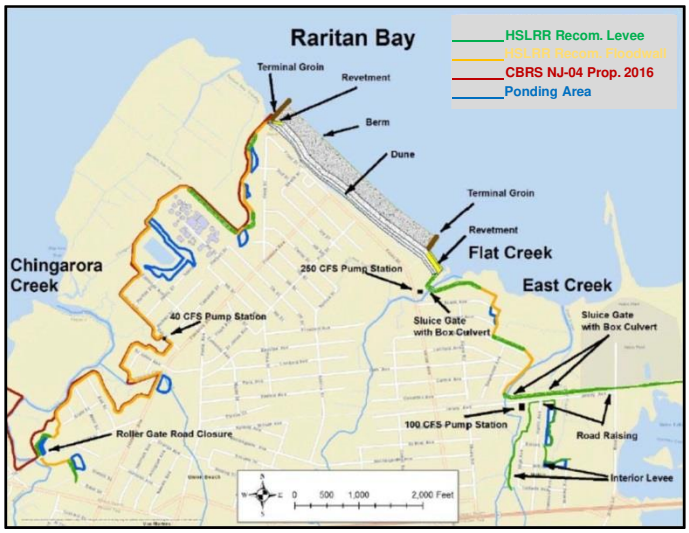
Figure 29. Union Beach plan overview from U.S. Army Corps of Engineering Limited Reevaluation Report (USACE, 2017).

The NJ State issued a report five years after Sandy with: (i) a record of damage and response; (ii) an agency-by-agency response/recovery playbook applicable to other states exposed to hurricanes; and (iii) rebuild measures co-funded by FEMA, the Departments of Interior and Housing and Urban Development (HUD), and Federal Highway Administration (FHWA), such as: Sea Bright wall, Mantoloking and Brick sheet piling, Belmar Lake Como discharge, Brigantine pump stations, Little Ferry tide gate, and Wildwood/Stone Harbor storm water/flood control. The Union Beach project in Raritan Bay (Fig. 29) would rebuild beaches and dunes and restore 100,000 m^2 (25 acres) of degraded wetlands to better absorb flood waters, with levees, flood walls, tide gates, and pump stations.

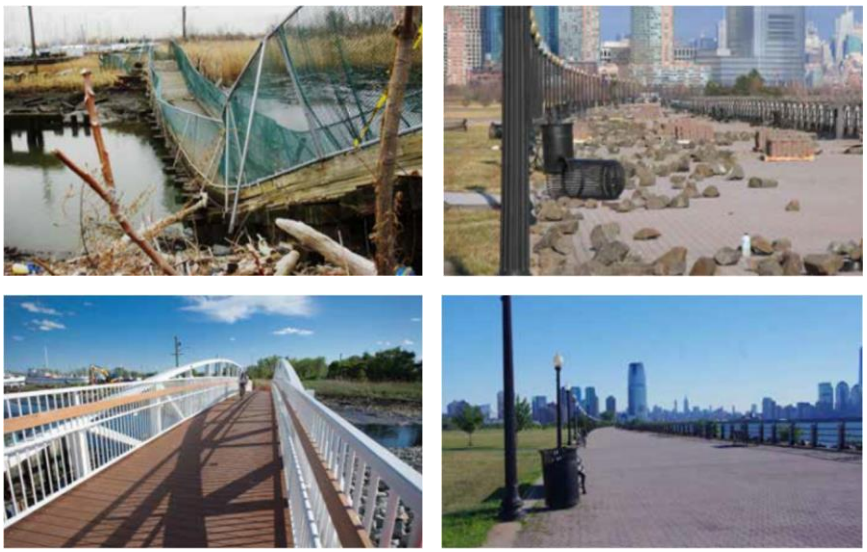
Figure 31. Liberty State Park (40.703100°N, 74.053700°W) before (top) and after rebuild (bottom). Photos by NJ State (2018).

Billions were invested to strengthen the electric and gas distribution networks toward a more resilient energy utilities grid. Advanced technologies were implemented to spot outages faster and deploy repair crews more efficiently. These projects increase the reliability of utility services, but also boost the NJ economy by creating new jobs. Investments in continuing the functionality of small businesses supported the tourism, which reached 98M in 2016 (breaking the 87M record of 2013). Intense efforts were made to reopen all parks within three months of Hurricane Sandy's passing, despite the enormous damage done across the entire state park system (Fig. 31).

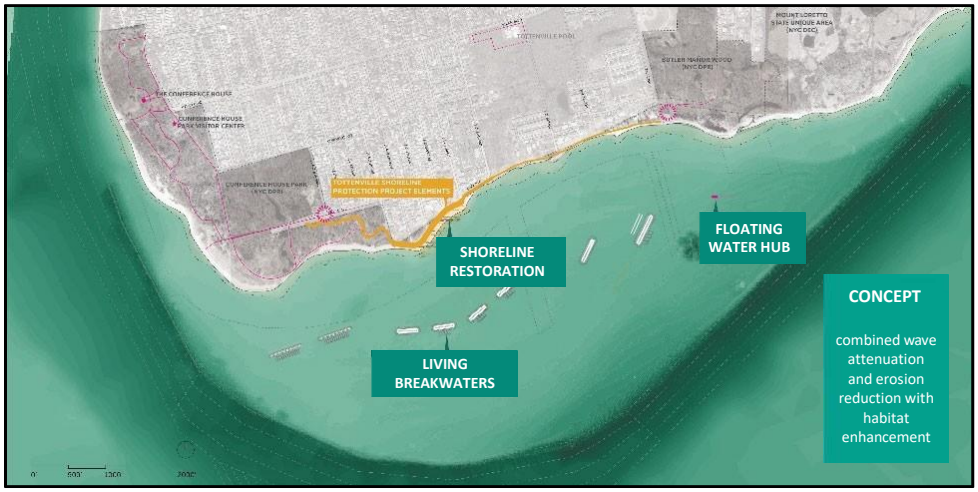
Figure 34. Living Breakwaters system: combined wave attenuation and erosion reduction with habitat enhancement.

added to the shoreline will protect vulnerable beaches, while breakwaters work to accrete beach elsewhere (Fig. 34). Similarly, in NJ, Rebuild by Design includes several projects, such as: (i) CDBG ($380M) projects to be completed by 2022; (ii) Hudson River ($230M) communities and critical infrastructure flood-resistance structures (e.g., N. Hudson Sewerage Authority); and (iii) protection of Meadowlands ($150M) Little Ferry, Moonachie, Carlstadt, Teterboro, and S. Hackensack.
