Hurricane Irma: Consequences of Intense Rainfall and Storm Surge from a Tropical Storm in North and Central Florida

KEYWORDS: reconnaissance, hurricane, sinkhole, karst, erosion, scour, beach, dam, infrastructure

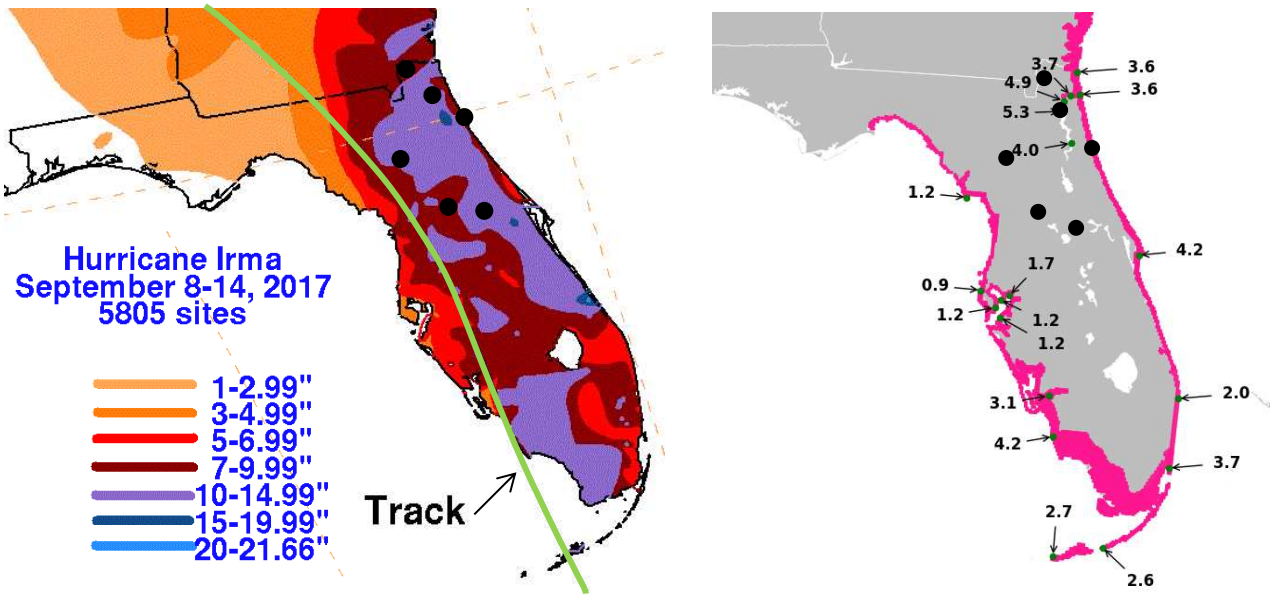
Figure 2. The track of Hurricane Irma, along with observed rainfall in inches from September 8-14, 2017 (left), maximum water levels from tide gauge measurements in feet above mean higher high water (MHHW) used to approximate inundation (right), and areas where storm surge warnings were made, in magenta (after Cangialosi et al., 2018). Black dots correspond to GEER investigation locations in Figure 1.

Water levels along the coast of Florida and in major estuaries and rivers are shown in Figure 2 (right). The data presented are tidal gage measured elevations in feet above mean higher high water (MHHW). MHHW is the Cangialosi et al. (2018) proxy for estimating the normal high-water mark, where water levels above these values indicate flooding from storm surge. Inundation is defined as the height of water over areas of normally dry ground due to the combination of both storm surge and astronomical tide. An estimated 0.9 m to 1.5 m (2.9 ft to 4.9 ft) of inundation above ground level occurred from Cape Canaveral, FL, in the south northward to the Florida-Georgia state line (Cangialosi et al., 2018). Tidal sensors reporting wave-corrected water levels above MHHW recorded values of 1.5 m (4.8 ft) in the Matanzas River just south of Vilano Beach and St. Augustine, and 1.25 m (4.1 ft) at Jacksonville Beach (Cangialosi et al., 2018), both of these being areas where GEER activities were focused. The United States Geological Survey (USGS) surveyed high water marks were reported to be 0.6 m to 1.2 m (2 ft to 4 ft) above MHHW in St. Augustine and 1 m (3.3 ft) above MHHW at Vilano Beach (Cangialosi et al., 2018). Cangialosi et al. (2018) also report that flooding in the St. Johns River in Jacksonville and the surrounding areas was significant due to both rainfall runoff and storm surge, where measured water levels were between 1.2 m and 1.6 m (4.0 ft to 5.3 ft) above MHHW.

The spatial distribution of rainfall from Irma is illustrated in Figure 2 (left). Between 0.18 m to 0.38 m (7 in to 15 in) of rainfall was recorded in north and central Florida. This heavy rainfall contributed significant amounts of water to overland flow and into natural and constructed water conveyance and storage systems (e.g., streams, culverts, retention ponds, and storm drains) and underground (e.g., through leaky underground piping and sinkhole conduits). The influx of water increased the potential for sinkhole activity. Rainfall and runoff along the coastal areas of Florida contributed to significant flooding. Many rivers in northeast Florida experienced major or record flooding. Record flooding occurred in Metropolitan Jacksonville

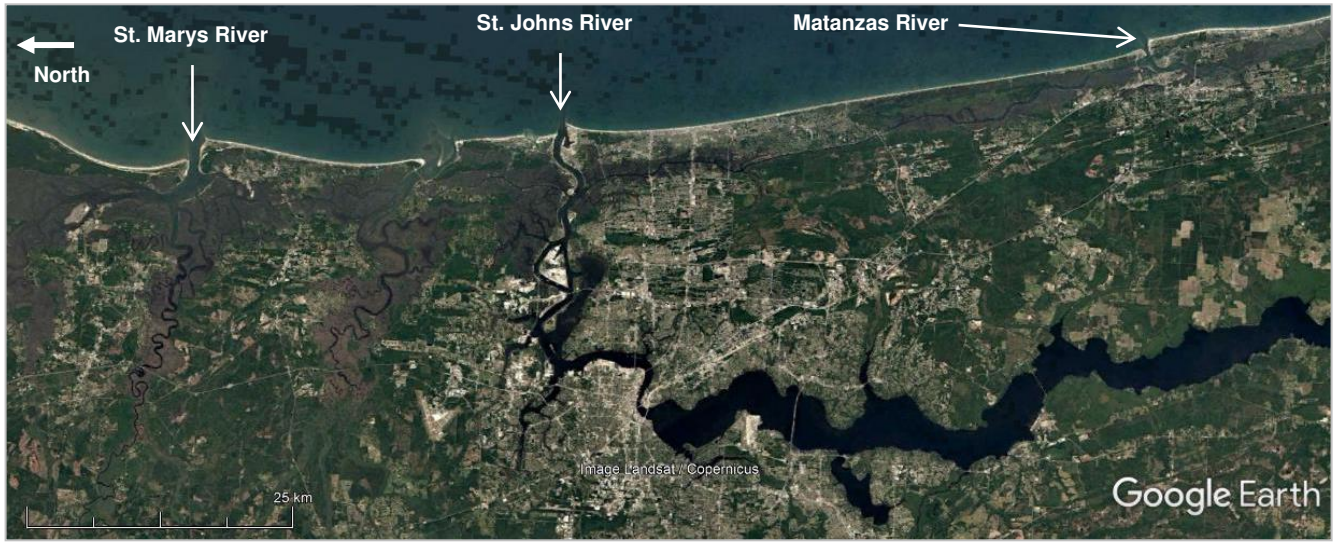
and Hampton Lake, which were the focus of this GEER reconnaissance. The St. Johns River in Jacksonville and St. Marys River downstream of Hampton Lake (Figure 3) were likely influenced by wind-induced storm surge that retarded the flow of rainfall out of the system and led to damage at the Lake Hampton Dam in Hilliard and the US-17 bridge embankment in Jacksonville.

Figure 3. Northeastern rivers influenced by runoff and storm surge, including St. Marys River leading to Lake Hampton, St. Johns River leading to Jacksonville, and Matazanas River near Vilano Beach and St. Augustine (Google Earth, 2018).
