Scour at the Seawall in Surfside, Texas, During Hurricane Harvey (2017)

ABSTRACT: *Hurricane Harvey was a Category 4 hurricane on the Saffir-Simpson hurricane wind scale. National Oceanic and Atmospheric Administration (NOAA) water level gages documented 1.1 m of water level elevation over predicted tide in Freeport, Texas, on 25 – 26 August 2017. The NOAA wave buoy 42019 offshore off Freeport documented wave heights > 7 m. A reconnaissance team of the Geotechnical Extreme Events Reconnaissance (GEER) Association visited Surfside, Texas, on 3 September 2017. While no significant damage to infrastructure was observed, the GEER team identified a significant scour runnel parallel to the Surfside seawall. The purpose of this article is to present the detailed observations of the scour runnel parallel to the Surfside seawall during Hurricane Harvey (2017). The sloped seawall is separating a shore-parallel street from the beach and is composed of angular boulders of approximately 30-50 cm in diameter. The observed runnel represented a depression of up to ~ 0.3 m in depth and ~ 4 m in width. It maintained mostly a distance of 0-5 m from the visible toe of the seawall. Boulders seemed par

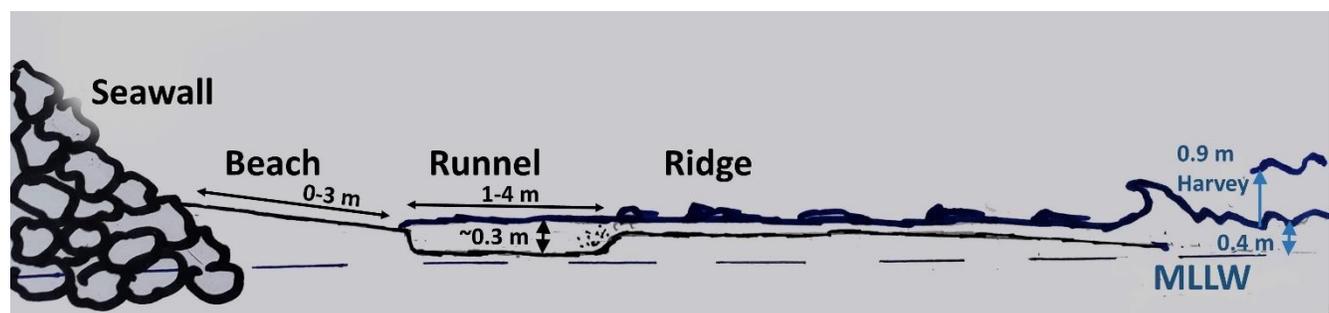
Figure 8. Conceptual sketch of observations by the GEER team at Surfside beach (yearday 246; 20:00 UTC).

A conceptual sketch of observations is provided in Figure 8. Overall, the runnel appeared to have formed through scour, which was driven by breaking or reflected waves from the seawall. It should be mentioned that the tidal level at the time of the observations was approximately 0.4 m above mean lower low water based on NOAA gage 8772447. This means that during Hurricane Harvey local water levels may have been up to 90 cm higher, submerging the beach entirely.

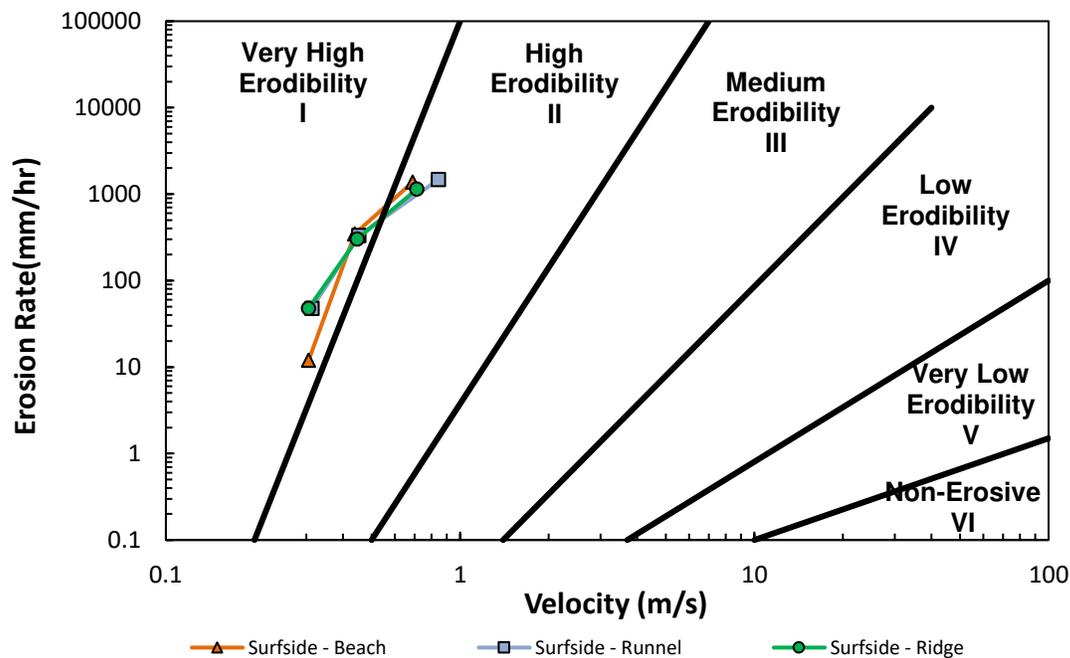
Figure 9. Summary of EFA test results.

The samples were remolded in the soil erosion laboratory at Texas A&M University. The samples were compacted in three equal layers in Shelby Tubes using a standard compaction hammer to achieve a minimum of 18 kN/m^3 total unit weight. Erosion Function Apparatus (EFA) tests were performed on each of the samples to investigate the erodibility of the material following the procedure outlined in Briaud (2001) and Briaud et al. (2017). The EFA measures the relationship between the erosion rate, water velocity, and hydraulic shear stress at the soil-water interface. Erosion rate was measured in terms of mm of sample height per hour for flow velocities of 0.306 m/s, 0.438 m/s, and 0.691 m/s, corresponding to shear stresses of 0.339 Pa, 0.672 Pa, and 1.55 Pa, respectively. Results for all three samples are shown in Figure 9, classifying the samples at the border of very highly erodible to highly erodible.

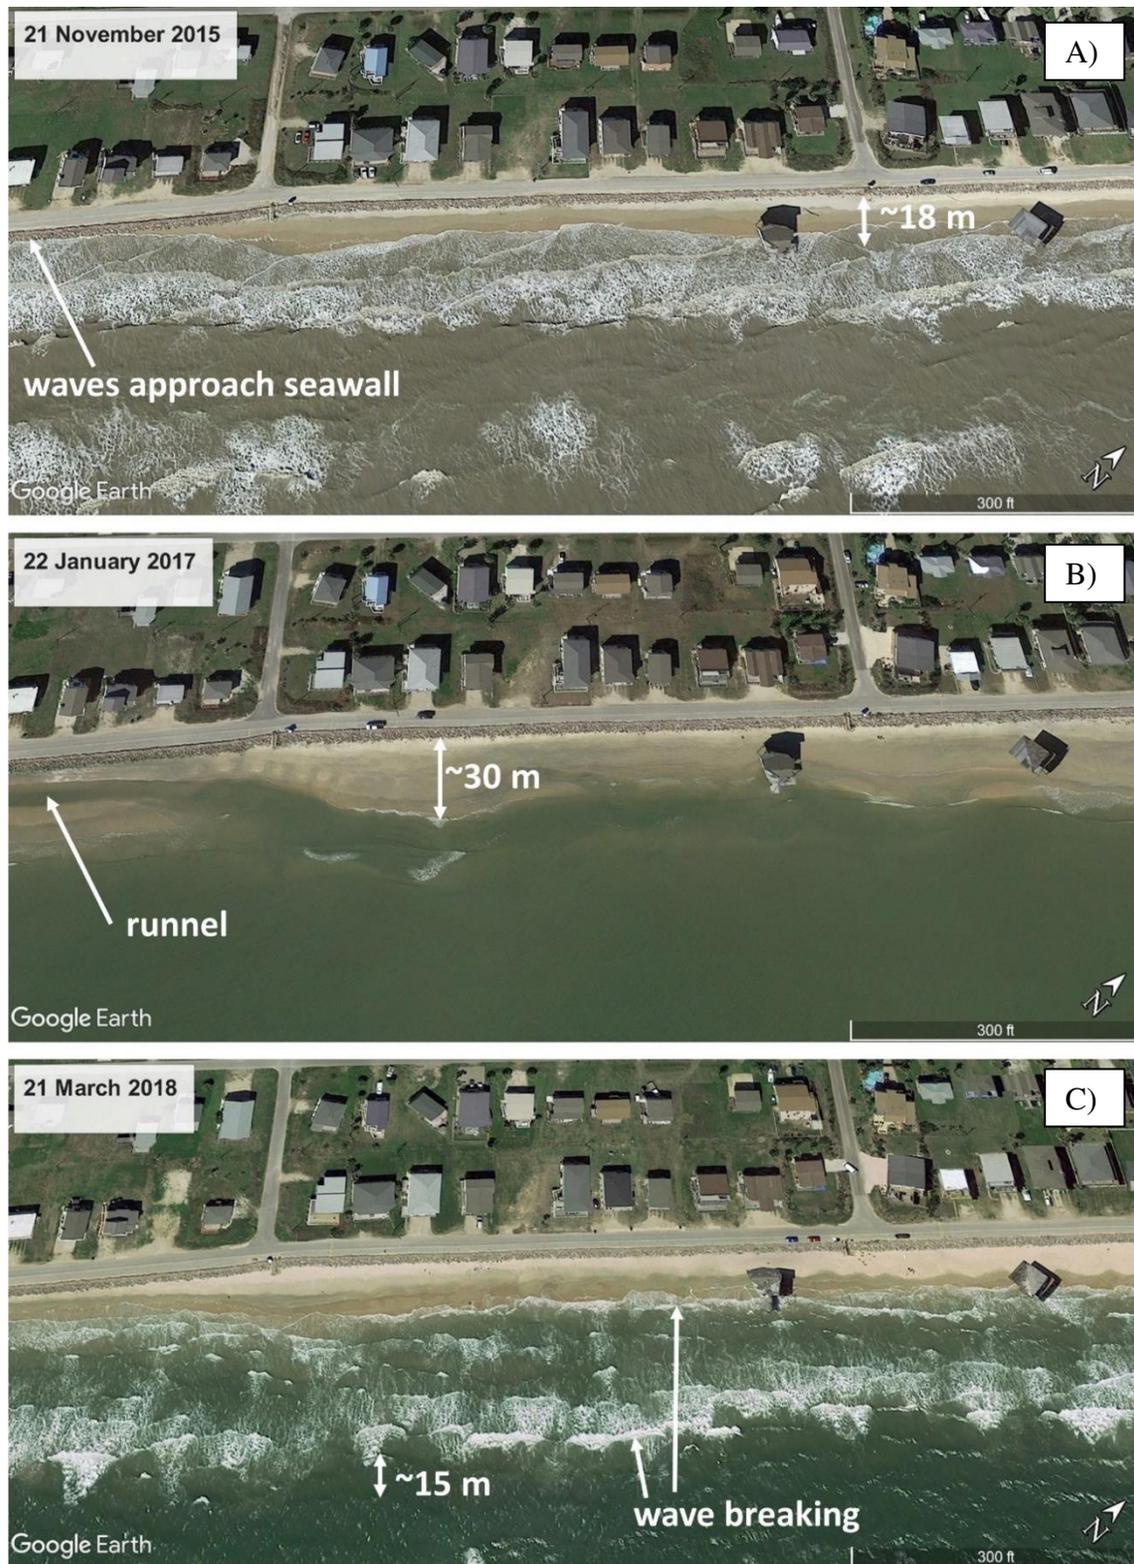
Figure 10. Google Earth satellite imagery from the area of interest at Surfside Beach well prior to and post Hurricane Harvey (Google Earth 2018a-c for panels A, B, and C, respectively).

Satellite imagery was obtained from Google Earth from 21 November 2015, 22 January 2017, and 21 March 2018 (Fig. 10). All of these dates are well prior to or post Hurricane Harvey and, therefore, represent conditions mostly unrelated to Hurricane Harvey. Even conditions in March 2018 are likely minorly affected by Hurricane Harvey, as no major damage to the seawall, significant net erosion, or major effects on local geomorphology can be identified in the image. The purpose of the presentation of these images is to provide a brief insight into general conditions at the site. In November 2015, wave action is present and visible. According to NOAA, offshore significant wave heights reached 0.8-3 m on the day of the image, with

a significant wave height of about 1.1 m at the time of the image. Crest-to-crest distances and wave lengths of the approaching waves were about 20 m from the satellite image. The width of a visible beach varied from about 0-18 m in front of the seawall and in the area of interest (Fig. 10). Wave breaking appears most prominent at the shoreline with the second line of waves breaking at a distance of ~ 85 m from the seawall. On 22 January 2017, wave conditions were calm.

A runnel system is clearly visible with beach widths from less than 2 m to 30 m, and associated variations in the position of the runnel. The runnel width varied similarly to the development of the runnel from less than a meter to about 10 m. It should be noted that wave conditions were overall rather energetic in this month, despite calm conditions at the time of the image. On 21 March 2018, waves were more visible in the image again, having crest-to-crest wave lengths of about 15 m in the area of interest in the image. The beach width reached from 5-20 m, and some wave breaking is visible at the shoreline, while dominant wave breaking occurred at a distance of ~ 60 m from the shoreline. It should be noted that water levels varied for the imagery. On 21 November 2015, water levels were about 0.75 m above mean lower low water at NOAA gage 8772447 at approximately noon local time (being a typical time for optical satellite imagery), and were about 30 cm higher than the predicted tide. On 22 January 2017 at noon local time, the actual water level was 0.12 m above mean lower low water, being about 10 cm lower than the predicted tide. On 21 March 2018 at noon local time, the actual water level was 0.34 m, being within 5 cm from the predicted values.

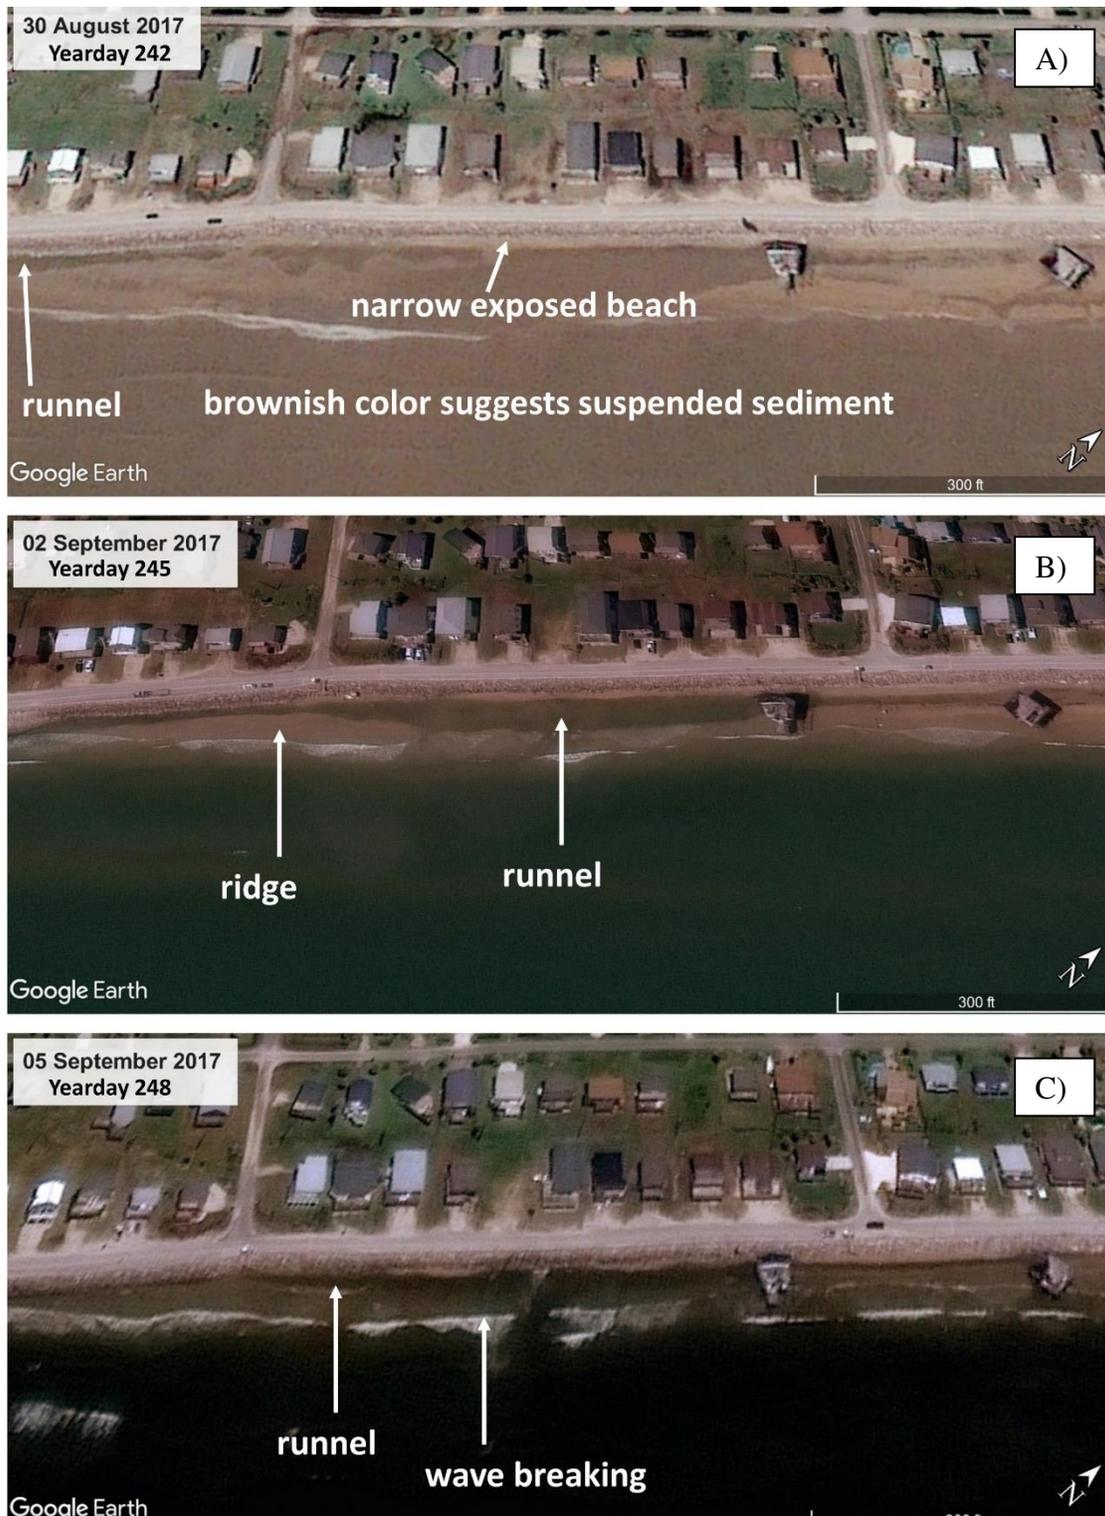
Figure 11 shows satellite images from yeardays 242 (30 August 2017), 245, and 248 during the Hurricane Harvey event. Only yearday 242 still featured elevated water levels in Freeport and somewhat larger offshore waves (Figs. 4 and 5). However, it should be noted that the measured offshore waves were mostly directed offshore at that time (Fig. 5). The satellite image from yearday 242 clearly shows a large amount of suspended sediments in the water. The beach width is narrow (0-7 m) in front of the seawall in the area of interest. It should furthermore be noted that a clearer morphology may not be visible due to the murkiness of the water from suspended sediments. The evolution of a thin runnel close to the seawall (0-4 m) and a partially less well-developed ridge appear visible. Some wave breaking is visible about 35 m from the seawall.

On yearday 245, the day prior to the visit of the GEER team, a well-defined ridge-runnel is visible with a beach width of 0-4 m, a runnel width of 3-10 m, and some wave breaking at the offshore edge of the ridge at a distance of ~ 25 m from the seawall. Imagery may suggest a second ridge at a distance of ~ 50 m from the offshore edge of the clearly visible ridge.

On yearday 248, the runnel is still visible. However, a decrease in width and a loss in height of the ridge seems to be indicated by the image. Again, assuming that imagery was collected around noon local time, some minor differences in water level must be expected (Fig. 4).

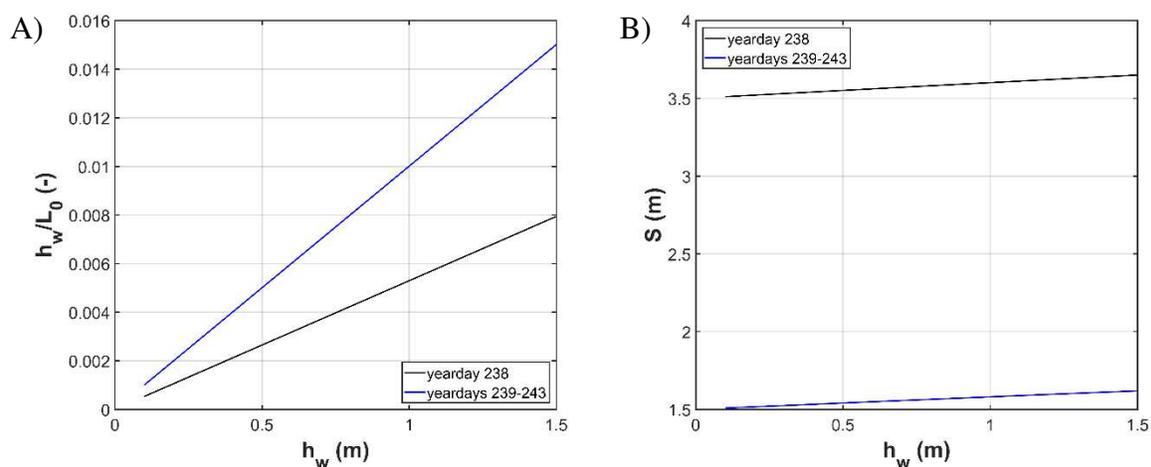
Figure 14. A) Water depth at the seawall h_w vs. the relationship between h_w and the deep water wave length L_0 for conditions on yearday 238 (black) and yeardays 239-243 (blue). B) Estimated scour depths S within the same days and range of h_w after Equation 1 (Fowler 1992).

Both scour assessment expressions shown in Equations 1 and 2 were tested. The following parameters were used: H_0= 7 m on yearday 238 and H_0= 3 m on yeardays 239-243; T= 11 s on yearday 238 and T= 8 s on yeardays 239-243; h_w ranging from 0.1-1.5 m, an estimated beach slope of 5°, and a grain size of 0.2 mm. The deep-water wave length was calculated using the dispersion relationship. Results using Equation 1 are shown in Figure 14. Figure 14 also depicts the relationship between h_w/L_0 within the tested range of h_w, showing that the conditions lie within the applicable range of $-0.011 < h_w/L_0 < 0.045$ for Equation 1 by Fowler (1992). The scour depth is clearly over-predicted (about ten times deeper than observed; Fig. 14 right). Equation 2 led to even larger over-predictions. This is not surprising, as these expressions were developed for vertical wall seawalls, breaking waves, and the associated scour at the seawall. Also, these expressions do not take into account the irregularity of the waves, amongst other limitations. Sumer and Fredsoe (2000) suggested a relationship between the angle of the sloped rubble-mound seawall, the ratio of water depth over wave length h/L, and the ratio of scour depth and wave height S/H. Assuming $0.05 \le h/L \le 0.1$ (for example, 1 m in water depth and 20 m in wave length), and a slope of 30-40°, S/H equals 0.1-0.7. To generate a scour depth of 30 cm, wave heights between 0.4-7 m would be needed, being well within the possible range.
