A Constructability Problem in a Deep Shoring System

KEYWORDS: Deep Excavation, Retaining Wall, Secant Bored Pile, Prestressed Anchors, Shotcrete, Inclinometer Measurements

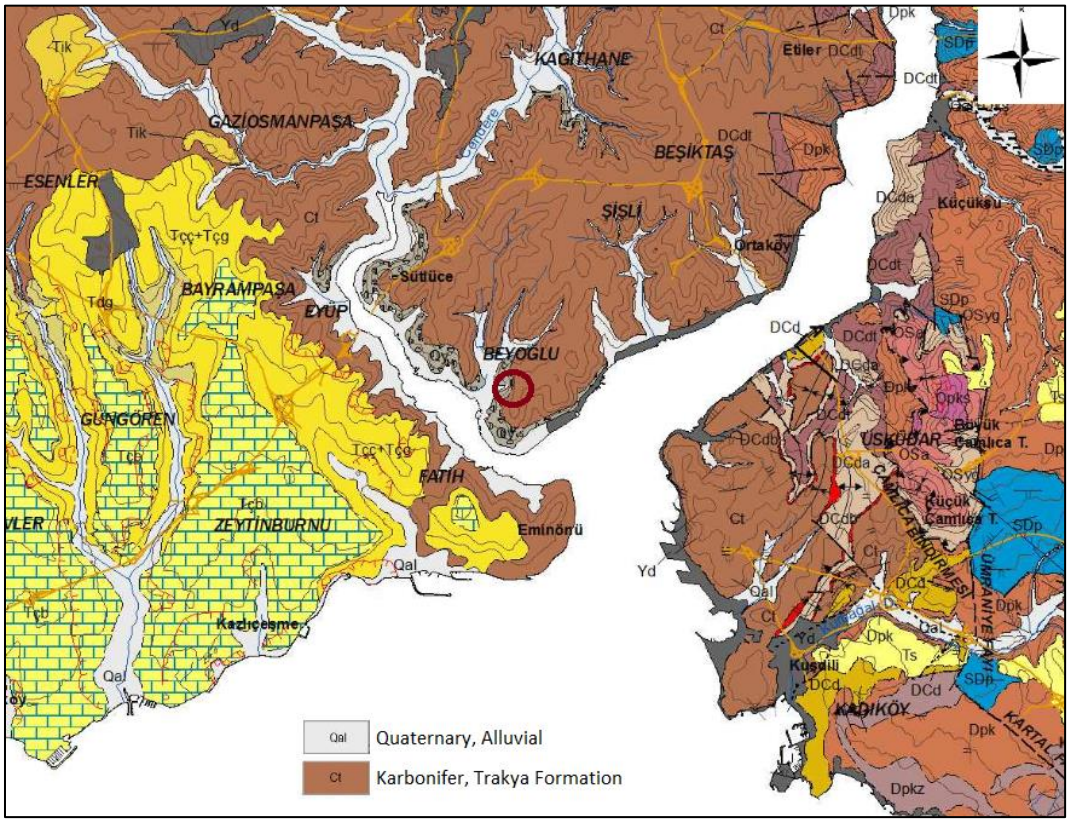
Figure 2. General Geology Map of Project Site (İstanbul Geology Map, İstanbul Metropolitan Municipality, 2011).

Trakya Formation is a succession of shale, siltstone, sandstone subordinate conglomerate, and carbonates, bounded by lydites at the base and limestone at the top. It is very intensely folded, faulted, fractured, and is also weathered, which makes it well developed along discontinuities. Hercynian orogeny of Late Paleozoic resulted in the regional uplift and erosion of Paleozoic rocks.

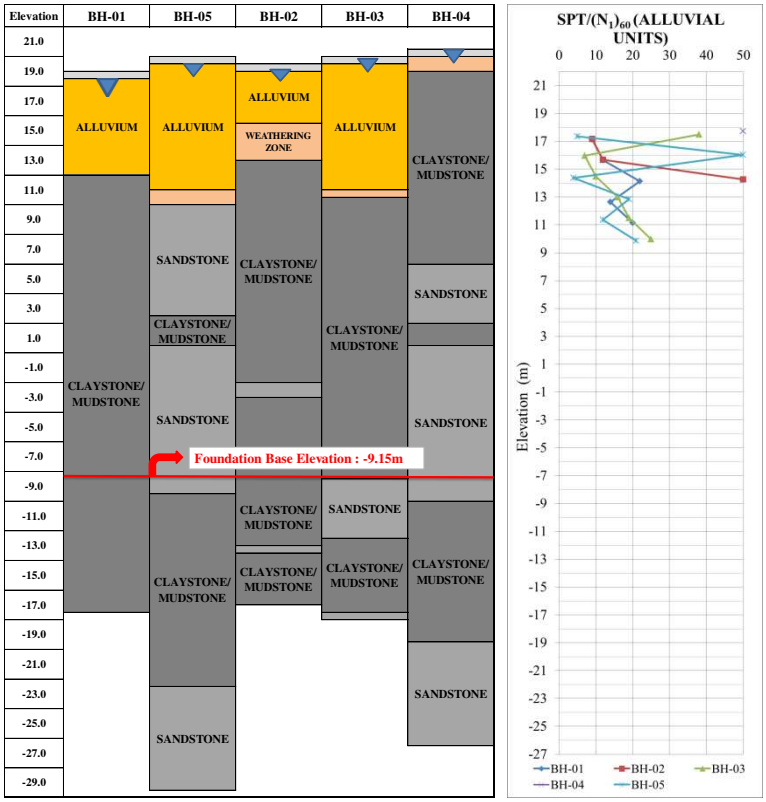
Figure 3b. Soil Model, Groundwater, and Corrected SPT/$(N_1)_{60}$ values of Alluvial Units.

With the exception of BH-4, encountered alluvium unit thickness varied between 3.7m and 8.9m. Alluvium layers were light brown, moist, fine-medium subangular - subrounded gravelly, with a medium plasticity very stiff-hard clayey, silty and fine-medium grained medium dense-dense sand. FeO and MnO traces were observed on gravel surfaces.

The daily groundwater readings were taken during site investigation and after the completion of site investigation. To monitor the groundwater levels, PVC pipes were installed, within the borings BH-1, BH-2, and BH-3. The groundwater table depth was found to range between 4.1m and 5.2m (January – March 2014).

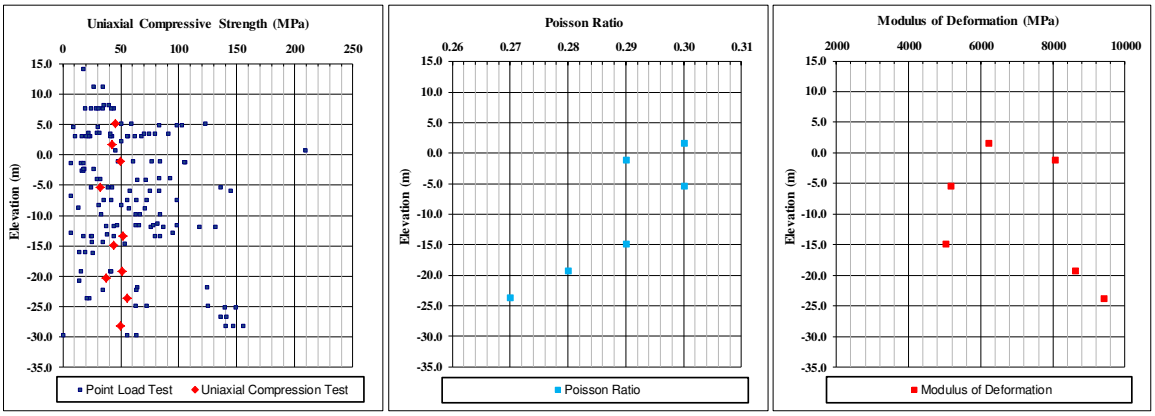
Figure 5. Rock Mechanics Laboratory Test Results.

The following soil laboratory tests were performed: sieve analysis, hydrometer tests, specific gravity, Atterberg limits, natural water content, consolidation, and undrained unconsolidated triaxial tests. Point load and uniaxial compression tests (with deformation modulus) were performed on obtained rock core samples. The results are summarized in Table 2 and Figure 5.
