Liquefaction and Non-liquefaction Cases from the Mataquito Bridge, Chile, after the M_w 8.8 (2010) and M_w 6.6 (2019) Earthquakes

Ricardo Moffat, *Civil Engineer, Universidad Adolfo Ibáñez, Santiago, Chile; email: ricardo.moffat@uai.cl*
Robb Moss, *Civil Engineer, California Polytechnic State University, San Luis Obispo, USA; email: rmoss@calpoly.edu*

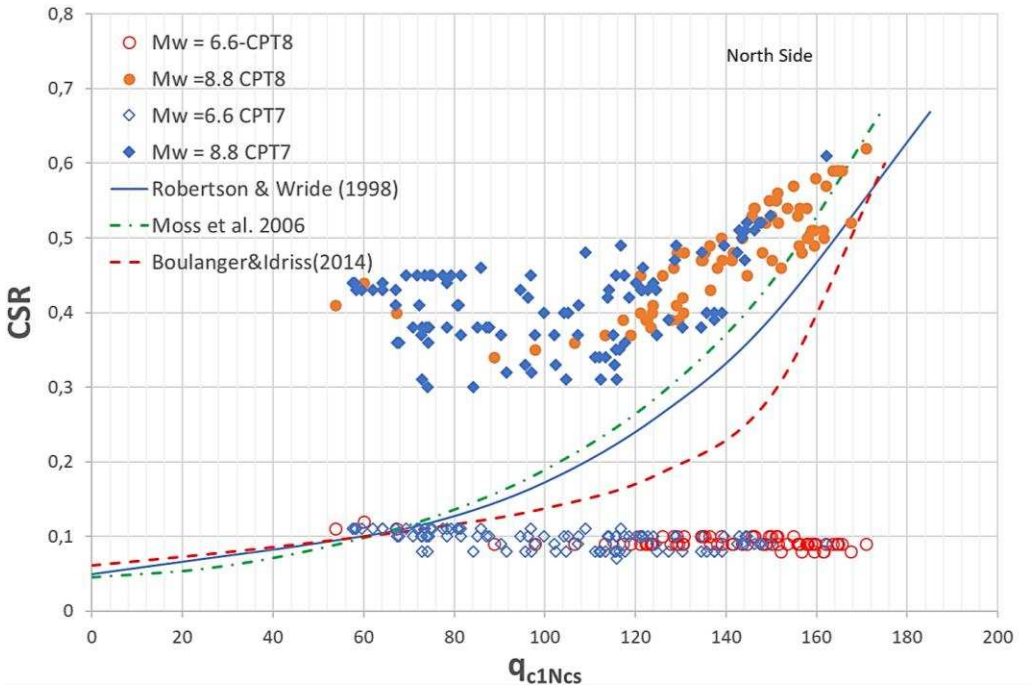
The liquefaction analysis using the CPT data and procedures Robertson and Wride (1997), Moss et al. (2006), and Boulanger and Idriss (2014) are shown in Figure 15. Boundary curves are deterministic or a 15% probability contour is used as deterministic. The analysis shown in this figure was performed for both earthquakes (M_w 8.8 and M_w 6.6), and used all CPT data until the gravel layer was reached. On the north side, the results agreed with what was observed in the field (see Figure 15). Liquefaction potential was deduced from the M_w 8.8 earthquake for almost any depth. Regarding the M_w 6.6, only a few points were on the liquefaction side, and these corresponded to depths between 7.3 m and 7.55 m, too deep to have a manifestation in surface of liquefaction (Ishihara, 1985, Youd et al., 1995).

Figure 15. Liquefaction analysis on the north side (CPTs 7 and 8) with three triggering relationships.
