Bridge Abutment Remediation – A Case Study

KEYWORDS: Transport and Main Roads, rainfall, failures, remediation, temporary works, permanent works

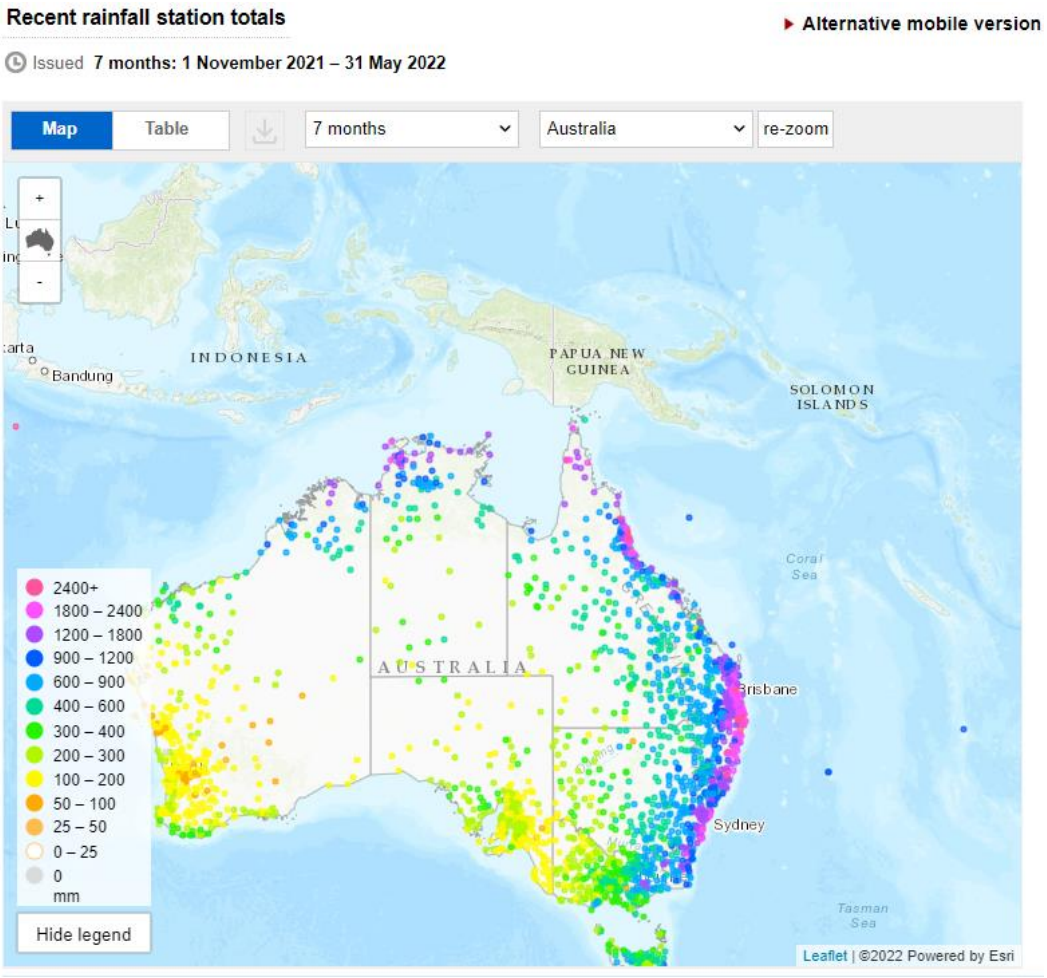
From November 2021 to May 2022, four weather events affected the east coast of Australia. During this period, Southeast Queensland experienced a cumulative rainfall of >1,800 millimeters (Figure 1).

Figure 1. Cumulative rainfall between Nov. 2021 and May 2022 in east coast of Queensland and Australia wide (Australian rainfall update (bom.gov.au)).

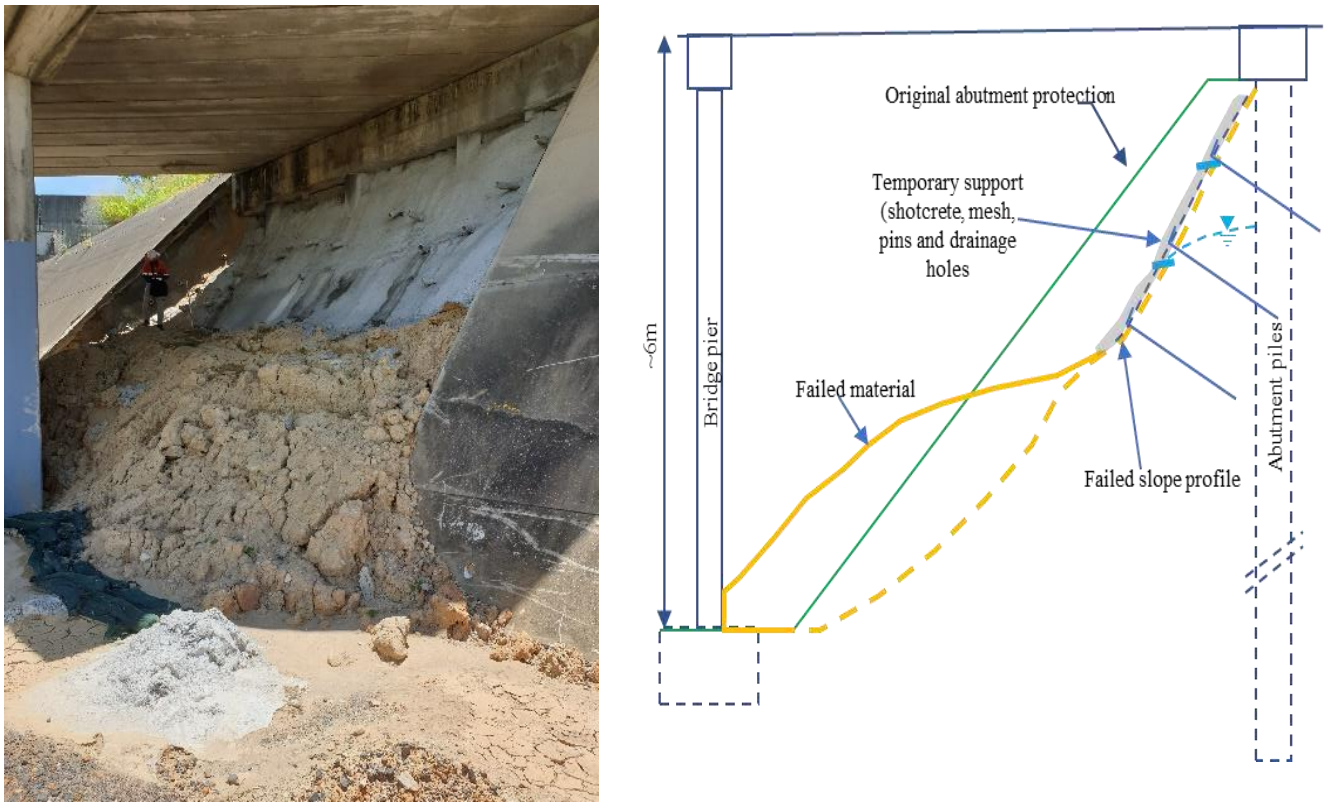
Due to a forecast of further rainfall in the days following the failure, there was an urgent requirement to making the abutment safe and prevent further slips from the exposed surface. The following immediate and urgent mitigation measures were implemented within 24 hours (Figure 3):

Figure 3. Temporary remediation (shotcrete with mesh, drainage holes, and driven pins) installed within 24 hours of the failure. The sketch illustrates the slope profile and temporary remediation installed. Seepage continued to occur two meters below the headstock at a reducing rate.

- Removal of failed material from batter face and abutting against slope toe to provide passive support.
- Installation of two rows of 1-m long drainage pipes.
- Installation of three rows of 2-meter long, 20-millimeters diameter cogged steel reinforcement bars (driven) at 1-meter spacing.
- Application of 160 millimeters (average) thick shotcrete with SL82 mesh.
- Closure of one lane on the road below with temporary traffic lights with contra flow.
- Risk management advice included daily inspections of the site (to later be reduced to weekly, granted there were no further movements) and checks after rainfall events.

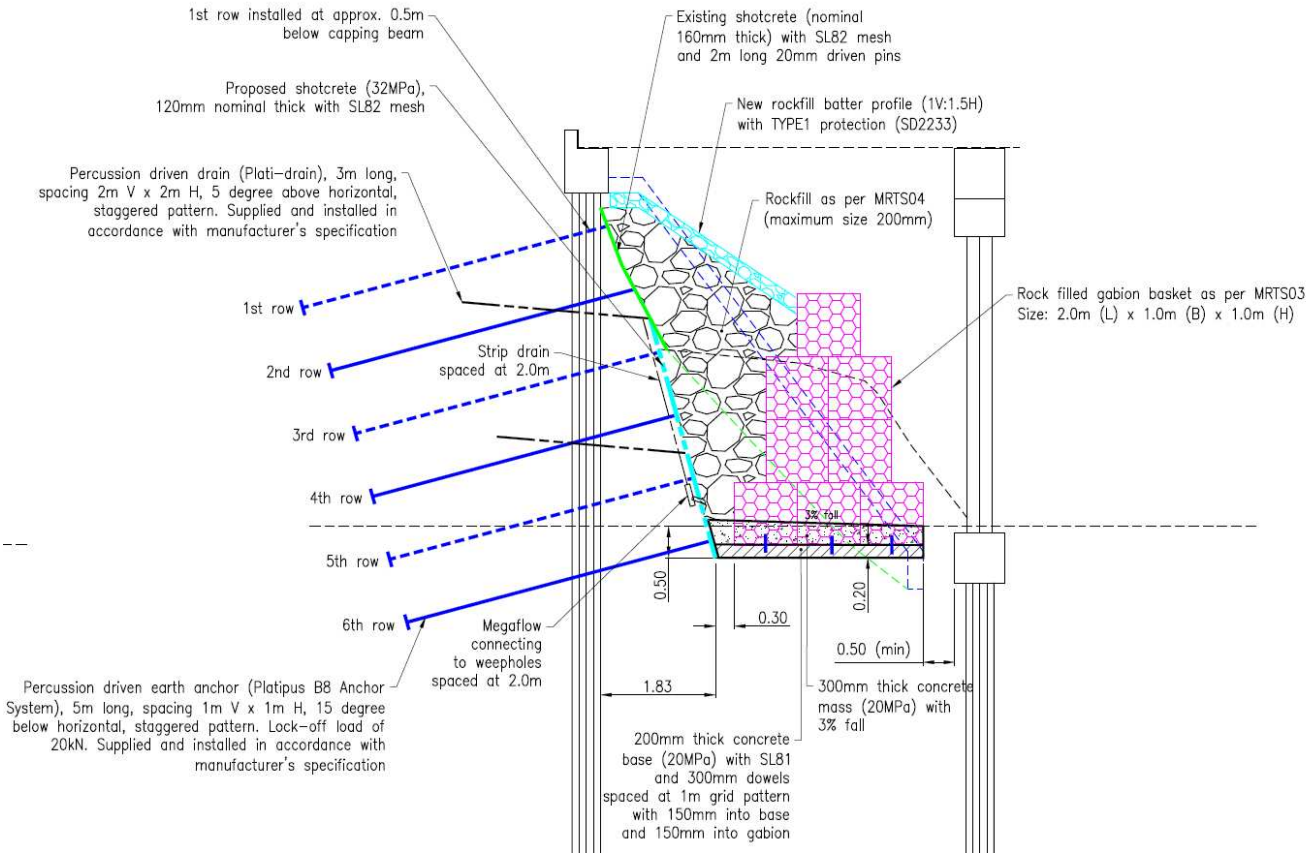
Figure 4. Permanent remediation of the bridge abutment.

To retain abutment stability during excavation to install permanent support, the following temporary measures were included:

- Installation of percussion anchors (300 millimeters wide head, 20 kilo Newton lock-off load) via slots cut into existing shotcrete (urgent works) at 1 meter vertical and horizontal spacing in a staggered pattern.

- Staged excavation at 1.2 meters lifts, followed by installation of percussion anchors, mesh and shotcrete, a row at a time until the toe of excavation was reached for formation of foundation for gabion.

- Installation of percussion drainage (three meters long by two rows at two meters staggered spacing).

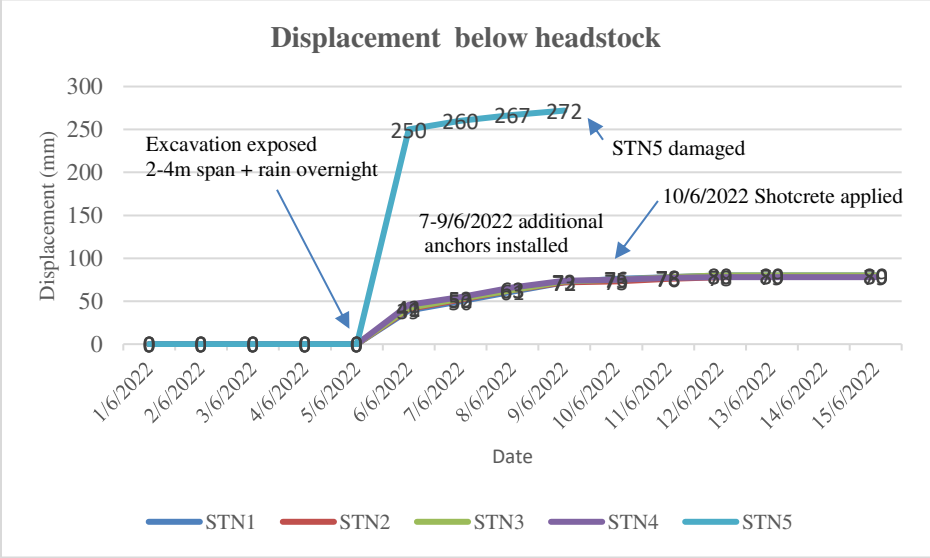
The excavation, anchor installation, and shotcrete application progressed well for the first three rows of anchors, after which, the contractor inadvertently excavated to full depth not following the support sequences specified in the design drawings. This resulted in the exposure of the slope face between 2-4 meters high without full protection. Consequently, approximately, 0.5 meter thick soil movement occurred behind the highest exposed face (Figure 6) with displacement of 250 millimeters in shotcrete below the headstock. On the same day, 13 millimeters of rainfall exacerbated the movement. Additional rows of anchors and steel mesh were installed to stabilize the movement. As a precautionary measure, the highway speed was also reduced to 60 kilometers per hour to minimize any vibration-induced movements. Surveillance was also increased to ensure safety was not compromised. The rate of the movement reduced after the installation of additional support measures and ceased two days after shotcrete application was completed (Figure 7).

Figure 7. Displacement (mm) in shotcrete below headstock. Station 5 (STN5) located on far right. Displacement ceased two days after shotcrete application.
