Geological Engineering Reconnaissance of Damage Caused by the October 15, 2006 Hawaii Earthquakes

Edmund W. Medley, Senior Consultant, Geosyntec Consultants Inc., Oakland, CA, USA, Email: emedley@geosyntec.com

KEYWORDS: Geological Engineering, Hawaii, Earthquake Damage, Rock Mass, Basalts, Rock Block Structures

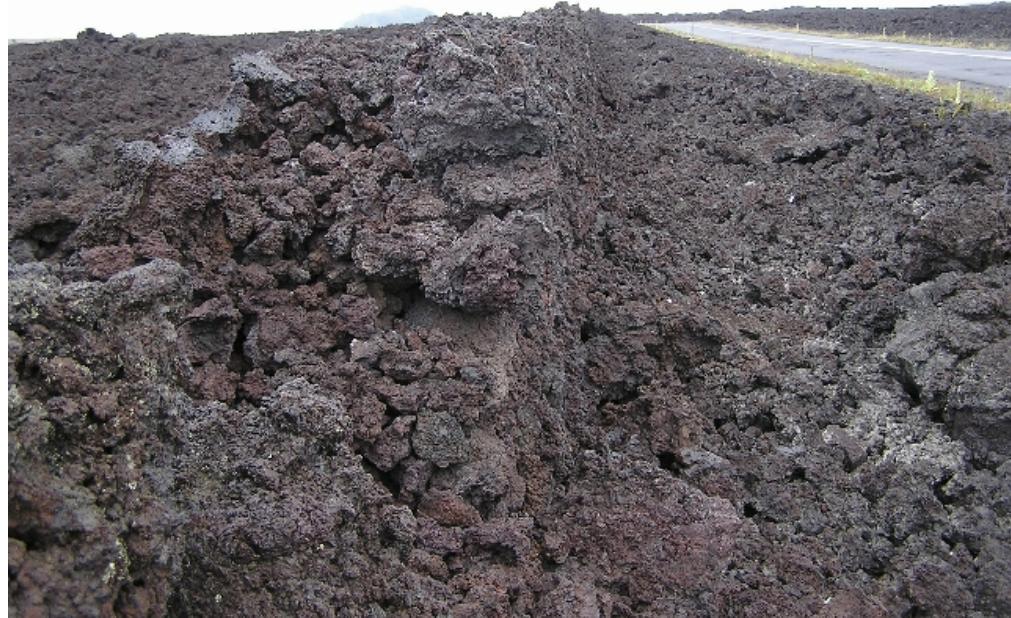
Figure 9. Location 11, Saddle Road (Hwy 200). Lava flow of a'a clinker and dry stacked wall of clinker composed of a'a blocks.

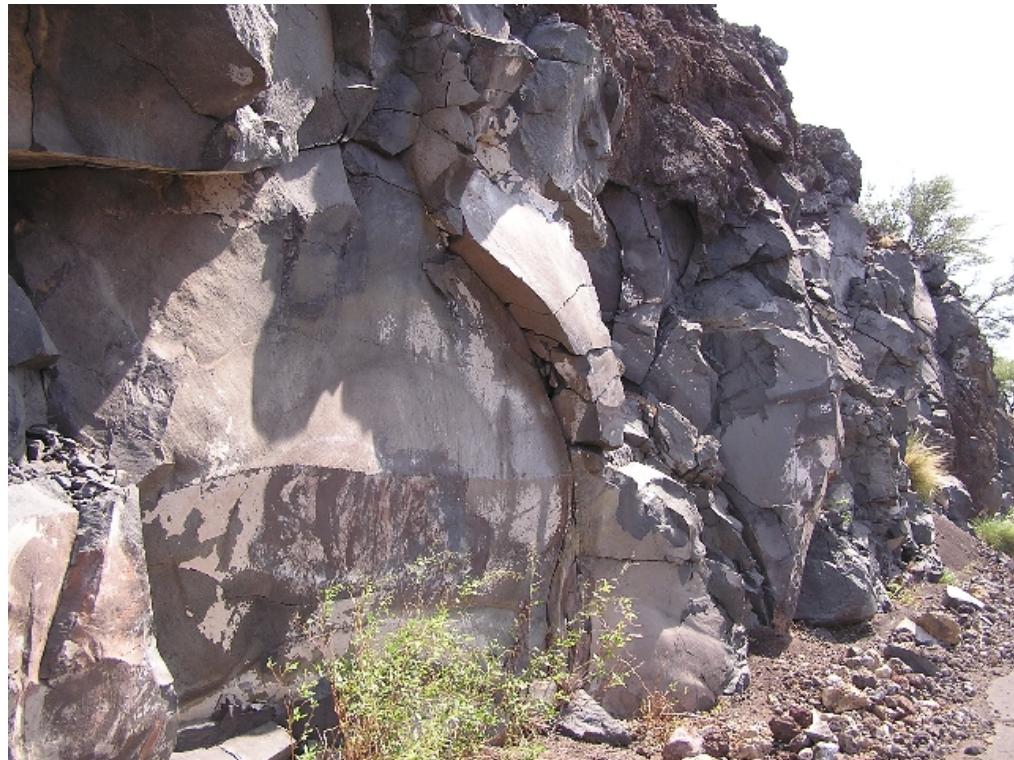
Figure 10. Location 32, road cut at Hwy 11. Massive basalt in a'a flow.

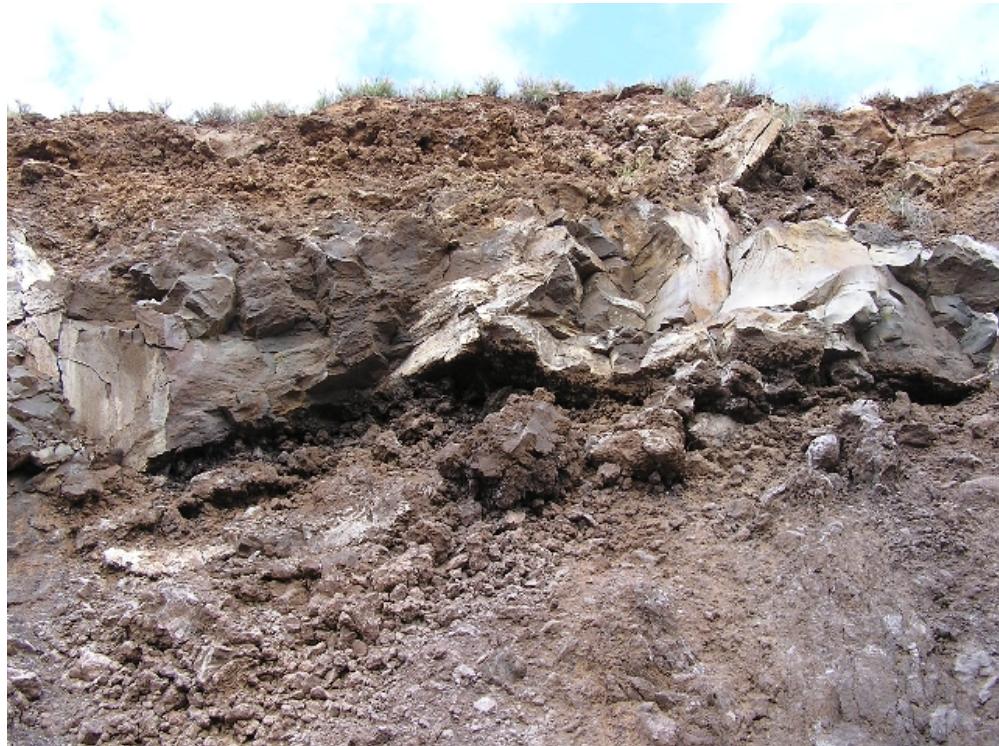
Figure 12. Location 2, near Kohala Ranch Estates, Hwy 270. View from road of excavation in mixed massive a'a and clinker. See stereo 3-D photographs of Figure 13 and Figure 14.

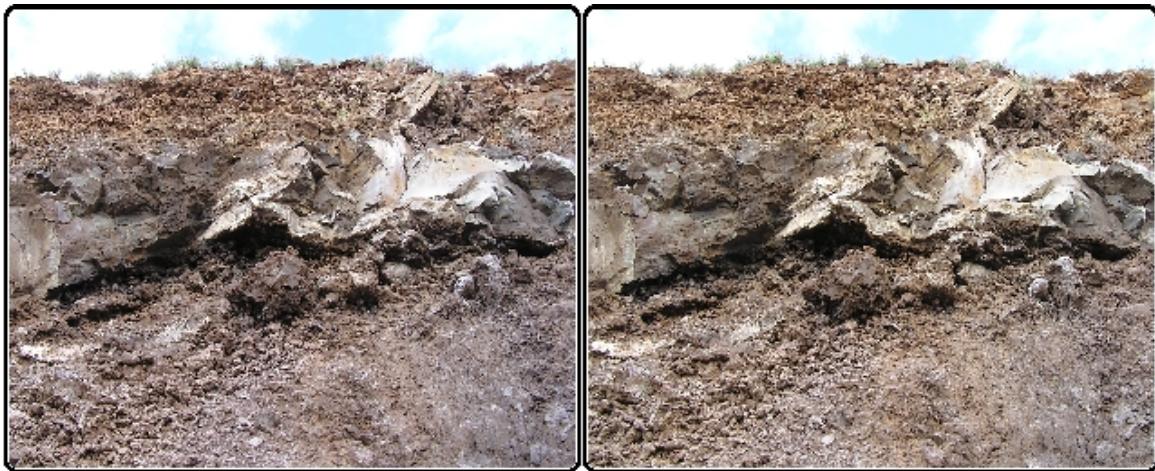
Figure 13. Location 25, near Kohala Ranch Estates, Hwy 270. 3-D stereo pair version of Figure 12. Road cut in mixed massive a'a and clinker.

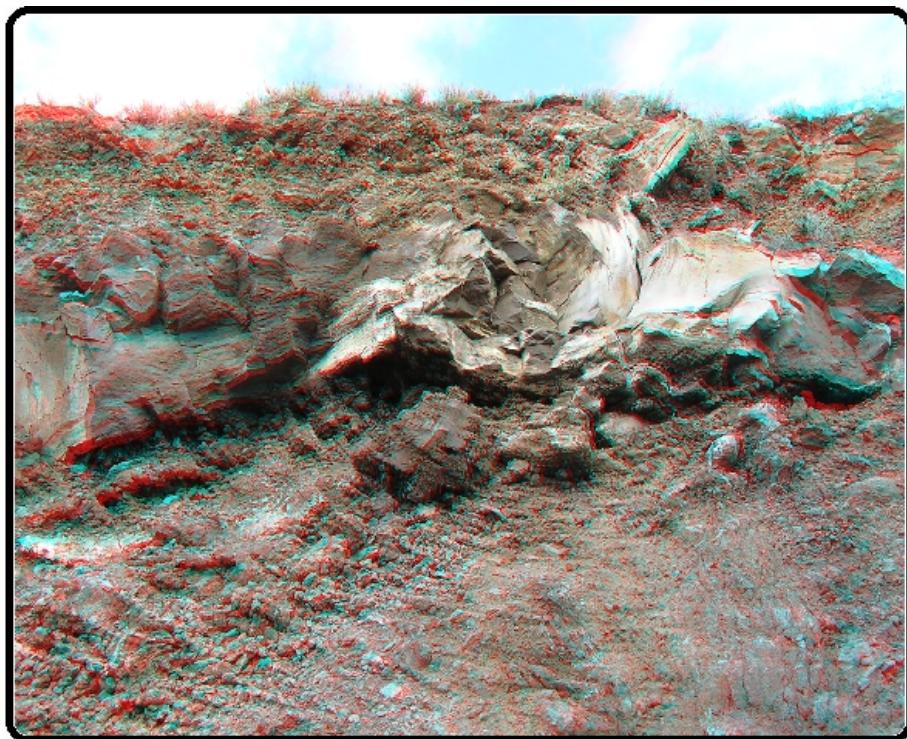
Figure 14. Location 2, near Kohala Ranch Estates, Hwy 270. Anaglyph 3-D image version of Figure 12. Road cut in mixed massive a'a and clinker.

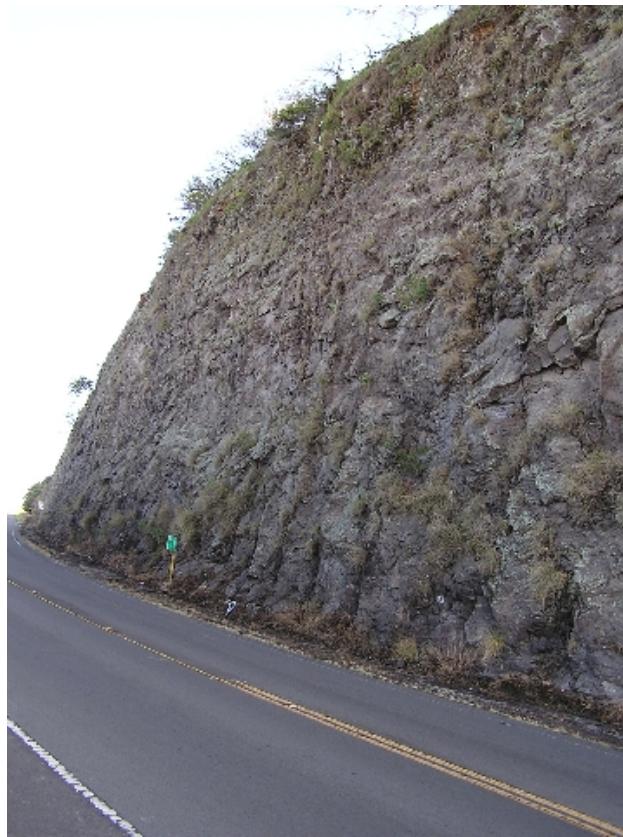
Figure 21. Location 13, Milepost 8, Hwy 250. Stable steep and high road cut.

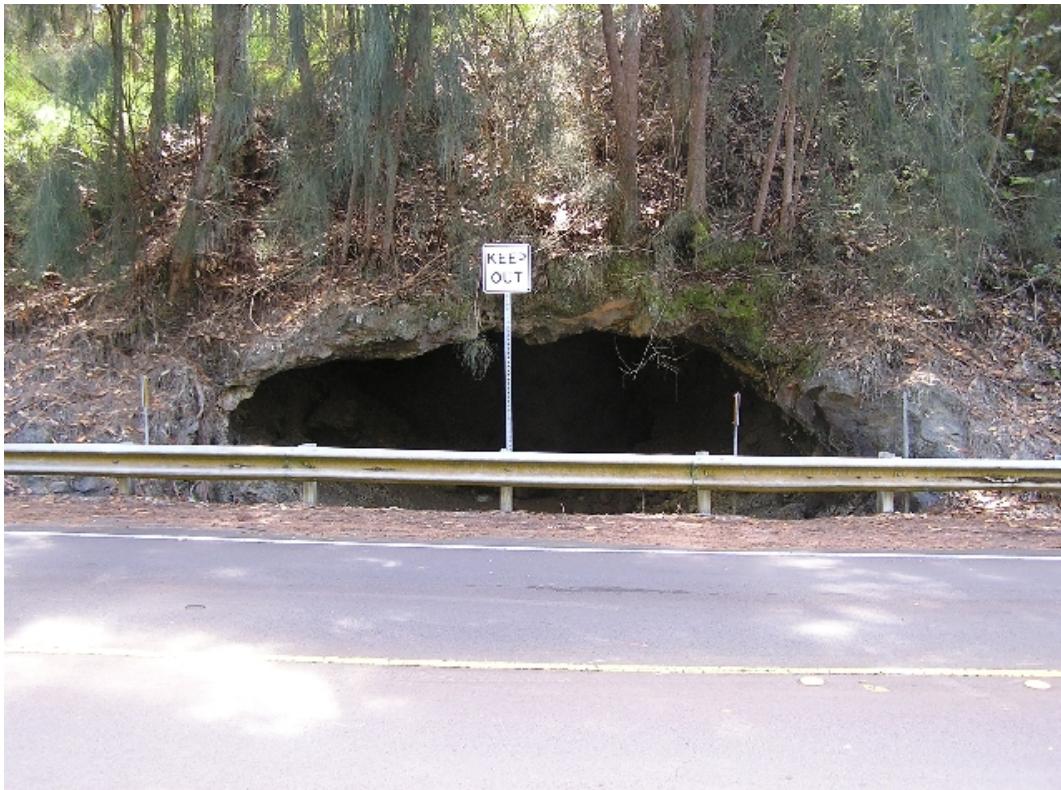
Figure 23. Location 7, Hwy 240, near Kapulena, north of Honokaa. Lava tube with apparently little rock fall from roof and walls.

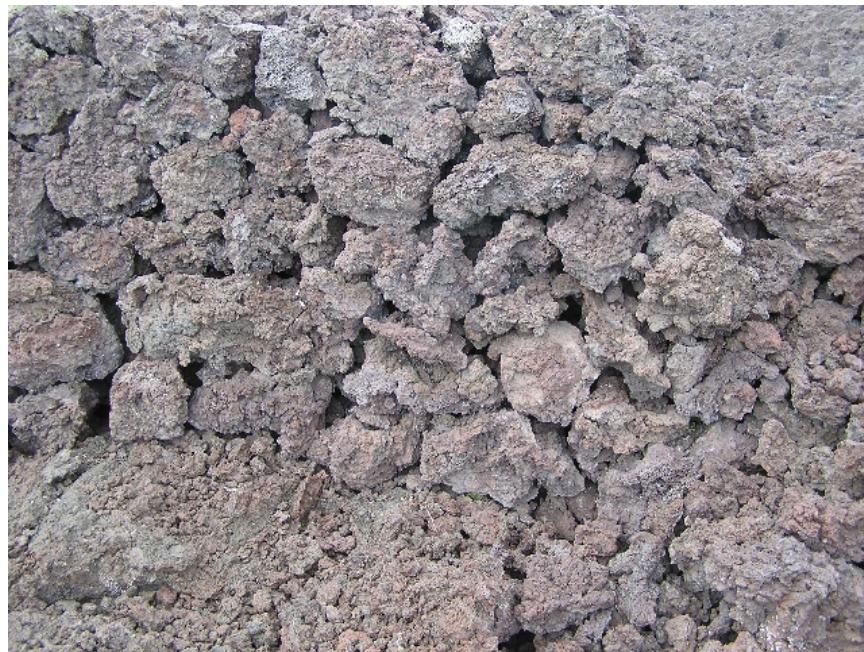
Figure 40. Location 11, Saddle Road (Hwy 200). Stacked rock wall of a 'a clinker.

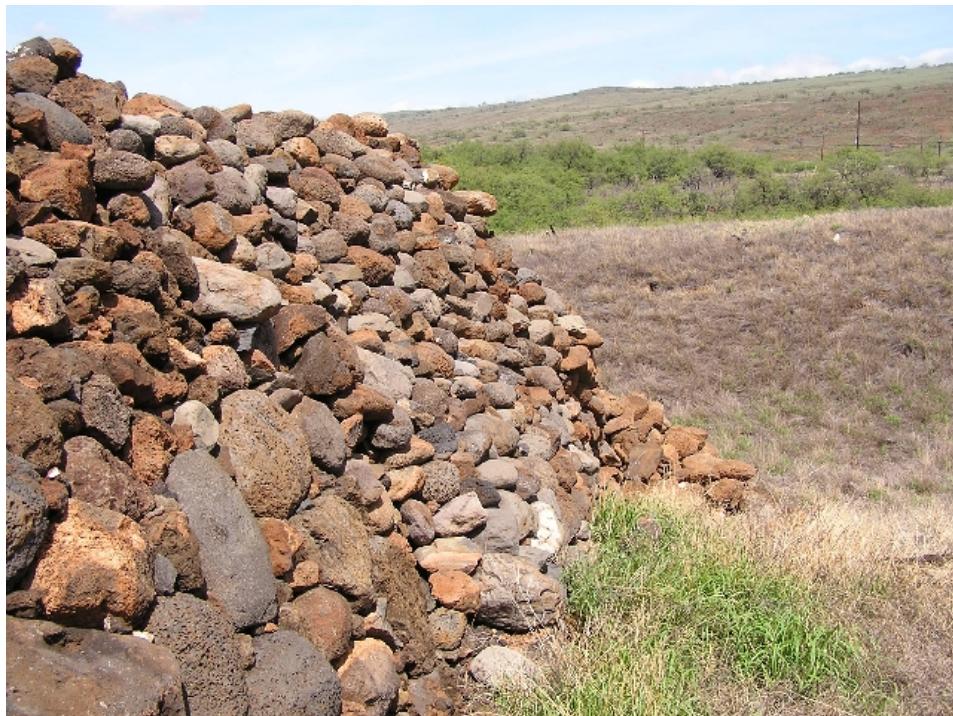
At the Mailekini and Pu'ukoholā heiaus damage in the form of slumps and raveling of the wall was observed that seemed to roughly match the behaviors described by Medley and Zekkos (2007). Many wall bulges were observed at originally steep wall faces (40 to 50 degree inclinations, Figure 52) resulting in further steepening of the wall faces near the bottom of the edifices (Figure 53; stereo Figure 54 and stereo Figure 55) although it is likely that some bulging had occurred before the earthquakes. Many wall bulges were observed where the slopes approached vertical (Figure 53), which suggests vulnerabilities to increased rock face instability and eventual collapse from future earthquakes or creep deformation. Some slumps and raveling of the wall faces occurred where the bulges over-steepened and collapsed (Figure 56, Figure 57; stereo

figure 58 and stereo Figure 59). The slumps apparently occurred in much the same fashion as sketched in Figure 60. The angle of repose for the slumps was about 30 degrees, with run-outs extending to more than 5 m from the original toes of the walls (Figure 52 and Figure 56).

Figure 52. Location 29, NE corner Mailekini heiau. In foreground: typical intact face inclined at about 50 degrees. In background, toe of raveled face shown in Figure 56.

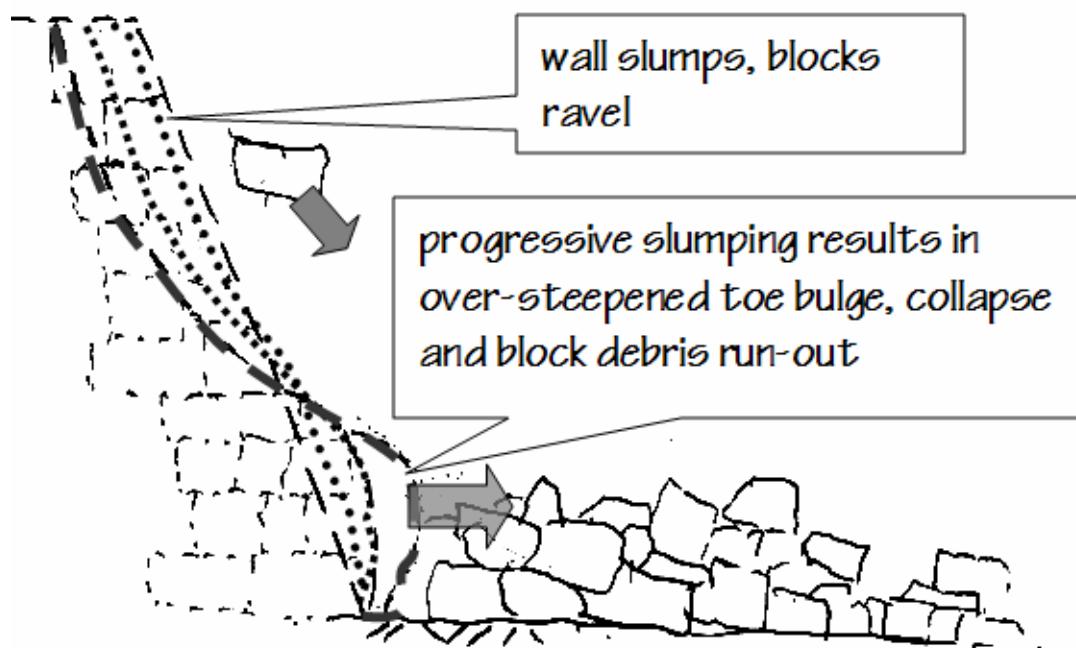
Figure 60. Raveling, bulging and slumping of the face of a rock block edifice (Medley and Zekkos, 2007).
