Quarry-Induced Slope Instability at a Broadcasting Transmission Plant near Valcava, Lombardia, Italy

Monica Barbero, Assistant professor, Politecnico di Torino (Torino, Italy); email: monica.barbero@polito.it
Fabrizio Barpi, Assistant professor, Politecnico di Torino (Torino, Italy); email: fabrizio.barpi@polito.it

ABSTRACT: Since 2006, a broadcasting tower and ancillary buildings on the top of a hill adjacent to a large, active limestone quarry, in northern Italy near the village of Valcava, has been heavily damaged by ground deformation due to slope instability. In 2005, the quarry began to work the slope toward the broadcasting plant, releasing bedding planes that affected the tower site: a number of fractures occurred in the warehouse and in the ground around it, that grew particularly during significant rainfalls. In October 2006 a landslide occurred in the quarry area, close to the broadcasting site. In order to understand what induced the fracture process in the buildings and define a support system to stabilize the broadcasting site, a detailed geotechnical survey and a number of numerical slope stability analyses were carried out. One of the main goals of the paper is to

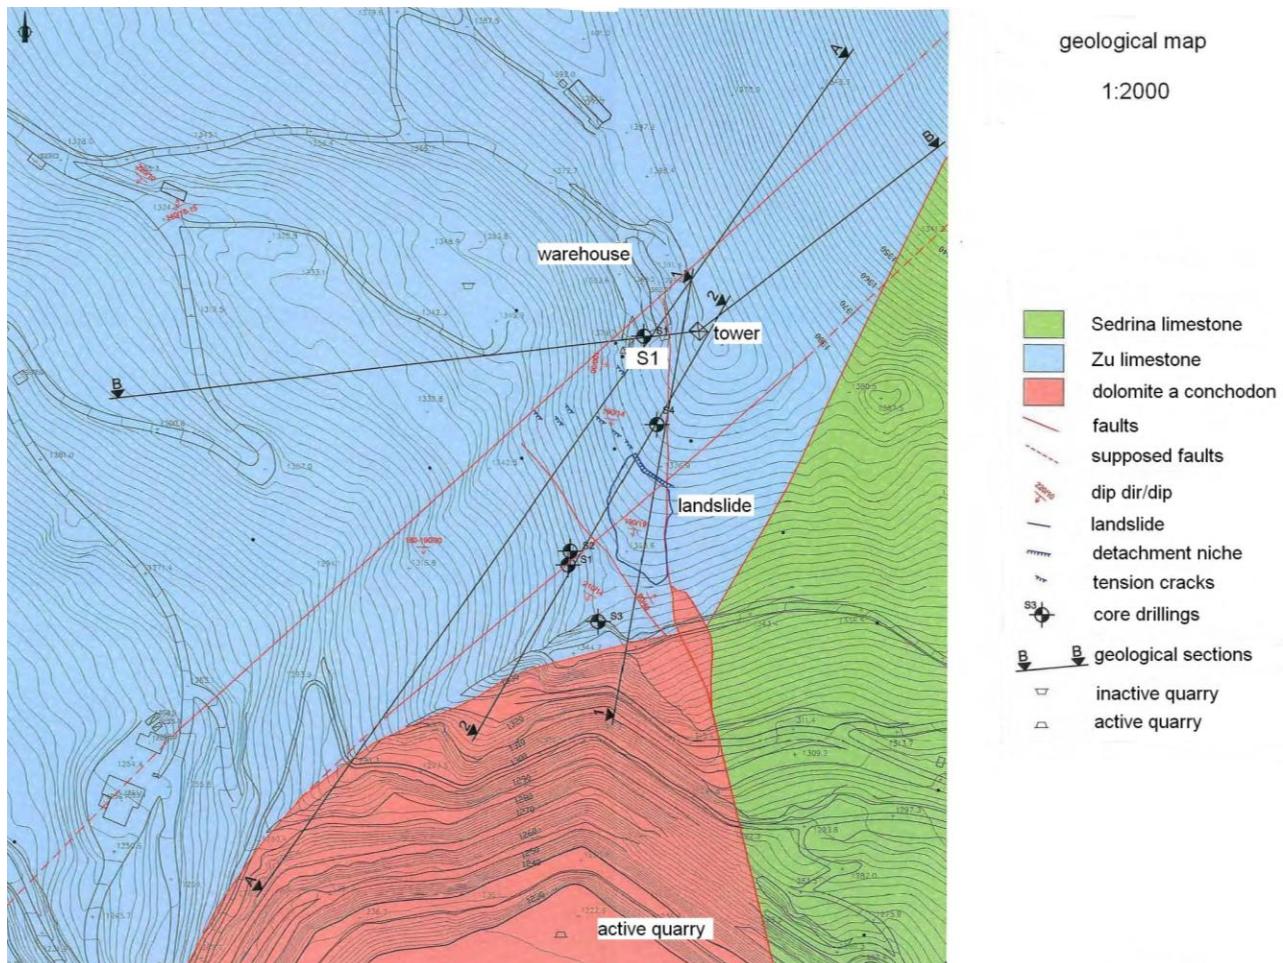
Figure 1. Geological map of the site.

The analysis of the geological map (Figure 1) and the results of the geological survey concluded that:

3. Fault A marks the eastern boundary of the landslide in the pit area. This involves a 30 m slope height and has a crown length of about 35 m;
4. In the west side of the edge and in the toe of the landslide, many opened cracks were observed, suggesting that the instability phenomenon is not completed yet and potential landslide progression toward the plant is possible;

A drill core was taken from a 45 m deep hole drilled adjacent to the building (labeled S1 in Figure 1), near the top of the slope (about 1392 m asl). The core drilling analysis allowed to define the rock mass stratigraphy. Four main geological levels were observed, from the plane of the site: a 3 m thick layer of filling material, about 11 m thick eluvium-colluvial sheet, highly fractured limestone until the depth of about 20 m and limestone bedrock. In situ observation of the main scarp depth suggested that the movement occurred at a depth of about 16 m. Comparing these data it was possible to assert that the contact between the 20 m deep weaker layer and the undamaged bedrock is a preferential sliding zone. At the depth of about 20 m, a cavity with air inside was found, indicating the absence of water bed above the depth of 20 m.

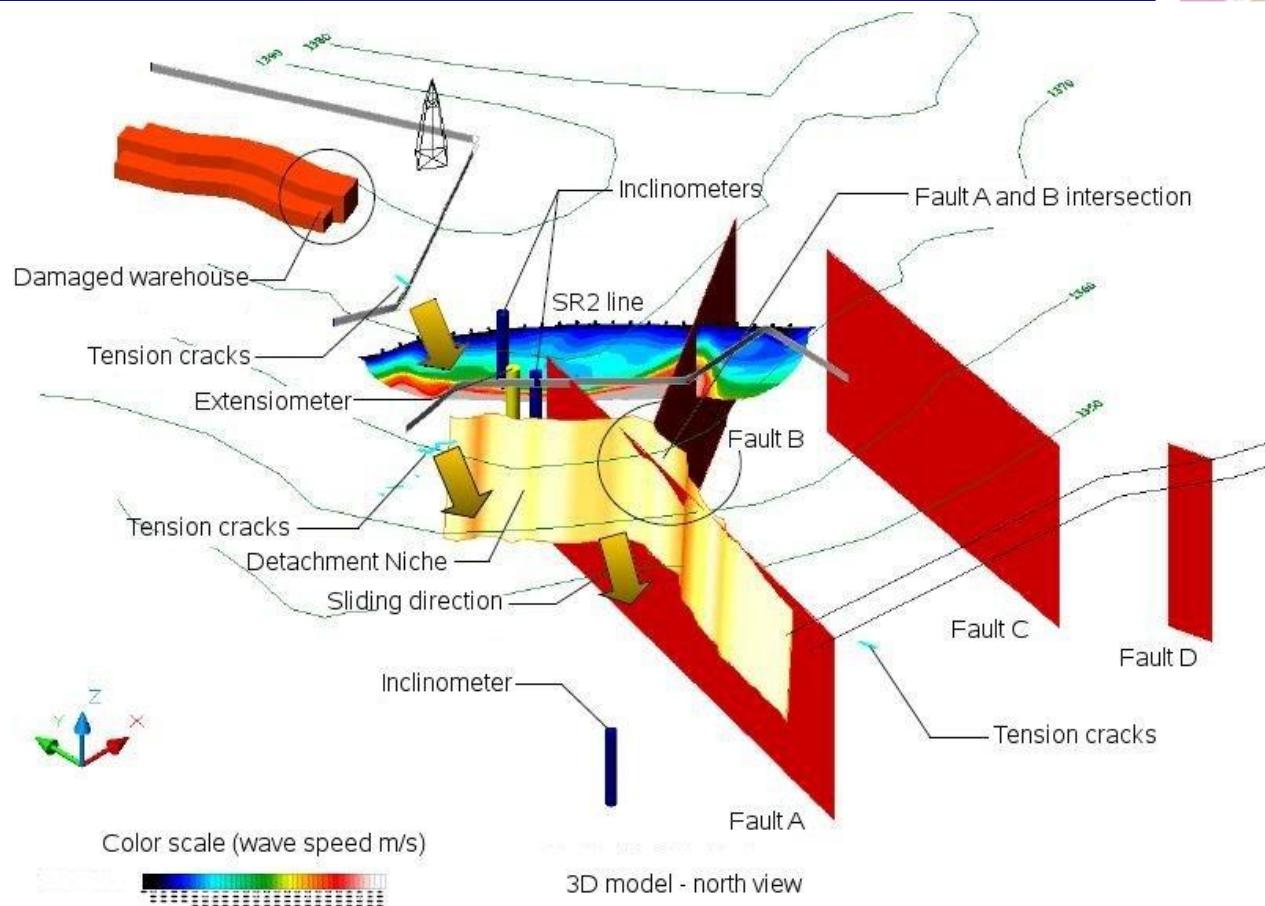
One seismic refraction and two geo-electrical soundings were located near the warehouse on the unstable slope, toward the pit. Another pair of seismic and geo-electrical outlines was located close to the broadcasting tower base (Figures 6 and 7). The data were processed with tomographic technique (Hampson & Russel, 1984; Olsen, 1989) and then interpreted considering the conventional exploration with core-drilling data. Similar results were generated in the slope and in the tower area. Upslope of the warehouse, in the tower area, there is a superficial layer of fill about 3 m deep, underlain by a layer of fractured limestone overlying apparently intact bedrock at a depth of about 16 m, as shown in Figure 8. Near the warehouse, upslope from the landslide, a pit showed the same stratigraphic sequence is observed in the tower area, as well as evidence of the two main faults A and B (Figure 9). Because of fault B, the apparently intact limestone is found at a depth of more than 20 m. The seismic survey thus confirmed the likelihood that the sliding surface was located above a depth of 20 m.

The results of the field surveys have shown that many natural weakness elements affect the site. Fault A marks the east boundary of the landslide. Its intersection with fault B (Figures 6 and 7) induces heavy fracturing in the limestone to significant depths contributing to the instability of the area. The downslope dipping bedding planes predispose the slope to sliding and the two sub-vertical sets of discontinuities can become preferential paths for water percolation.

Figure 7. Three dimensional model for the seismic and geo-electrical survey.

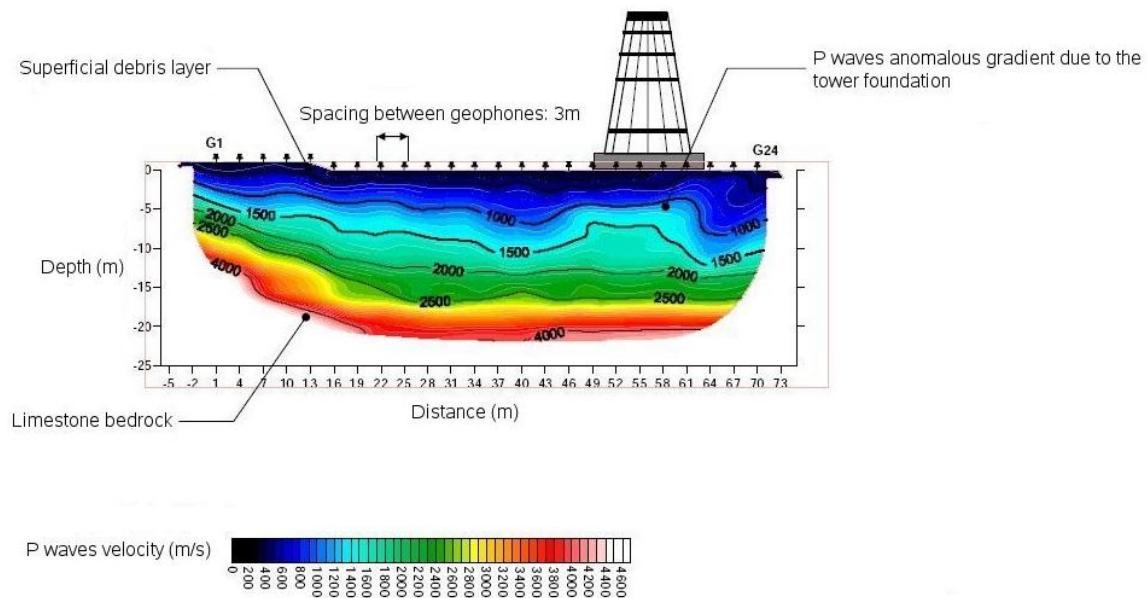
Figure 8. Seismic refraction survey results: P waves velocity trend inside the rock mass near the broadcasting tower.

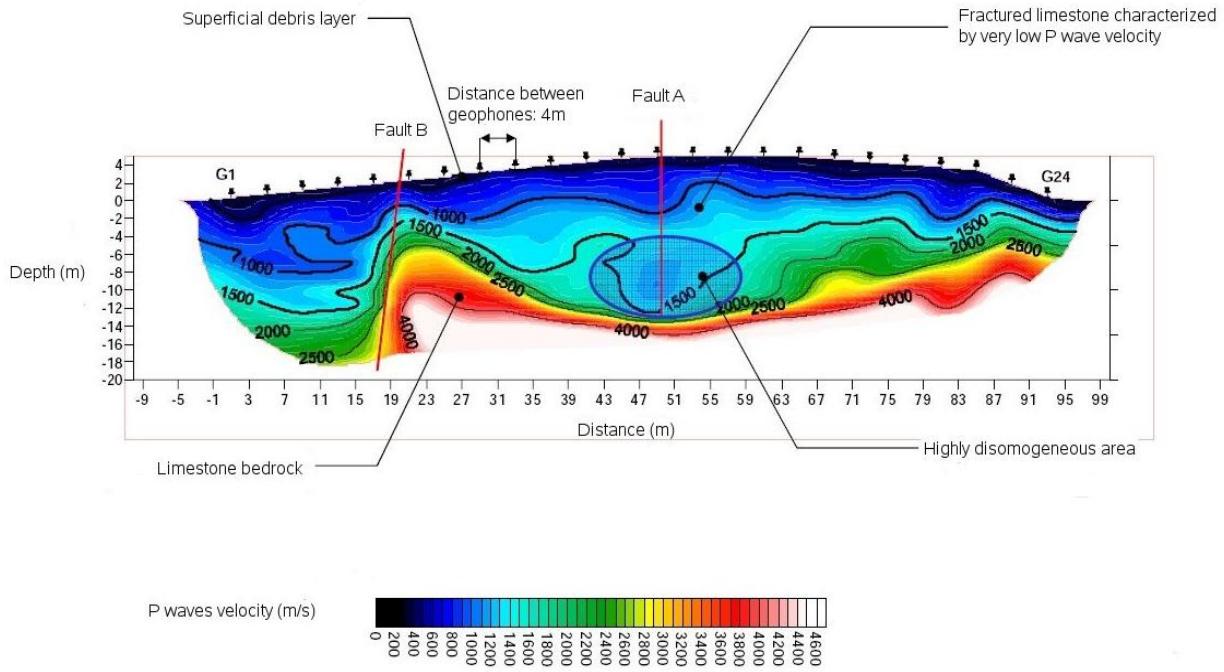
Figure 9. Seismic refraction survey results: P waves velocity trend inside the rock mass, below the warehouse area.

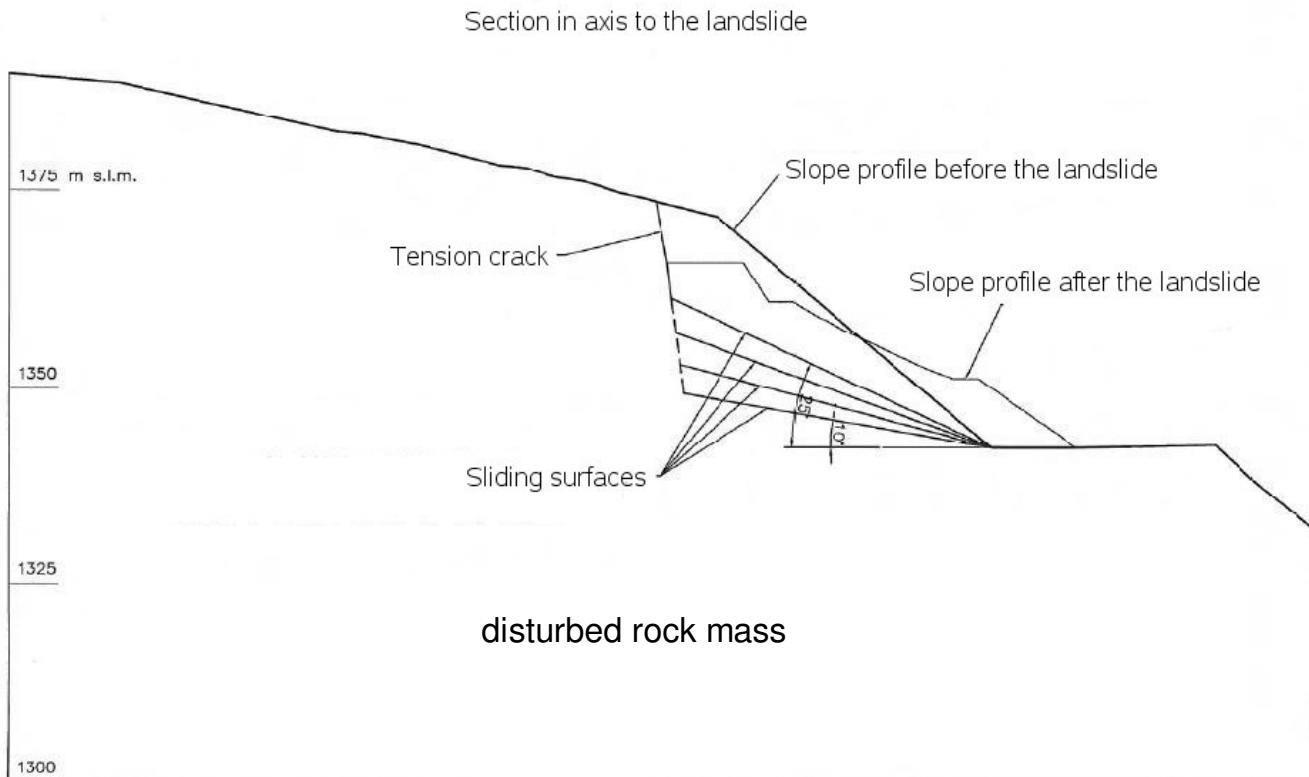
The stability analyses were carried out by using the limit equilibrium method (Janbu solution) implemented in SLOPE-W (Geo-Slope International, 1998). A section in the middle of the landslide was considered for the analyses (Figure 10). The model is constituted by a single material, characterized by disturbed rock mass mechanical parameters. The anisotropic function was used to introduce Mohr-Coulomb parameters, obtained by the linearization of the Barton-Bandis criterion, along the sliding surfaces. The parameters listed in Table 4 have been considered.

Figure 10. Slope section used for the limit equilibrium analyses (Slope-W).

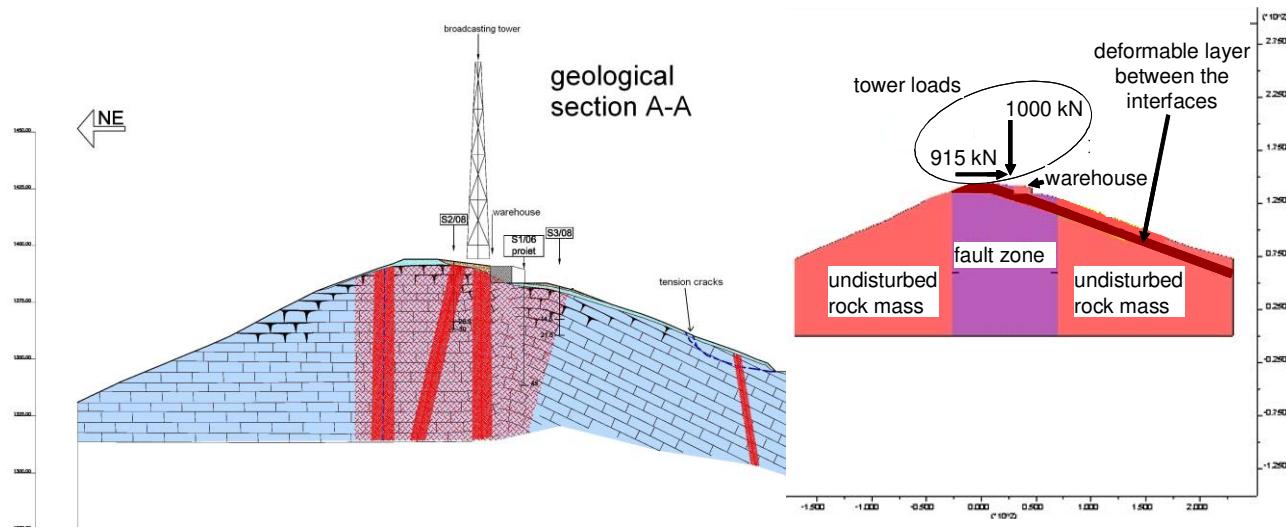
A section of interest was modeled (section A-A in Figure 1 and Figure 11, left), in the NE-SW direction, between the broadcasting site and the pit, across the zone in which tension cracks were observed and close to the landslide. According to the geotechnical characterization, two materials with different mechanical characteristics were used in the model: one to represent the fractured fault zone in the central part of the model, below the broadcasting plant, and the other to simulate the undamaged rock mass.

An ideal elasto-plastic model was considered for the rock mass, the interfaces and the ubiquitous joints. Plane strain conditions were assumed in 2D analyses. The strength and deformability parameters used in the numerical analyses, defined by the geotechnical characterization (minimum values), reduced by a partial safety factor of 2 for the cohesion and 1.25 for the friction coefficient, are collected in Table 5. The model was discretized with quadrangular, four-nodes plane elements; the presence of the warehouse on the top of the slope has been simulated using quadrangular elements with linear elastic behavior (unit weight: 10 kN/m³, elastic parameters equal to those of the undisturbed rock mass). A vertical force of 1000 kN and a horizontal force of 915 kN were applied on the top of the slope, to simulate the broadcasting tower loading, according to the tower design data (Figure 11, right).

Figure 11. Geological section A-A (left) and model for numerical analyses (right).

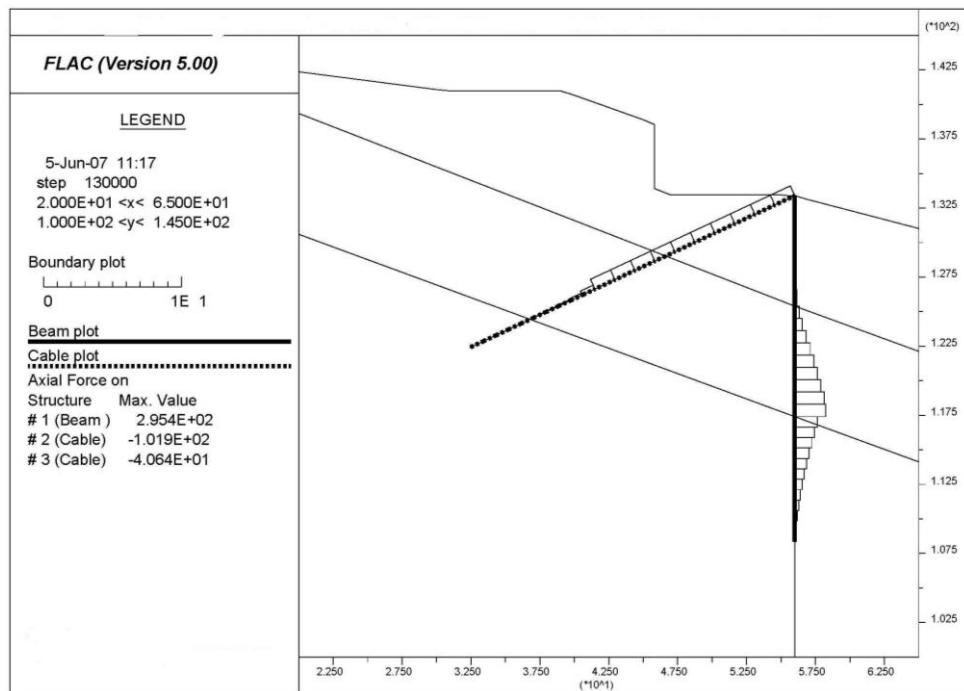
Figure 17. Axial forces acting on micropiles and anchors.

numerical analyses provided the normal force, bending moment and shear force acting on the micropiles and the axial forces acting on the anchors (Figures 17, 18 and 19). These results were used to design the steel elements.

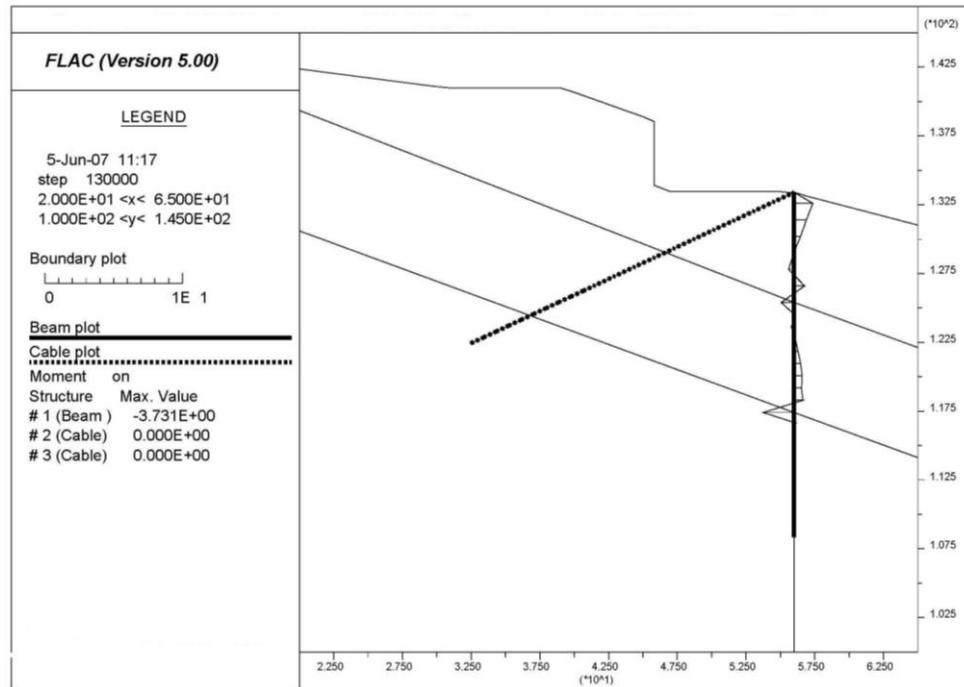
Figure 18. Bending moment acting on micropiles.

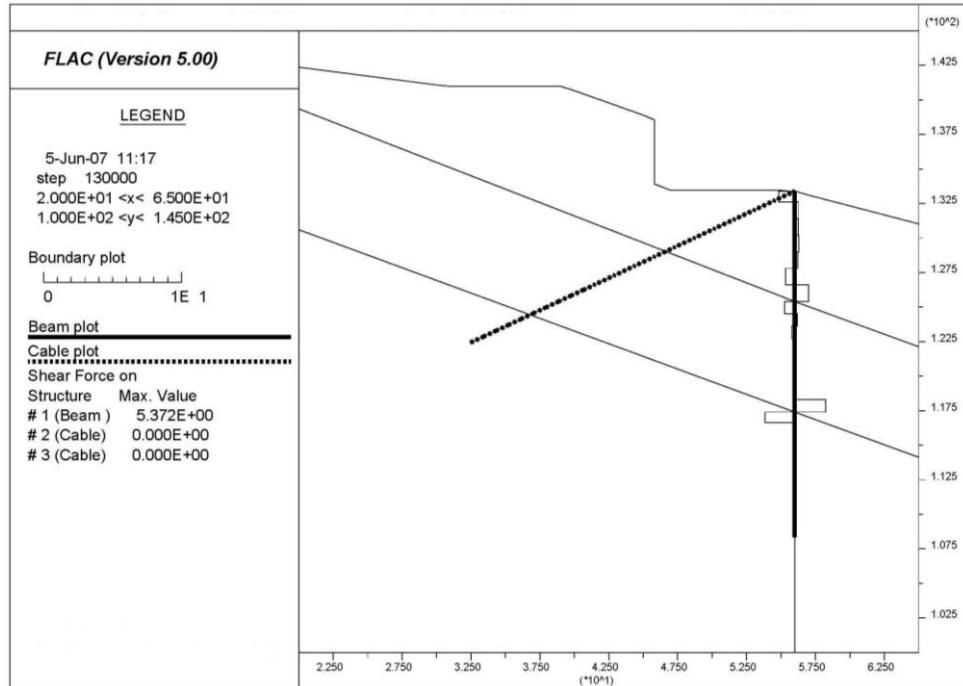
Figure 19. Shear force acting on micropiles.
