Embankment Failure in Residual Soils at Nivsar, Ratnagiri

Reference: Juneja, A., Chatterjee, D., and Kumar, R. (2013). *Embankment Failure in Residual Soils at Nivsar Ratnagiri*. International Journal of Geoengineering Case histories, <http://casehistories.geoengineer.org>, Vol.2, Issue 3, p.229-251. doi: 10.4417/IJGCH-02-03-04

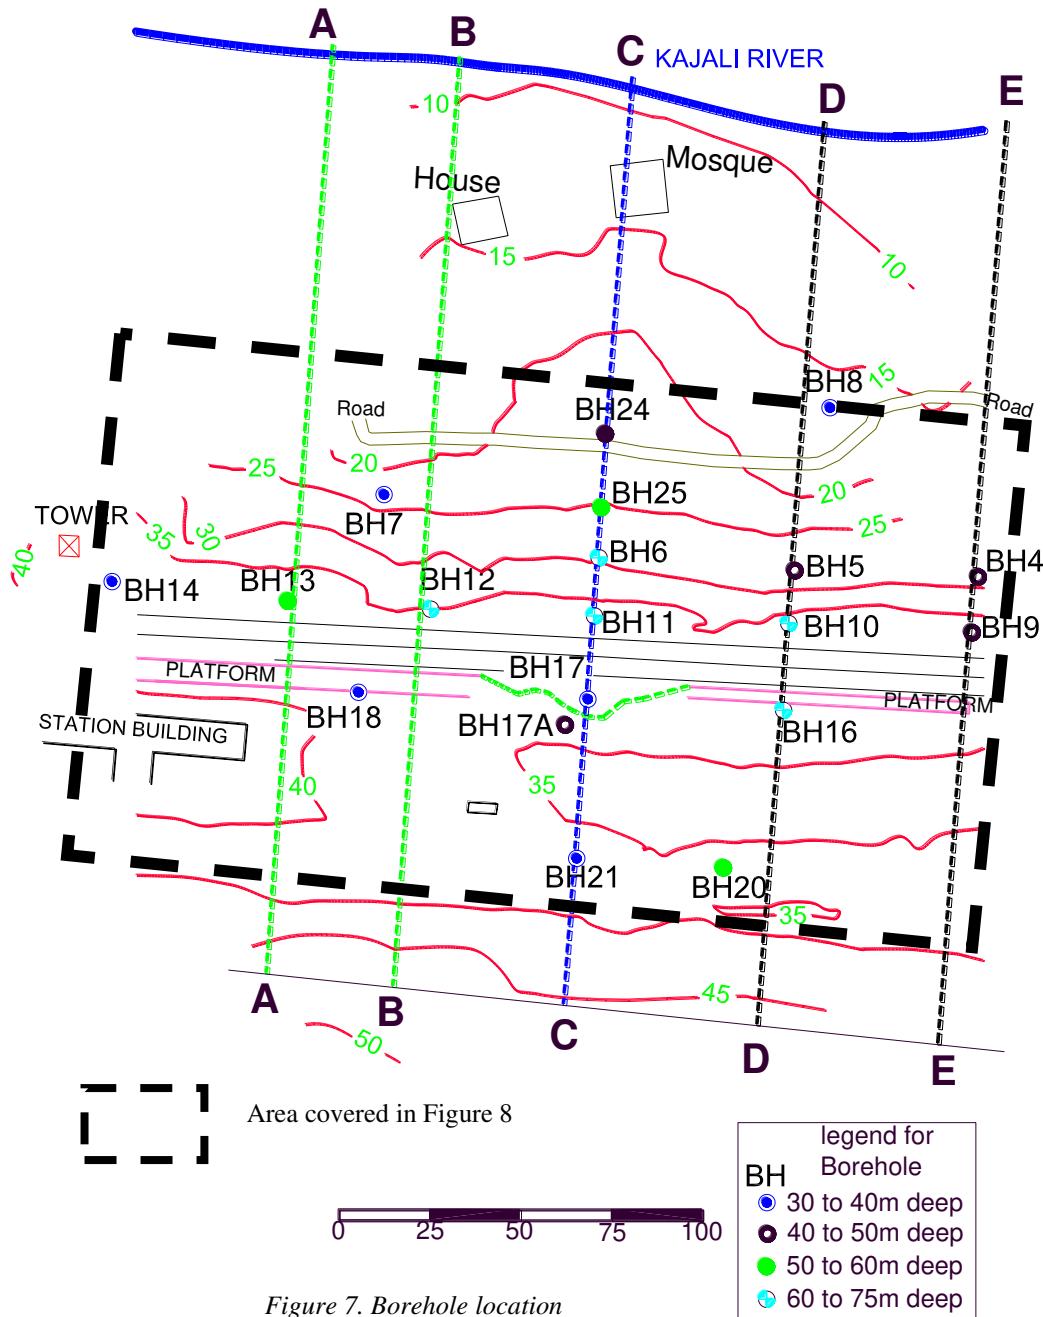
Figure 7. Borehole location

Geotechnical data was collected from 19 boreholes drilled at the top and bottom of the embankment. These boreholes were drilled in the year 2010. Figure 7 shows the location of the boreholes. All boreholes, except for BH-20 and BH-21, were

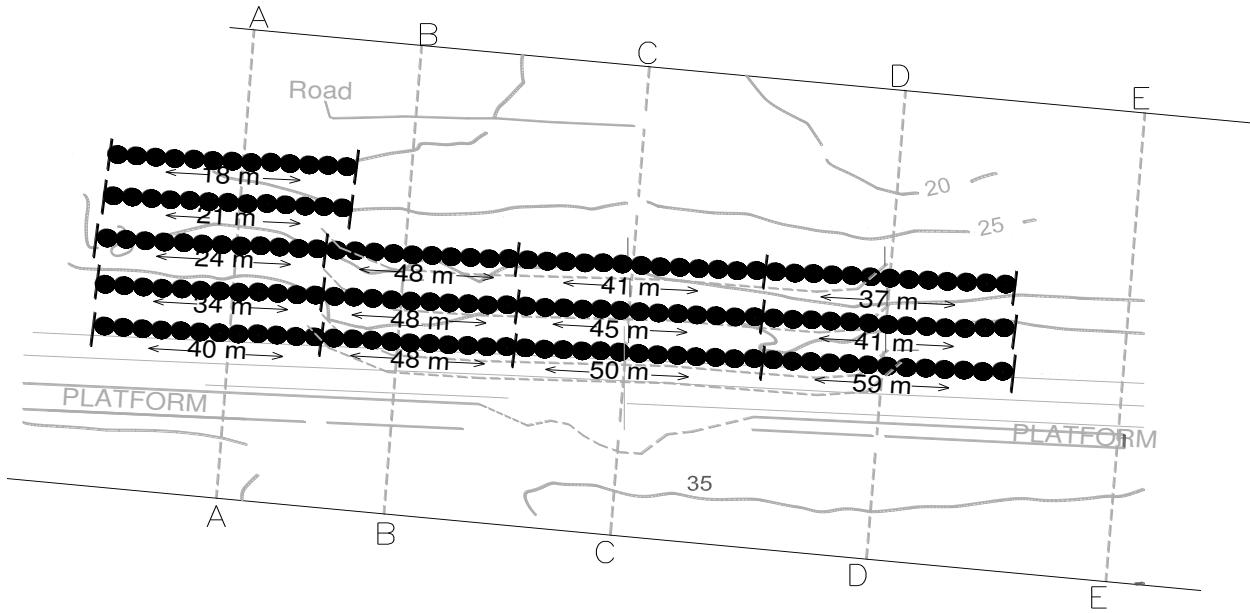
Figure 16. Schematic layout of the proposed 1.2m diameter bored pile wall at 1.2m c/c (contiguous bored pile wall). Note: Numbers below the piles indicate length of the piles.

One possible solution to enhance the stability of the slope was with the use of large diameter piles to retain the (failed) soil mass. In this case, safety factors of sections A-A to E-E were also deduced by assuming that the slope was reinforced with single or multiple rows of contiguous bored pile wall constructed parallel to the platform. Figure 16 shows the schematic layout of the proposed bored pile wall. The 1.2m diameter piles terminated below the slightly-to-moderately weathered basalt rock because of which sections B-B and C-C had long piles to provide adequate anchorage (Table 3). Table 9 shows the location and length of the piles used in the analysis. Figures 17a-d show the minimum safety factor and the location of critical circles in sections A-A to D-D for the wet season when the slope is reinforced with contiguous bored pile wall. As can be seen, the minimum safety factor increased up to 1.2 and 1.38 with the use of contiguous bored pile wall.

The cost to use the bored pile wall was over 200 million Indian Rupees (US\$ 3.6 million) and appeared to be prohibitive. As an alternative to this design, the old rail alignment was removed and replaced by a new alignment. The new alignment consisted of 3 loop-lines and 1 main-line. Figure 18 shows section C-C along with the location of the new alignment. In this section, the top left side of the hill was slightly levelled to accommodate the main line and the loop lines. Section C-C was chosen because the new alignment was closest to the failure surface at this section. The horizontal distance from the vertex of the failure surface and the 4 lines was 16m, 21.3m, 26.2m and 46.4m, respectively. The stability of the slope was then reinvestigated using the computer program Talren-4 (Terrasol 2005). As in the previous case, all the lines were loaded by 125 kN/m^2 . This assumption was unduly conservative in absence of strict guidelines (RDSO 2003b). Nonetheless, it permitted trains with more overtaking opportunities on the passing-loops. The ground water level was modeled using the highest RL recorded in Table 5. The failure circles are shown in Figure 19. As can be seen, the minimum safety factor is

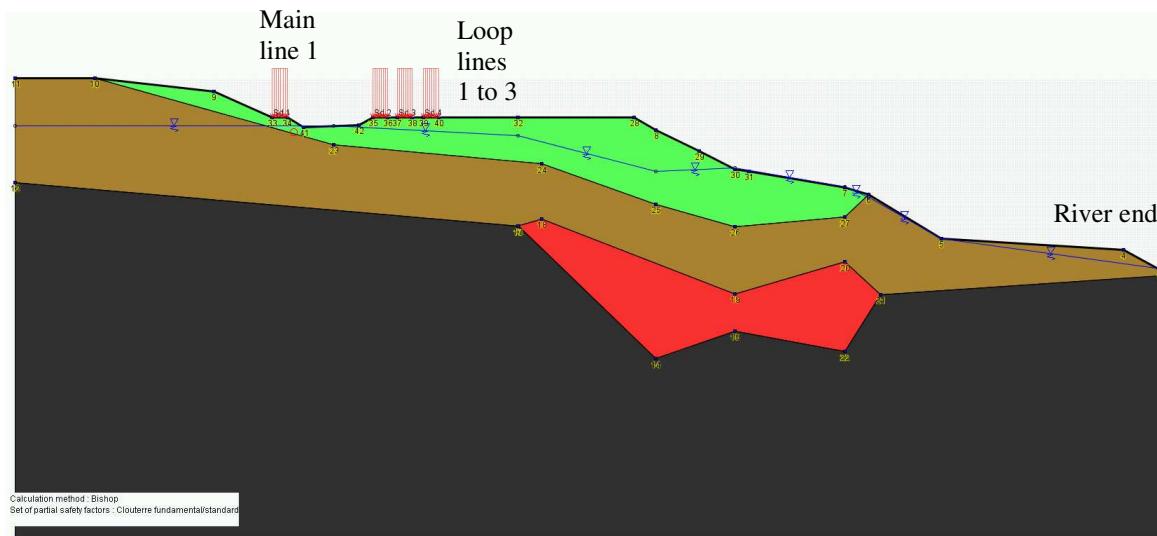
Figure 18. Section C-C with new rail alignment. The main alignment consists of 3 loop lines and 1 main line.
