The May 25th 2011 Railroad Embankment Failure in Ann Arbor, Michigan, As a Means for Teaching Geotechnical Engineering

Reference: Zekkos, D., Athanasopoulos-Zekkos, A., Grizi, A., and Greenwood, W. (2016). *The May 25th 2011 Railroad Embankment Failure in Ann Arbor, Michigan, As a Means for Teaching Geotechnical Engineering*. International Journal of Geoengineering Case Histories, Vol.3, Issue 4, p.234-245. doi: 10.4417/IJGCH-03-04-03

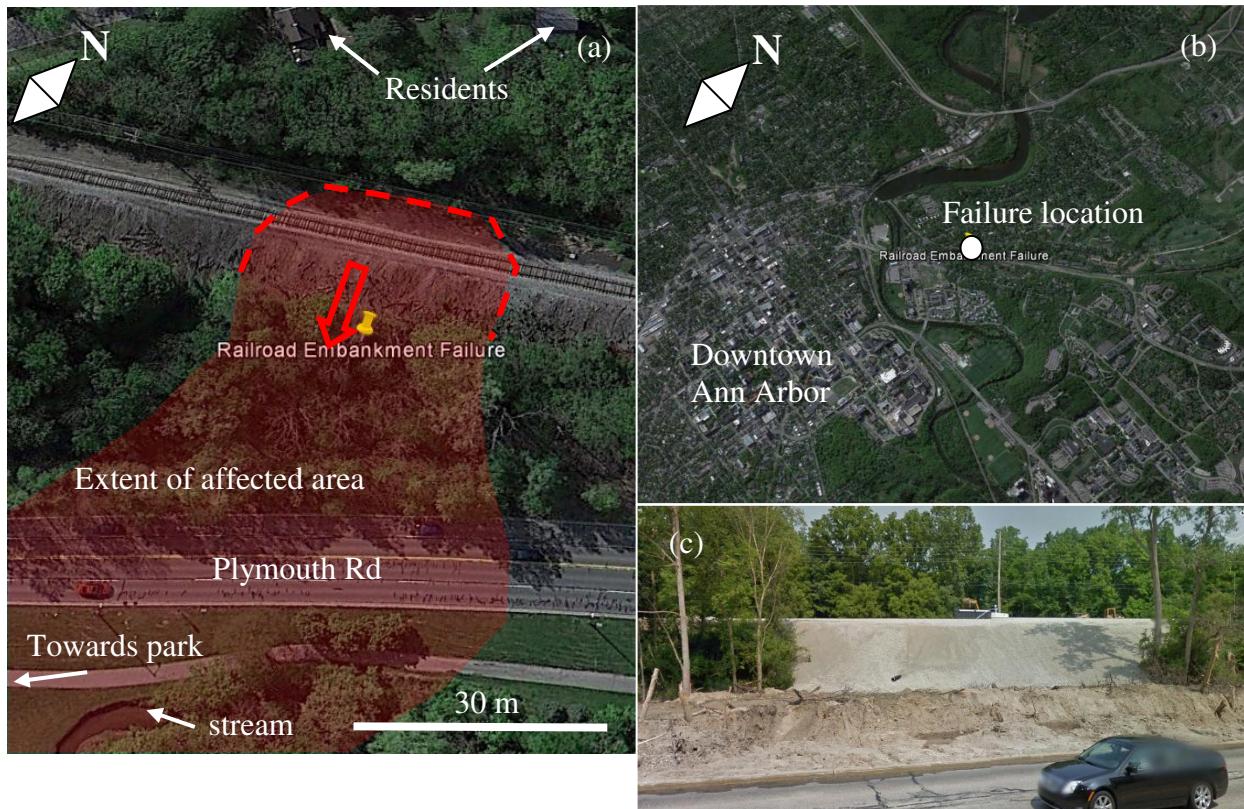
The failure site is located to the north of downtown Ann Arbor in Michigan, USA, as shown in Fig. 2b. The failure took place on the railroad embankment that is heading parallel to Plymouth Rd and adjacent to residential structures. Fig. 3 illustrates an intact portion of the embankment immediately to the East from the failure location. The failure resulted in:

Figure 2. (a) Satellite imagery of the railroad embankment at the failure location; (b) location of the failure; (c) View of the repair works as recorded by coincidence by the Google Earth Camera.

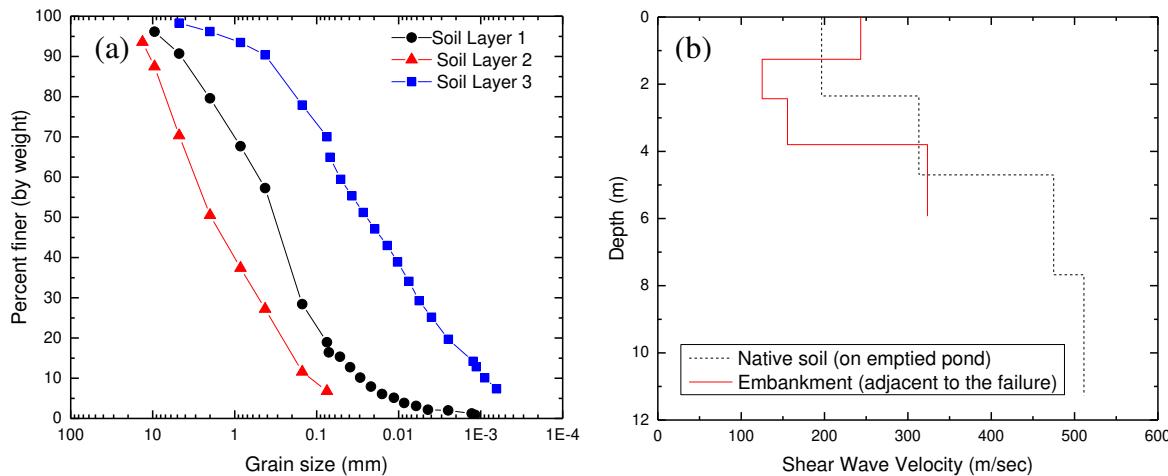
Soil Layer 1: This soil layer represents the main embankment layer, as shown in Fig. 5, and is classified per USCS as silty sand (SM). 18.9% of the material are non-plastic fines as shown in Fig. 8a. Since undisturbed samples were impossible to collect for the sandy fill, tests were conducted on reconstituted specimens at two different density states to evaluate the range of shear strengths expected for these materials. The direct shear tests were conducted in dry conditions. The shear strength of the material at a dense state was evaluated on the basis of direct shear testing, and the peak friction angle was found to be equal to 46° , whereas the post-peak was found to be equal to 38° without any cohesion, as shown in Fig. 9. The large-displacement friction angle at a dense state is approaching the peak friction angle of the soil at the loose state that was found to be equal to 35° . The hydraulic conductivity of the soil at a dry unit weight of 1.71 gr/cm^3 , was equal to $5.1 \times 10^{-5} \text{ cm/sec}$ based on a falling head hydraulic conductivity test conducted in the laboratory.

Figure 8. Results of (a) grain size distribution analyses and (b) in-situ shear wave wave velocity

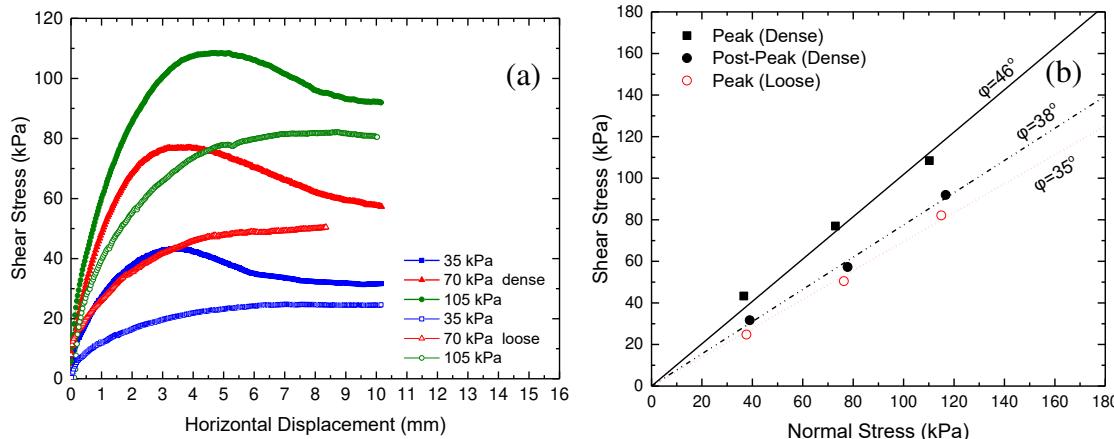
Figure 9. Direct shear results at nominal vertical stresses of 35 kPa, 70 kPa, and 105 kPa on reconstituted specimens of Soil Layer 1.
